## COMPOSITE HULL FOR AN AMPHIBIOUS VEHICLE

Design, Fabrication, and Testing of a  
Composite Hull for a Tracked Amphibious Vehicle  
Phase I and II Final Report

August 1988  
Period Covered:  
30 December 1983 - 31 October 1986

Martin Marietta Corporation  
Aero & Naval Systems  
103 Chesapeake Park Plaza  
Baltimore, Maryland 21220

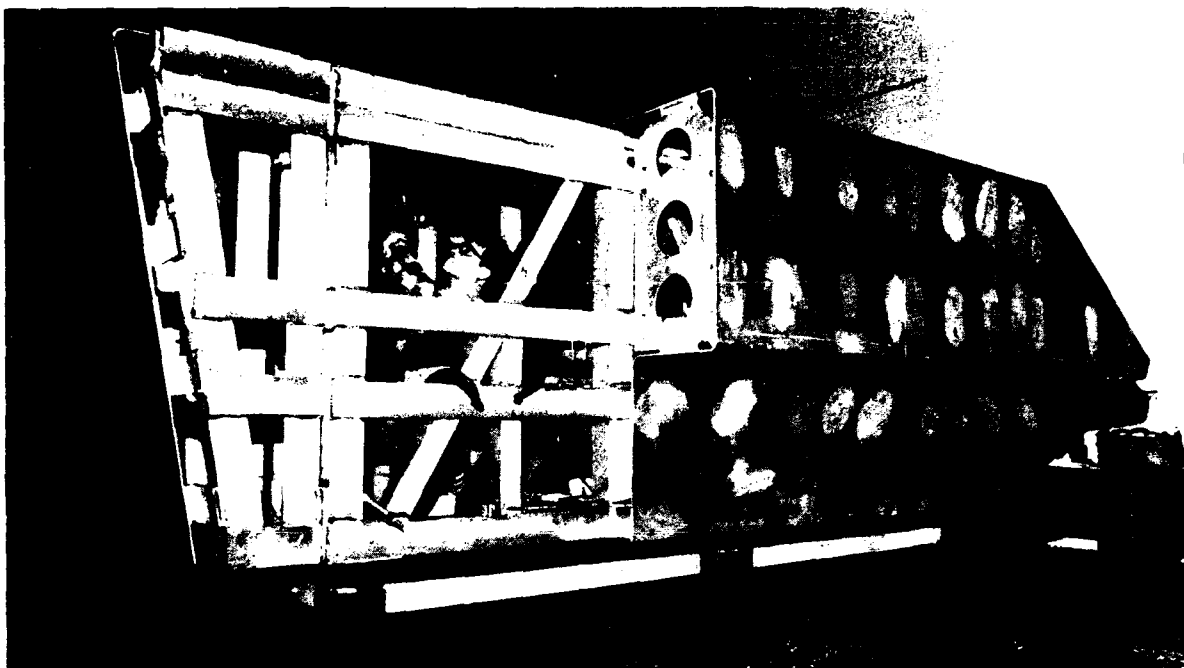
Figure 6-2. Upper Hull Layup Tool

The only major tool used in the manufacture of the demonstration hull was the upper hull lay-up mold. This large multiple piece tool was used for the lay up and cure of the GRP upper hull laminate. An overall view of the tool during its assembly is shown in Figure 6-2. It consisted of a central load bearing structure made up of square extruded aluminum pieces welded together. The actual lay-up surface consisted of brake-formed pieces of 1/4-inch thick aluminum plate with interior bulkheads to rigidize each individual section. The sections of the layup surface were bolted to the load bearing truss. The sections were arranged so the central truss could be removed first and the geometrically trapped sections of the layup surface could be slid inward until they were free to be removed from the cured layup. Since the interior dimensions of the GRP upper hull are critical to a proper fit-up with the lower hull and installation of some M113 equipment, the tool was sized to compensate for the differential thermal expansion between the GRP laminate and the aluminum tool.

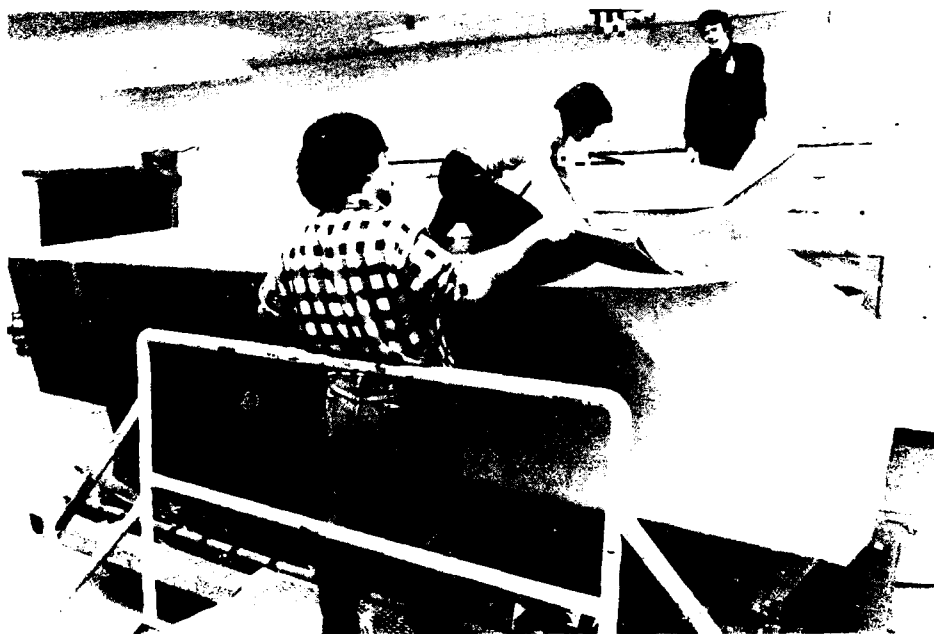
Figure 6-3. Layup of Upper Hull

The GRP upper hull was fabricated in two stages; a basic 3/4-inch thick laminate and a 1/2-inch thick roof doubler. The 3/4-inch thick laminate makes up all of the surfaces of the upper hull. The doubler was added inside the roof area of the 3/4-inch thick layup to bring the total roof thickness up to 1-1/4 inches.

Prior to beginning the layup, the aluminum tool was solvent wiped with clean solvent and coated with Frekote 33 release agent. The overall 3/4 inch thick laminate was then laid up. The ply sequence of the layup is shown in Table 6-1. Also included in the table are the roll number and properties of the preimpregnated woven roving used in each ply. The layup was debulked under vacuum bag pressure for a minimum of one hour every second ply to ensure that female radii were properly compacted and to avoid "puckering" of the male radii and corners. Figure 6-3 shows the hull layup in progress. Debulking was accomplished by placing one ply of breather material over the layup, applying a nylon film vacuum bag and evacuating the bag to a pressure of less than 26 torr. All debulks were

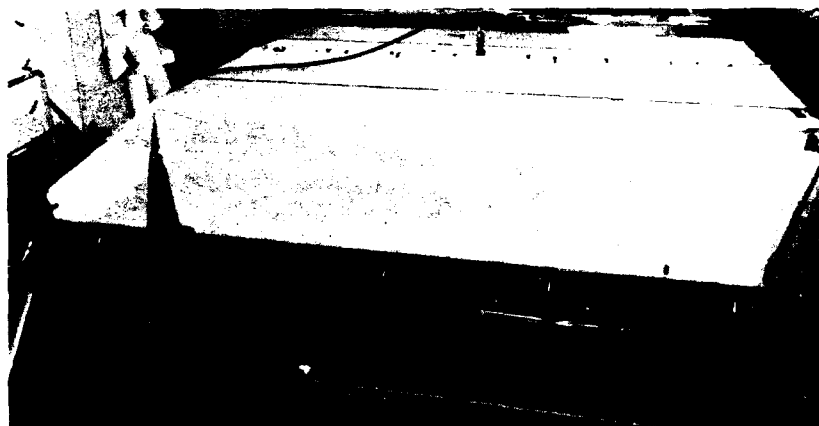
Figure 6-4. Upper Hull Layup Bagged and Ready for Autoclave Cure

The completed layup was prepared for curing by placing one layer of nylon tear ply, one layer of Mauchberg bleeder ply, and a nylon film autoclave bag on the outer surface. The bag was sealed to the tool just below the layup. The layup and tool were instrumented with 12 thermocouples to monitor temperatures during cure. Two vacuum fittings were connected to the bag, one in the center of the aft end, the other in the center of the roof. The bagged upper hull layup is shown in Figure 6-4. A vacuum of 26 torr was pulled on the bag, the assembly was placed in the autoclave, pressurized to 100 psig, and heated to 250°F. The part was cured for two hours at 250°F and cooled to 150°F before removal from the autoclave. The internal part temperatures were measured by thermocouples embedded in the center of the layup (ply level 18) on the roof and aft end. These measurements are particularly significant because they show the amount of exothermic heating occurring during cure. Temperatures in the center of the laminate rose about 45°F above the desired cure temperature. This level of exothermic heating is considered acceptable and will not cause any degradation of the finished laminate. The cured upper hull layup is shown in Figure 6-5.

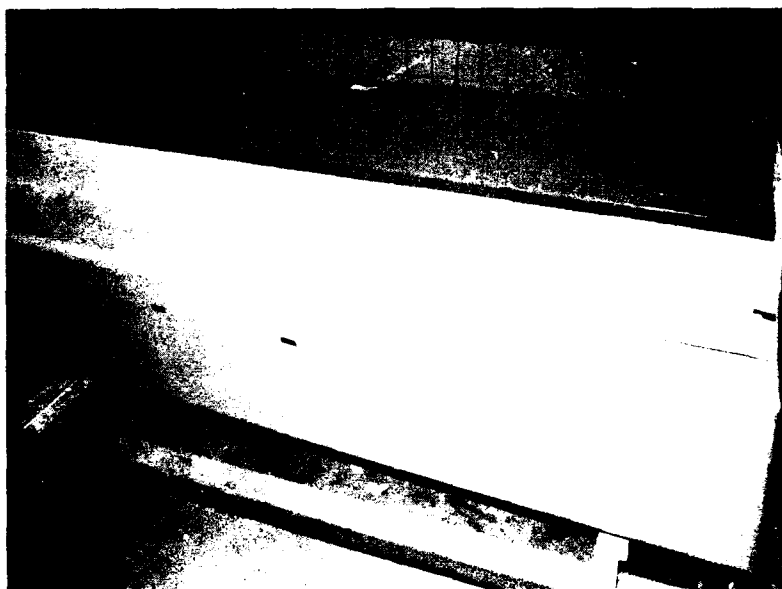
Figure 6-6. Grid used for NDI Reference

The cured upper hull was nondestructively inspected twice using pulse-echo A-Scan with a 1 MHz, 3/4-inch diameter ultrasonic transducer. The 36-ply hull was laid out in a 6 inch by 6 inch grid pattern, labeled, and photographed (see Figure 6-6). Each square was scanned using water as a couplant. The instrument was set up using a piece of trim with 3/8 inch diameter flat bottom holes, 0.25 and 0.50 inch deep as a standard. Both of these defects were readily visible. The criteria for notation of an anomaly were an observation of an intermediate reflection or a loss of the back wall reflection. This inspection process was repeated for the 18 ply doubler after it was cured. The anomalies observed are outlined in Figure 6-7. The only visual anomalies in the hull after trim were a slight bridging condition in the sponson radius and a rough interior surface. This later condition was attributed to air leaks in the layup tool.

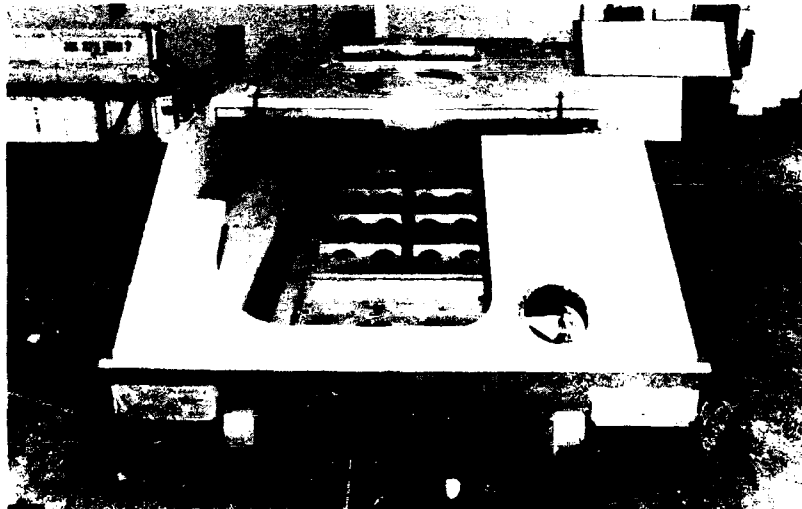
Figure 6-9. Upper and Lower Hull Fit-Up

The upper and lower hulls were joined by means of a bonded, bolted lap joint. The initial step in joining the hull sections was to lower the upper hull onto the lower hull. During the initial fit-up it was observed that residual stresses in the GRP upper hull had caused it to distort locally when it was trimmed and the various openings were cut into it. These distortions resulted in mismatches between the upper and lower hulls when they were mated. When the forward roof beam and the hatch/door frames were installed and clamped in place, the mismatches were eliminated and a good fit resulted (Figure 6-9). Once the fit-up was verified, the hull pieces were separated, the lower hull was grit blasted, and the surfaces that would mate with the upper hull were brush treated with Iridite 14-2. Next, the hull pieces were mated again and EA 9330 adhesive was injected between all faying surfaces. The lower edges of the joint were sealed with round rubber stock to prevent the adhesive from draining out from the joint. The adhesive was allowed to cure 16 hours at room temperature.

Once the adhesive was cured, holes for the bolts were drilled using a Quackenbush Model 444 power feed drill. The holes were located by means of a template. A total of 500 3/8-inch diameter holes were drilled for the main joint. Next, the bearing plates were located over the hole pattern and the main joint bolts were installed. The bearing plates were dip Iridited and their faying surfaces were covered with EA 9330 prior to installation. All fasteners were coated with zinc chromate primer and installed wet. All main joint bolts were torqued to 20 foot-pounds.

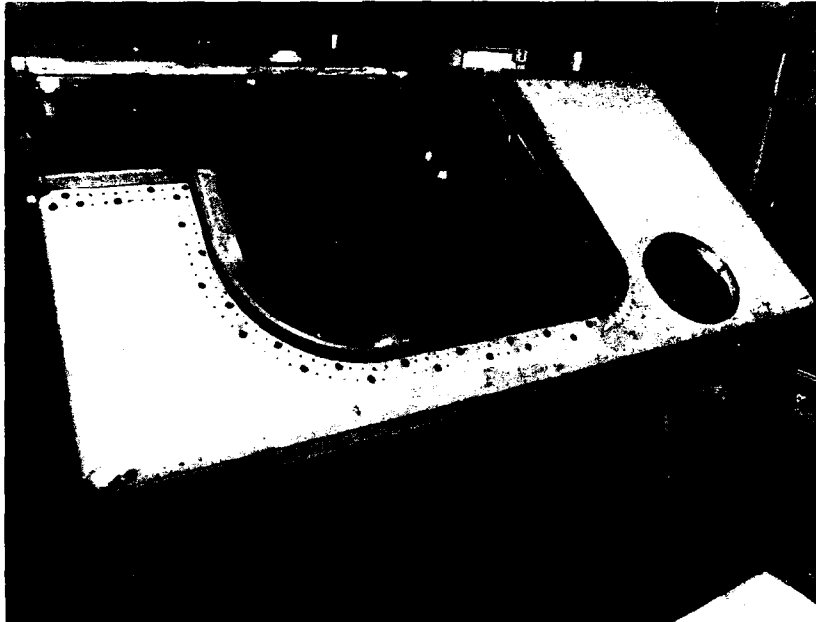
Next, the vertical edge guard fenders and the track shroud attachment bars were installed. The edge guards were attached using expanding threaded inserts in holes drilled into the GRP, while the track shroud mounting strips used custom made through hull nuts. The fenders were attached using bolts and a combination of the above inserts. The hull is shown during assembly in Figures 6-10 and 6-11.

Figure 6-10. Front View of Hull During Assembly

Figure 6-11. Side View of Hull During Assembly

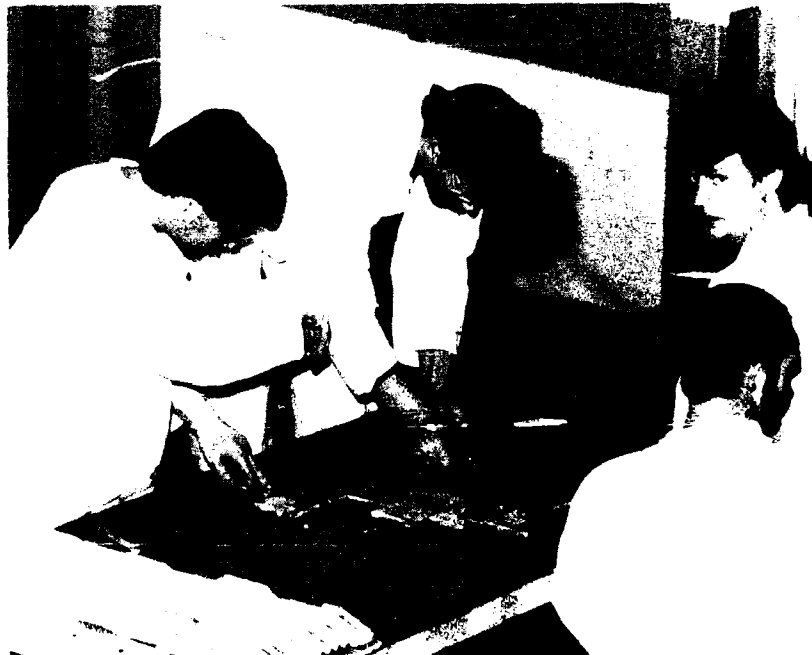
Figure 6-12. Tile Bonding

For the baseline case, tile bonding and coversheet bonding were accomplished in the same process. The surfaces of the GRP laminate were prepared for bonding by removing the nylon tear ply. The aluminum coversheet was prepared by a sodium dichromate/sulfuric acid etch and the tiles were cleaned by vapor degreasing. The aluminum and tiles were primed with Furane 88060 primer. Precured urethane elastomer spacers 0.063-inch thick were bonded to the top, bottom, and sides of each tile to control tile-to-GRP, tile-to-tile and tile-to-cover bondline thickness. Prior to bonding, temporary aluminum dams were placed along the edges of the sides and front, not already framed by edge guards, to form a contained area into which adhesive would be poured. The hull was then rotated so the area to be bonded was horizontal. The tile bonding was accomplished in three separate operations, one for each side and one for the front. The first step of the bonding process was to pour an excess of mixed Uralane 8089 adhesive into the dammed area. The tiles were then pressed into the uncured adhesive until they bottomed out on the spacers, Figure 6-12. Then, on the left side and front, an aluminum coversheet was placed over the tiles and pressed down until it contacted the spacers on top of the tiles. Excess adhesive was scraped away and the assembly was allowed to cure 16 hours at room temperature. On the right side of the hull no coversheet was installed at this stage; excess adhesive was scraped away to expose the tiles. After the adhesive had cured on the right side a cover of abrasion resistant urethane elastomer was applied by airless spraying. The material was applied in 0.10-inch coats with a drying time of 20 minutes between coats. The final cure was 16 hours at room temperature.

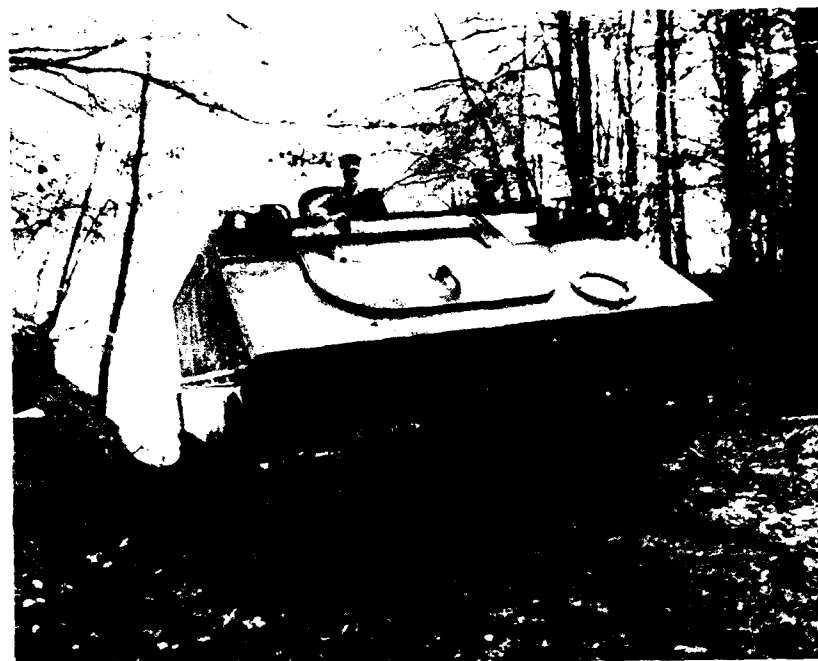
Figure 6-13. Complete Vehicle

Equipment installations in the composite hull were, with only a few exceptions, identical to those in the standard M113A1. The exceptions were: use of threaded inserts to attach support clips for wiring harnesses to the GRP, the addition of wires to ground electrical equipment attached to GRP, installation of lifting eyes by bolting through the hull, and minor rerouting of the engine compartment fire extinguisher plumbing.

The completed vehicle is shown in Figure 6-13.

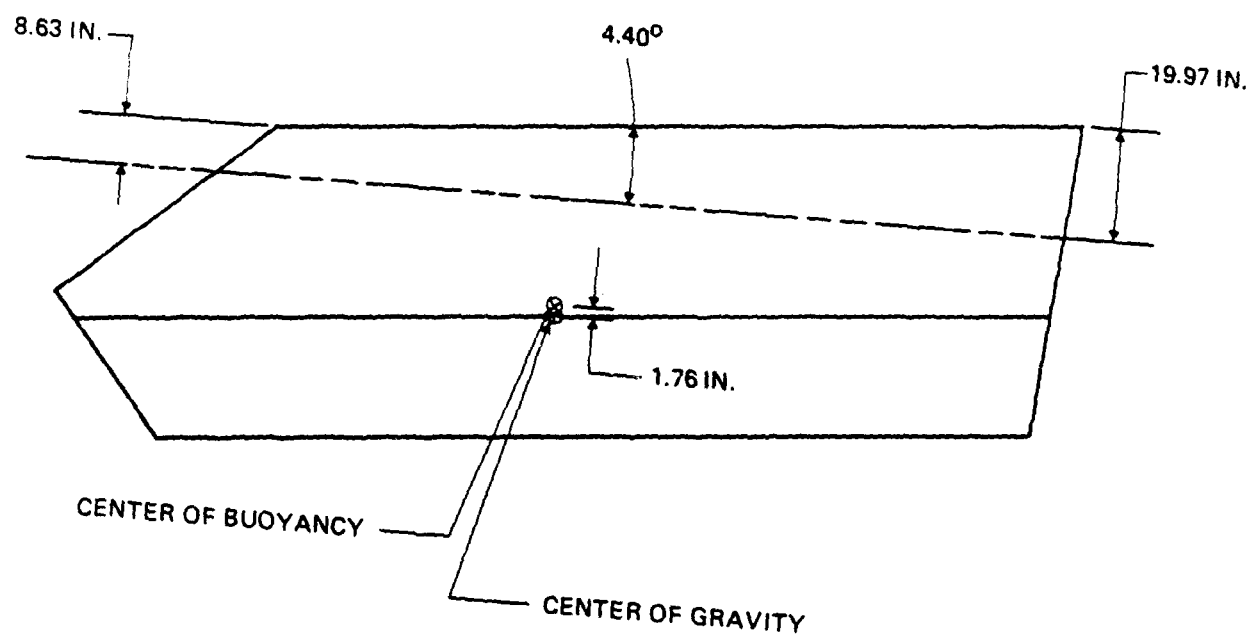
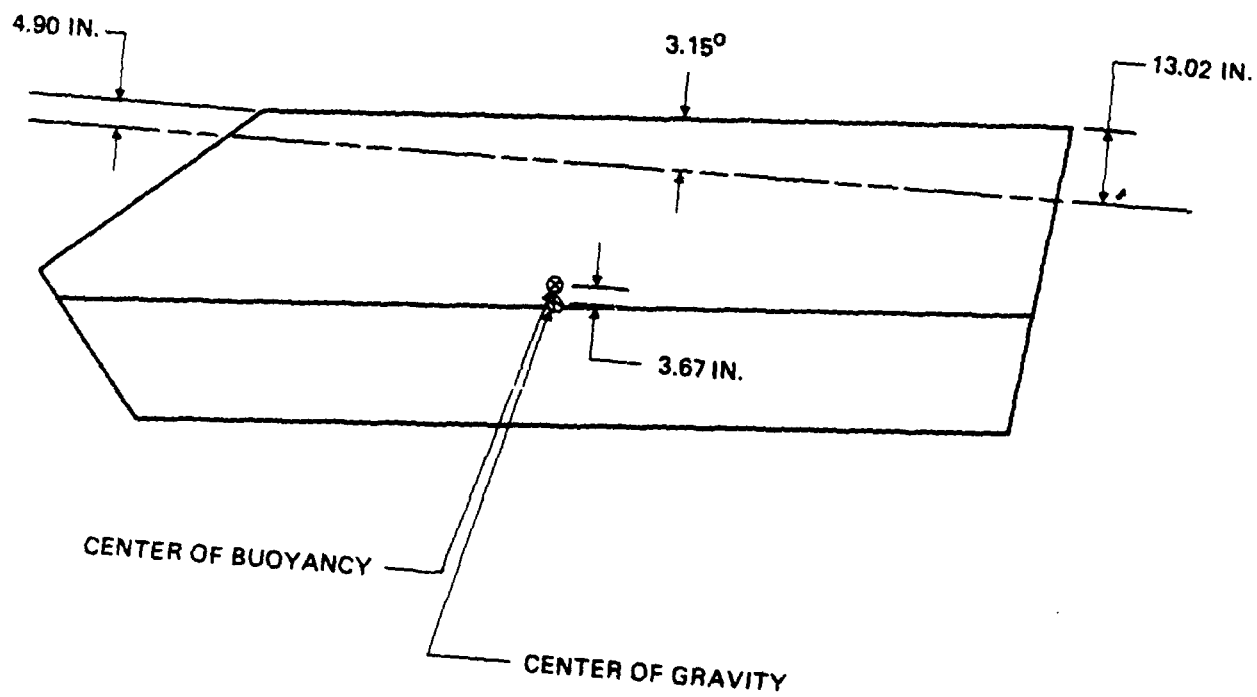
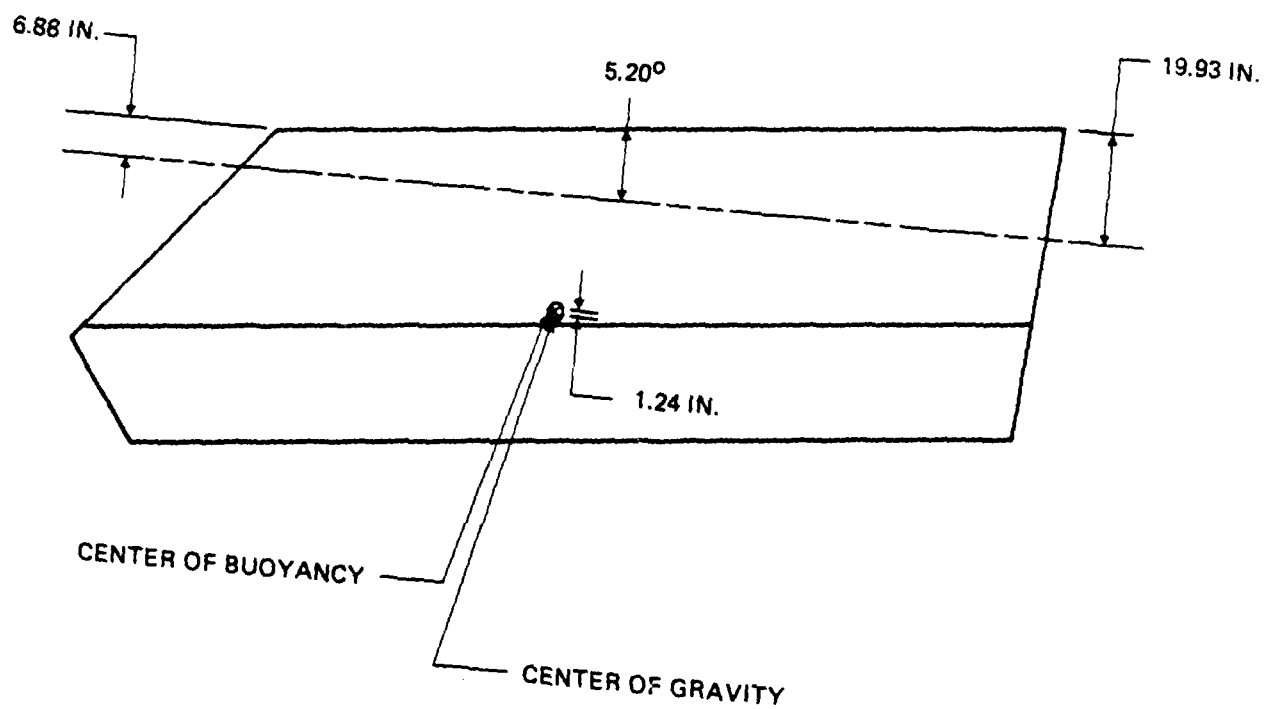
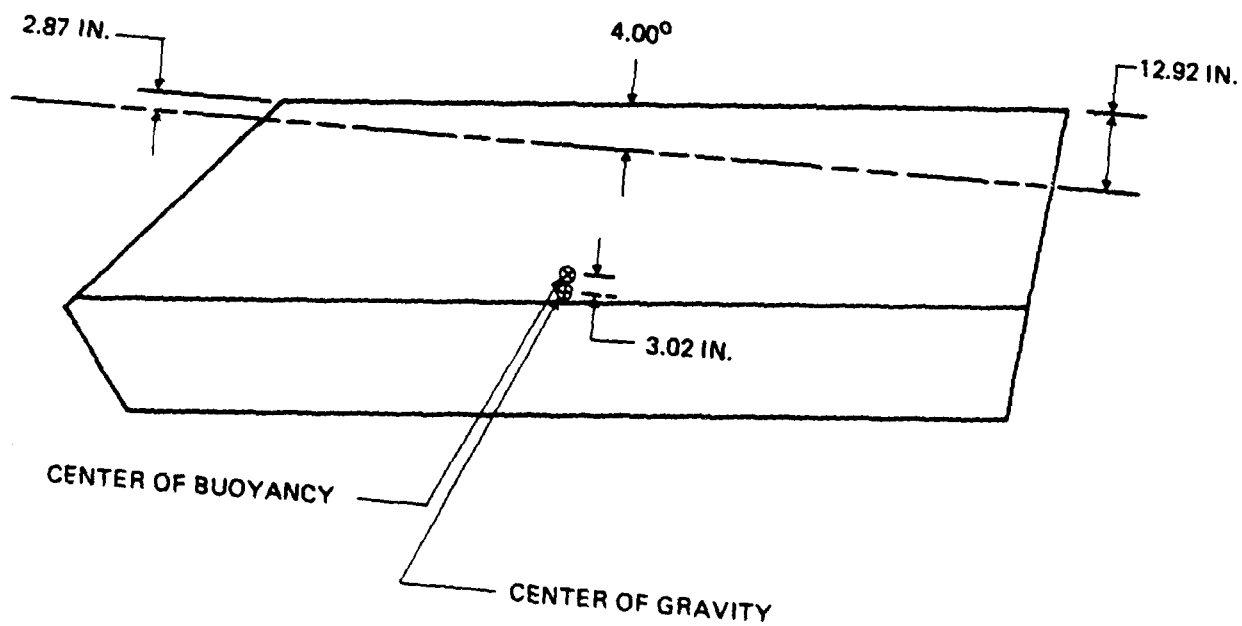
The center of buoyancy (CB) was calculated for both the aluminum M113 hull and the GRP M113 hull. Since a comparison of the flotation stability was the desired goal rather than an absolute measure of the stability, simplified models of the aluminum and composite hull were constructed using the Computervision<sup>R</sup> graphics system. The models were representative of the outer moldline of the respective hulls without attachment hardware and running gear. The vehicle waterline and CB were determined by several iterations of rotating the vehicle longitudinally (the lateral water line was assumed to be parallel with the hull) and matching the displaced water weight with the desired vehicle weight. At the same time, the center of buoyancy was lined up with the vehicle center of gravity on a line perpendicular to the waterline. The results of these calculations for the combat loaded and curb weight vehicles are shown in Figures 7-1 through 7-4.

The composite hull is trimmed more nearly level in the water for both the curb weight and combat loaded conditions. This is a result of the larger volume up front on the composite hull caused by the lower angle of the nose plate. Measurement of the distance between the CB and CG indicates that the composite hull will be more stable, with a center of gravity about 1/2 inch further down from the CB for both load conditions.

Figure 7-1. Composite Hull Curb Weight

Figure 7-2. Composite Hull Combat Loaded Weight

Figure 7-3. Present M113 Curb Weight

Figure 7-4. Present M113 Combat Loaded Weight
