REPAIR, EVALUATION, MAINTENANCE, AND  
REHABILITATION RESEARCH PROGRAM

TECHNICAL REPORT REMR-CO-10

STUDY OF BREAKWATERS CONSTRUCTED  
WITH ONE LAYER OF ARMOR STONE  
DETROIT DISTRICT

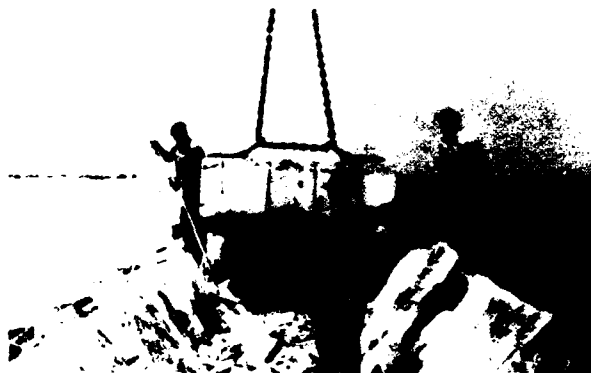
Figure 2. Block of cut armor stone being placed on the crest of rubble-mound breakwater using a chain sling and hooks

25. Figures 1 through 9 show breakwater construction, armor-stone quarrying, and breakwater structures. Figures 1 through 3 show armor stone being placed on a breakwater and being cut in the quarry. Figures 4 through 9 show six breakwaters in the Great Lakes which have one layer of armor stone.

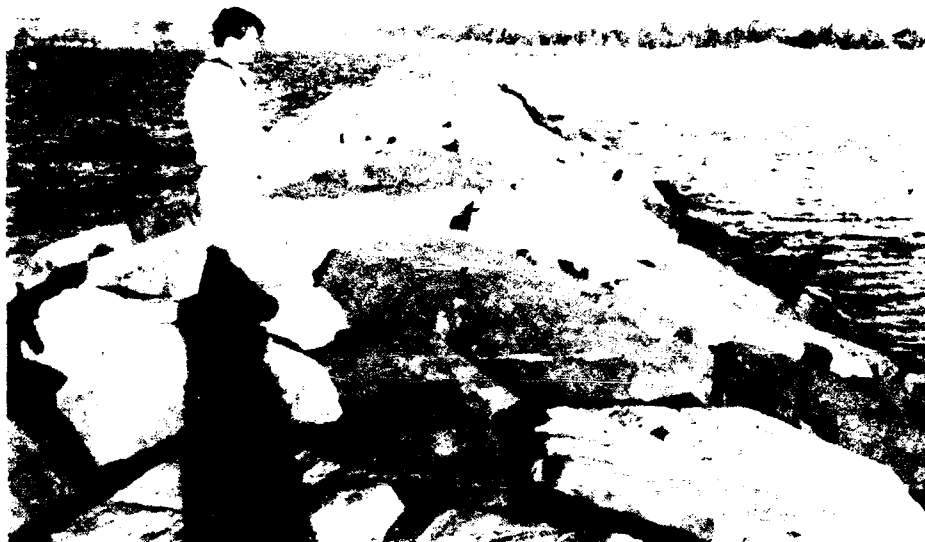
Figure 4. Marquette Harbor breakwater constructed with one layer of armor stone of hard rock

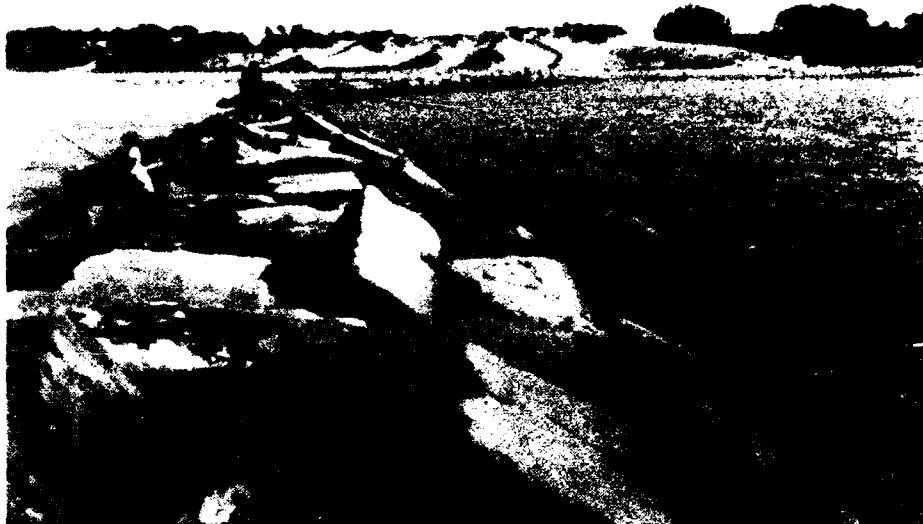
Figure 6. New Buffalo Harbor breakwater constructed with one layer of Bedford Limestone armor stone

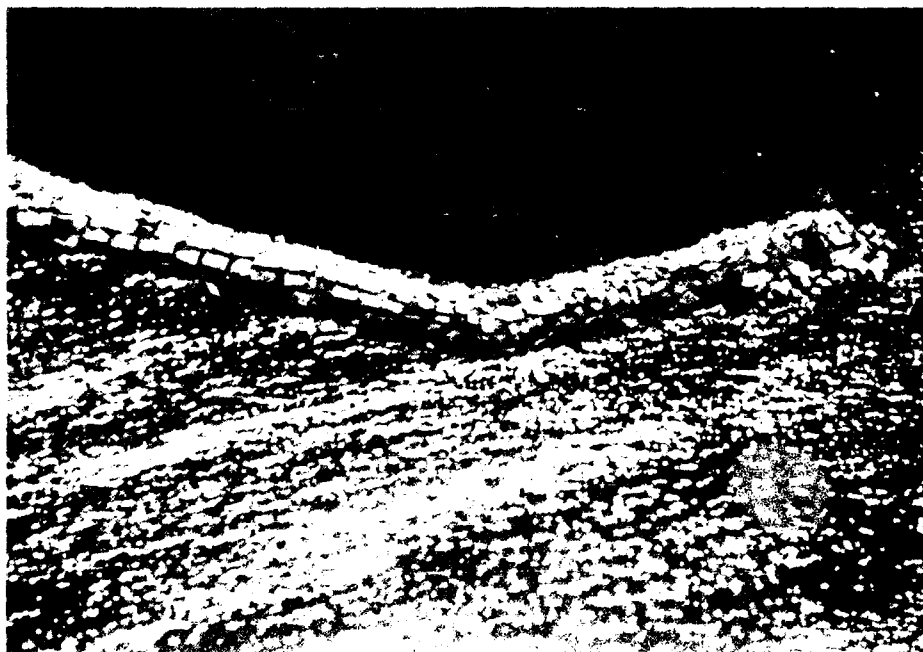
Figure 7. Leland Harbor breakwater constructed with one layer of Bedford Limestone armor stone
