# The Human Factors Relating to Escape and Survival from Helicopters Ditching in Water

Captain(N) C.J.Brooks  
Defence & Civil Institute of Environmental Medicine  
1133 Sheppard Avenue West  
P.O. Box 2000  
Downsview, Ontario M3M 3B9  
Canada

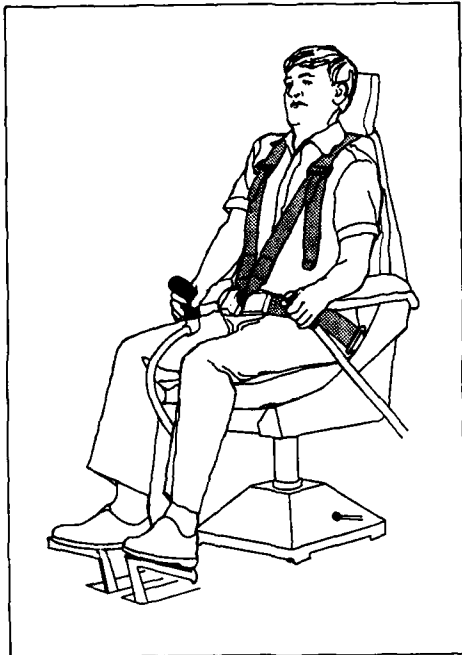
Figure 6. Recommended positions for pilots ditching helicopters in water using a 4 or 5 point restraint harness.

A. Pilot in control - Headrest

(iii) Pilot in Control - Headrest Fitted (Figure 6A)

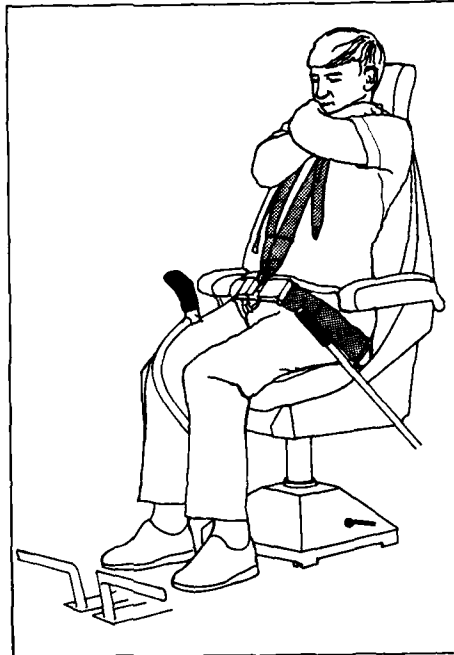
B. Pilot not in control - Headrest

(iv) Pilot Not in Control - Headrest Fitted (Figure 6B)

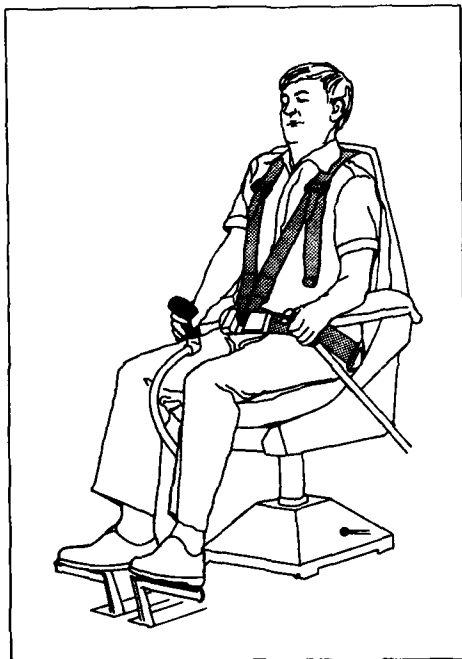
C. Pilot in control - No headrest

(v) Pilot in Control - No Headrest (Figure 6C)
