AFIT/GAE/ENY/89D-34

IMPACT DAMAGE TOLERANCE OF
COMPOSITE CYLINDRICAL PANELS

THESIS

Eugene A. Senn
Captain, USAF

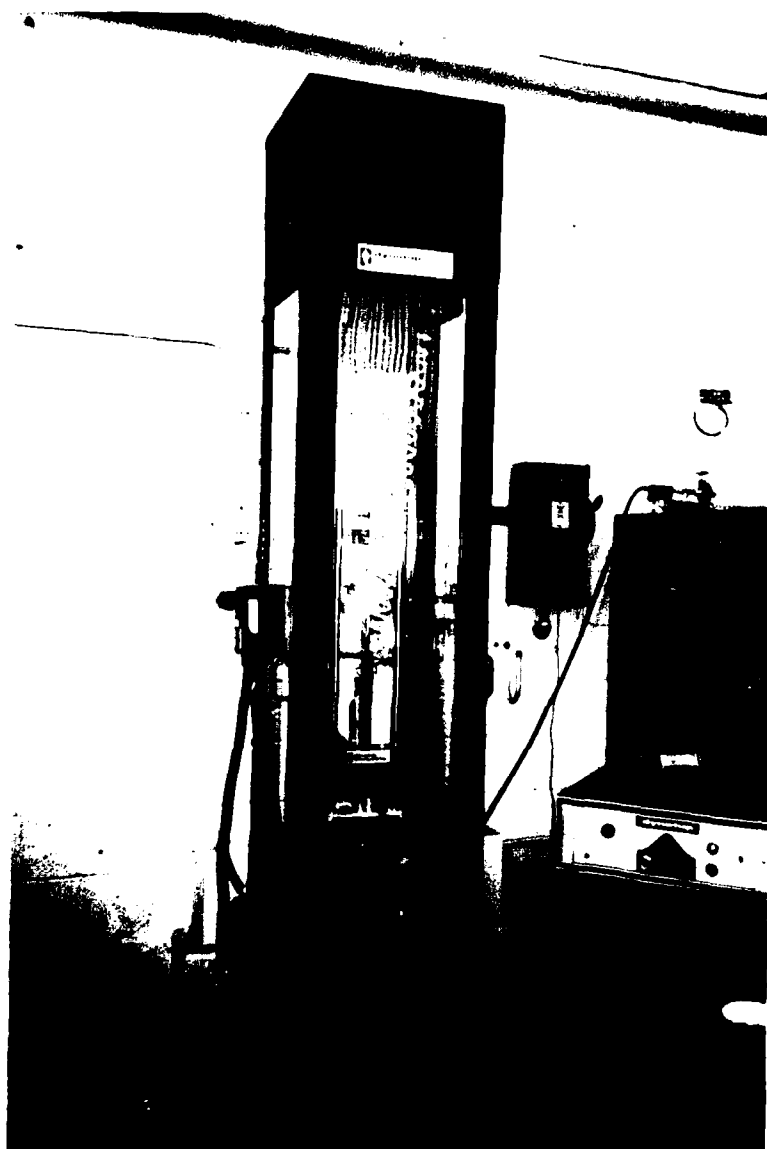
Figure 2.2 - Dynatup Impact Test Machine

The panels were subjected to a single, transverse (-z direction) impact normal to the surface of the panels. A GRC 8250 Dynatup Impact Test Machine (hereafter called Dynatup) made by General Research Corporation, was the test fixture used (see Figure 2.2) [12]. The impactor used was a 1/2" diameter tup weighing approximately 5.5 pounds and instrumented with an accelerometer to measure the contact force between the tup and the panel. The data obtained from the accelerometer is acquired and analyzed by a GRC 730-I Instrumented Impact Test Data System.

The panel-support block assembly is placed on an adjustable support plate underneath the impactor. As was mentioned earlier, the mass of the impactor used was approximately 5.5 lbs. Therefore, the impact velocity and subsequently the energy is varied by changing the drop height. For the Dynatup, the drop height was set using a tape measure. The height can be adjusted by using an Up-Down switch on the control panel shown in Figure 2.2.

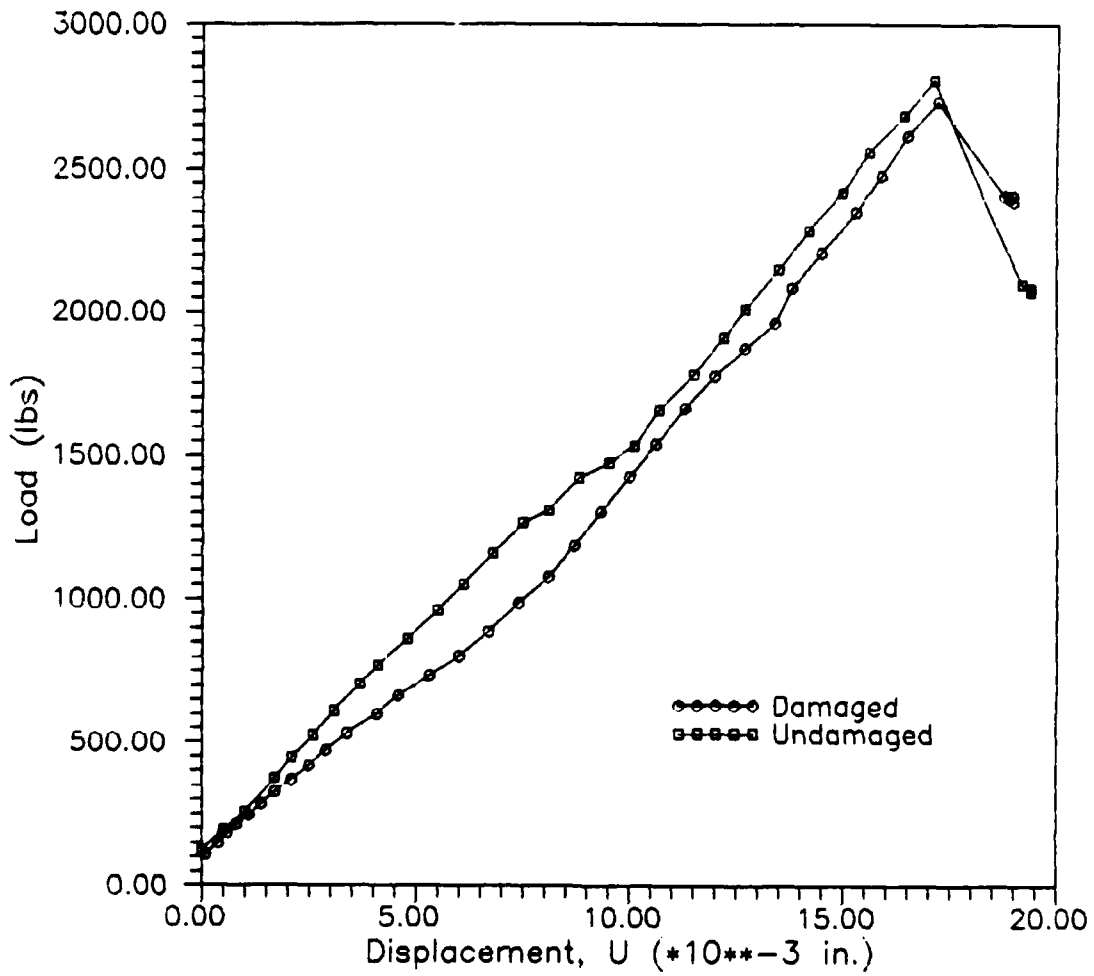
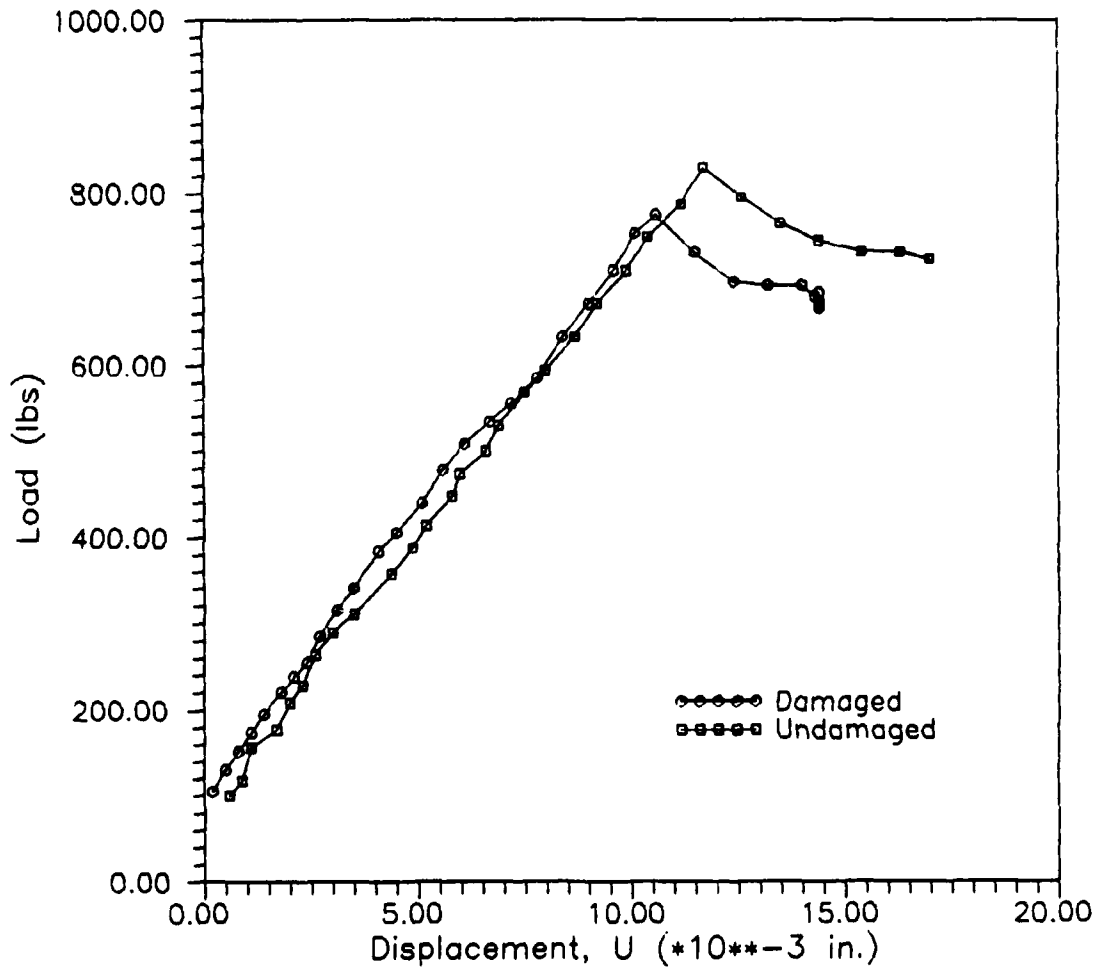
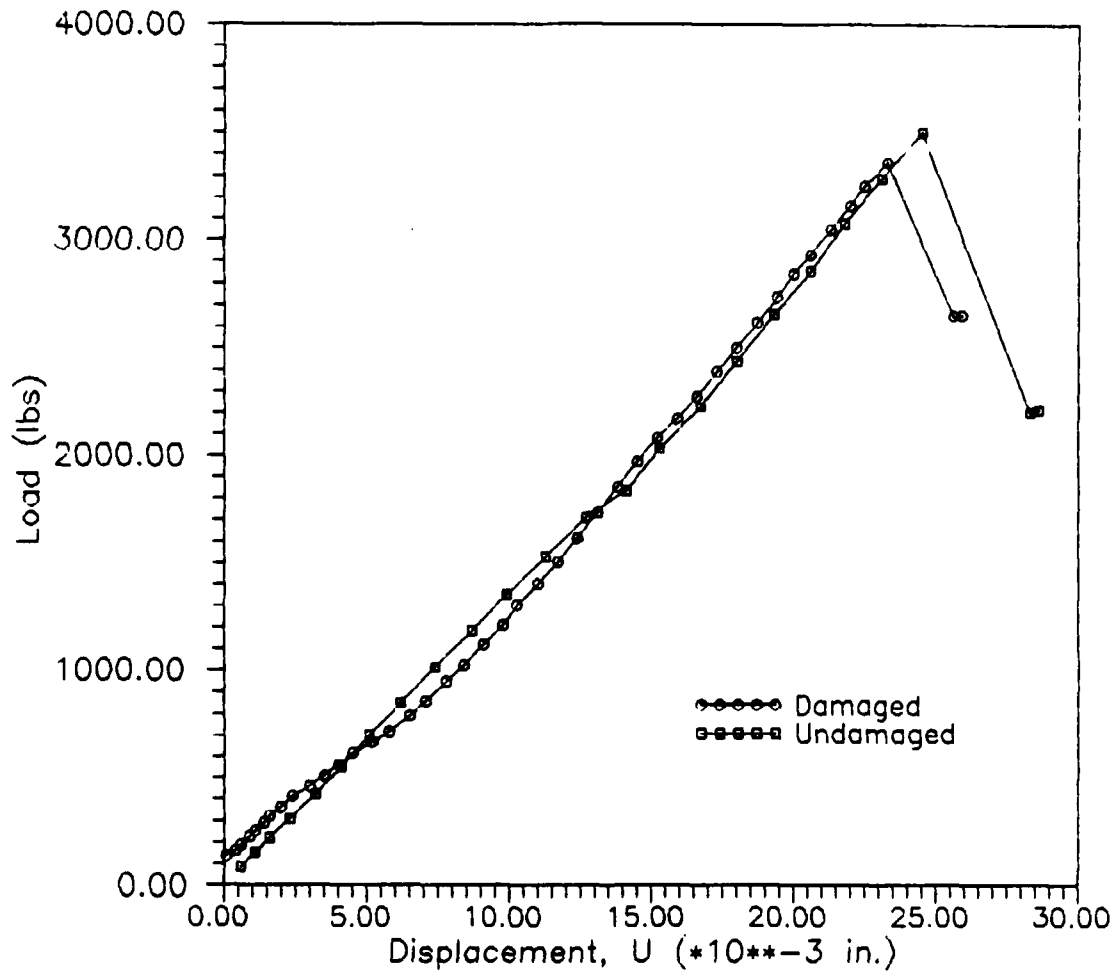
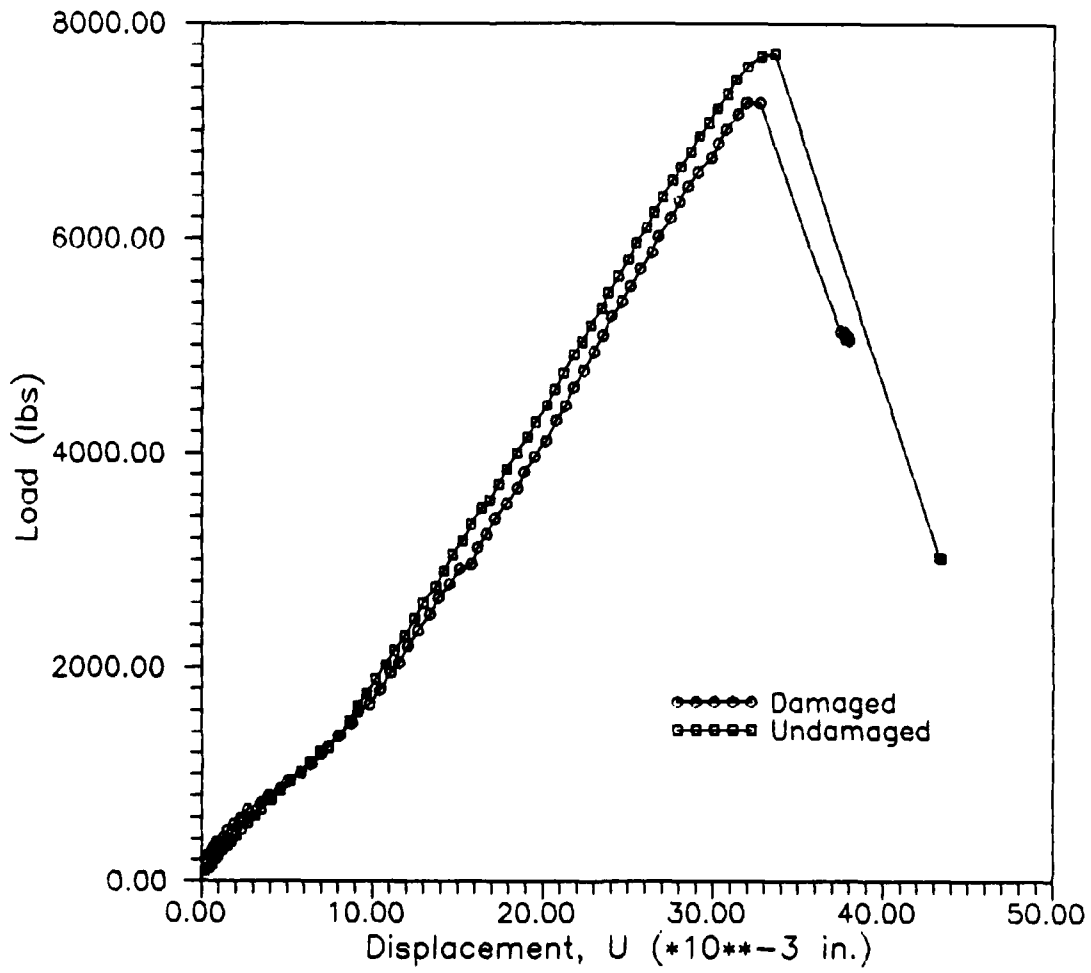
Figures 2.17-2.22 show plots comparing load vs. in-plane displacement, u , for damaged and undamaged panels of each material and ply orientation used to generate Tables 2.3 and 2.4. In each case, little difference in the stiffness of the damaged panels can be seen compared to the undamaged panels. Only the collapse load differs.
