REPAIR, EVALUATION, MAINTENANCE, AND  
REHABILITATION RESEARCH PROGRAM

TECHNICAL REPORT REMR-CO-14

## REPAIR OF LOCALIZED ARMOR STONE DAMAGE ON RUBBLE-MOUND STRUCTURES

### Coastal Model Investigation

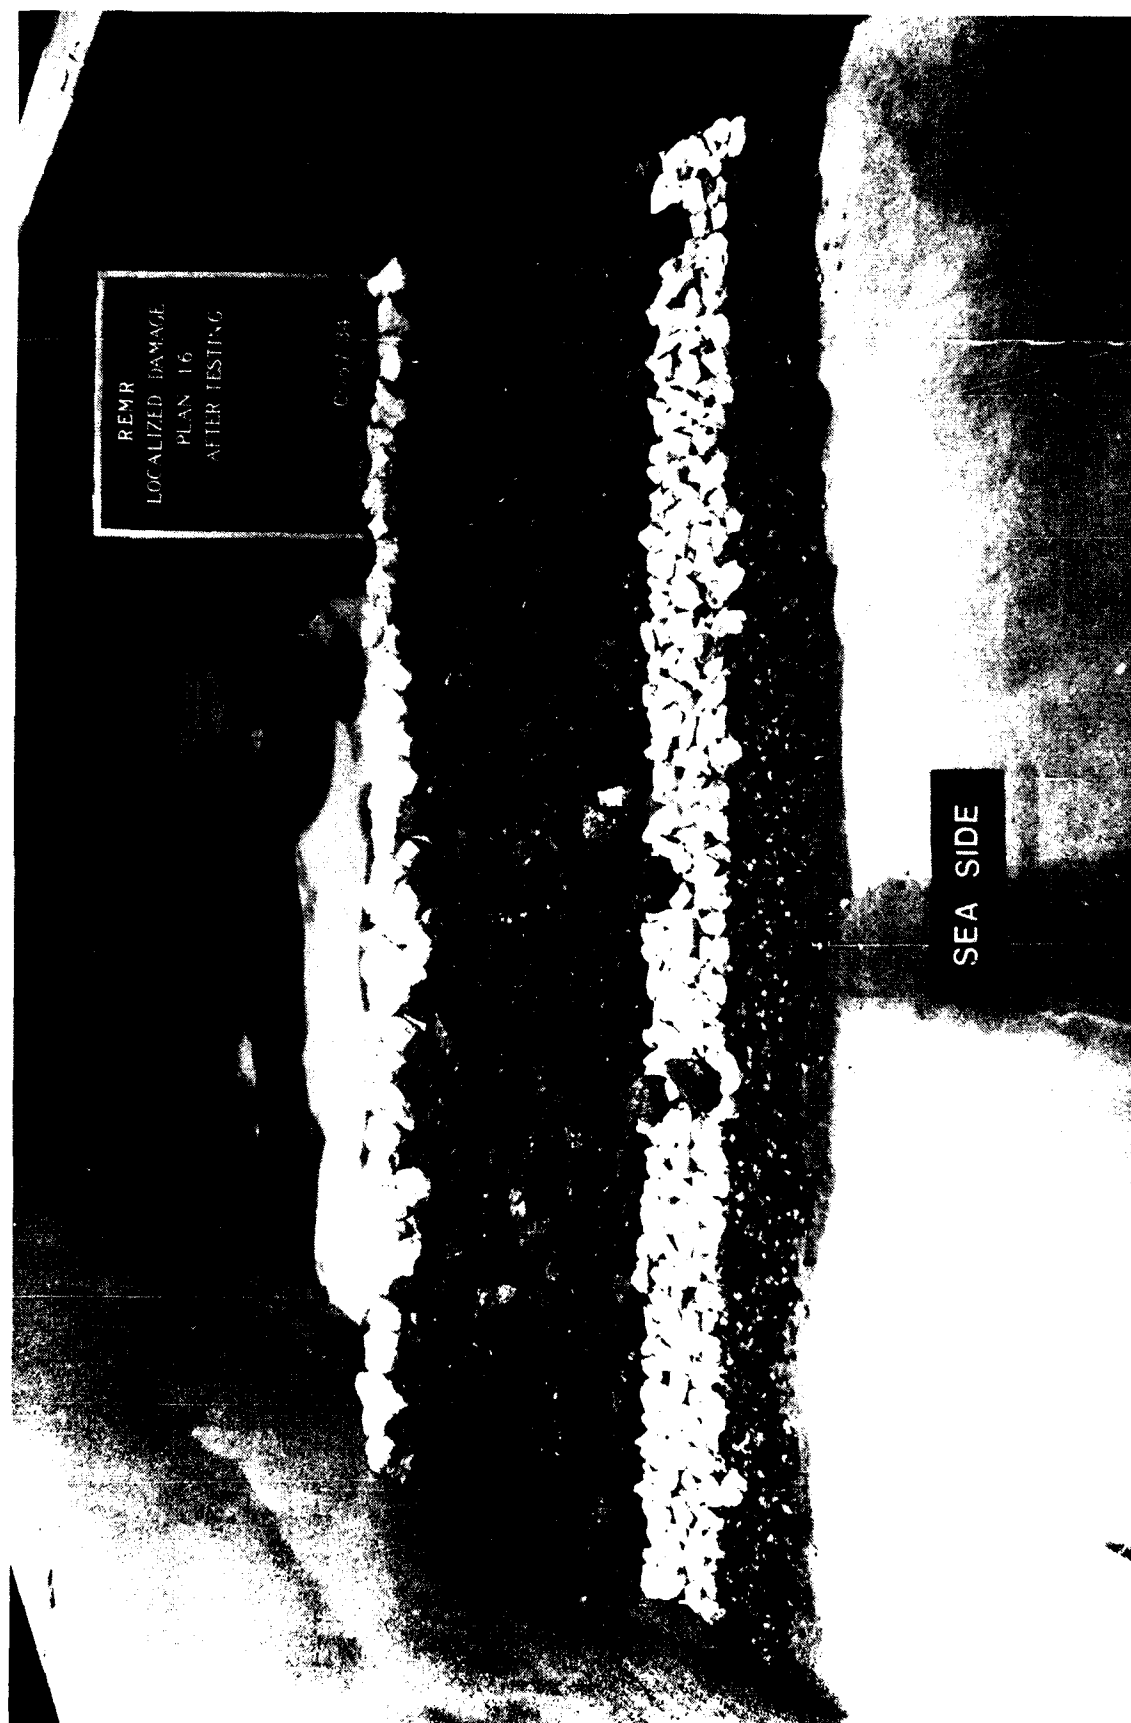
Photo 3. Typical damage to structure in 6.75-ft flume during Phase I

18. The Phase I test procedure was performed as follows. After the structure was completed in the facility, photographs of the structure were taken to record the initial condition of the structure. The flume then was filled to the selected water depth, and a set of waves of moderate height was run to settle the structure and simulate exposure of the structure to natural wave conditions prior to a design storm. Design waves then were generated for 30 min for each test. To minimize contamination of the incident waves by reflected waves, test time was accumulated on the structure in cycles of 30-sec generation time followed by a 5- to 7-min stilling time. The structure then was drained and the damage documented by photographs and written summaries. Damage to the structure was repaired using a selected repair method, and the structure was again documented with photographs. The structure then was exposed to the same test conditions that caused the damage to determine the repair option's response to wave attack. After testing a repair method, the flume was drained and the after-test conditions of the test sections were documented with photographs and written summaries. The test section armor layers and berm stone then were rebuilt, documented with photographs, and exposed to test conditions to produce damage for testing another repair method. The Phase I test procedure is shown in Figure 6; typical wave damage to the structures is shown in Photos 2 (5.00-ft flume) and 3 (6.75-ft flume).

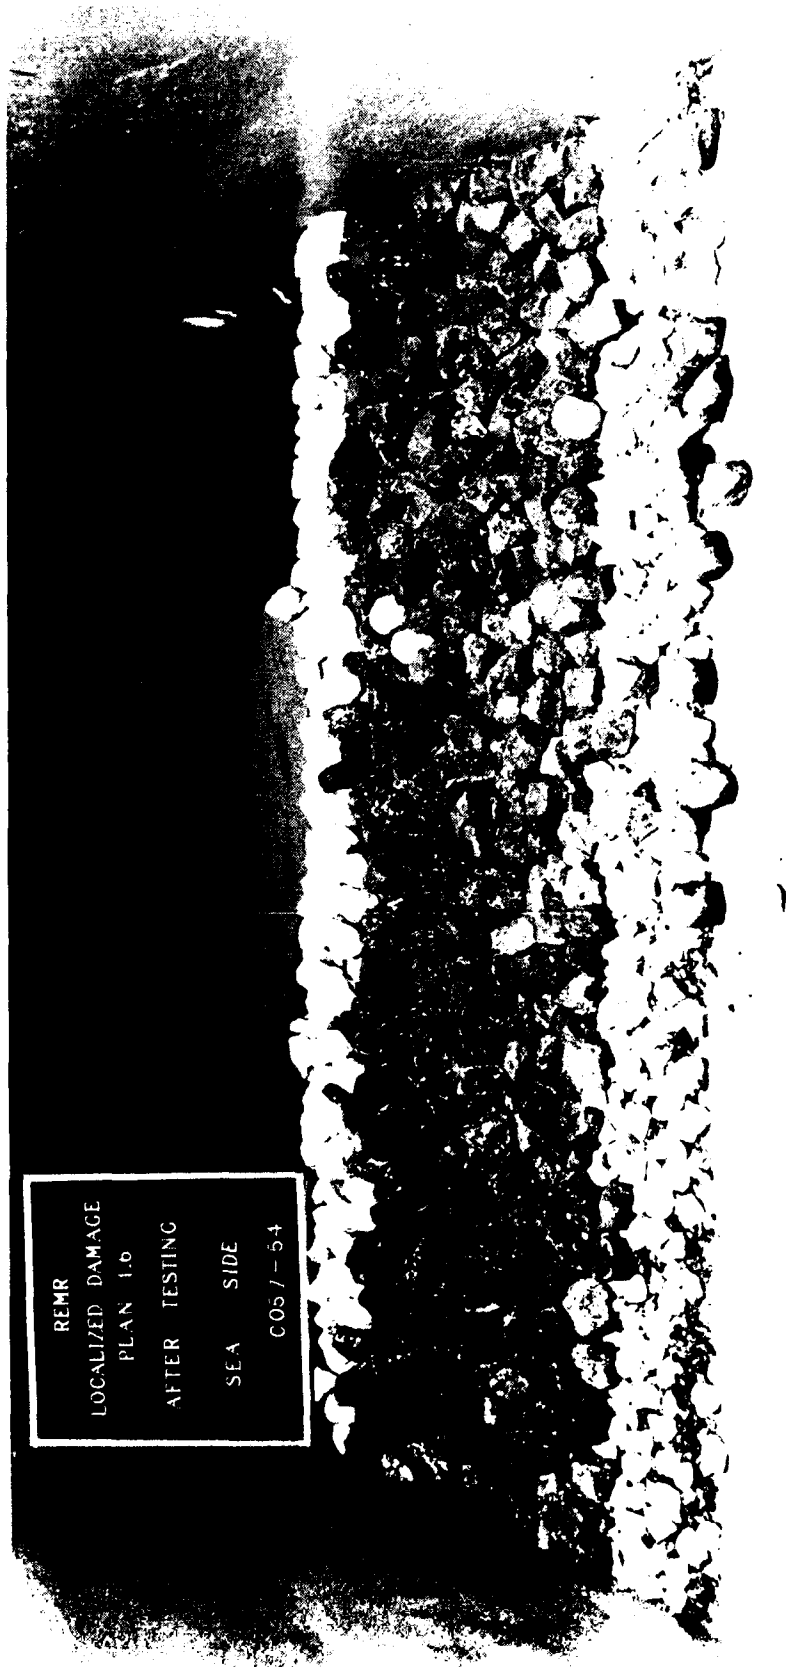
REMR  
LOCALIZED DAMAGE  
PLAN 1.0  
AFTER TESTING  
SEA SIDE  
C057-54

Photo 4. Typical damage to structure in 6.75-ft flume during Phase II

23. At this point, the armor layer was removed, and the structure was rebuilt. Photographs were taken to document the initial condition of the structure, and the procedure described in paragraph 20 was repeated except that repair options d and e replaced options a and b, respectively. Figure 7 illustrates the procedure used in Phase II; typical damage to the structure in Phase II is shown in Photo 4.
