REPAIR, EVALUATION, MAINTENANCE, AND  
REHABILITATION RESEARCH PROGRAM

TECHNICAL REPORT REMR-EI-5

THE EFFECTS OF VEGETATION ON THE  
STRUCTURAL INTEGRITY OF SANDY LEVEES

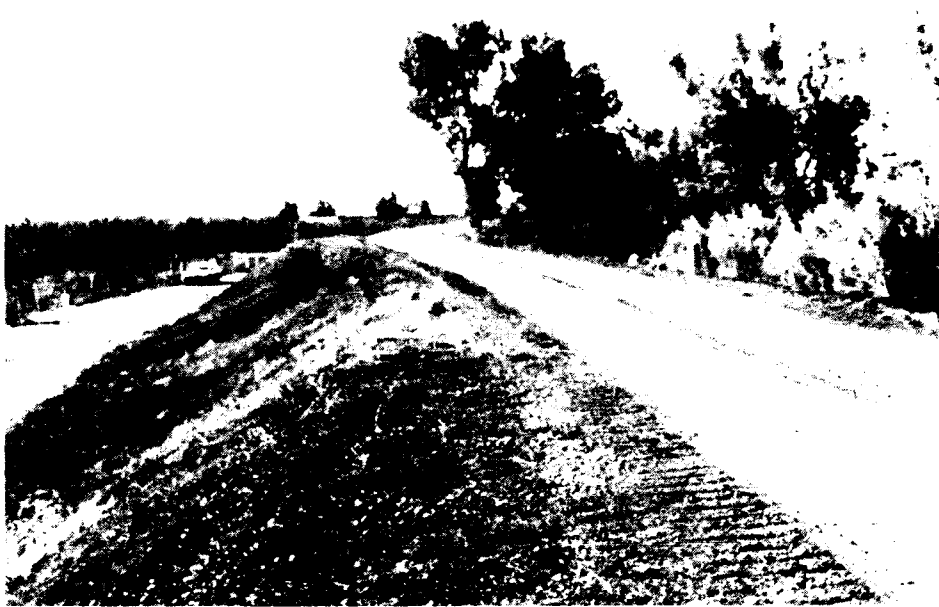
Figure 7. General view of levee at study site showing vegetation growing on riverward side and burned-over slope on landward side

58. The levee embankment is composed primarily of sandy soils which support mature, 30+-year-old cottonwoods and valley oaks. Black locust, shrubby willows, wild rose, and poison oak make up the balance of the woody plant community growing on the levee. Burning is used to maintain the levee vegetation at its current levels. The fire environment can significantly modify or change levee vegetation. Unfortunately, reliable information on the frequency and timing of burning was not readily available. Only limited information was gathered about the extent to which past burning practices might have altered the vegetative spectrum and other conditions, e.g., root structure and distribution, relative to that which would exist under natural succession. California ground squirrel burrows are ubiquitous in the levee. A general view of the levee illustrating some of the aforementioned features is shown in Figure 7.

59. The steeper, xeric landward slope of the levee generally faces to the west and receives not only the afternoon sun but also the force of occasional strong winds. Additionally, this face of the levee is burned annually to help prevent field fires (see Figure 7). Little grew in this harsh

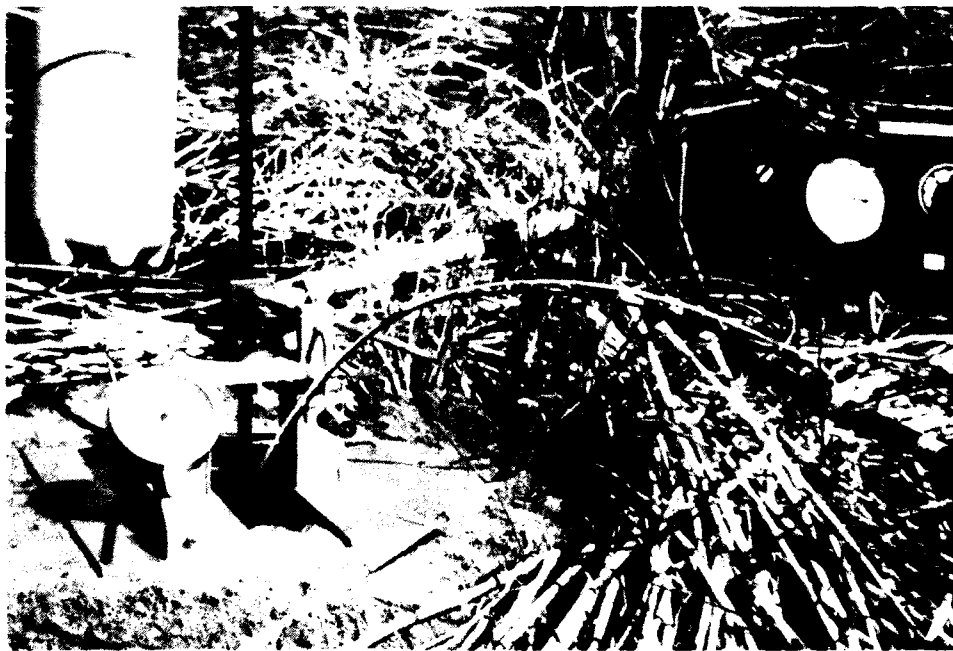
Figure 11. Iowa borehole shear test set up at levee site

borehole, direct shear device (Wineland 1975; Handy 1986). Shear strength can be determined rapidly as a function of depth with this device without the need to obtain samples. The borehole shear test consists of augering a pilot hole and then reaming to a diameter of 3 in. in order to create a borehole with smooth sides. A small pneumatic piston with serrated shearing heads at either end is then lowered down the borehole to the depth of interest. The serrated heads are next expanded out against the sides of the hole with a known normal stress. After an appropriate consolidation interval, the heads are pulled up the hole, thus creating a shearing stress. The tangential or shearing stress is recorded by means of a force platform at the surface which transfers the tensile force in the pulling rods to hydraulic cells which record the shearing stress at the serrated heads in the borehole as shown schematically in Figure 10. A photograph of a borehole shear test set up at a levee site is shown in Figure 11.

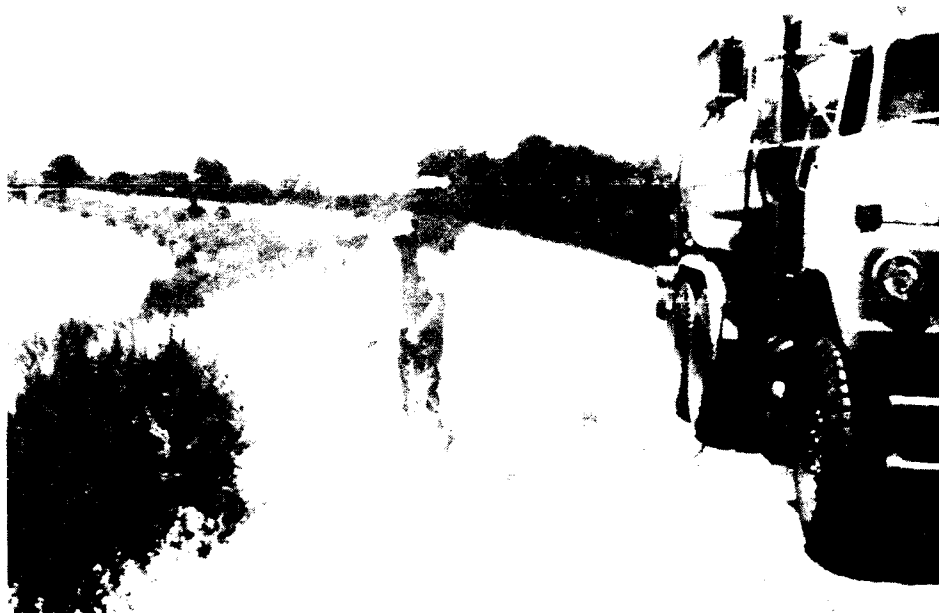
Figure 12. Watering truck and spray hose employed to wet site prior to excavation

76. Because of the loose, sandy nature of the levee soils it was necessary to water the site before excavation could proceed. Watering developed sufficient capillary cohesion in the soil to permit trenching without collapse of the vertical face of the trench. An 8,000-gal watering truck and spray hose (see Figure 12) were employed for this purpose. The live oak site required four truckloads of water before sufficient capillary cohesion developed over the entire trench site.

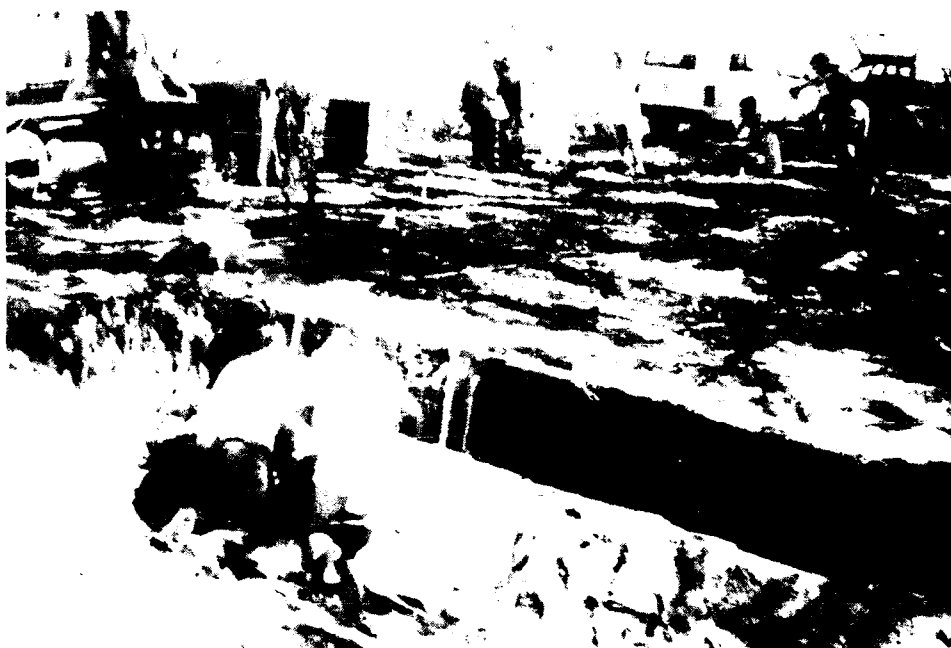
Figure 15. Mapping in progress along upper half of trench face at valley oak site (mapping frame is resting on mid-height ledge)

79. Mapping procedure. The roots were mapped on an acetate overlay held on a portable PVC mapping frame. The tubular frames were rectangular in shape with a mapping area 1.0 m by 0.5 m. Strings were strung across the frame on a 10-cm grid spacing. The string grid greatly facilitated keeping track of features as they were mapped and also maintaining correct placement of the mapping frame. Removable holders were placed at each end of the frame for both take-up and supply of the acetate rolls. The frames were pressed against the smoothed, vertical face of the trench, and roots plus other

features mapped directly on the acetate. Mapping was done along the upper half of the trench by successively moving the frame along the ledge and advancing the acetate roll to a new position. After the upper half was mapped, the ledge at midheight was trimmed away, and the bottom half mapped in a similar fashion. Views of a mapping operation in progress are shown in Figures 15 and 16.

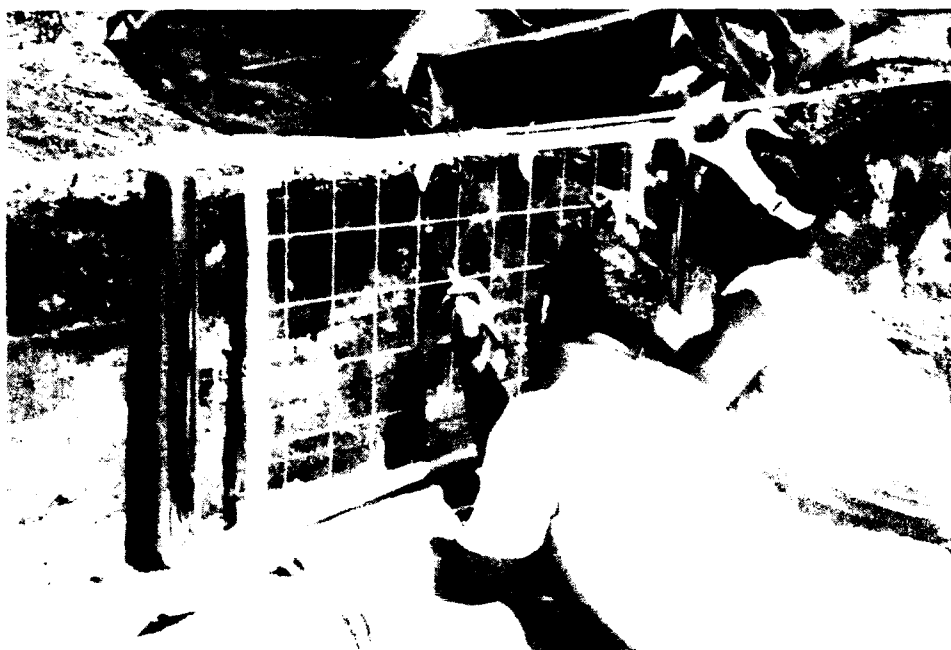
Figure 16. Closeup view of mapping frame showing acetate sheet, take-up and supply holders, and string grid

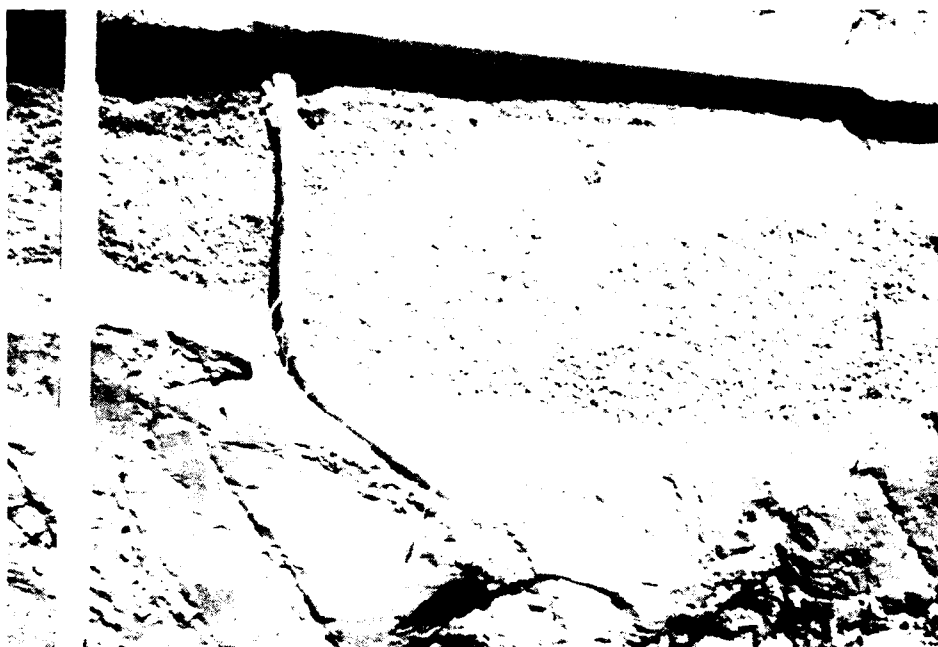
Figure 21. Fissure in large clay clod or inclusion that has been permeated by a tree root

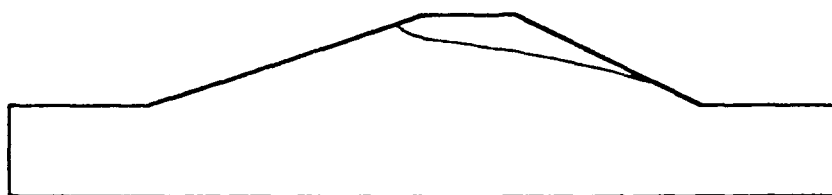
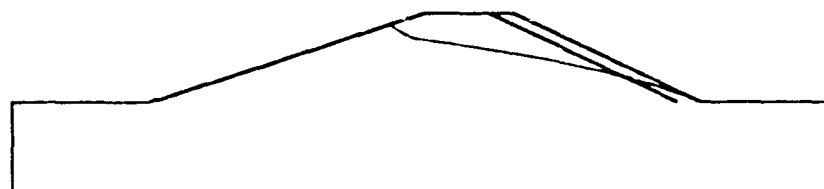
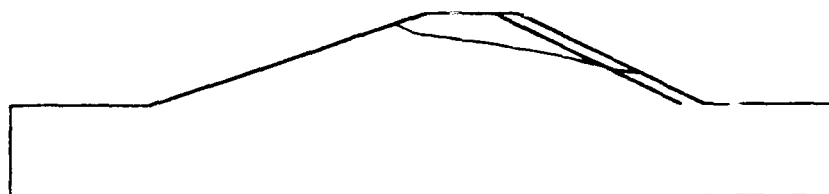
a) levee with constant permeability ,  $k_2$

b) levee with a 1-ft layer of permeability ,  $k_1$  and  $k_1 / k_2 = 10$

c) levee with a 1-ft layer of permeability ,  $k_1$  and  $k_1 / k_2 = 0.1$

d) levee with 1-ft layer of permeability ,  $k_1$  and  $k_1 / k_2 = 10$

e) levee with 1-ft layer of permeability ,  $k_1$  and  $k_1 / k_2 = 0.1$

Figure 54. Schematic illustration showing influence of a modified surface permeability on the line of seepage

124. The first task was to determine the influence of a surface layer or skin on the location of the phreatic surface as shown schematically in Figure 54. This was accomplished by following the transfer condition rules summarized earlier in Figure 51. The "skin" was assumed to be either more or less permeable than the core by a factor of 10. The subsequent influence on the location and orientation of the phreatic surface as a result of this permeability contrast is depicted schematically in Figure 55.

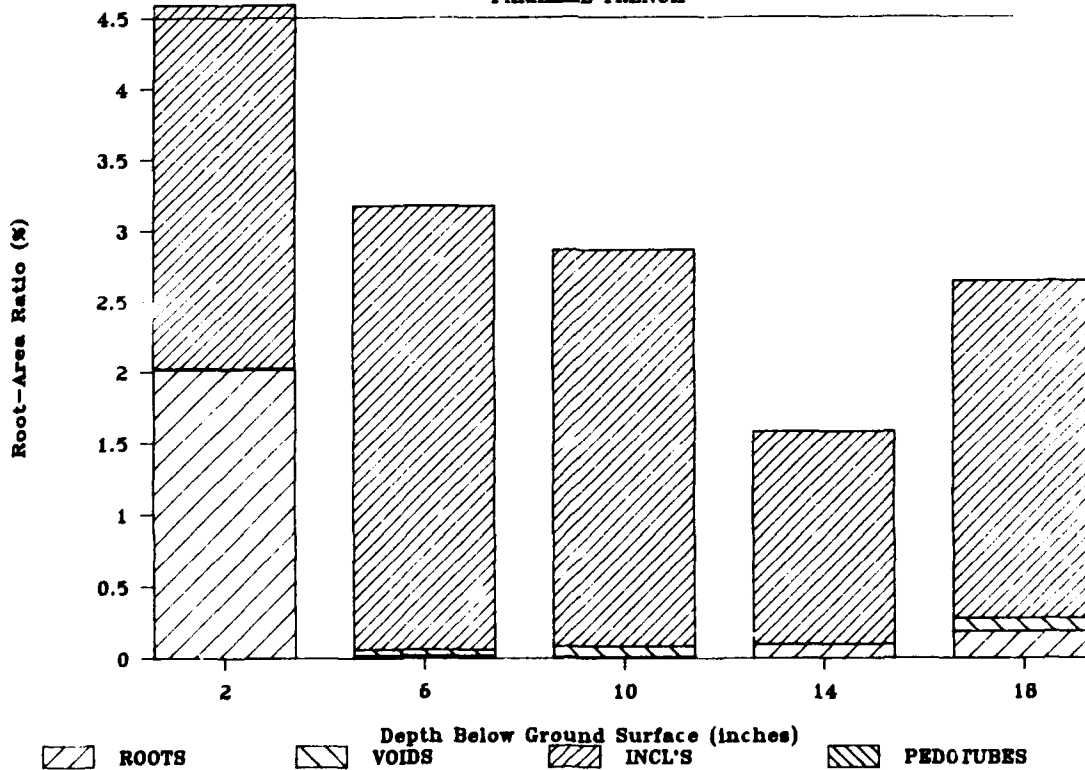
## Control Trench Root-Area Ratio

### PARALLEL TRENCH

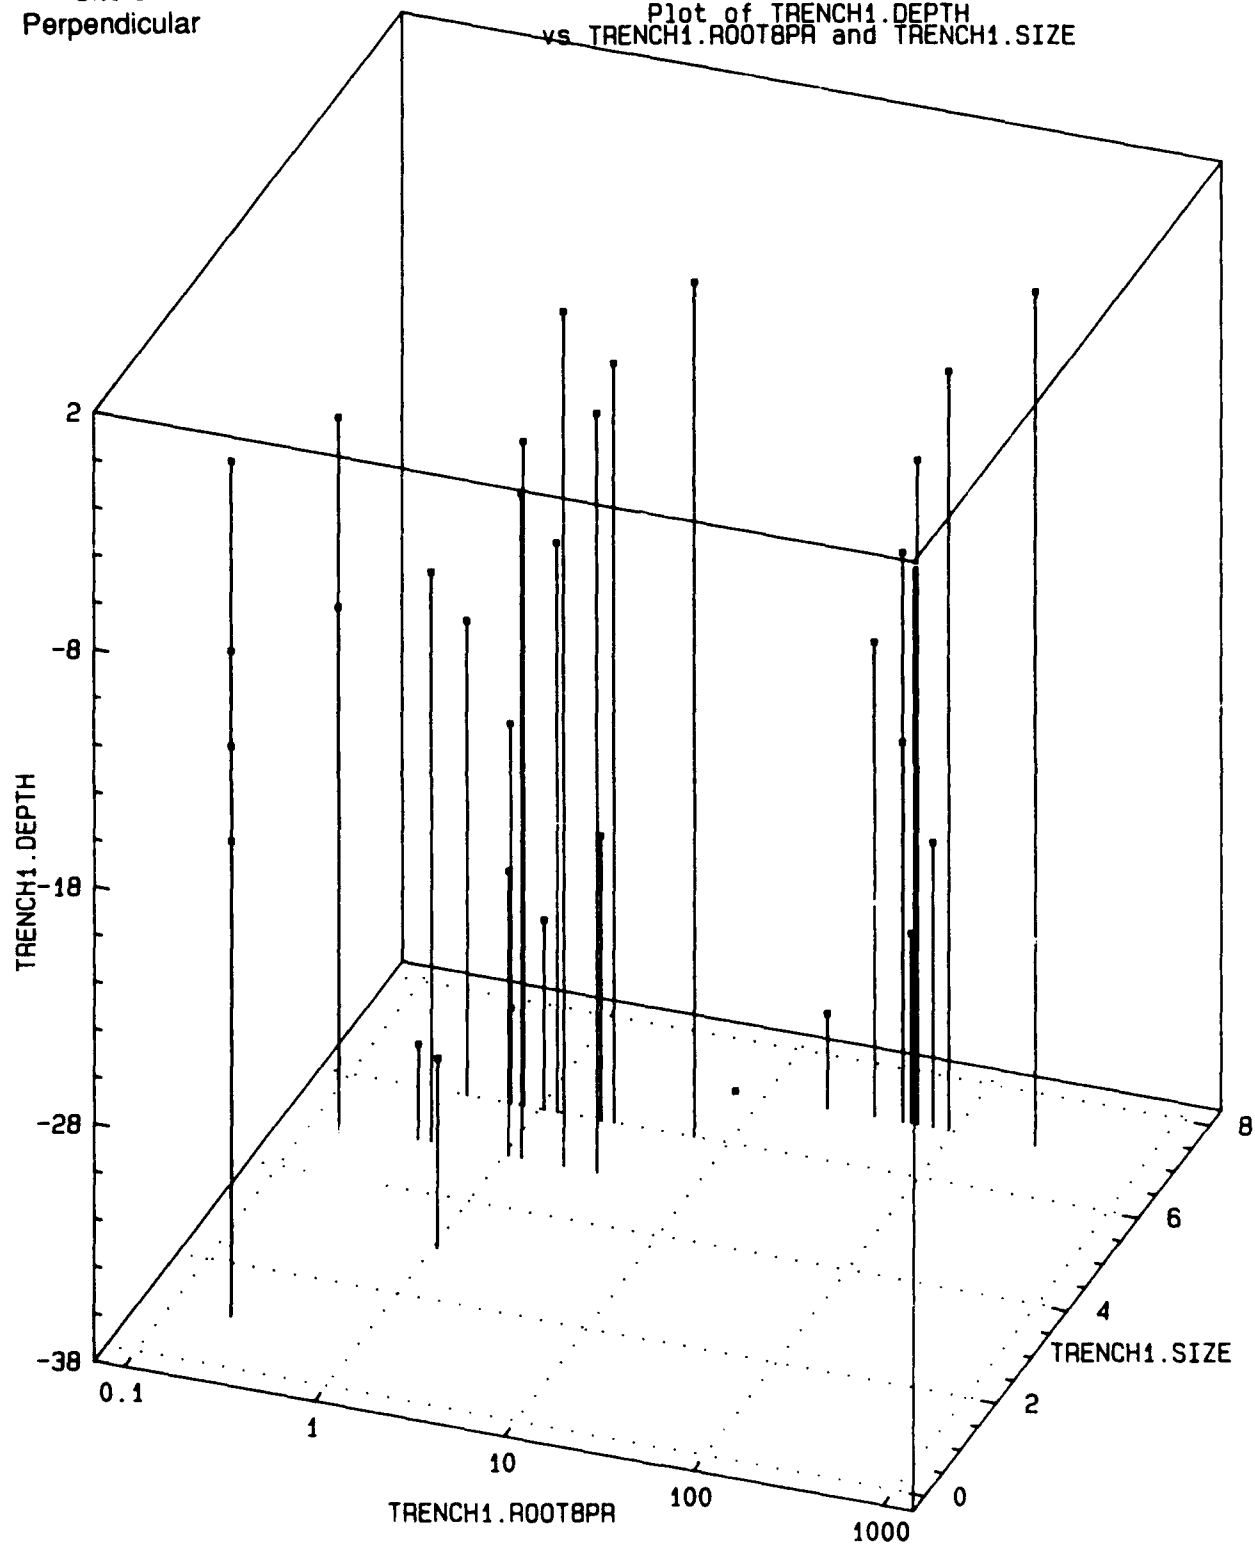
Site 8  
Perpendicular

Plot of TRENCH1.DEPTH  
vs TRENCH1.ROOT8PR and TRENCH1.SIZE
