**LASER PAINT STRIPPING**

J.D. Head, J. Peter Niedzielski  
Laser Technologies, Inc.  
10131 Colonial Industrial Drive  
South Lyon, Michigan 48178

**Final Report for Period April 1988 - January 1991**

**WRIGHT LABORATORY  
MATERIALS DIRECTORATE  
AIR FORCE SYSTEMS COMMAND  
WRIGHT-PATTERSON AIR FORCE BASE, OHIO 45433-6533**

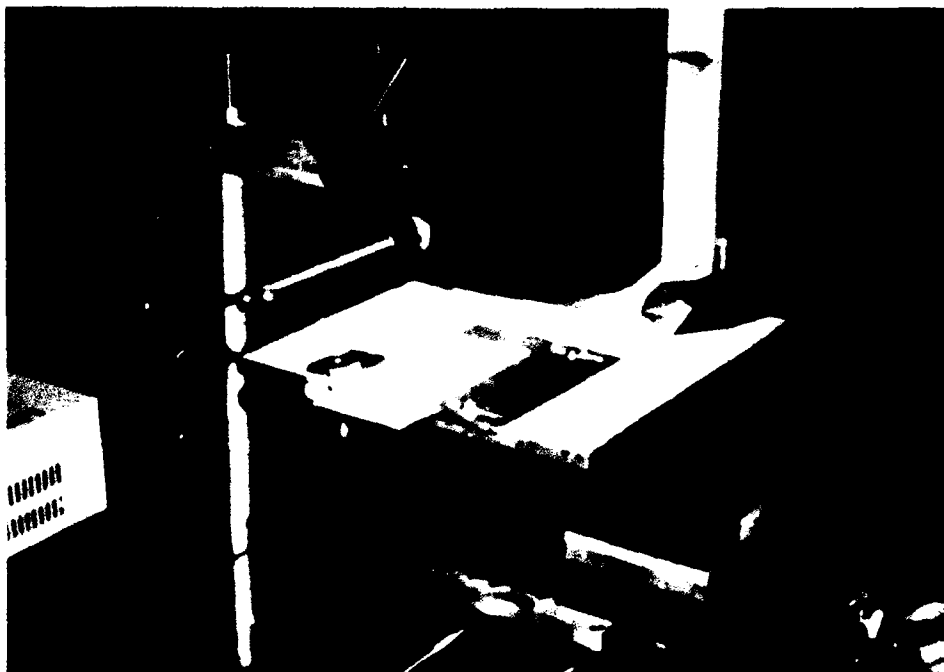
Figure 3. High Power Rapid Pulse Equipment

Larger paint removal areas were achieved with the full scale LTI equipment which produces an output of 1.2 joules per pulse at a variable rate from 40-250 pulses per second. This equipment can produce pulses of controlled duration varying from 10 to 30 microseconds. The pulse characteristics are very nearly identical to those produced by the lower powered equipment described under 1.4.2. The same x-y table and lens system allowed similar control of uniformity of treatment and variations of fluence.

The simple vacuum system was satisfactory for removal of waste products. The equipment was also used for the development of the wobbler system for automatic distribution of the pulses along a line which was manually advanced across a sample by the use of the x-y table. The wobbler was equipped with a 10 inch focal length reflector and samples exposed beyond focus were given exposures of 8-20 J/sqcm according to the distance from focus.

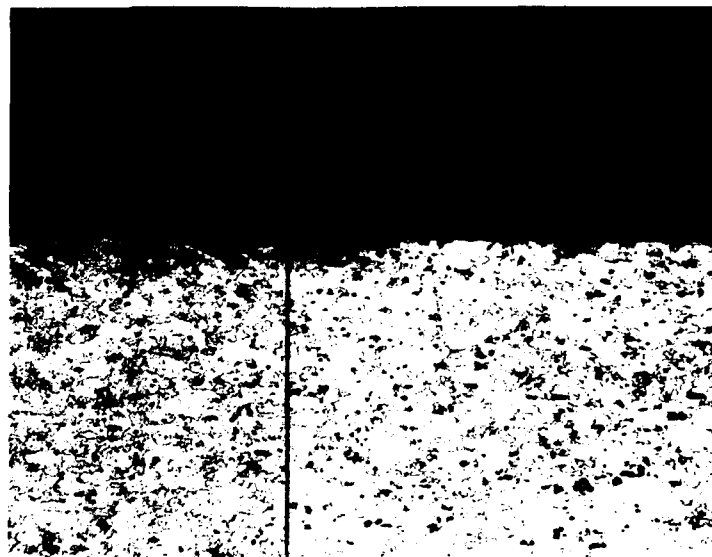
Figure 7. 2024-T3 bare anodized

Magnification 100x

Cross sectional view of the prepared surface. Left side of photo shows the stripped surface. Right side of photo shows the unstripped surface.
