## Helicopter Nighttime Parking Test Results - UH-1

| 4. Title and Subtitle<br>HELICOPTER NIGHTTIME PARKING TEST RESULTS - UH-1H | | | | 5. Report Date<br>March 1992 | |
| <p>16. Abstract</p> <p>Flight tests had previously been conducted at the Federal Aviation Administration (FAA) Technical Center to examine issues regarding rotortip separation in ground maneuver areas at heliports. Technical Note DOT/FAA/CT-TN88/30, "Heliport Surface Maneuvering Test Results," details the results of those tests. However, those tests were conducted under visual flight conditions (VFR) daylight conditions. Given the limitations of scoptic vision, it was determined that nighttime testing was needed to determine whether pilot parking separation performance and perception deteriorates under night, low ambient light conditions.</p> <p>This report documents the results of nighttime parking tests conducted at the Technical Center between January 1989 to August 1989. Over 100 parking maneuvers were conducted using a UH-1H helicopter. All were conducted under head, tail, and crosswind conditions, with an unlit and a lit obstacle and without an obstacle in place. Pilot subjective data in reference to these

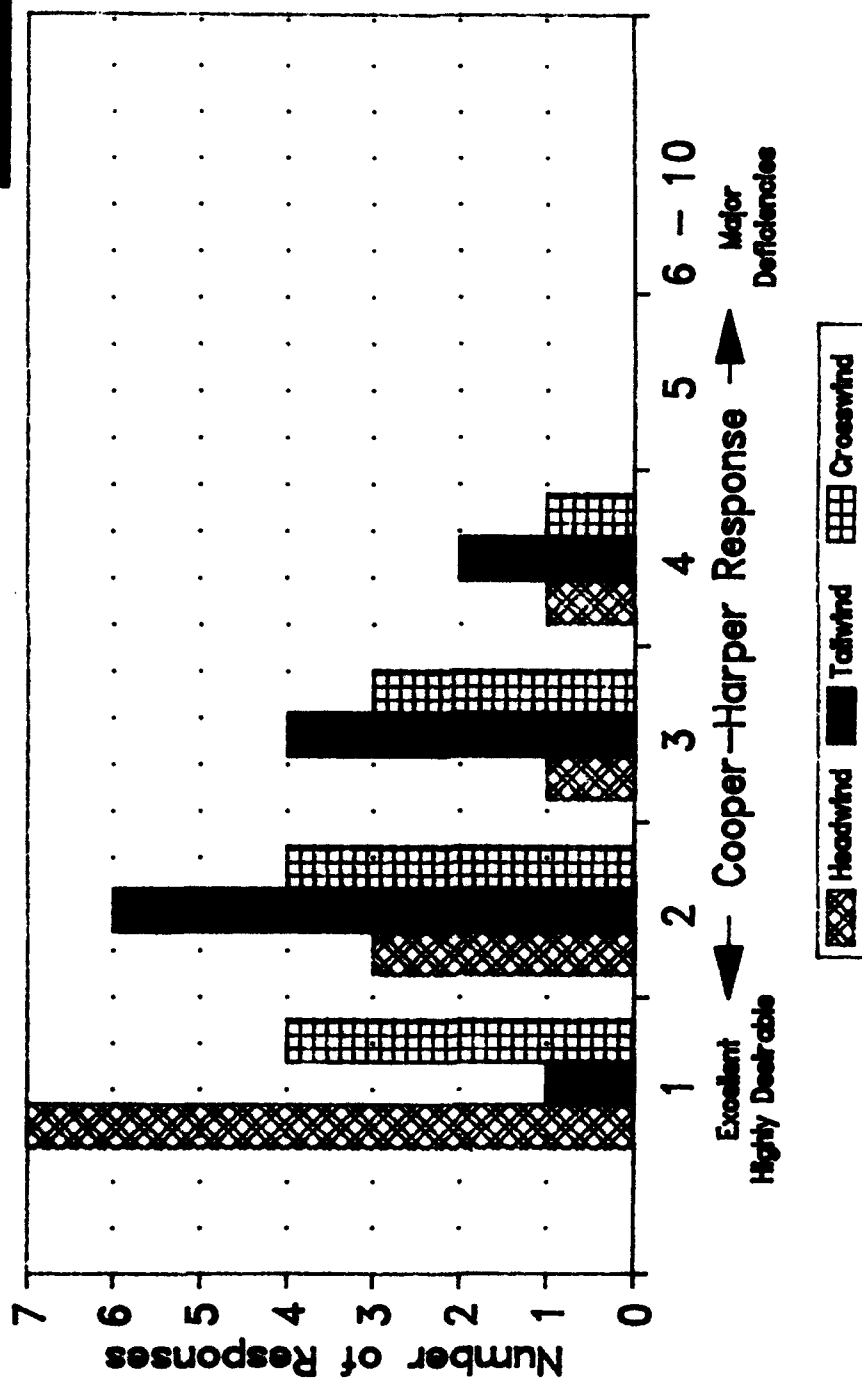
FIGURE 8. COOPER-HARPER RATINGS FOR CONTROL MARGIN: NO OBJECT

### With No Object

Figures 8, 9, and 10 present the results of the Cooper-Harper ratings in graphic form for the control factor. As can be seen, the control margin was rated as unacceptable for routine operations in 13 of 110 responses (4 out of 37 with no
