# DEBRIS SPILLWAY AND CHUTE FOR MILLERS FERRY POWERHOUSE ALABAMA RIVER, ALABAMA

## Hydraulic Model Investigation

Deborah R. Cooper

Hydraulics Laboratory

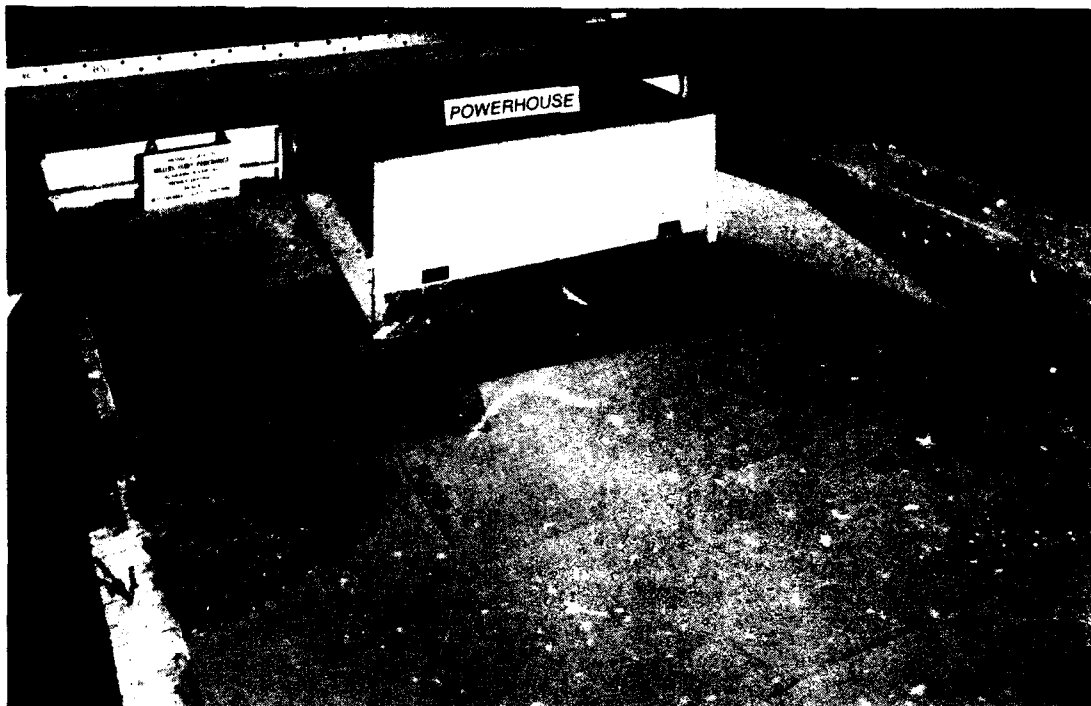
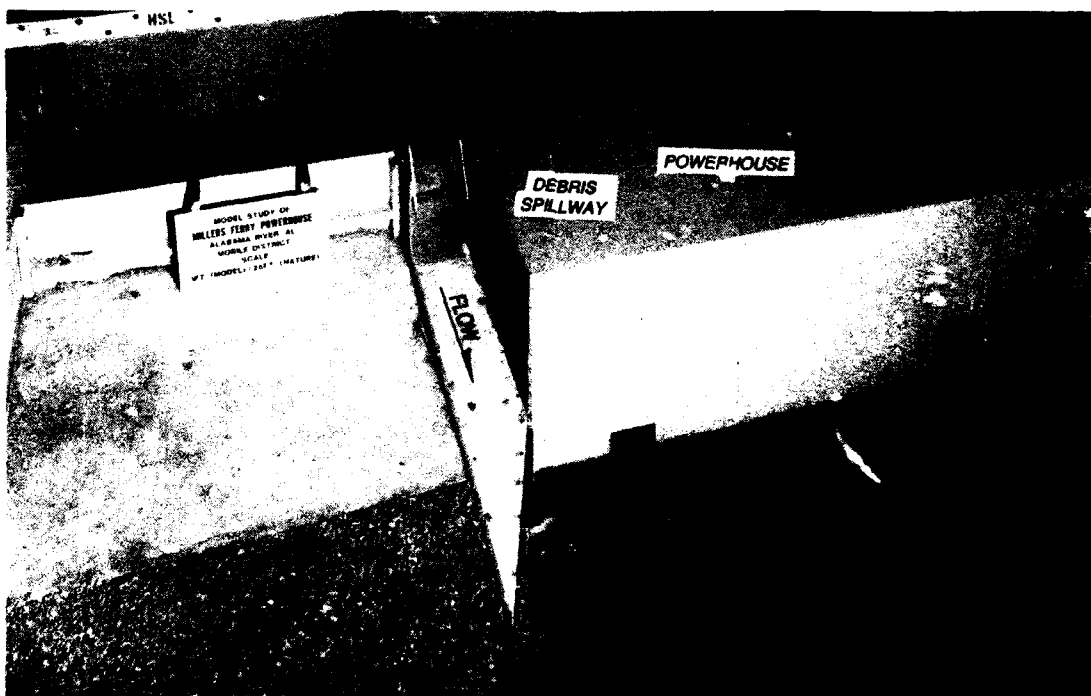
Figure 2. 1:25-scale model

a. Overall view looking upstream

b. Closeup view looking upstream

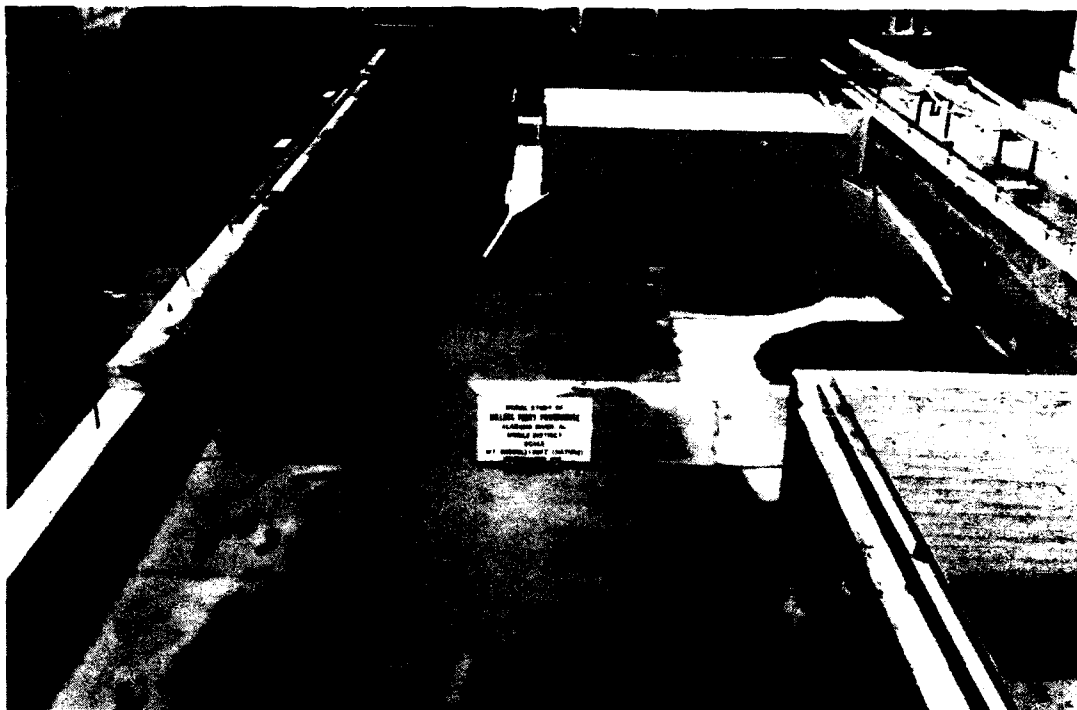
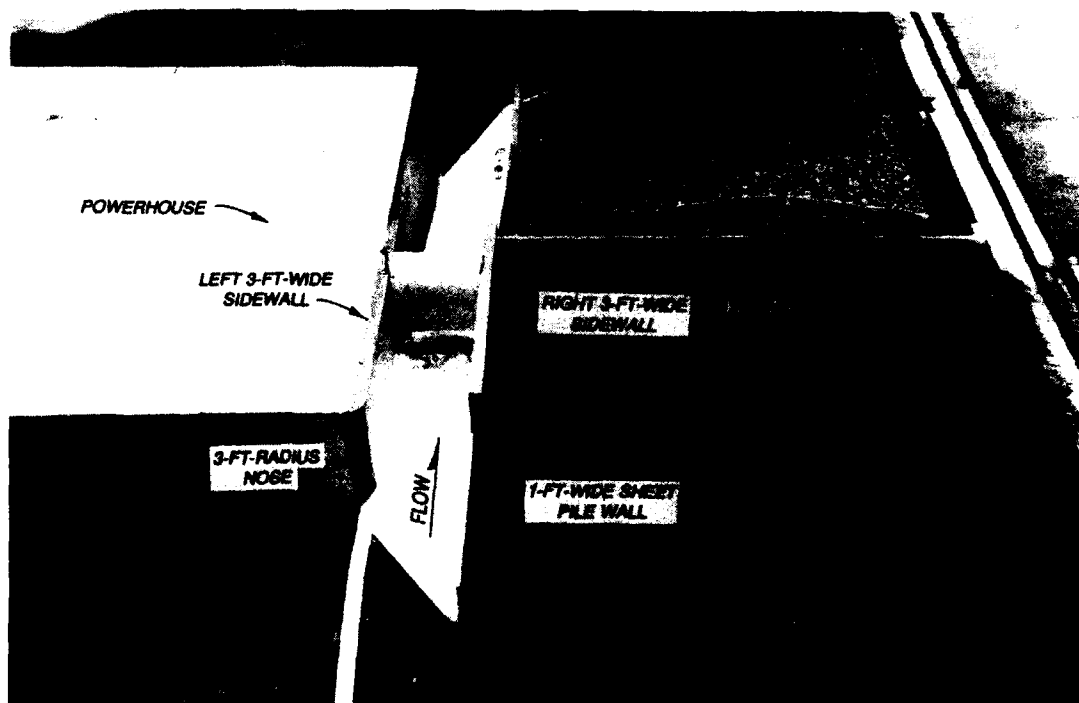
Figure 3. Type 3 design

a. Overall view looking upstream

b. Closeup view looking downstream

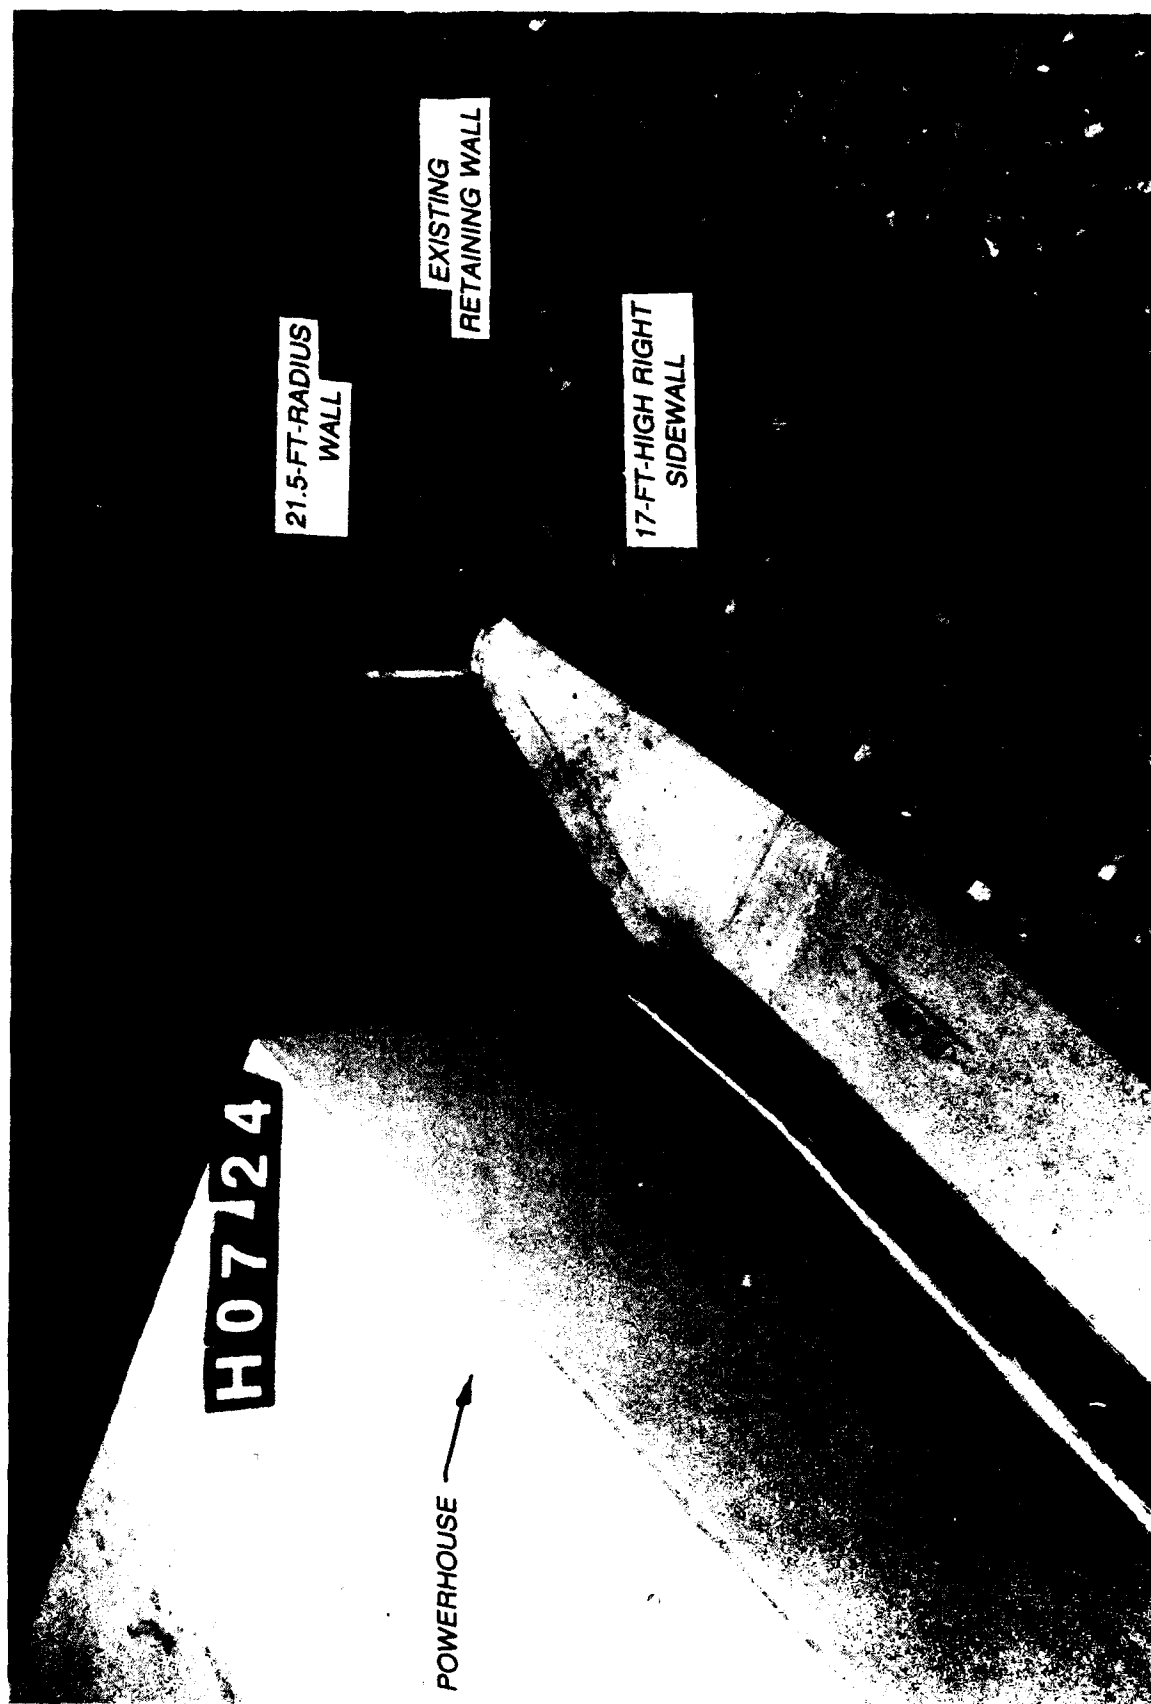
Figure 4. Type 17 design, 21.5-ft-radius wall without 1-ft chamfers and modified topography

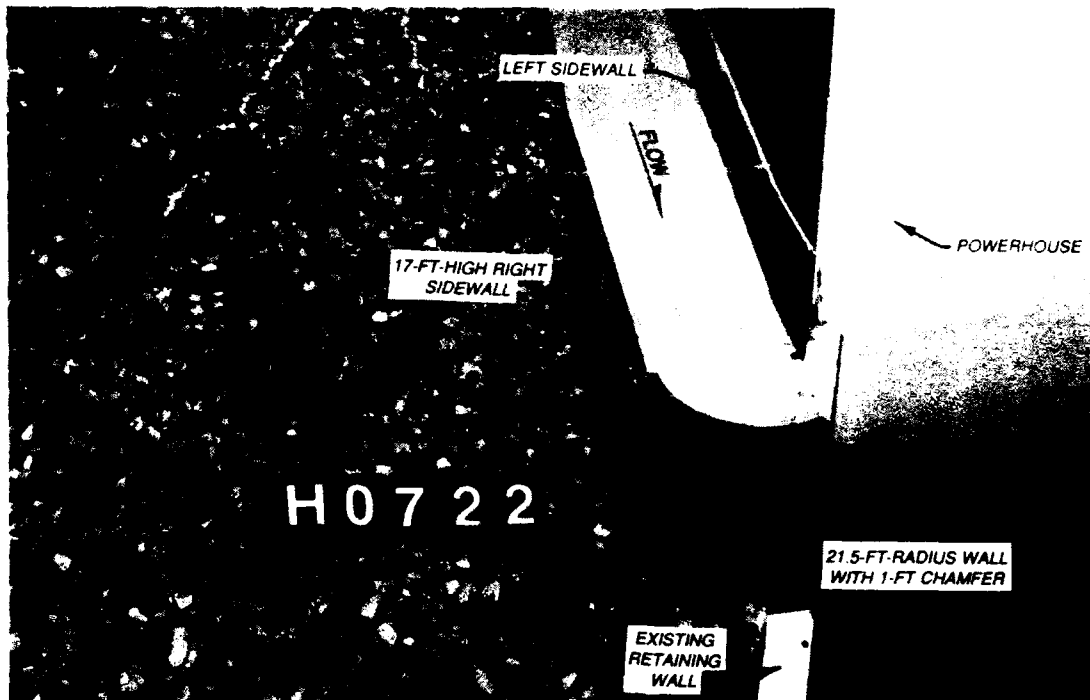
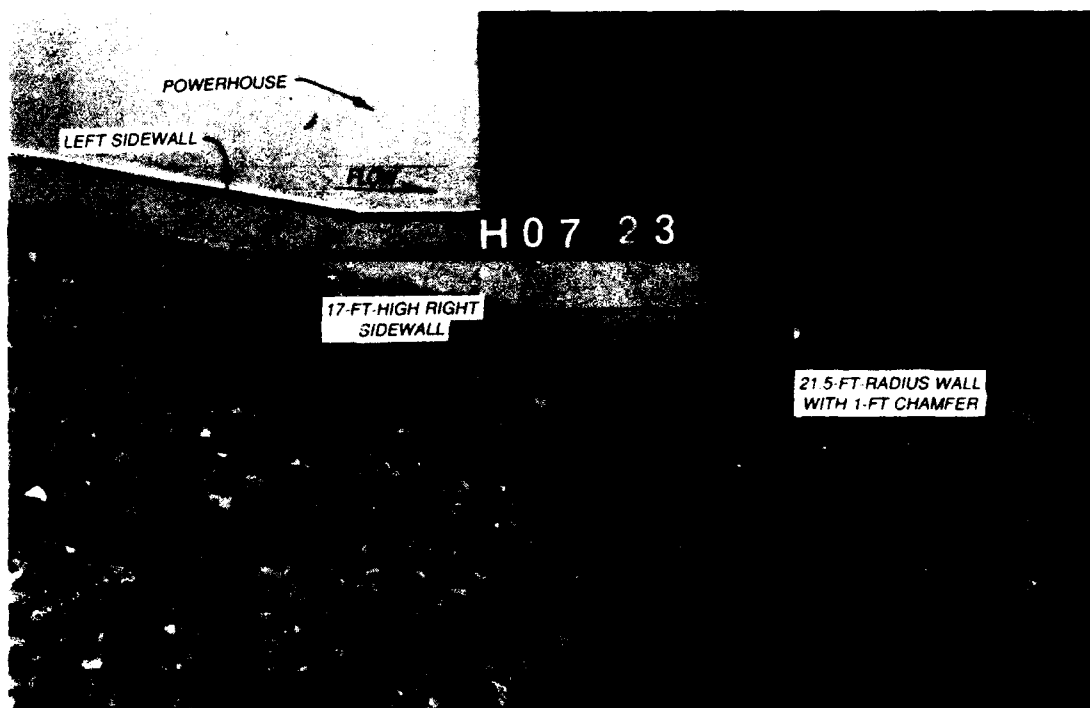
Figure 5. Type 17 design

a. Looking upstream

b. Profile view

27. The 1-ft chamfer was removed from the end of the curved wall (type 17 design, Figure 5 and Plate 22). The tailwater was varied from el 66.0 to 32.0 (Photos 13-20). The model was operated for 2.5 hr at minimum

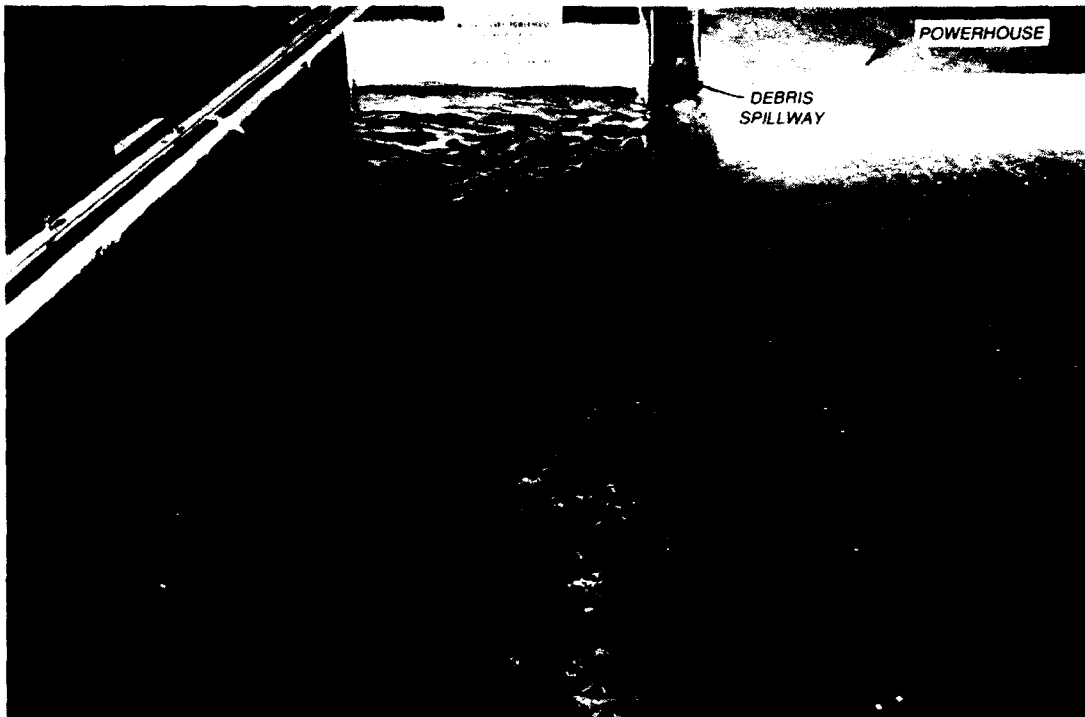
Photo 1. Flow conditions, type 1 design, discharge 2,640 cfs;  
pool el 80.8; tailwater el 66.0

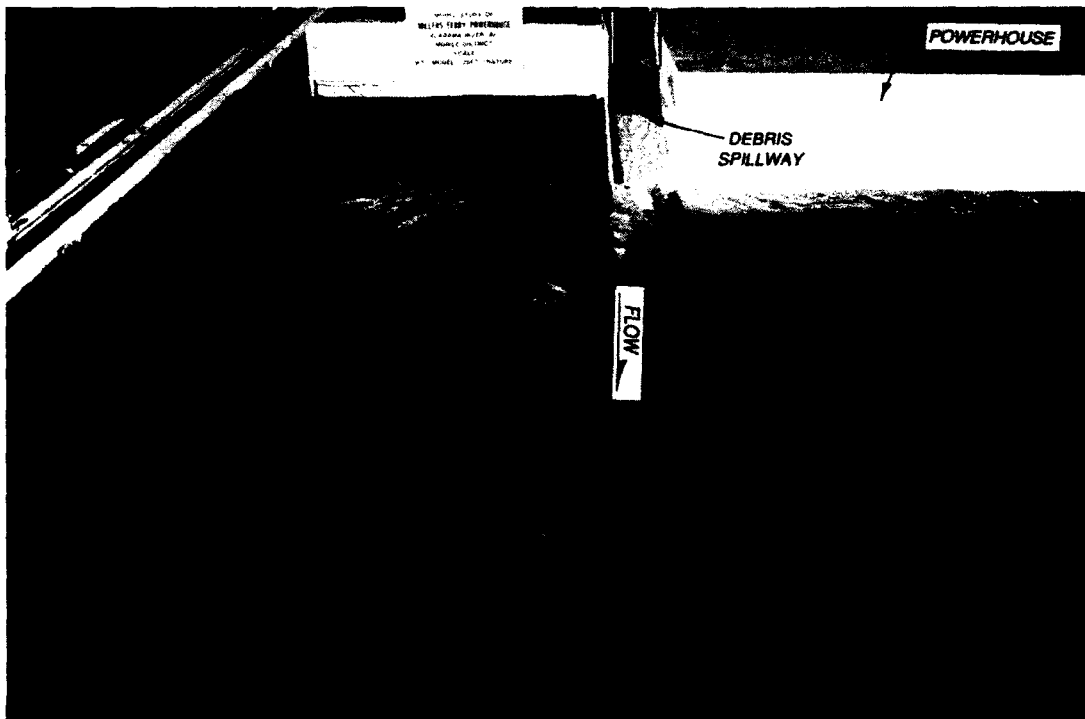
Photo 2. Flow conditions, type 1 design, discharge 2,640 cfs;  
pool el 80.8; tailwater el 50.0

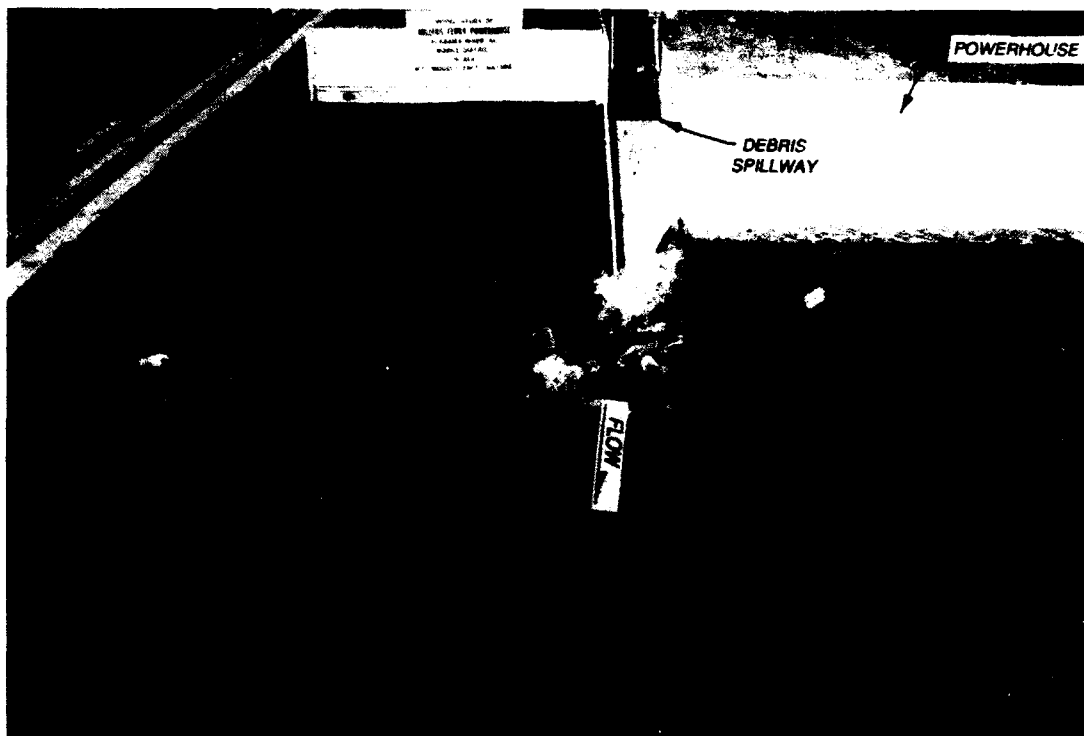
Photo 3. Flow conditions, type 1 design, discharge 2,640 cfs;  
pool el 80.8; tailwater el 40.0

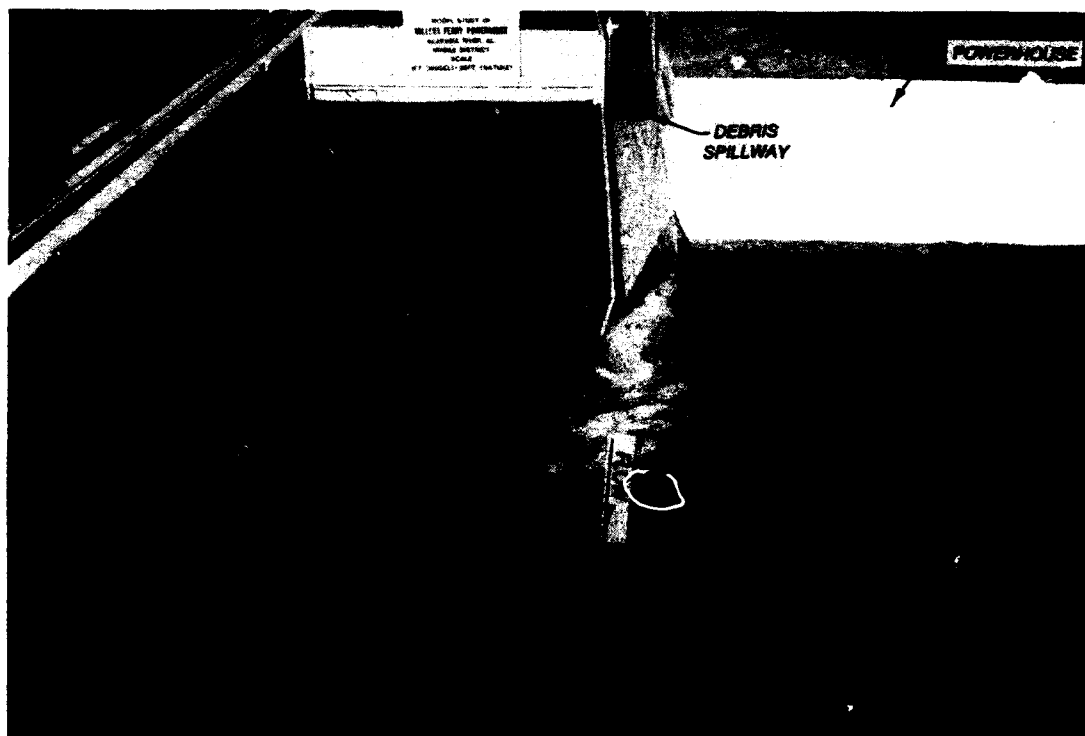
Photo 4. Flow conditions, type 1 design, discharge 2,640 cfs;  
pool el 80.8; tailwater el 32.0

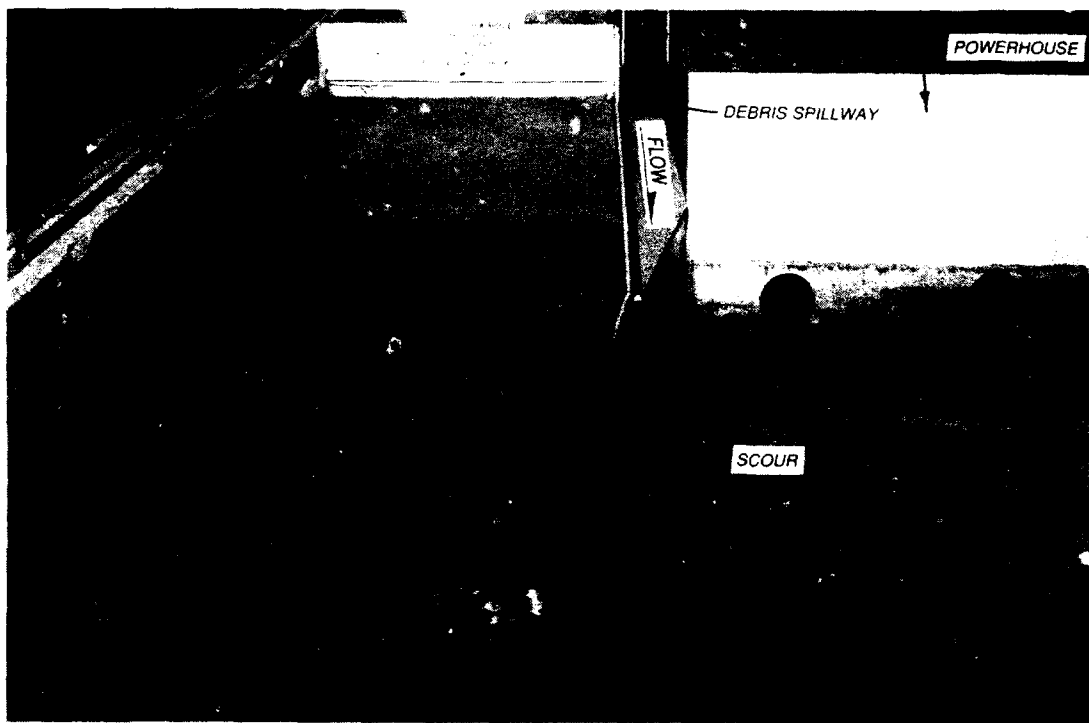
Photo 5. Scour downstream, type 1 design debris spillway;  
discharge 2,640 cfs, pool el 80.8; tailwater varied from  
el 66.0 to 32.0

ar hole formed in the tailrace riprap when the tailwater was lowered from 36.0 to el 32.0 (Photo 5). Flow exited the spillway at an angle to the right (looking downstream), causing increased turbulence and scour potential on the right downstream embankment.

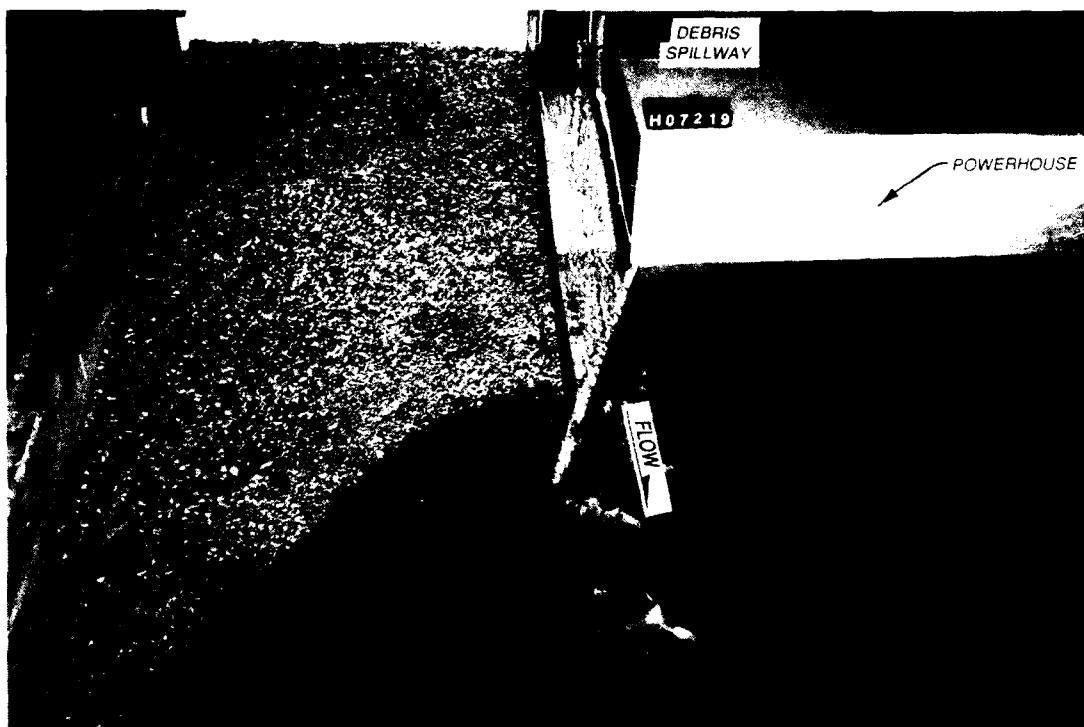
Photo 8. Flow conditions, type 3 design, discharge 2,640 cfs;  
pool el 80.8; tailwater el 40.0

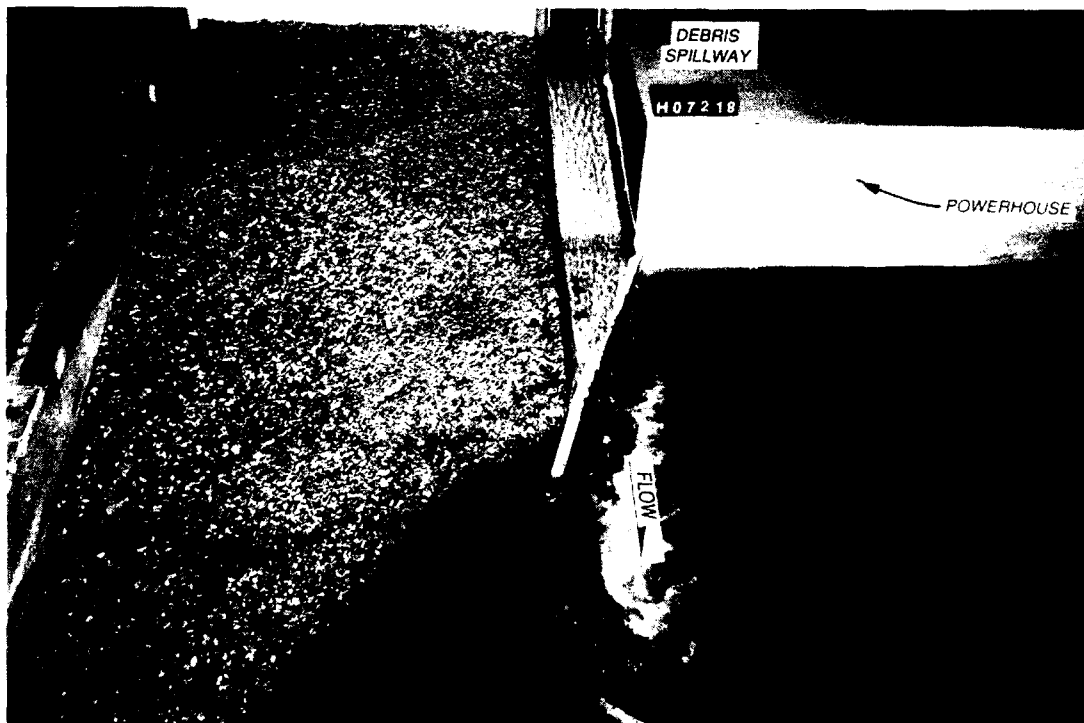
Photo 9. Flow conditions, type 3 design, discharge 2,640 cfs;  
pool el 80.8; tailwater el 32.0

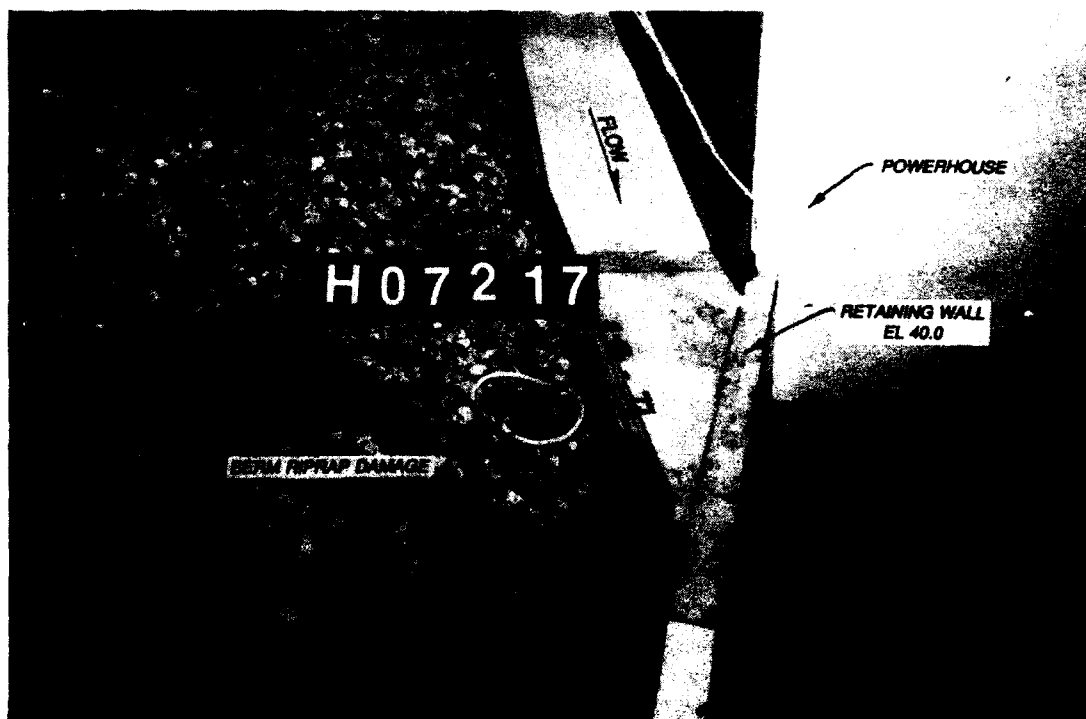
a. Looking upstream at 0 hr

b. Scour after 30 min

Photo 10. Riprap damage on the berm at el 47.5, type 3 design, discharge 2,640 cfs; pool el 80.8; tailwater el 50.0

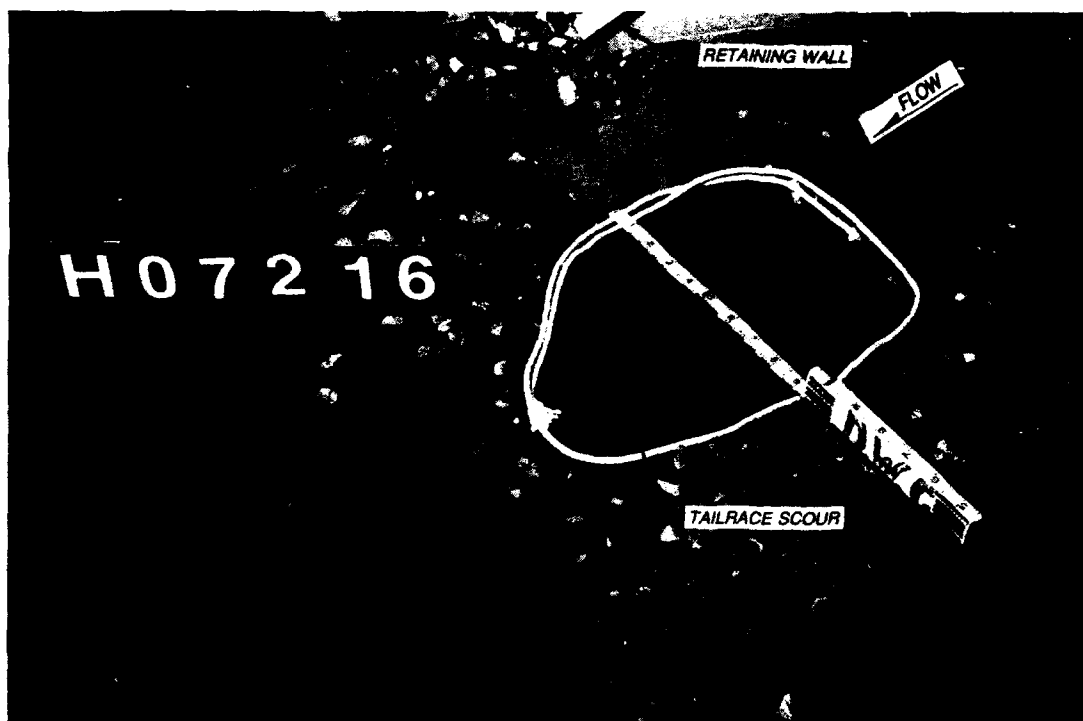
Photo 11. Scour in the tailrace riprap, type 3 design, discharge 2,640 cfs; pool el 80.8; tailwater el 32.0, 2.5 hr

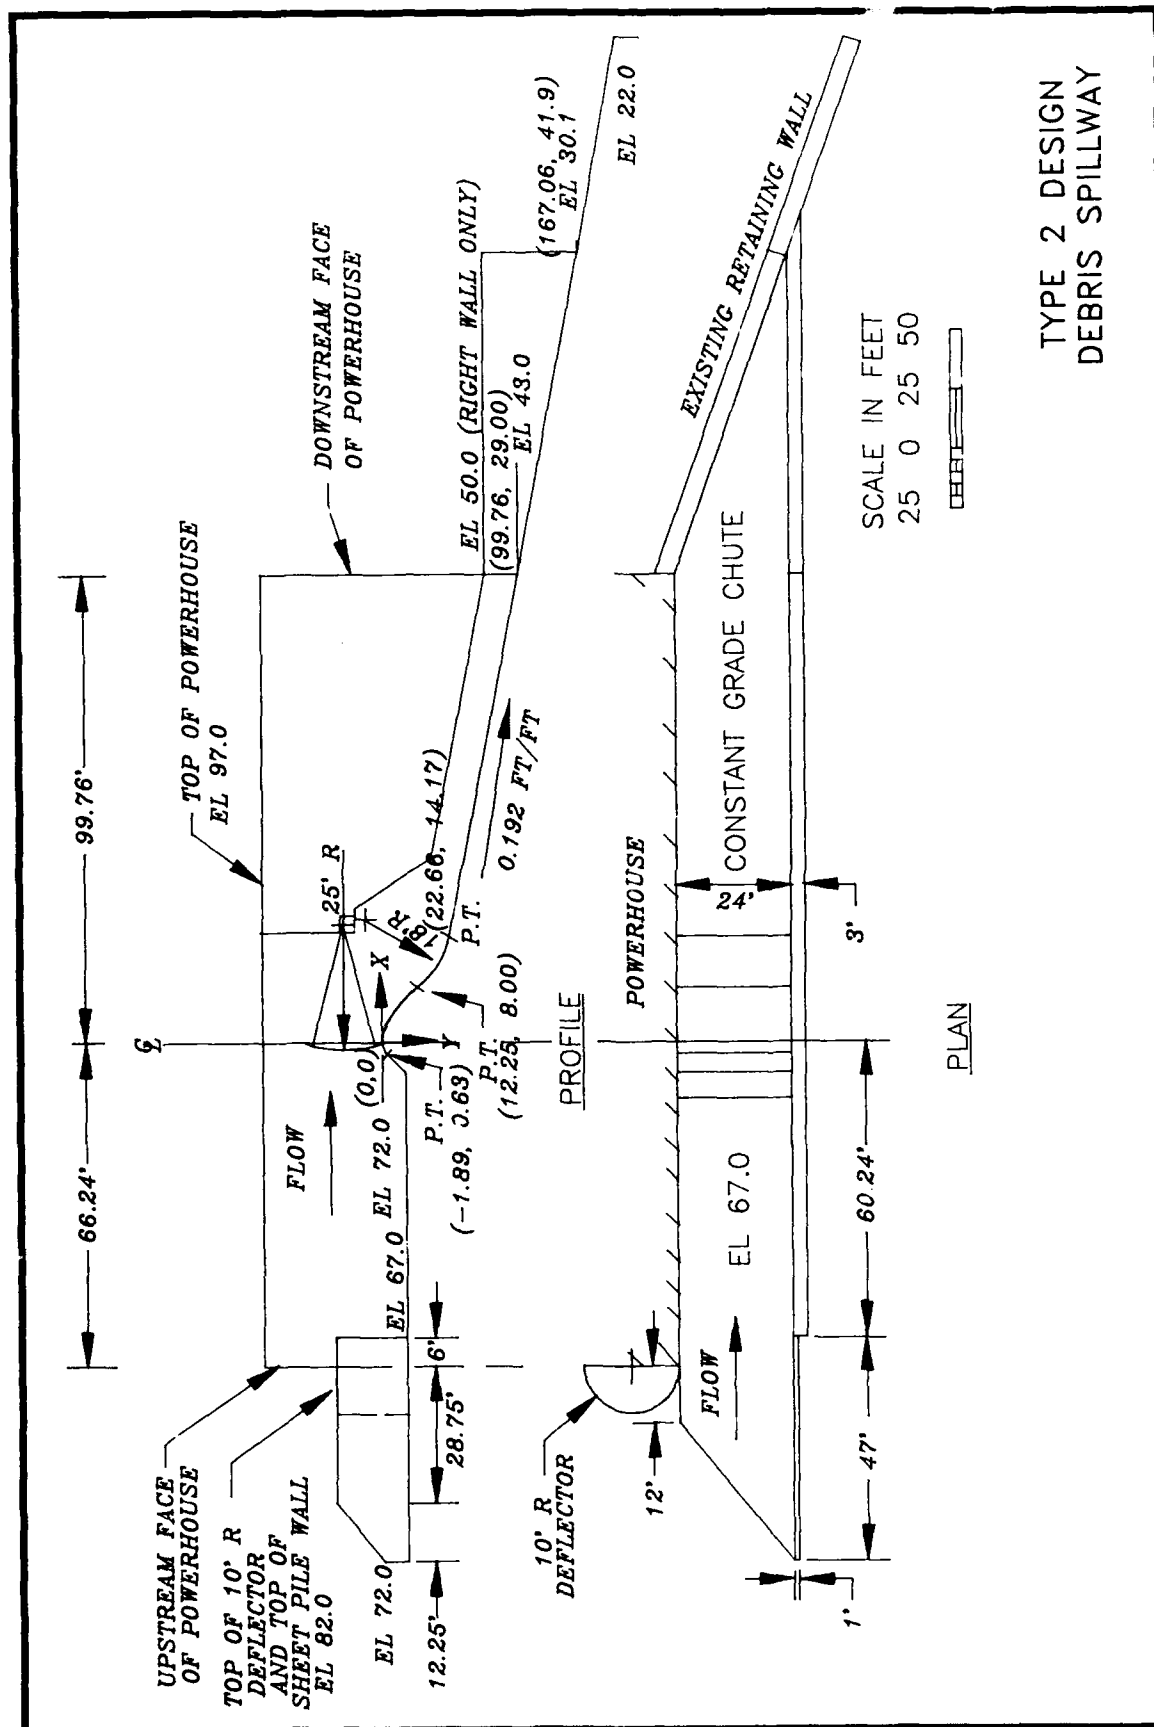
TYPE 2 DESIGN  
DEBRIS SPILLWAY

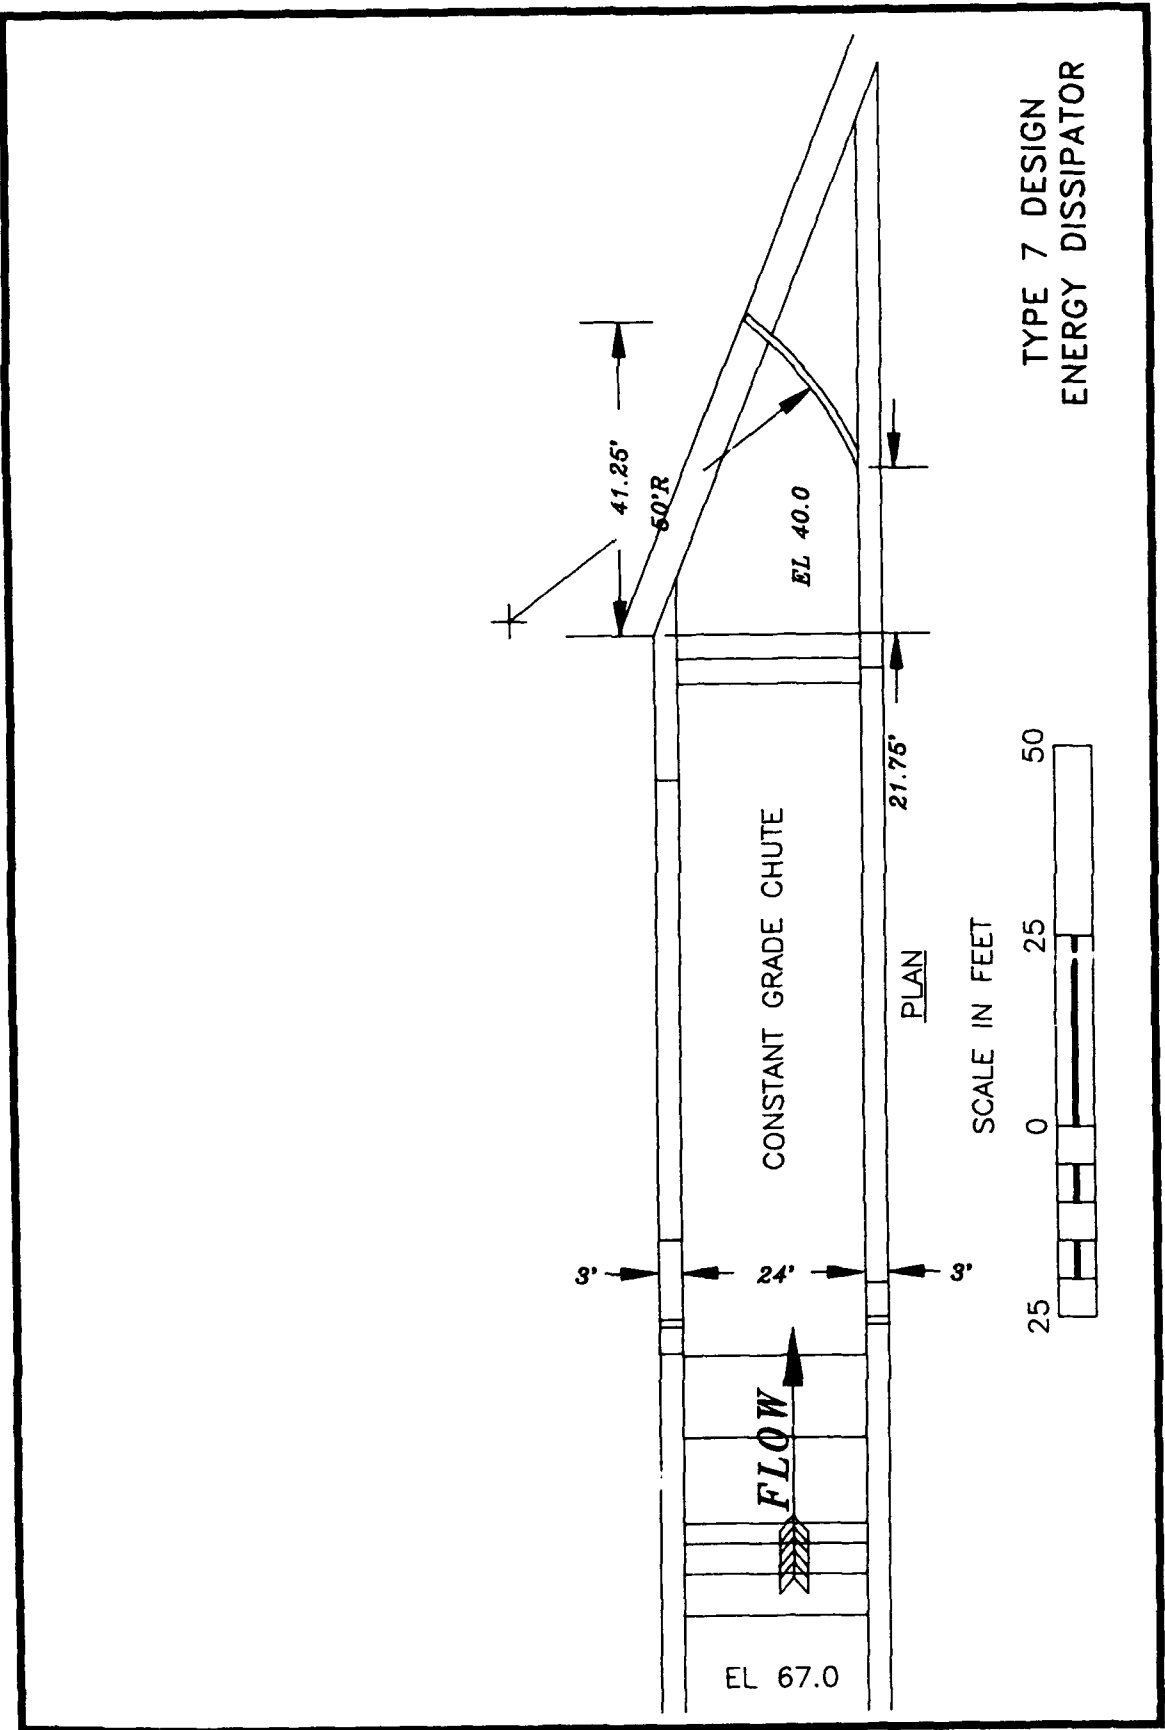
TYPE 7 DESIGN  
ENERGY DISSIPATOR

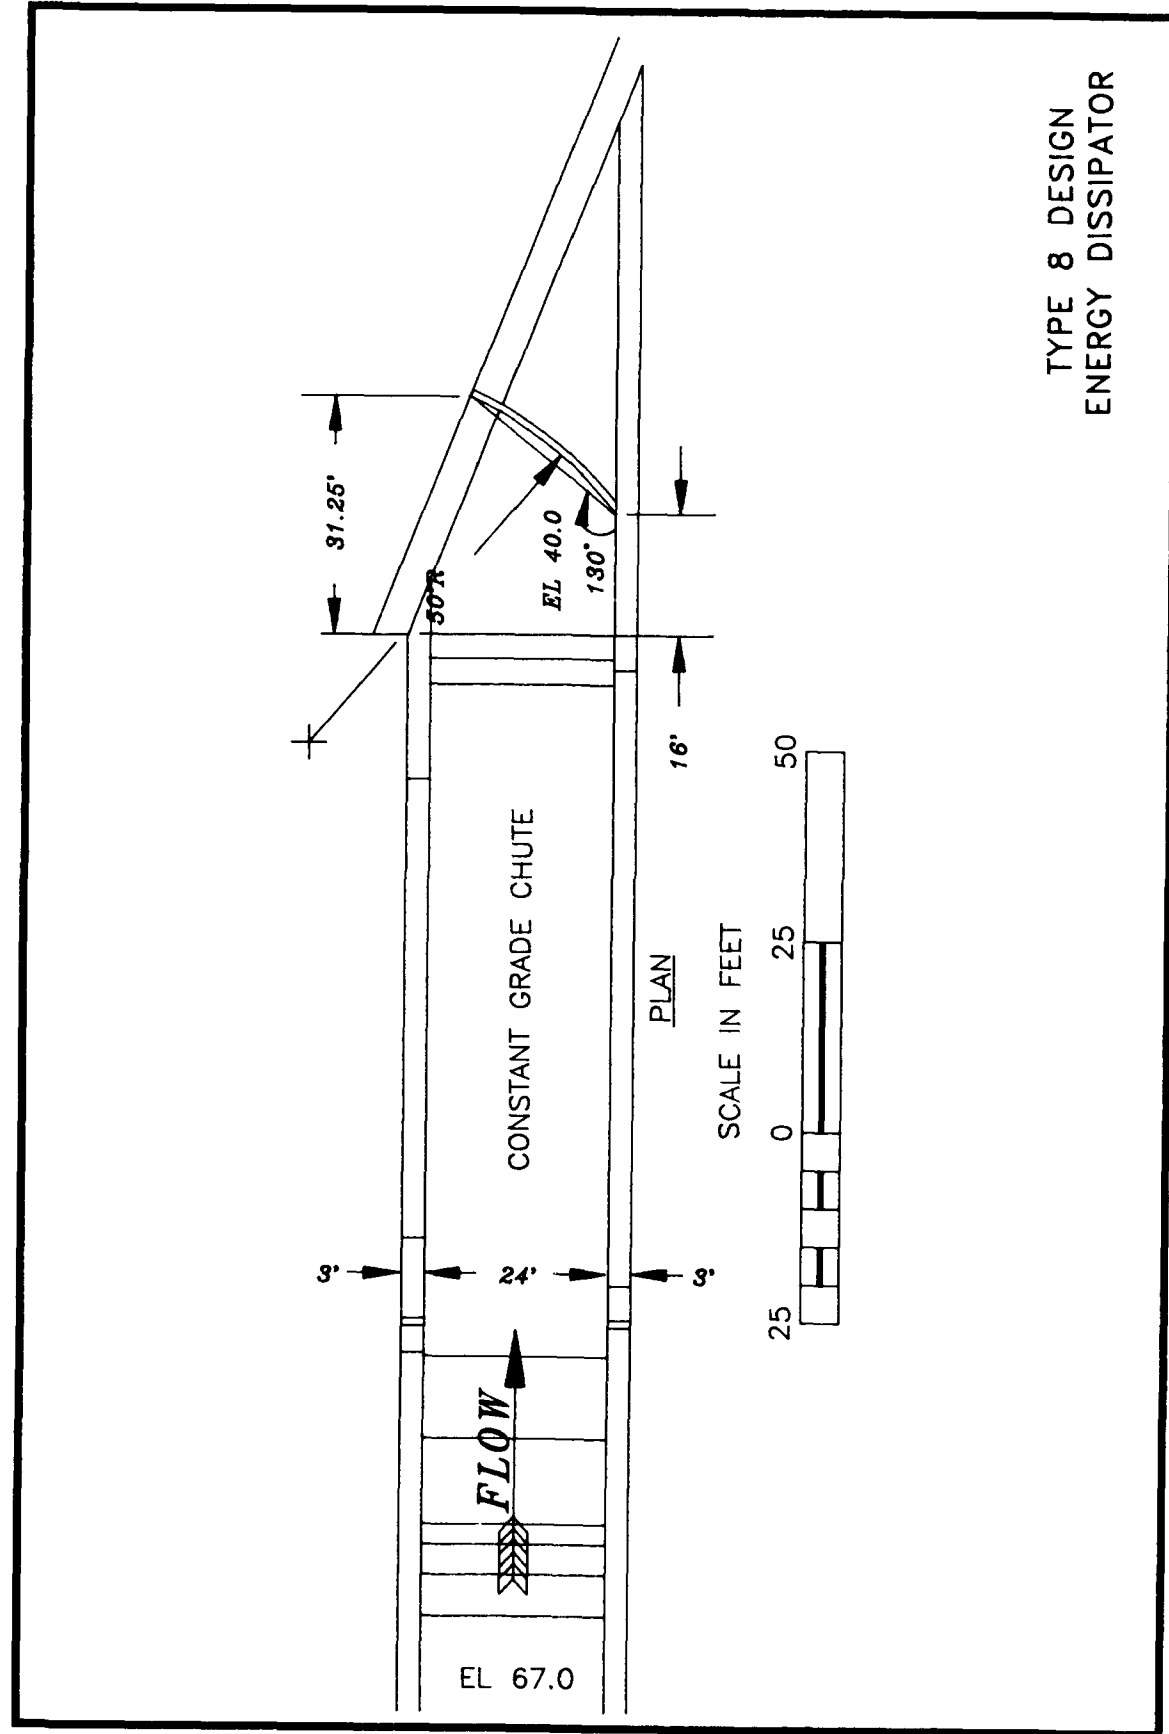
TYPE 8 DESIGN  
ENERGY DISSIPATOR

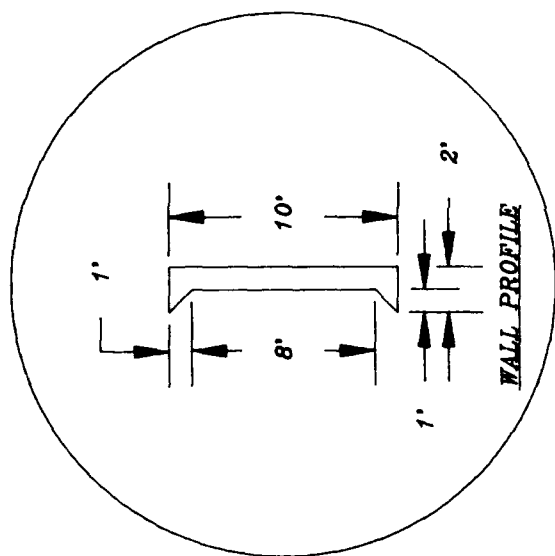
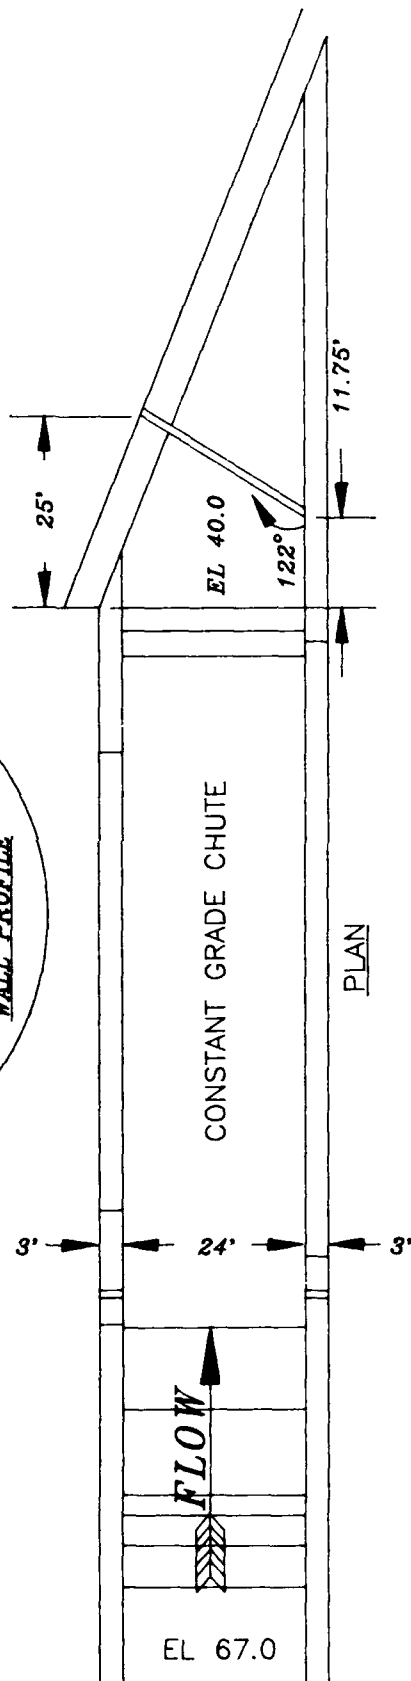
TYPE 9 DESIGN  
ENERGY DISSIPATOR

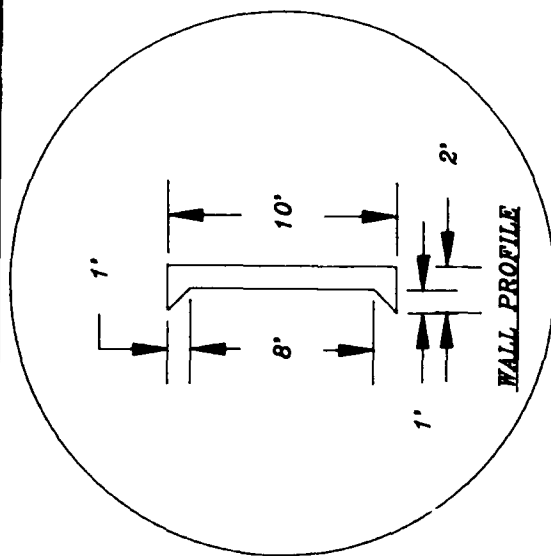
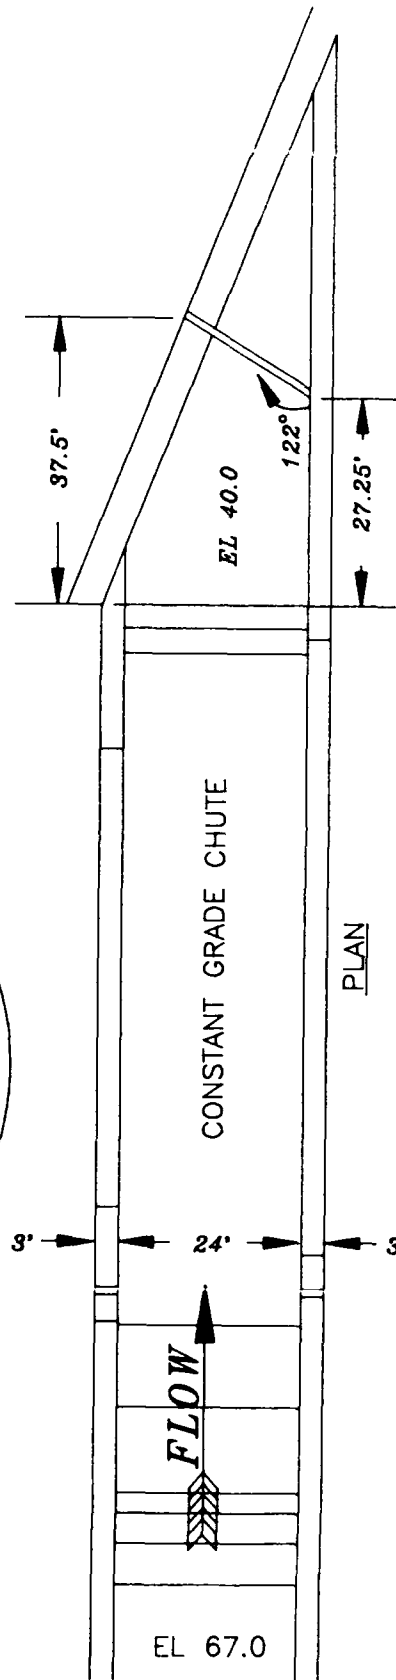
TYPE 10 DESIGN  
ENERGY DISSIPATOR
