# DEBRIS SPILLWAY AND CHUTE FOR MILLERS FERRY POWERHOUSE ALABAMA RIVER, ALABAMA

## Hydraulic Model Investigation

Deborah R. Cooper

Hydraulics Laboratory

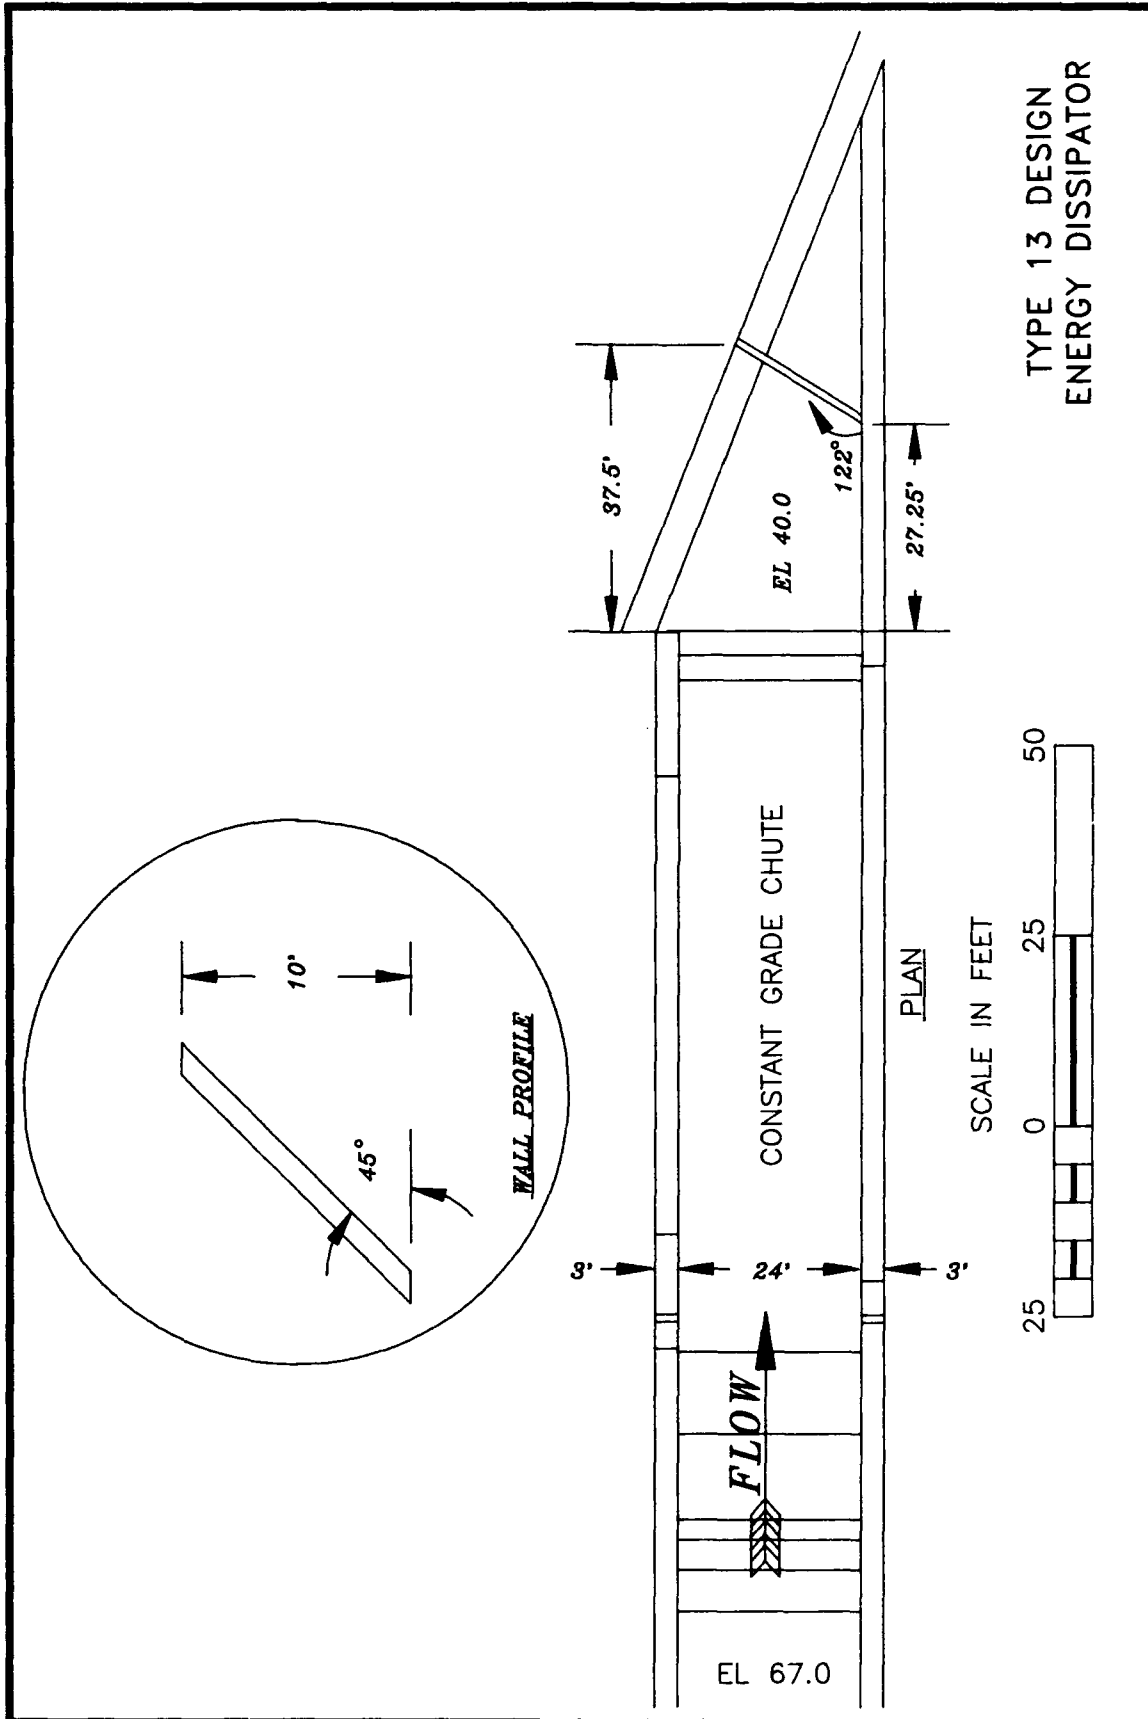
TYPE 13 DESIGN  
ENERGY DISSIPATOR

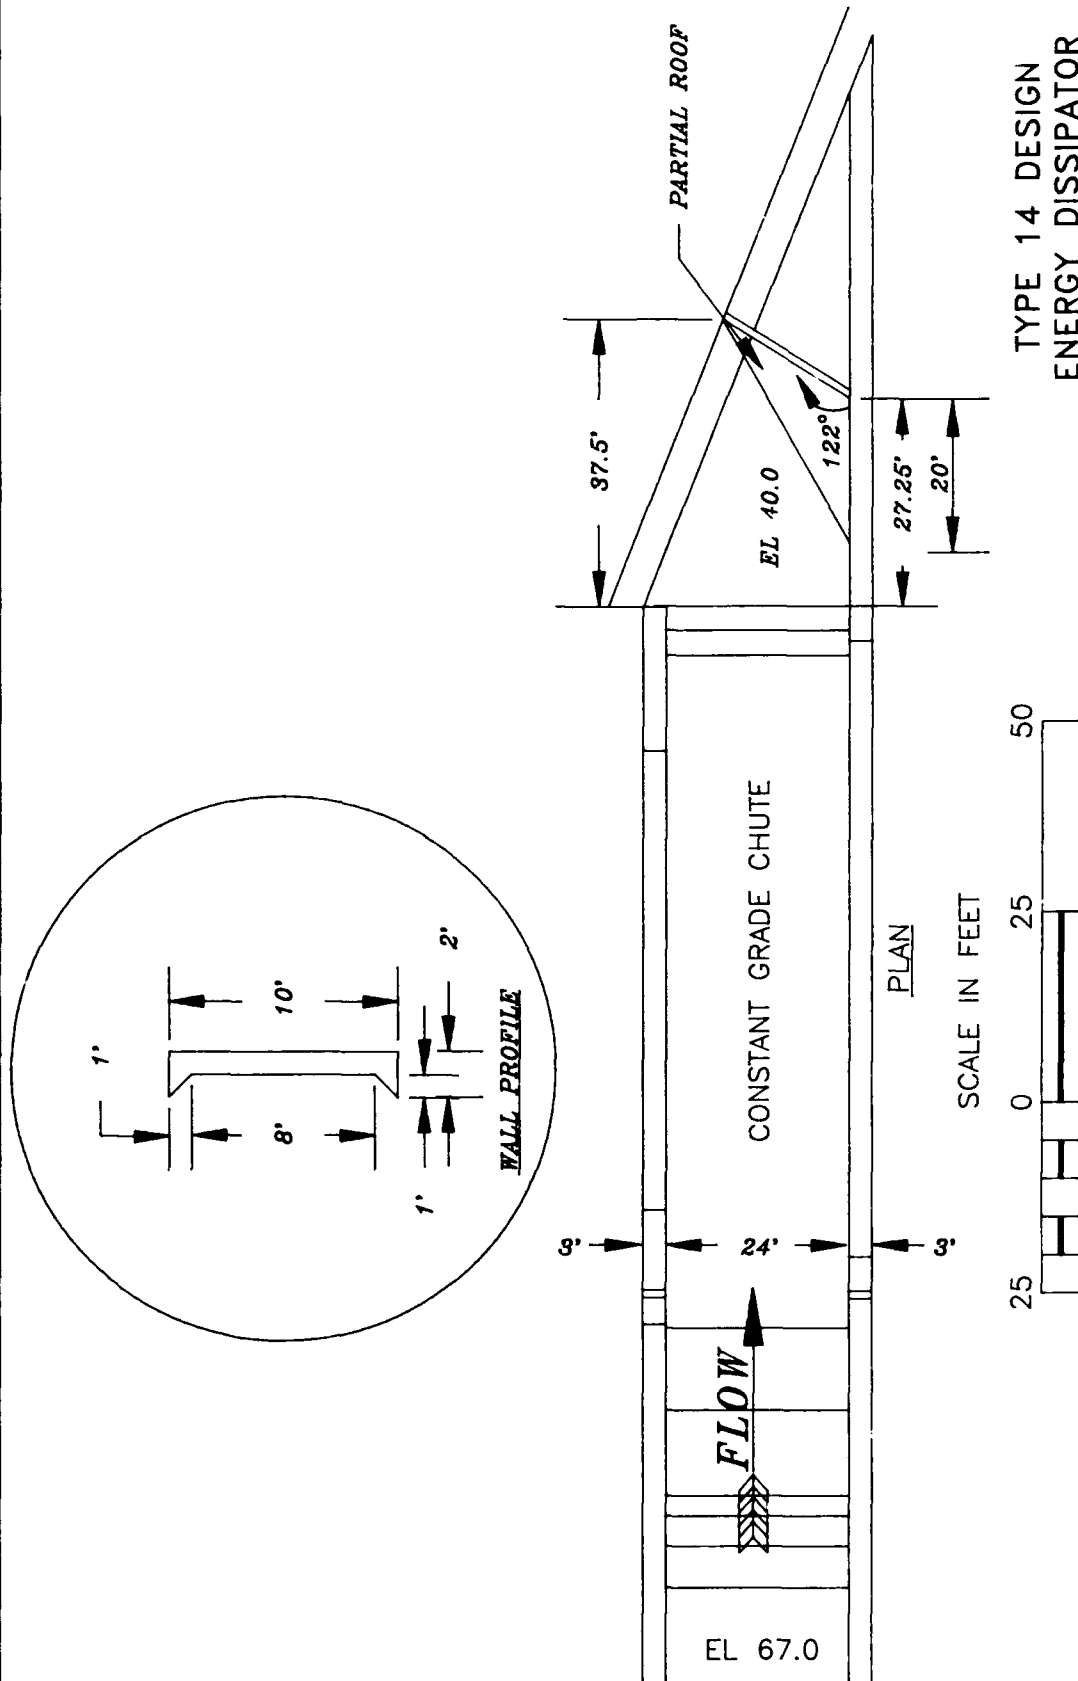
TYPE 14 DESIGN  
ENERGY DISSIPATOR

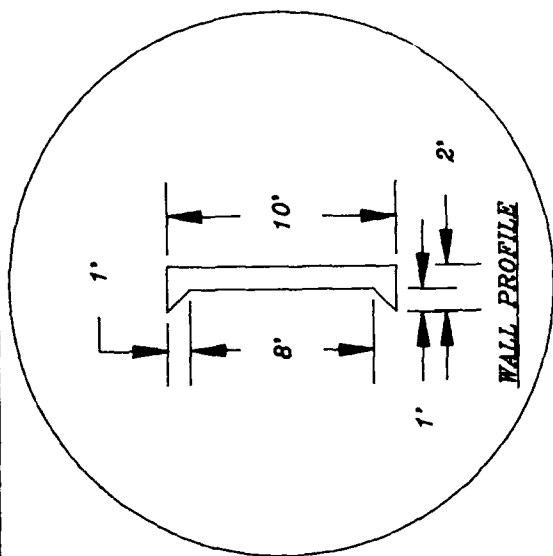
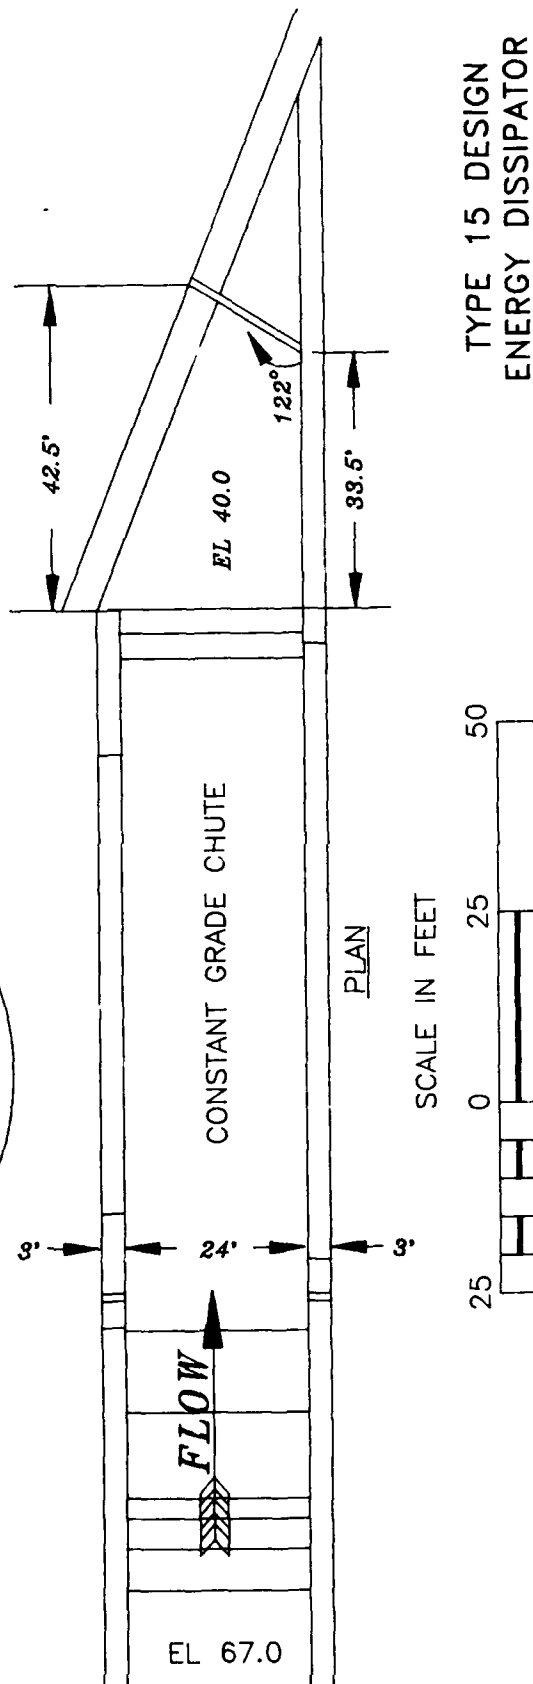
TYPE 15 DESIGN  
ENERGY DISSIPATOR

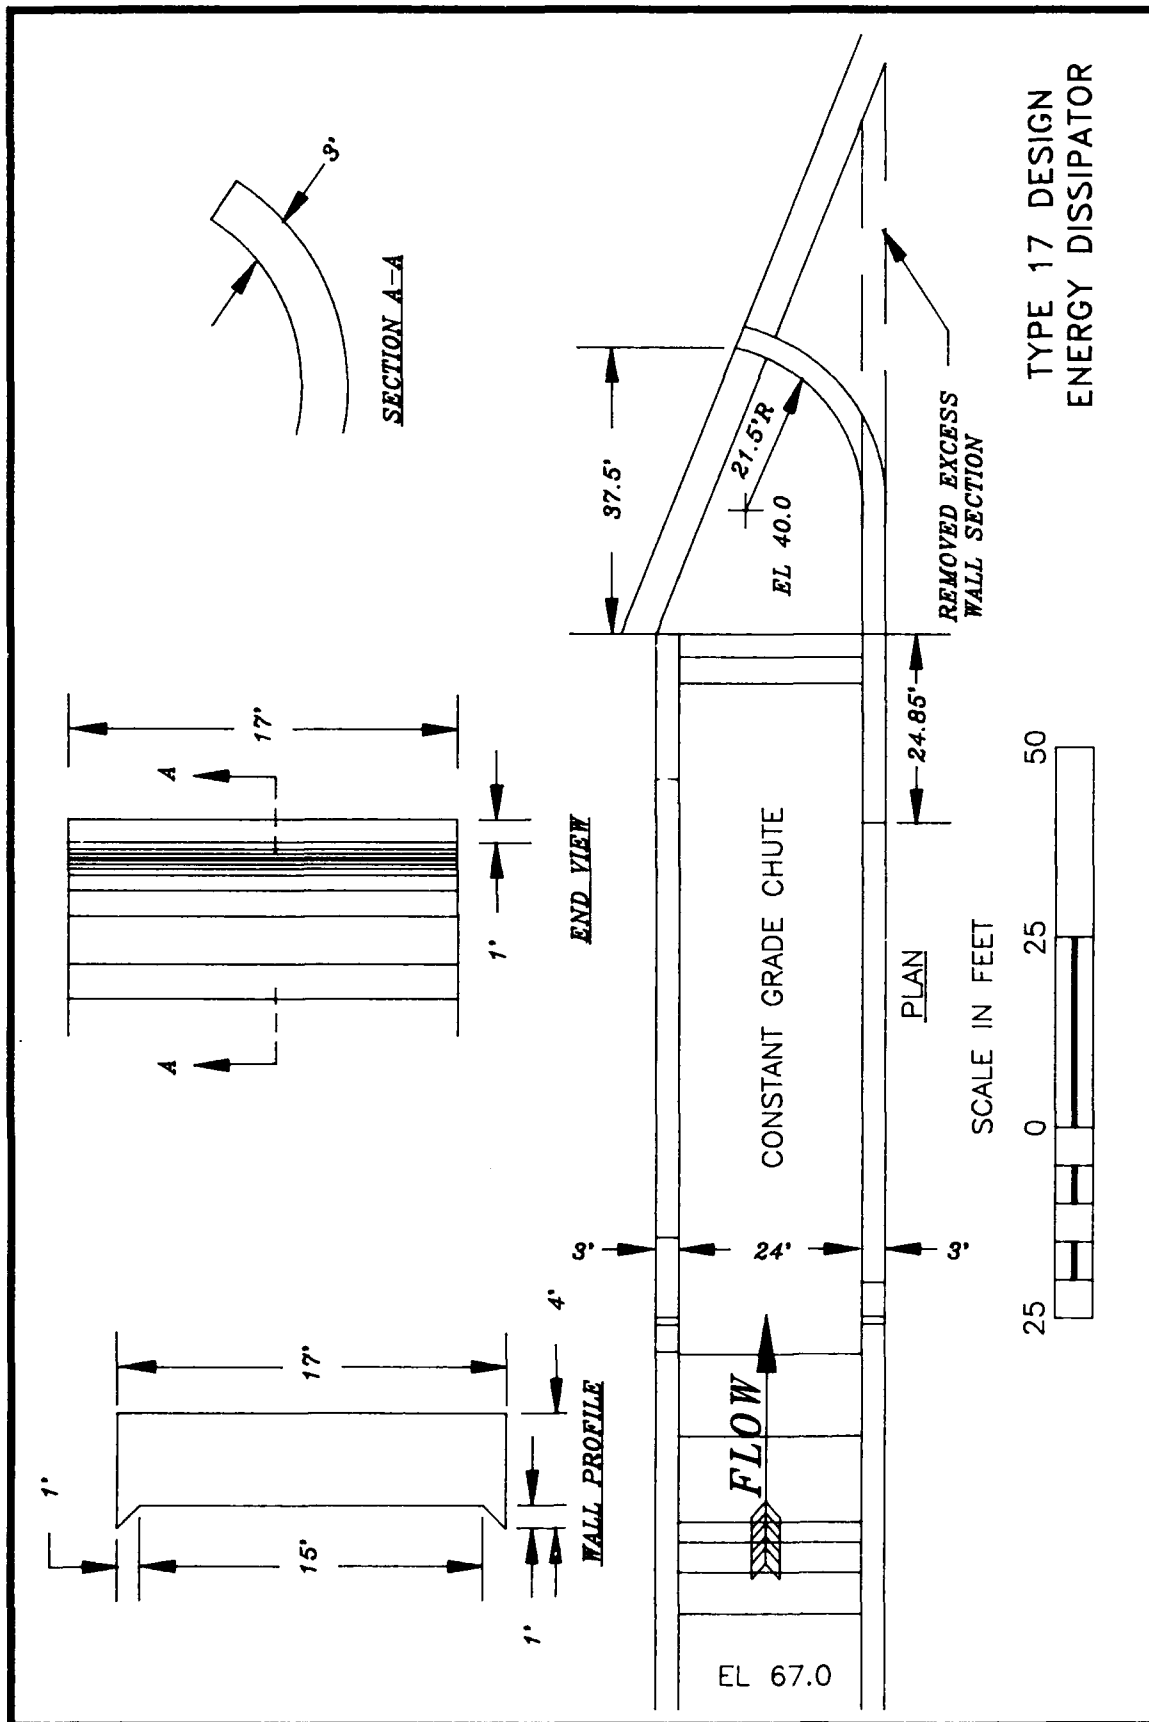
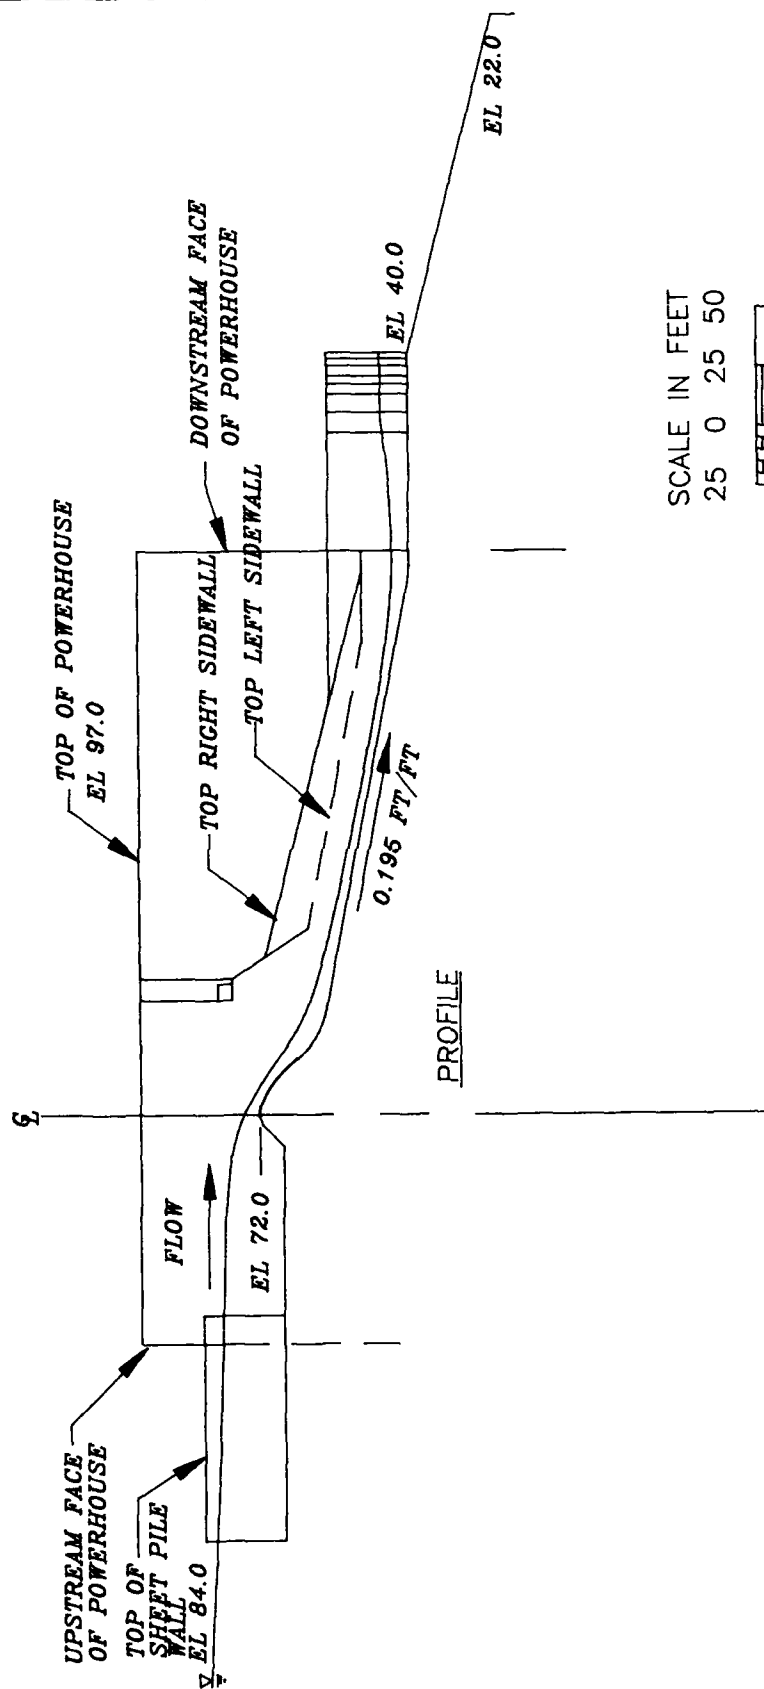
TYPE 17 DESIGN  
ENERGY DISSIPATOR
