# AIRFIELD PAVEMENT EVALUATION

GRAND TURK ISLAND  
INTERNATIONAL AIRPORT  
BRITISH WEST INDIES

SEPTEMBER 1994

AIR FORCE CIVIL ENGINEER SUPPORT AGENCY  
139 BARNES DR, SUITE 1,  
TYNDALL AIR FORCE BASE, FLORIDA 32403-5319

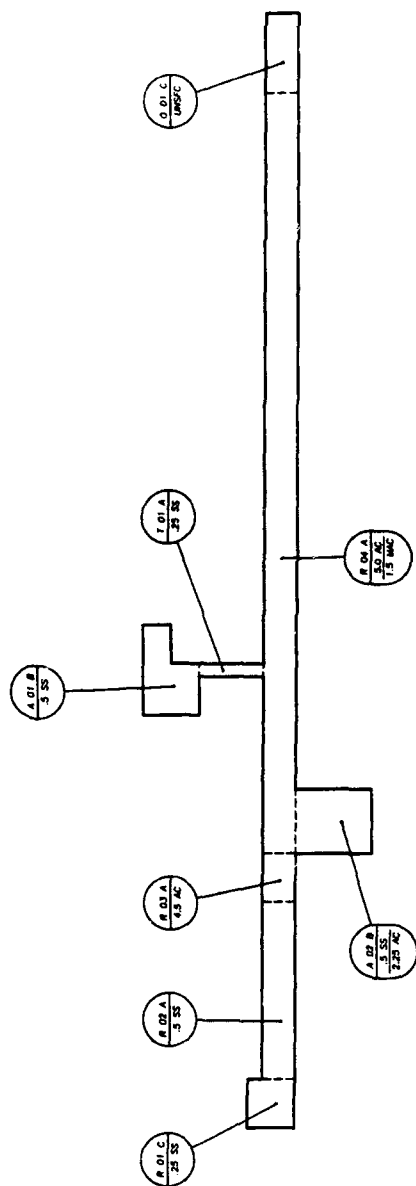
SHEET 1 OF 2

R 02 A FEATURE DESIGNATION (SEE NOTE 1)  
S SS PAVEMENT THICKNESS: IN INCHES & TYPE

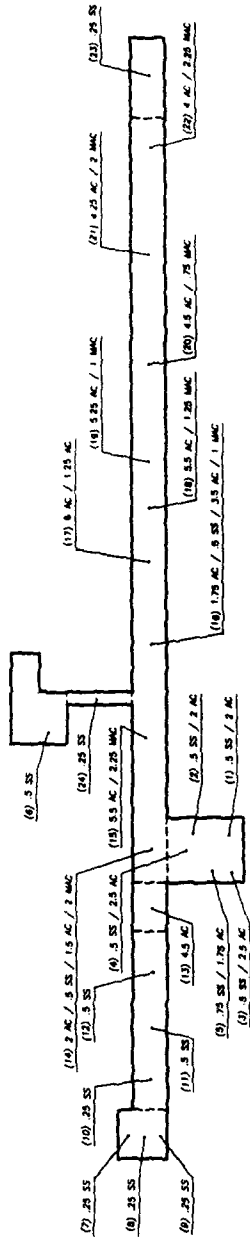
- (22) 4 AC / 2.5 MAC
- (21) 4.5 AC / 2 MAC
- (20) 4.5 AC / 7.5 MAC
- (19) 5.5 AC / 2.5 AC
- (18) 5.5 AC / 1 MAC
- (17) 5 SS
- (16) 5.5 AC / 2.5 AC
- (15) 5.5 AC / 2.5 AC
- (14) 2 AC / 5 SS / 1.5 AC / 2 MAC
- (13) 5 SS
- (12) 4.5 AC
- (11) 3 SS
- (10) 2.5 SS
- (9) 2.5 SS
- (8) 2.5 SS
- (7) 2.5 SS
