USCG-M-1-94.1
DOT-VNTSC-CG-94-5.1

Passenger Vessel Damage Stability Study for 1990 SOLAS Amendments Volume I

Final Report
September 1994

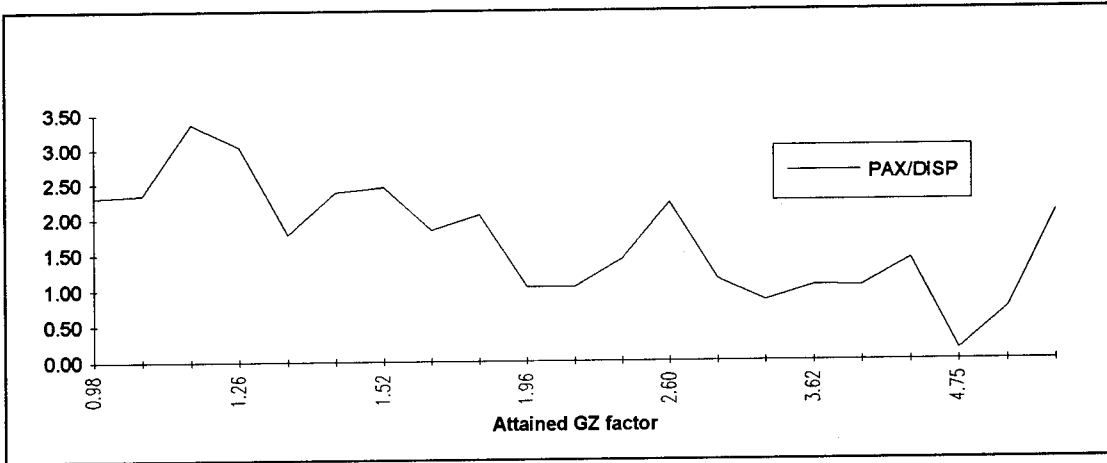
Figure 4.1
Attained GZ Factor

Figure 4.1 plots A_{GZ} against the ratio of passengers to displacement (LT) in the departure condition. The ratio describes the extent to which passenger capacity is maximized and trends the obvious proportional effect of the resulting heeling loads, tending downward with increasing A_{GZ} . The anomaly at the high end is the 105' dinner boat, whose relatively high C_b and flared shell contribute positively.

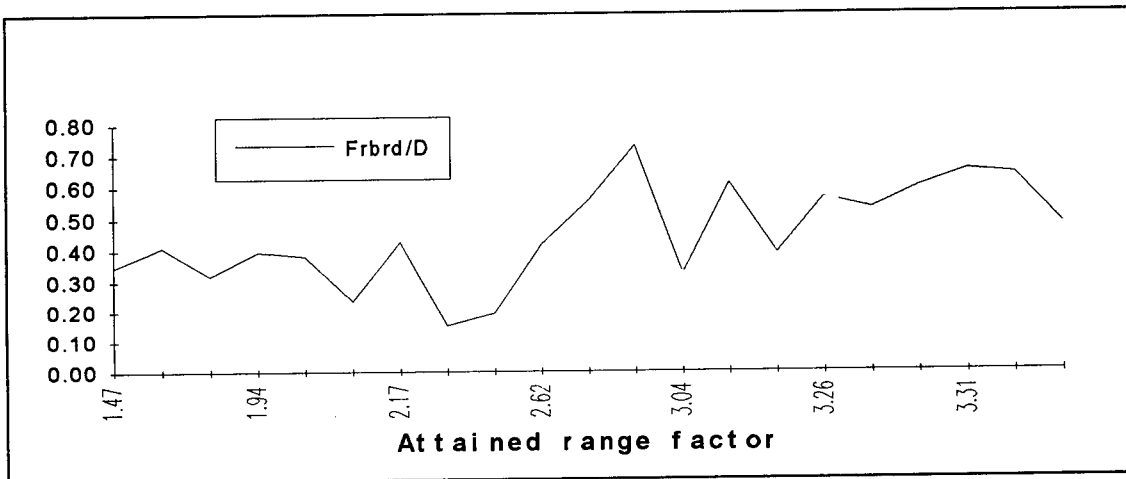
Figure 4.2
Attained Positive Righting Range Factor

Figure 4.2 plots A_{range} against freeboard/depth (f/D) and depth/breadth (D/B), both of which trend unevenly upward with increasing A_{range} . The low f/D and D/B values at the high end correspond to the 84' ferry, which is beamy and shallow but with barge-like form and a very high C_b .
