**US Army Corps  
of Engineers**  
Construction Engineering  
Research Laboratories

# Ten-Year Summary and Final Report of Fort Irwin, CA, Family Housing Comparison Test: Operation and Maintenance Costs of Manufactured vs. Conventionally Built Units

by  
Robert D. Neathammer

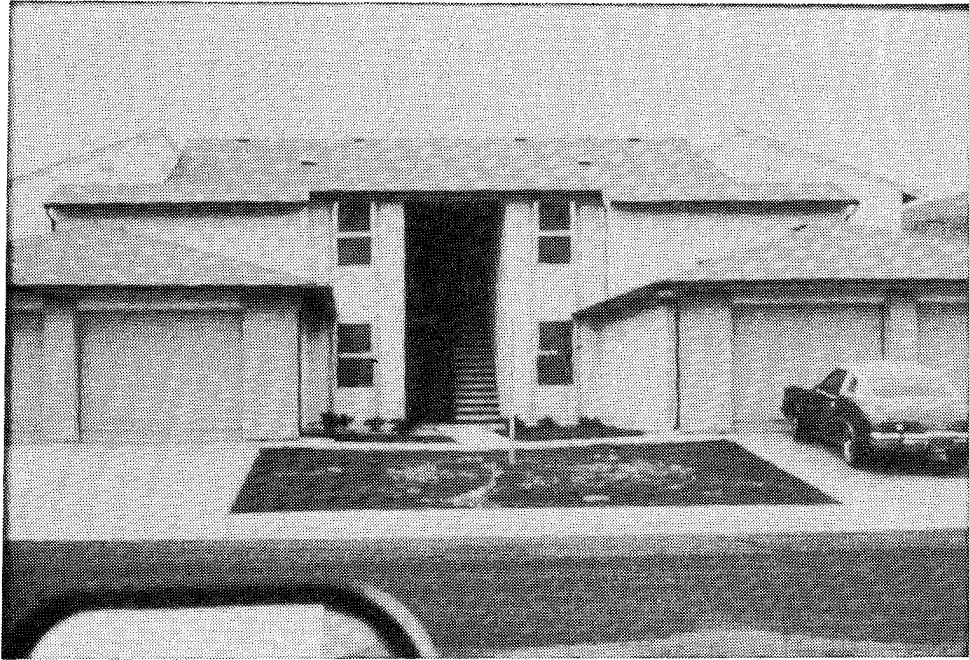
Front View - CBU

Rear View - CBU

Figure 2. Front and rear views of typical CBUs.

The 144 units consist of 13 sixplexes, 6 fiveplexes, and 9 fourplexes, all two-story buildings. Net floor area is 950 sq ft/unit and gross area averages 1120 sq ft/unit. These units were constructed on perimeter footings with building slab. Each unit has two bedrooms, a kitchen, living-dining area, one bathroom, utility room, either a fenced patio or balcony-porch (for upper unit), and a one-car garage. Figure 2 shows front and rear views of typical buildings. The fourplexes have two units on each level. There are two units on the second story in the five- and sixplexes with the additional unit(s) on the first level. The CBUs also have a refrigerator, gas range, gas water heater, garbage disposal, dishwasher, central air conditioning, and gas-fired forced-air furnace.

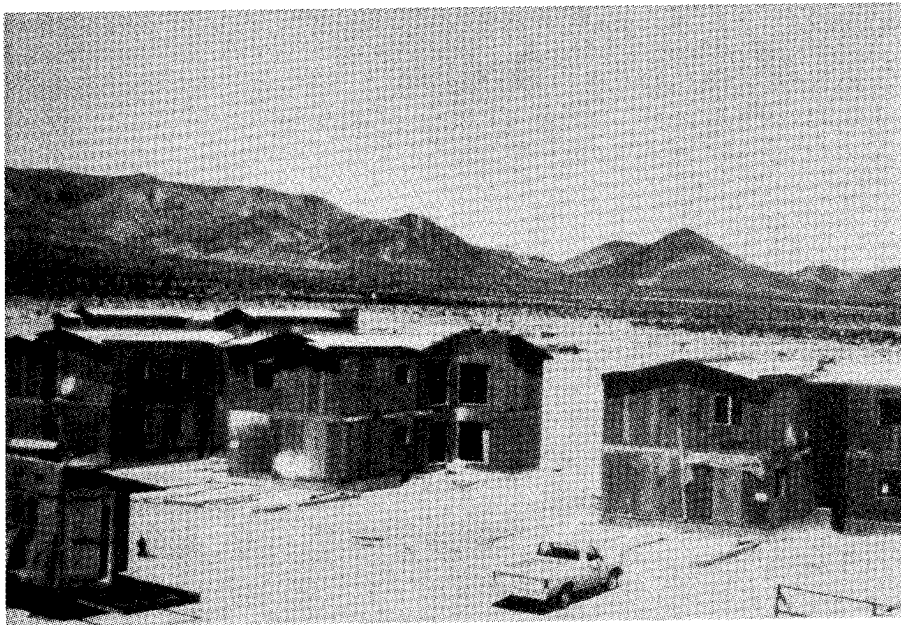
**Figure A6. Overview of buildings without garages.**
