# Redeye Crossing Reach, Lower Mississippi River

## Report 2 Navigation Conditions

Technical Report HL-95-13  
March 1996

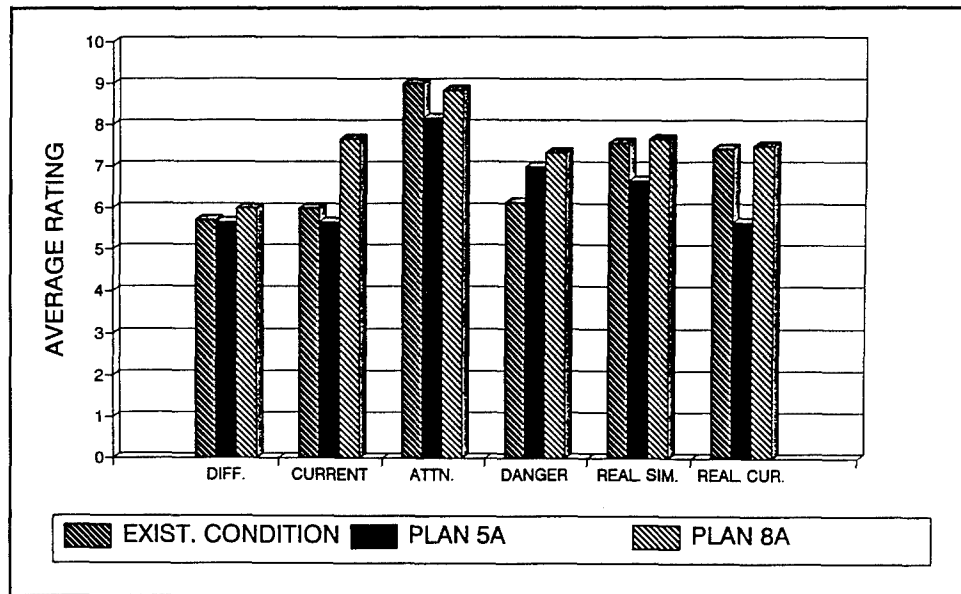
Figure 9. Ship pilot ratings, 1,500,000-cfs flow, downstream runs

Downstream runs, 1,500,000-cfs flow. Plan 5A is rated lower for all questions, except for danger of striking an object, than the existing condition (Figure 9). Plan 8A is rated nearly the same as or higher than the existing condition for all questions except for attention required, where it was rated slightly lower.

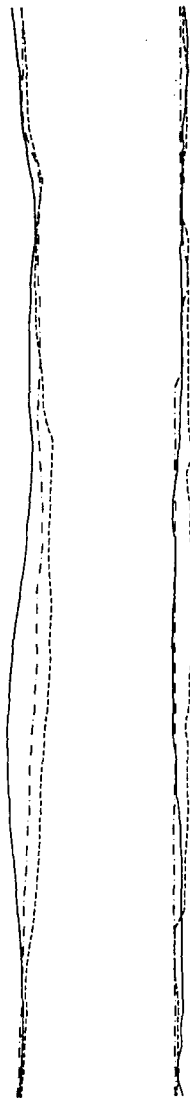
SPEED IN MPH  
16  
14  
12  
10  
8  
6

ENGINE RPM IN  
PERCENT OF MAXIMUM  
100  
80  
60  
40  
20  
0

**ENGINE RPM AND SPEED**  
840' X 138' X 43' SHIP  
1,500,000-CFS FLOW  
UPSTREAM RUNS

DISTANCE ALONG TRACK IN FEET

**LEGEND**  
BASE CONDITION  
PLAN 5A OPTIMIZED  
PLAN 8A OPTIMIZED

**1,500,000-cfs flow.** The upstream runs (Plate 45) show that the existing condition and Plan 8A runs averaged almost maximum rpm for the entire run. Plan 5A averaged slightly less rpm, especially through the crossing. This is reflected in the speeds for the runs. Plan 8A was slower than the existing condition, especially through the crossing, due to the increased current speed off the ends of the dikes. Plan 5A was slower than Plan 8A due to the lowered engine rpm. The downstream runs (Plate 46) show that the existing channel runs averaged less rpm from the beginning of the run through the bend than the two plan conditions. The pilots also tended to use slightly more rpm for Plan 8A than they did for Plan 5A for a majority of the run. Speed for the existing condition was expectedly slower for almost the entire run than for the plan conditions. Plan 5A was about the same as or slightly faster than Plan 8A.
