**GLASS WINDOW/WINDSHIELD  
REPAIR GUIDELINES**

**RICHARD J. OLSON**

**BATTELLE  
505 KING AVENUE  
COLUMBUS, OH 43201**

**AUGUST 1995**

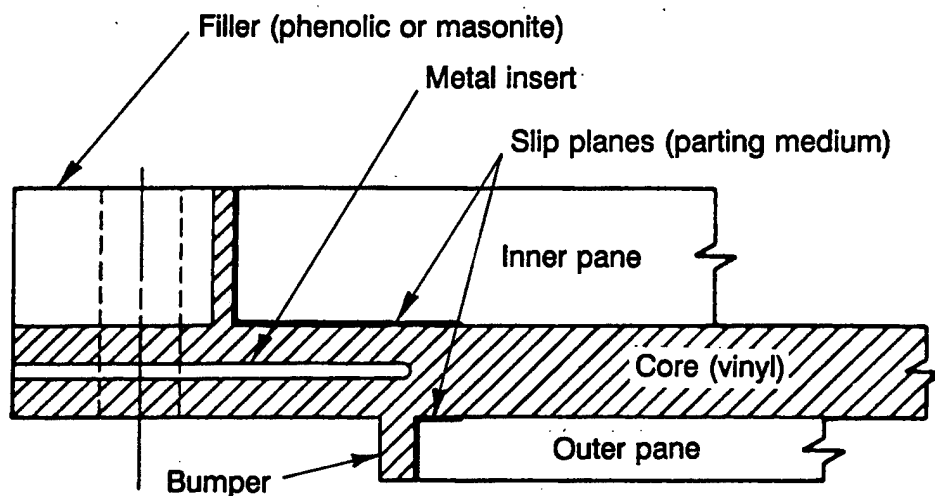
Figure 2.1 C/KC-135 and B-52 W/WS General Construction

Figure 2.1 shows the general construction of the glass C/KC-135 and B-52 W/WS. The W/WS have a three-part glass and vinyl laminate construction. The inner layer is thick, heat-strengthened plate glass designed to withstand cabin pressure forces. A transparent, plasticized, polyvinyl butyral core layer acts as the "fail-safe" load carrying member and prevents shattering in the event of inner ply failure. The outer ply is a relatively thin layer of heat-strengthened glass with no structural significance, but it provides rigidity and a scratch-resistant surface. A phenolic or masonite filler strip, located around the edge of the W/WS, and a metal filler strip embedded in the vinyl provide the means to attach the W/WS to the airframe. Vinyl or vinyl and rubber bumpers protect the edges of the glass plies.

An integral part of the C/KC-135 and B-52 W/WS construction is slip planes or a parting medium at the edges of the glass. A slip plane is located between both the inner glass ply and the vinyl and the outer glass ply and the vinyl as shown in Figure 2.1. The slip planes are thin strips of material at the glass-vinyl interface that keep the glass from bonding to the vinyl. This allows the various plies to move independently at these locations in response to pressure loads and differential thermal expansion. Without the slip planes, the glass at the edges of the W/WS would be prone to fracture because it would exceed its strain limit as it tried to move with the underlying vinyl. The slip planes form a "softer" connection that promotes a more gradual build up of strains in the glass so that it does not exceed its strain capacity. Although the slip planes look similar to delamination, they are not defects but an intentional part of the W/WS design.
