**DOT/FAA/AR-95/15**

# **Development of a D SIGHT Aircraft Inspection System: Phase II**

Final Report

6. Performing Organization Code	
7. Author(s) F. Karpala and O.L. Hageniers				8. Performing Organization Report No.	
9. Performing Organization Name and Address Diffracto Limited 2835 Kew Drive Windsor, Ontario N8T 3B7				10. Work Unit No. (TRAIS)

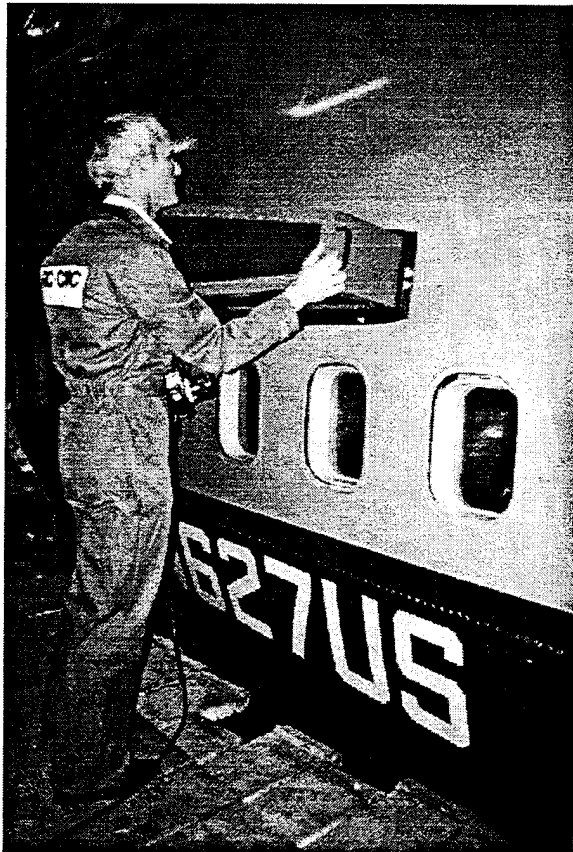
FIGURE 16. INSPECTING UPPER WINDOW BELT

The following figures (figures 13 to 21) show the new DAIS equipment being used at various facilities during the field trials. A few typical *D SIGHT* images of the aircraft surfaces are also shown at different corrosion levels (figure 15, figure 20, and figure 21).

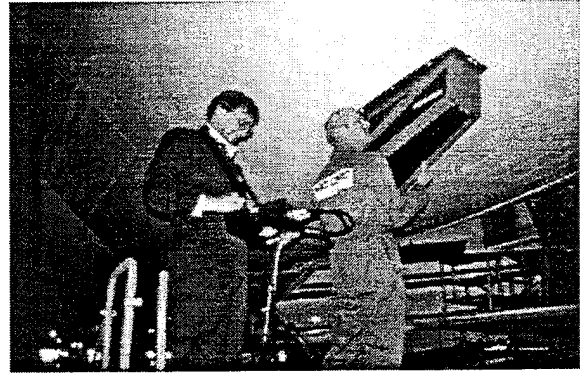
FIGURE 18. B-747 FORWARD BELLY INSPECTION

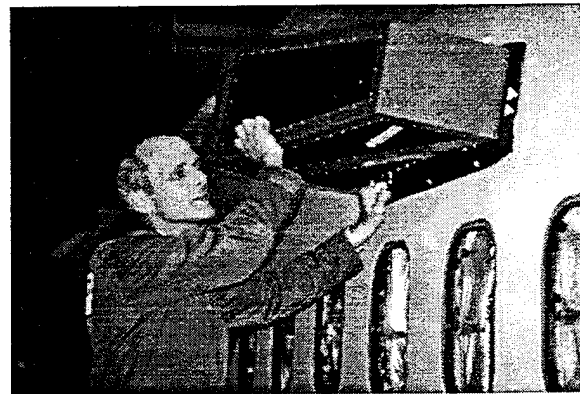
FIGURE 19. UPPER WINDOW BELT INSPECTION
