Miscellaneous Paper CERC-96-3
May 1996

Physical Model Study of Breakwater Stability, Kodiak, Alaska

Prepared for U.S. Army Engineer District, Alaska

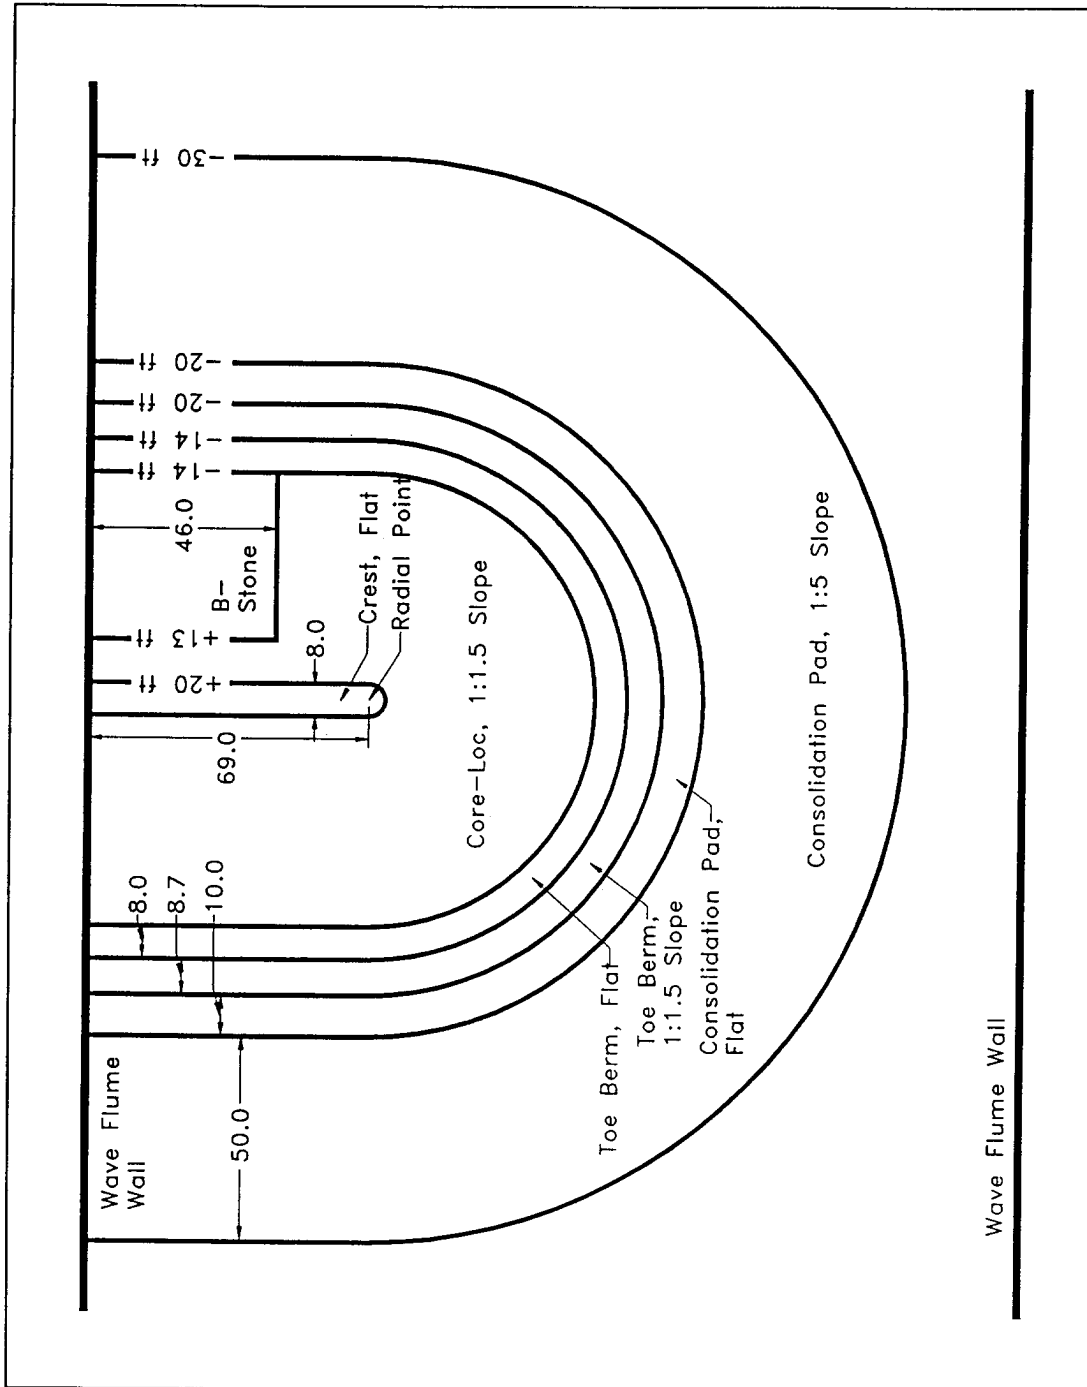
Figure 3. Overhead view of Plan 1 in test flume

Primary concern of the model tests was stability of the structure head. Due to refraction, angle of incidence, and other 3-D effects, structure head tests are normally conducted in a 3-D wave basin. However, there were no 3-D wave basins available at CERC during the time frame in which the physical model tests were required. It was therefore decided to construct the model head extending out from one wall of one of the largest two-dimensional (2-D) wave flumes at CERC. The model would extend part-way across the flume, perpendicular to the flume walls, allowing wave action to be channeled past the model head. Because the stub breakwater at the prototype also will channel wave action past the main breakwater head, the "quasi-3-D" representation in the 2-D wave flume was thought to be adequate. The model would include the main breakwater head plus part of the breakwater trunk. Figure 3 illustrates the quasi-3-D nature of the test with an overhead view of Plan 1 in the test flume.

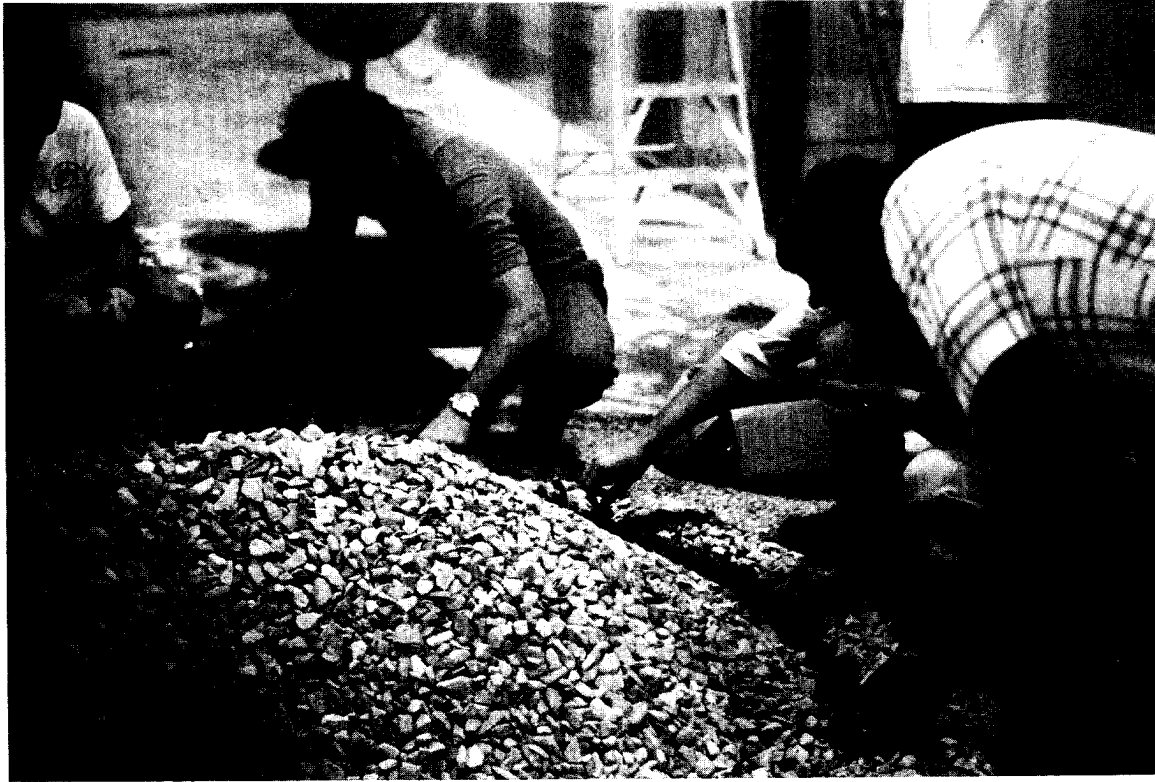
Photo 3. Placement of Core-Loc concrete armor units on model toe

Core-Locs along the toe were placed individually in a uniform pattern as shown in Photo 3. All Core-Locs placed above the toe row were randomly placed. On the harbor side, first row above B-stone also was uniformly placed as at the toe, with all subsequent rows randomly placed.

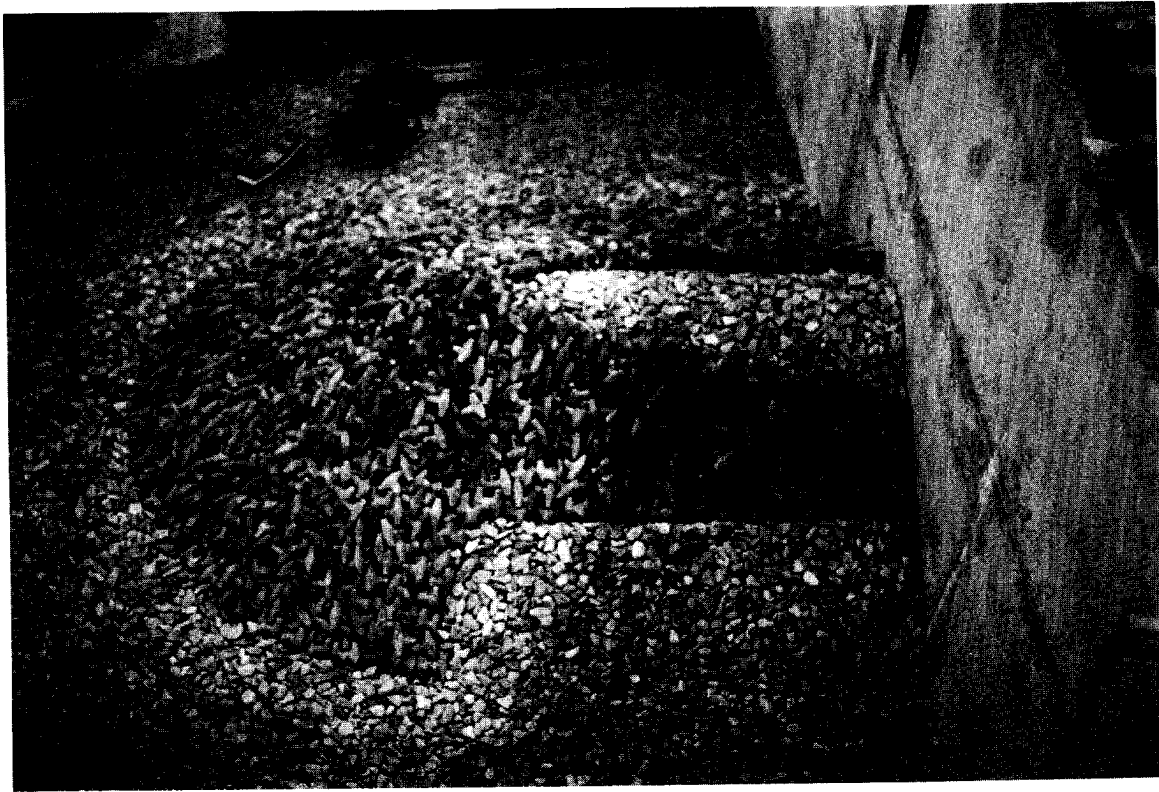
Photo 4. "Inverted V" placement technique for concrete armor units

Placement of Core-Locs on the structure crest followed an “inverted V” (Photo 4). Working from the head back along the crest, Core-Locs were placed in such a manner that they formed a “V” with the point on the crest pointing toward the head. Core-Locs were placed along each side of the structure such that the “V” shape moved along the structure crest from head back along the length of the trunk. This method, recommended by Messrs. Melby and Turk (inventors of the Core-Loc), appeared to produce a more consistent placement of units on the crest and reduced problems with a “seam” that occurs when armor units are placed up each side of the structure and meet at the crest. Where the sides meet, it is difficult to ensure that individual units are keyed into the matrix.

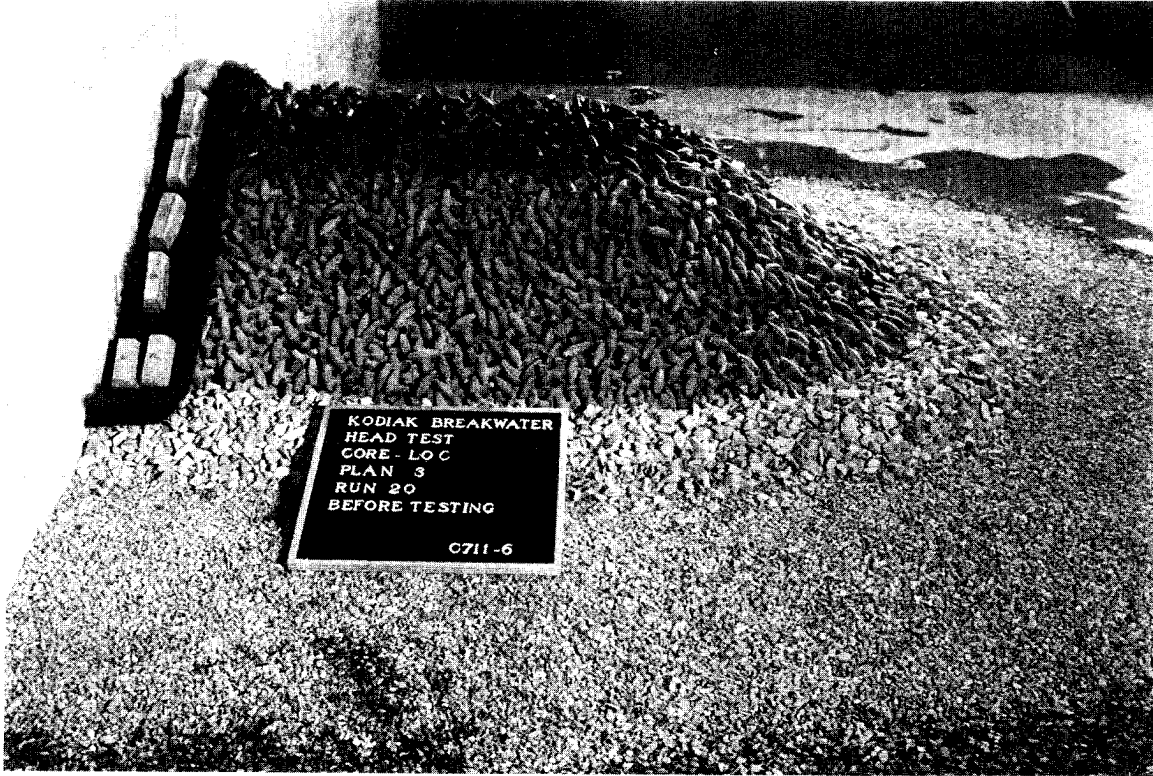
Photo 11. Sea-side view of model breakwater Plan 3 before testing

The sea-side slope and structure head were not rebuilt after Plan 2 testing. All Core-Locs were removed from the crest and harbor-side trunk, and the larger-sized B-stone on the harbor-side trunk were removed. The crest and harbor-side trunk were then rebuilt. Plan 3 used 143 more Core-Loc units than Plan 2 due to placing the Core-Locs further down from the crest on the harbor-side trunk. A strip of horsehair 0.15 m (0.5 ft) wide was placed over the structure along the wall from the sea-side toe to the harbor-side toe to protect units near the wall from wall effects. Photos 11 and 12 show the sea side and harbor side, respectively, of Plan 3 before testing.

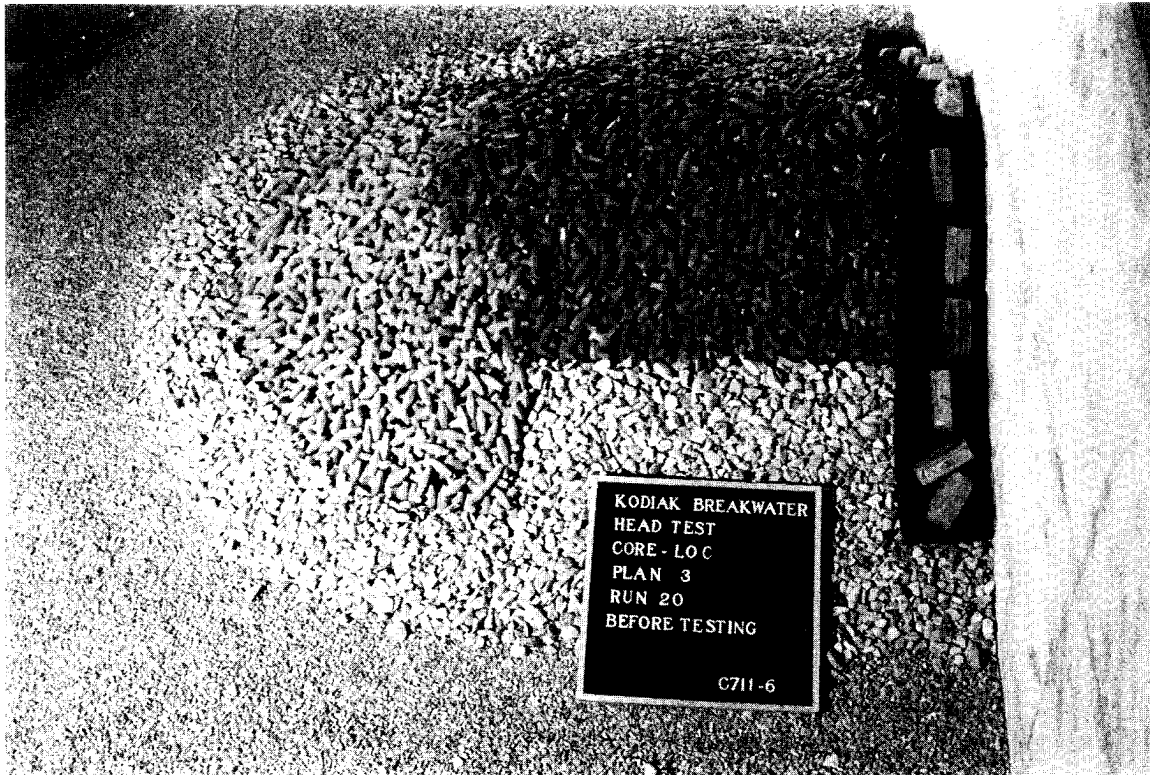
Photo 12. Harbor-side view of model breakwater Plan 3 before testing

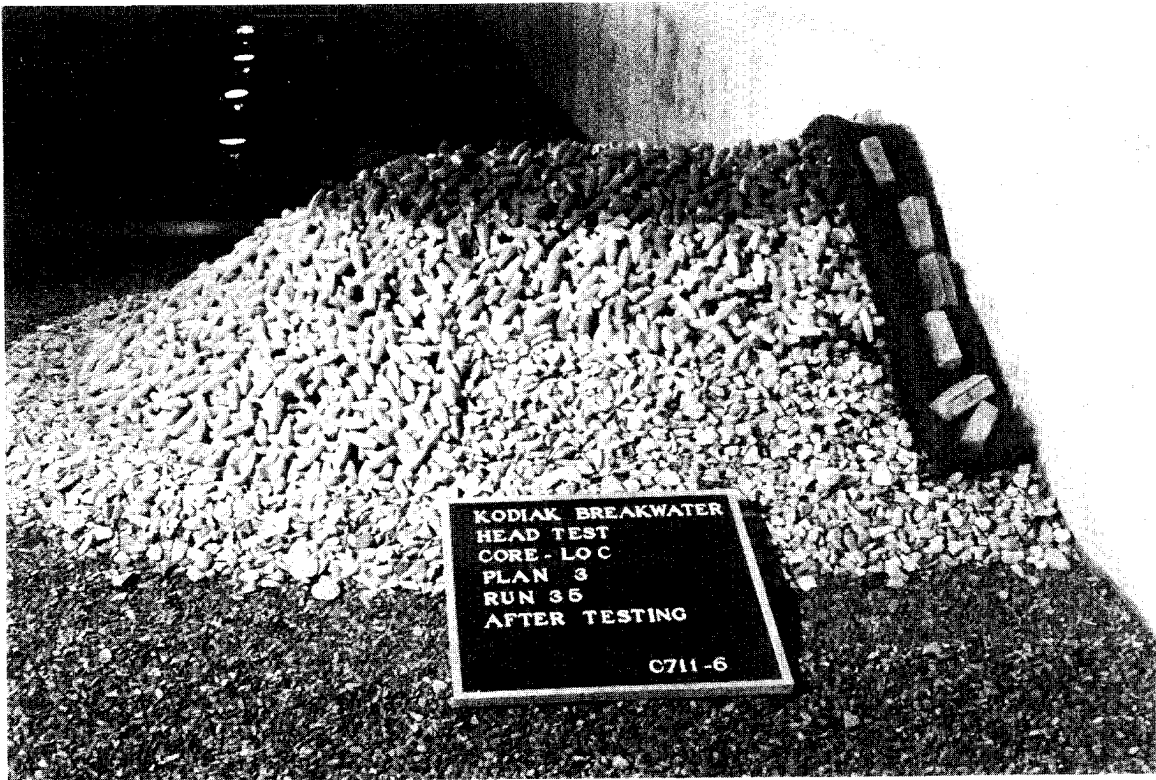
Photo 14. Harbor-side view of model breakwater Plan 3 after testing

Three runs of 48 min each were conducted at $T_p = 14.0$ sec and $H_{m0} = 2.1$ m (7.0 ft). During the third run, the structure failed when heavy overtopping pushed Core-Loc units down the harbor side of the trunk with enough force to push the B-stone on down the slope in front of the Core-Locs. There was no evidence of undermining. The 14-sec waves overtopped the structure trunk as a surging breaker, causing a very heavy downrush on the harbor side. Because the B-stones were placed by dumping, they were not interlocked into a matrix as is the case with individually placed and seated armor units. The B-stone therefore had little resistance to sliding. Hydrodynamic forces on the Core-Locs were sufficient to push the B-stone downslope and cause a slumping failure in the Core-Locs.
