R-TR-77-013

**EVALUATION OF LUBRICATING
COMPOSITES FOR THE M16A1 RIFLE**

FEBRUARY 1976

**GENERAL THOMAS J. RODMAN LABORATORY
ROCK ISLAND ARSENAL
ROCK ISLAND, ILLINOIS 61201**

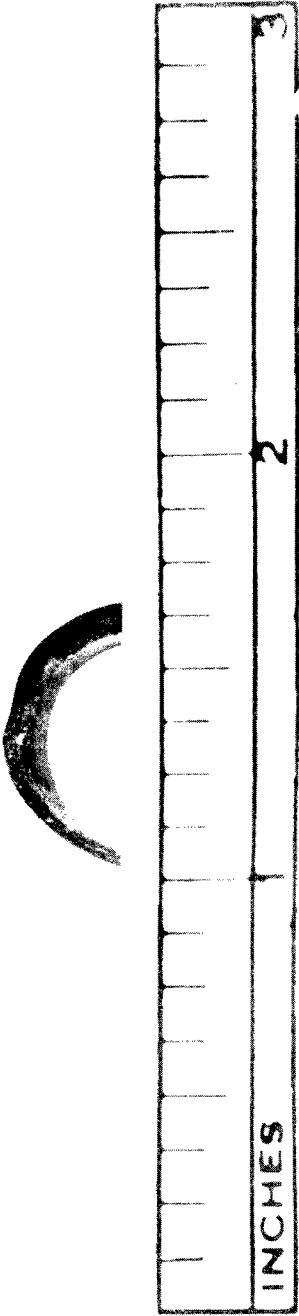
Figure 5. Left Side of Bolt Carrier Showing Inserts in Place.

The types of composite inserts used are shown in Figure 4. These inserts were glued in place with epoxy resin, as shown in Figures 5 and 6. The composite inserts were then ground down until they protruded .005 inch above the surfaces to which they were applied. The appearance of the bolt carriers after this grinding process is shown in Figures 7 and 8.

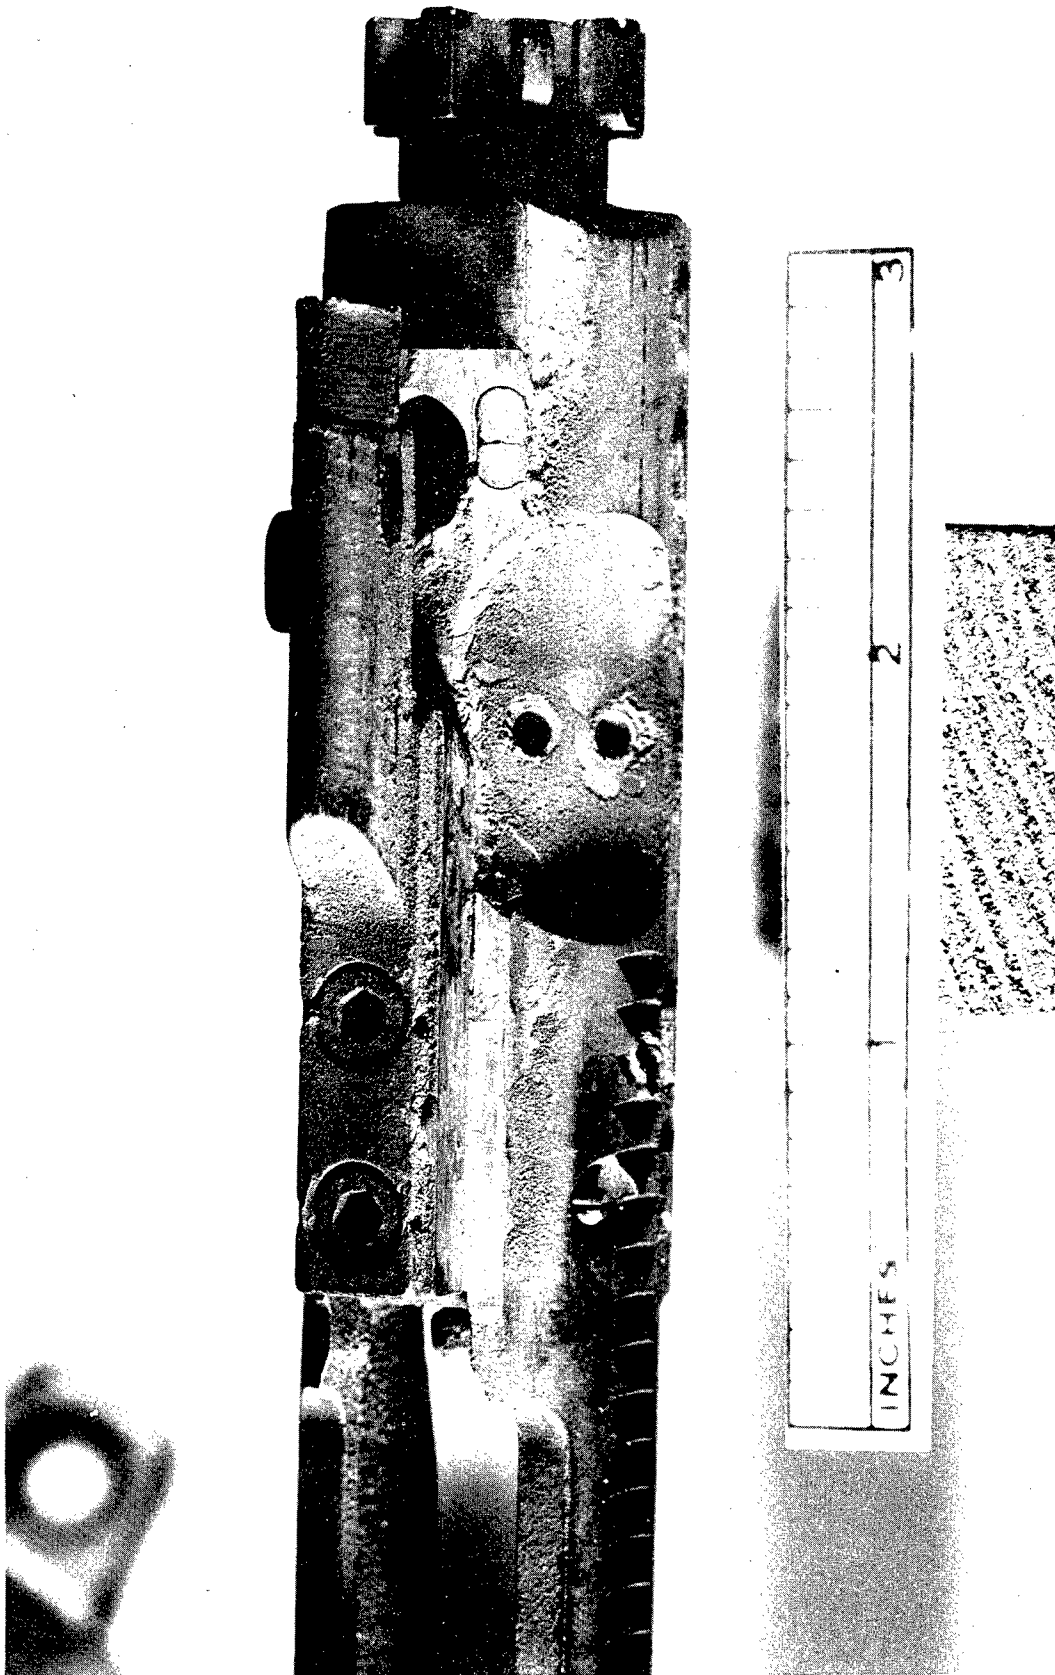
Figure 9. Bolt Carrier after 10,000 Rounds Showing Cracked Insert.

Although Rifles Nos. 2 and 3 completed the 10,000-round test, the composite insert in the cam path area had cracked. In Figure 9, the bolt carrier of Rifle No. 3 is shown at the end of the test with the cracked insert. Therefore, with the exception of Rifle No. 4, which was in the test for only a short time, the composite insert in the cam path area, at which the cam path wall was broken through during machining, either fell out or broke off, or was cracked. The effect of this on the test results is difficult to assess. The exact time at which these inserts cracked could not be determined; however this cracking could have occurred very early in the test. Some malfunctions undoubtedly occurred because of these cracked inserts and not because of any lubrication deficiencies. In spite of the difficulties encountered with the inserts in this one area of the carrier cam, the 6-malfunction rate per composite-lubricated rifle is considered very good.
