# **Periodic Inspection of Burns Harbor North Breakwater, Indiana**

## **Report 1 Base Conditions**

by *Robert R. Bottin, Jr., WES*  
*Erik W. Matthews, Chicago District*

Technical Report CERC-96-8  
September 1996

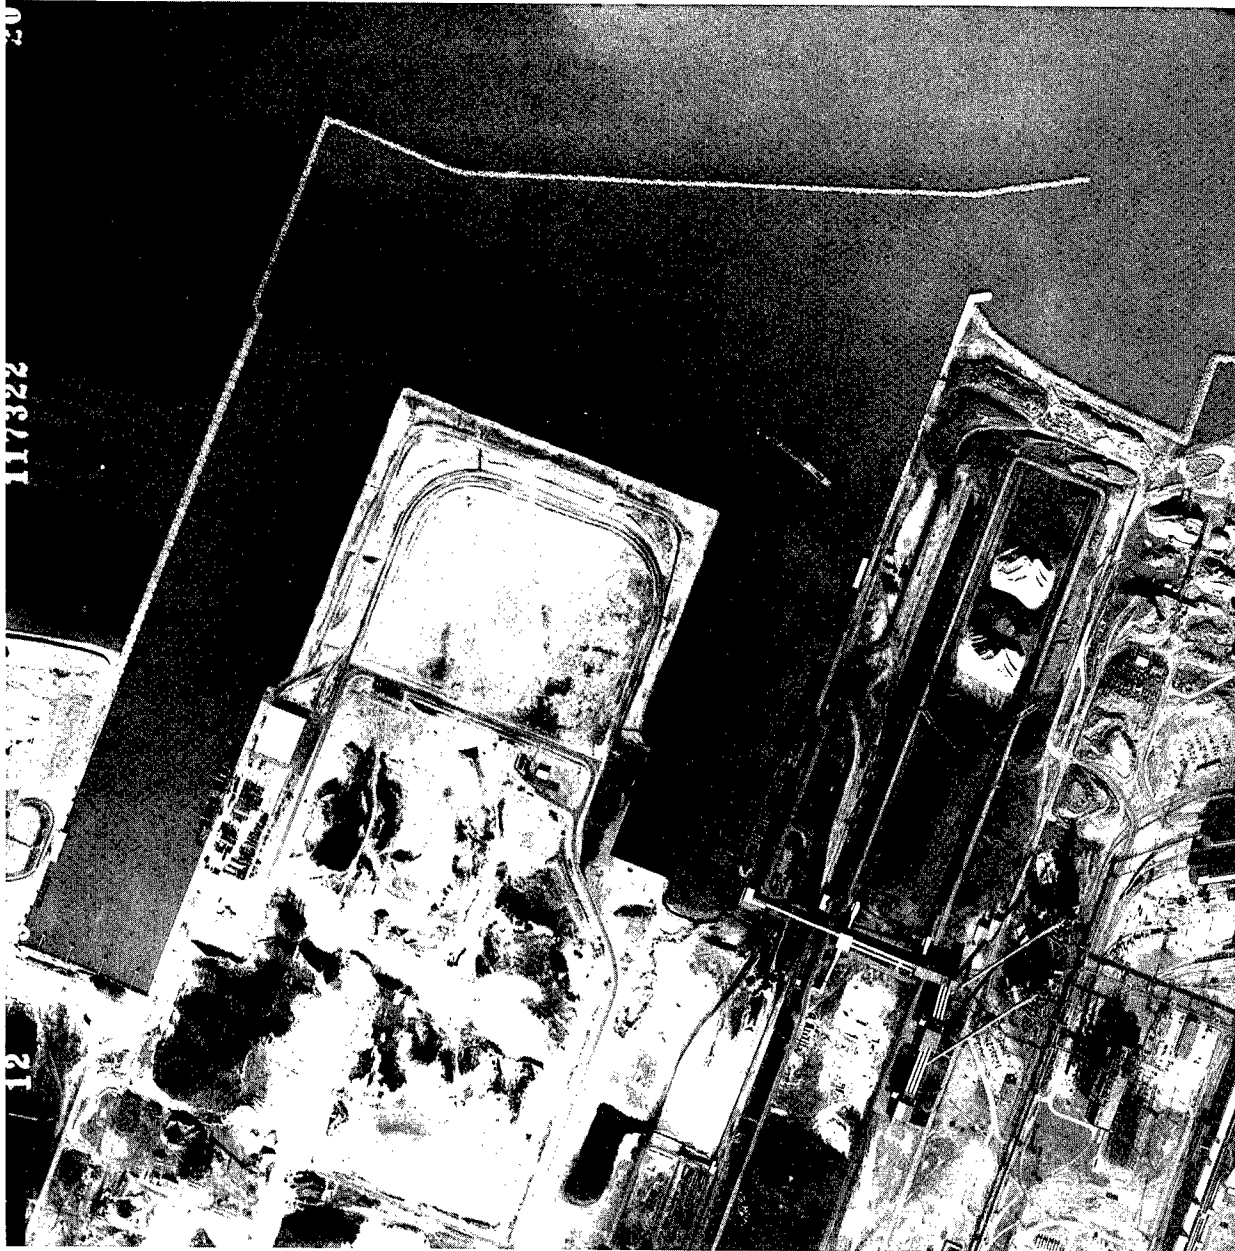
Figure 3. Aerial view of Burns Harbor

cellular steel sheet-pile extension connecting the west breakwater to shore. An aerial photograph of the harbor is shown in Figure 3.

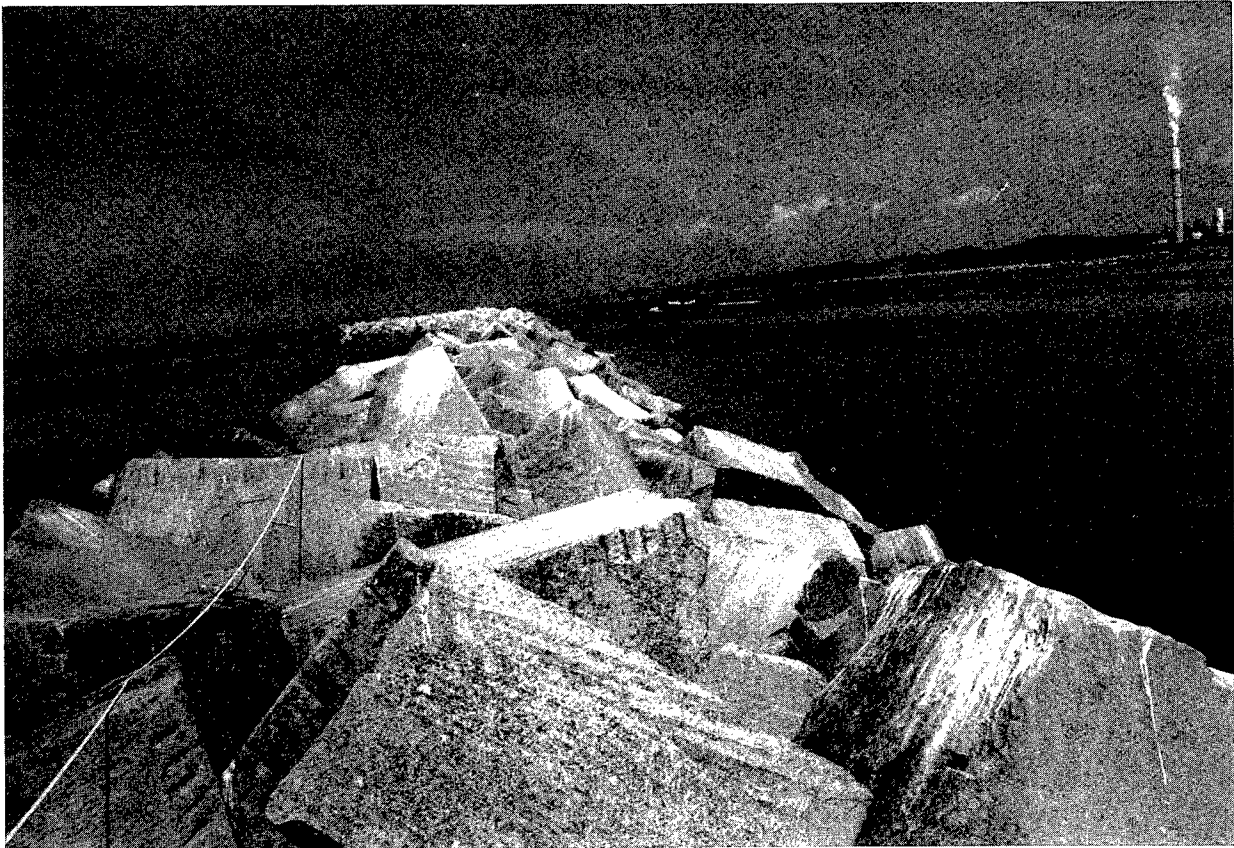
Figure 4. View of armor stone on breakwater trunk

The rubble-mound breakwater was constructed with a multi-layered design and random placement of the armor stone cover layers. The crest elevation of the structure was +4.3 (+14) and the toe elevation was approximately -12.2 (-40). Armor stones consisted of rectangular cut Indiana Bedford limestone blocks ranging from 9,100 to 13,600 kg (10 to 15 tons) on the trunk (Figure 4) and 13,600 to 18,100 kg (15 to 20 tons) on the head. A cross section of the original breakwater is shown in Figure 5.

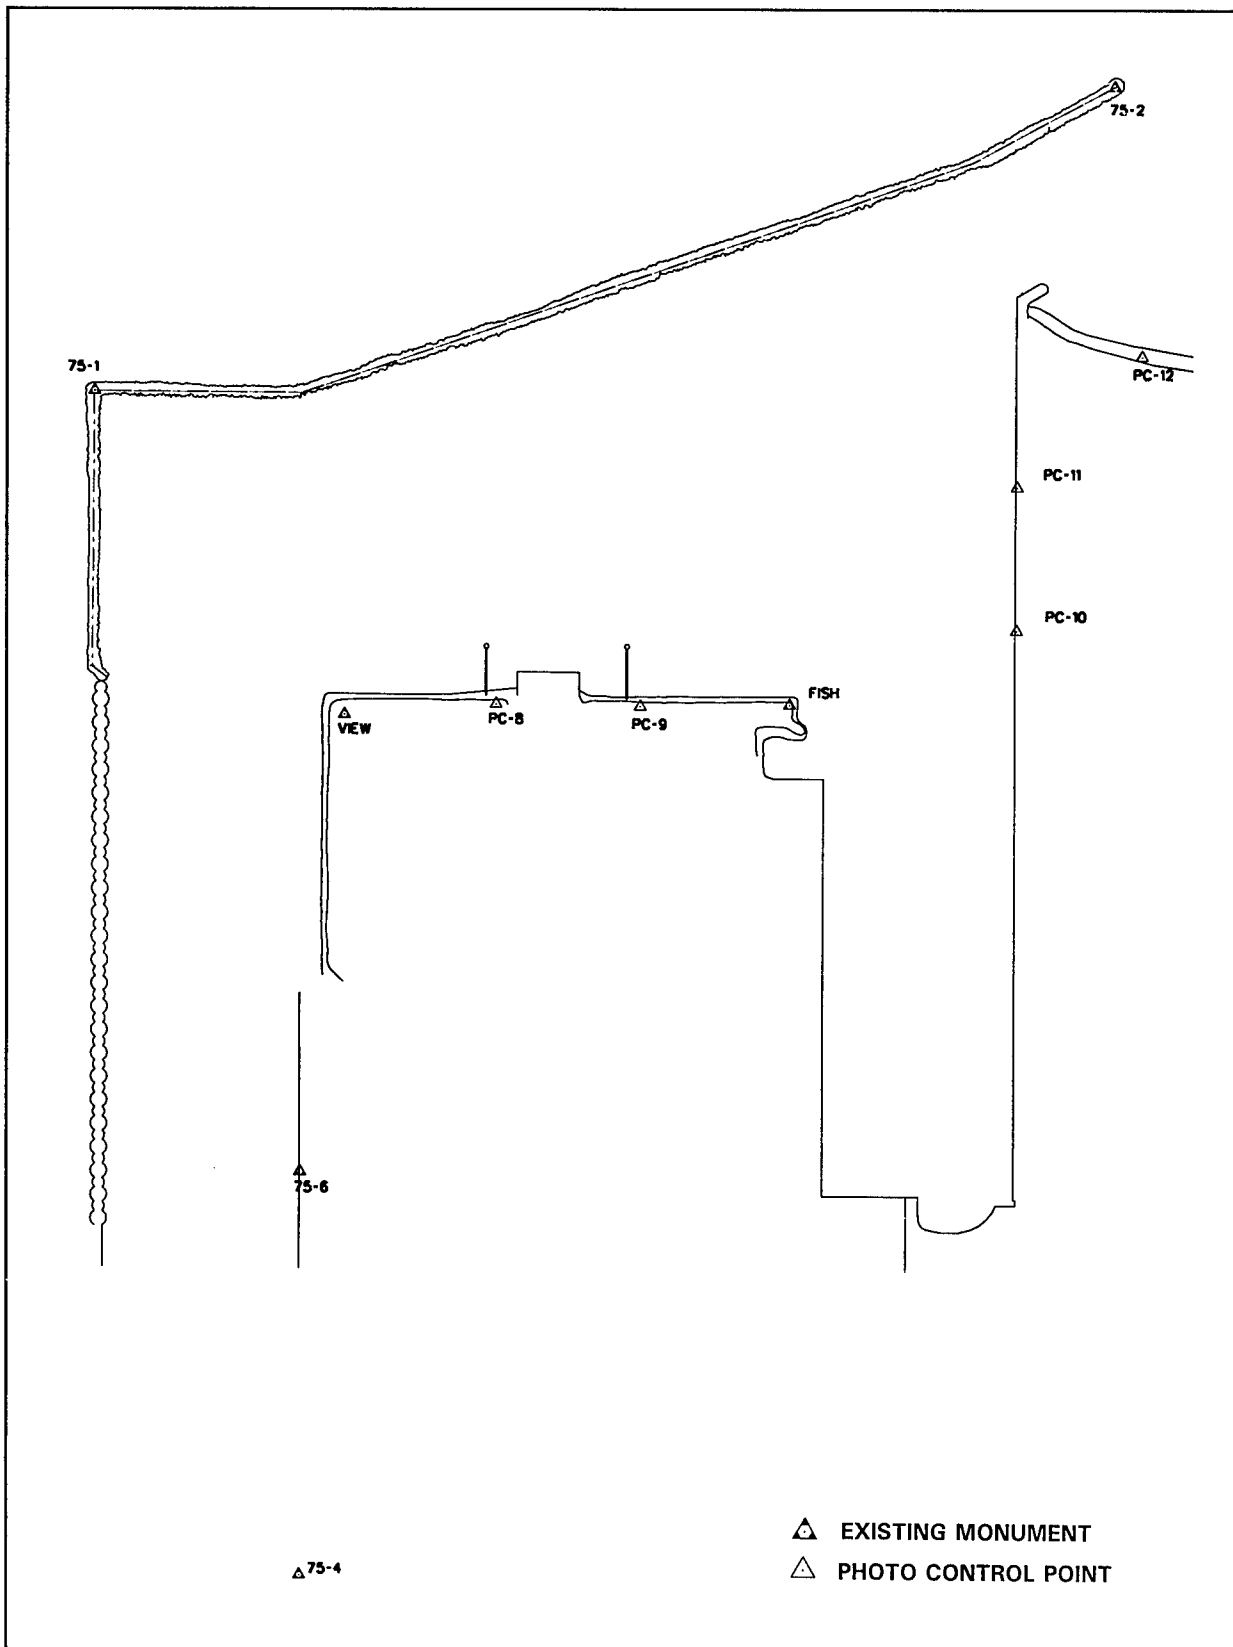
Figure 6. Locations of existing monuments and photo control points

Existing monuments in the vicinity of the harbor were used to serve as reference points (both horizontal and vertical reference) for the ground-based survey work as well as photogrammetric work. Ground surveys were initiated from these monuments. In addition, photo control points were established using global positioning system (GPS) control surveying and electronic land surveying techniques. The existing monuments were bronze disks, cemented into place, and photo control points were established with steel rods. Locations of the existing monuments and the photo control points are shown in Figure 6. Positions and elevations of the monuments and photo control points are listed in the following tabulation:

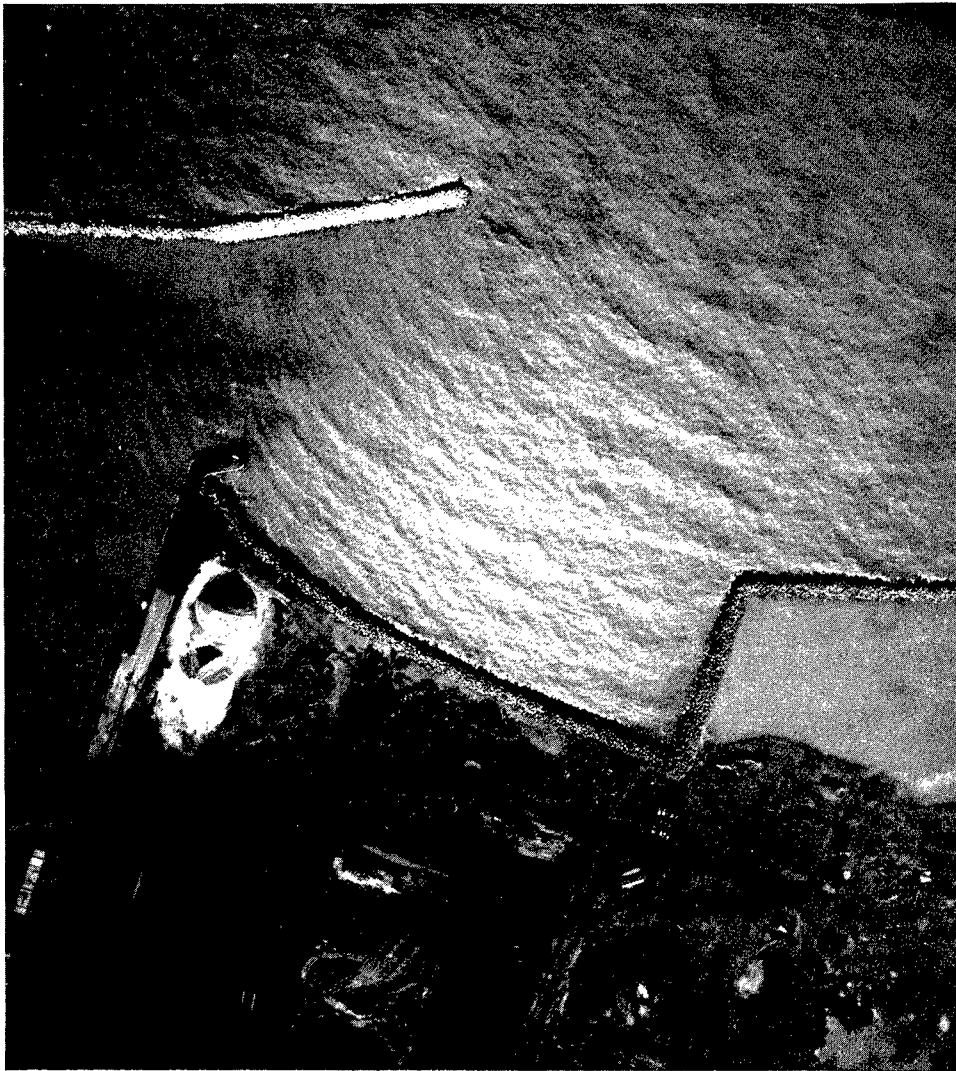
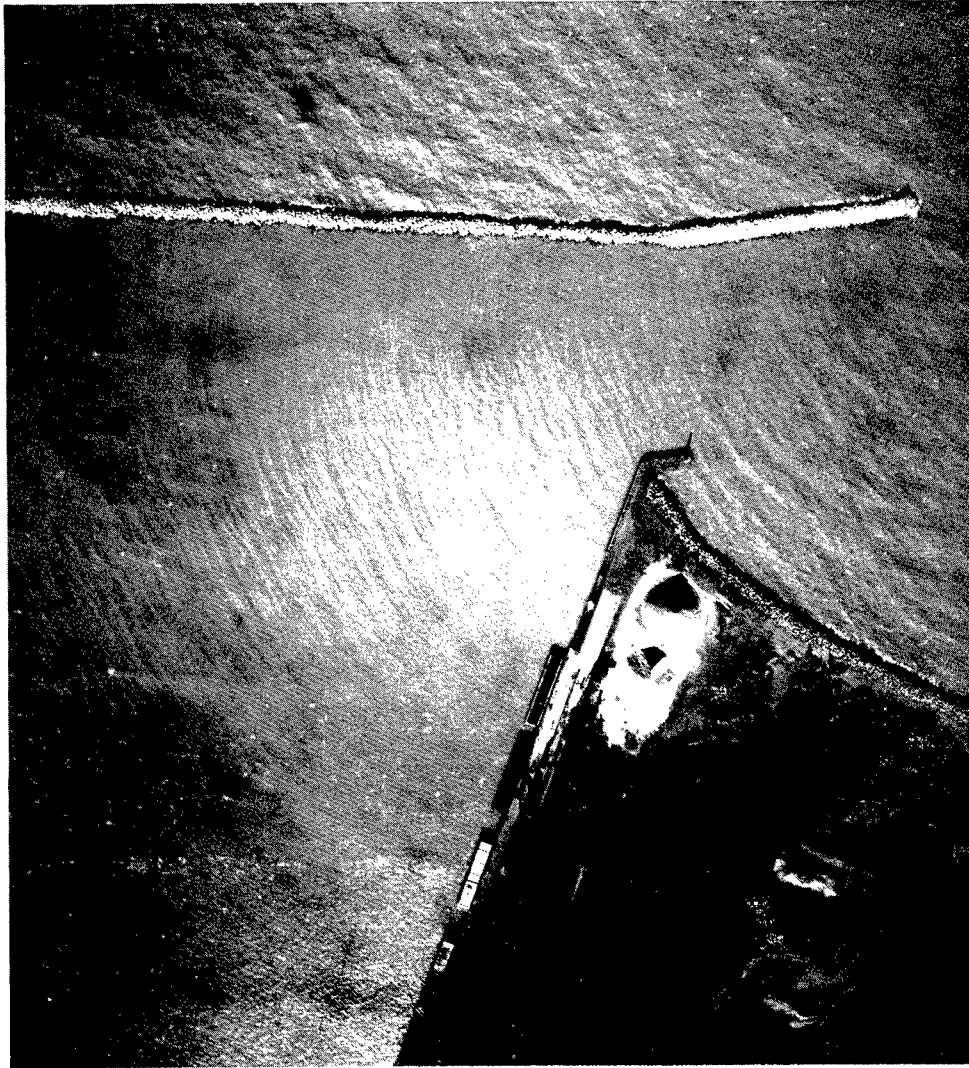
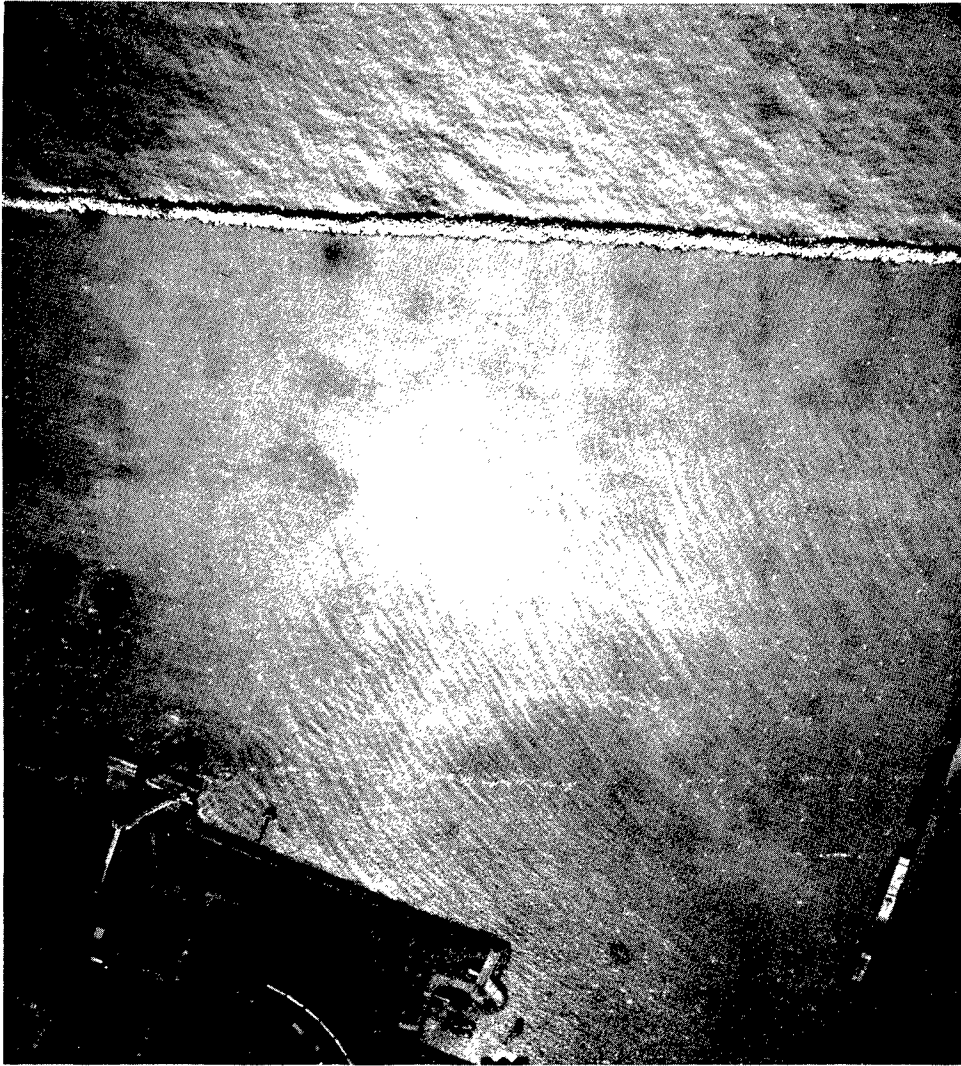
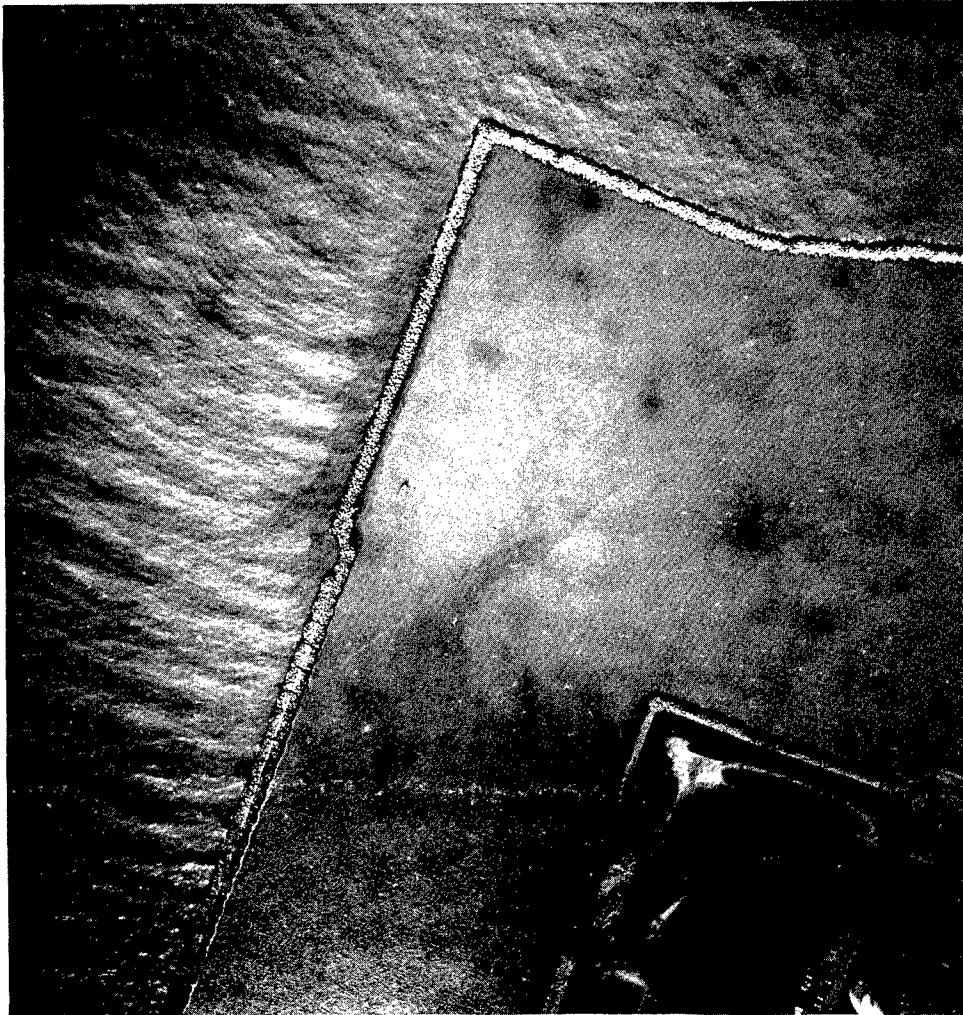
Figure 7. Stereo pair photographs for Burns Harbor North Breakwater  
(Sheet 1 of 5)

Aerial photography was obtained along the breakwater with a Zeiss RMKA 15/23 aerial mapping camera (228-mm by 228-mm (9-in. by 9-in.) format). Color photos were secured from a fixed-wing aircraft flying at an altitude of 549 m (1,800 ft), which resulted in high-resolution images and contact prints with scales of 1:3,600. Photographic stereo pairs were obtained during the flights. Stereo pairs secured for the breakwater are shown in Figure 7. The aerial photography was obtained on 10 November 1994. The lake level during the photography was +0.7 m (+2.3 ft) lwd.

The stereo pair images obtained during aerial photography at Burns Harbor were viewed in a Galileo Digicart Model 40 Analytical Stereoplotter, and stereomodels were oriented to the monument data previously obtained. In the stereomodel, very accurate horizontal and vertical measurements can be made of any point on any armor unit appearing in the print. The accuracy of photogrammetric spot elevations are on the order of  $\pm 0.06$  m ( $\pm 0.2$  ft). The stereomodel was used for all photogrammetric compilation and development of orthophotography.

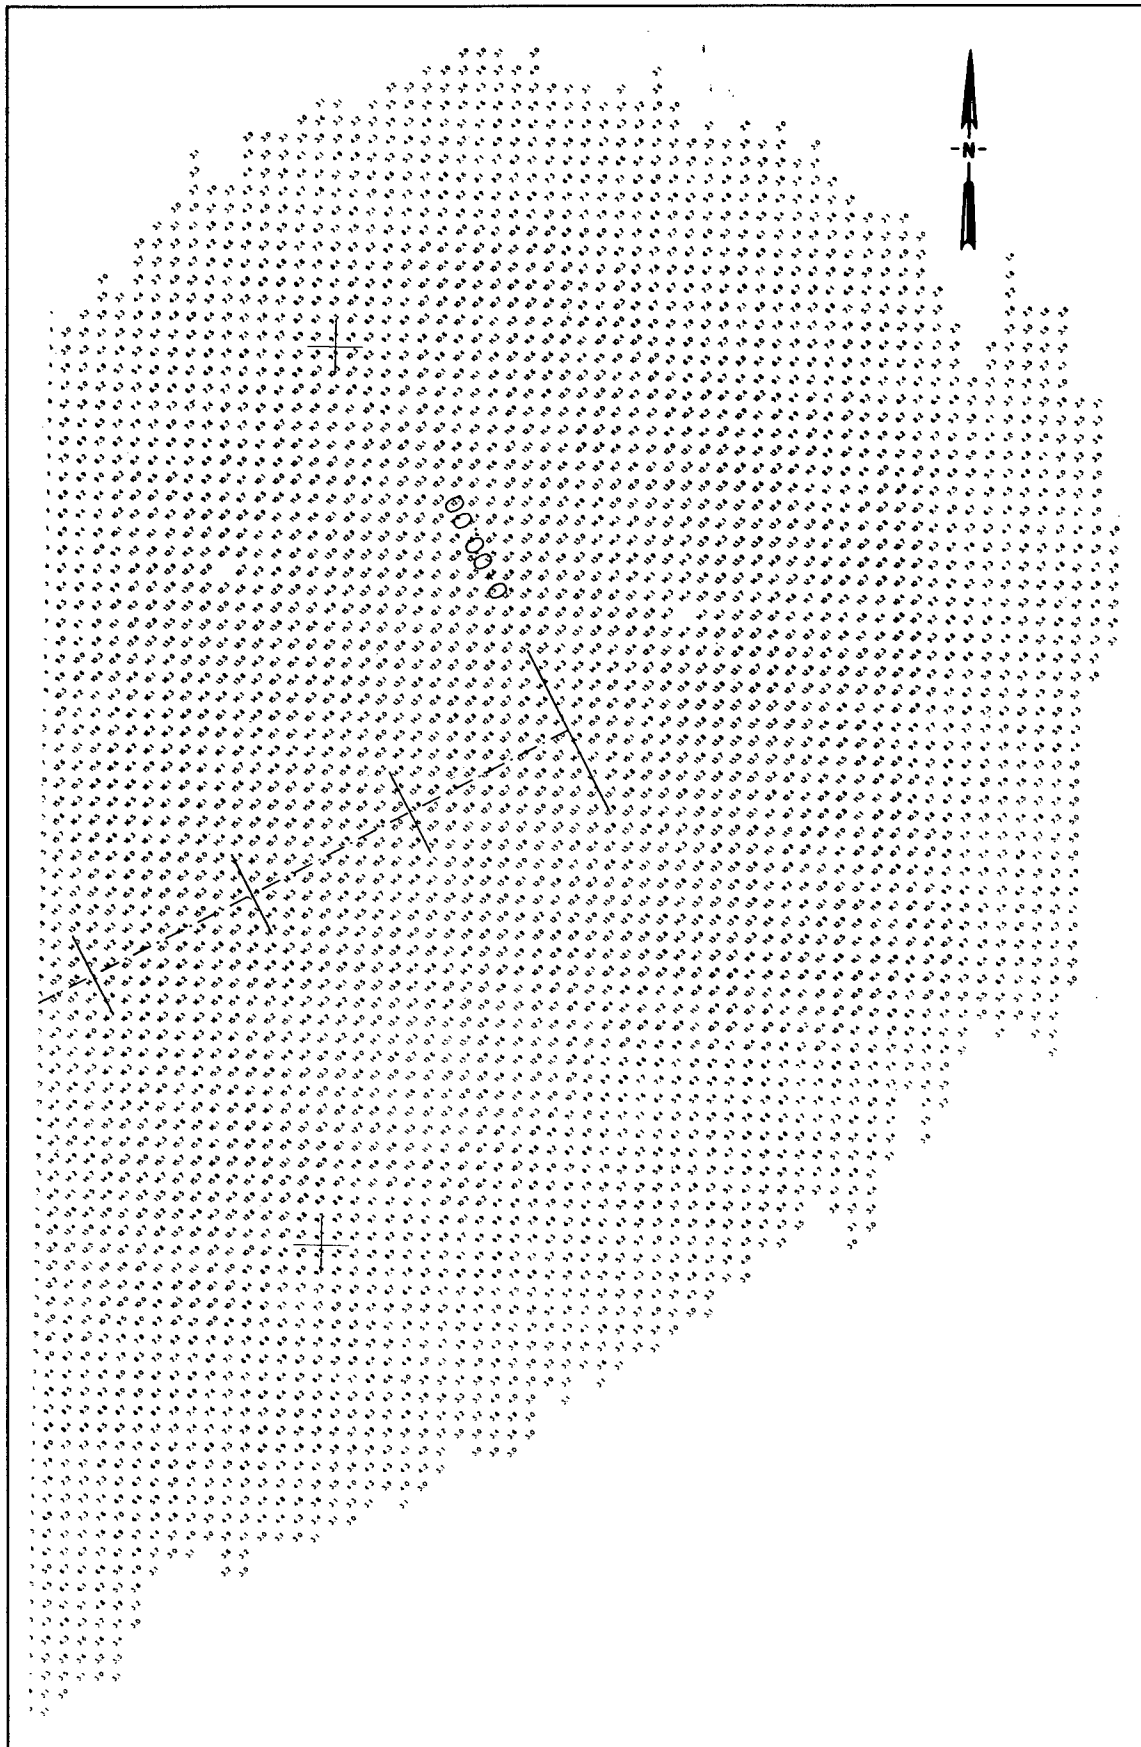
Figure 9. Point plot map for a portion of the North Breakwater

In addition to digital orthophotos, point plot maps, contour maps, and cross sections were developed for the North Breakwater using a digital terrain model (DTM). Point plot maps consisted of an approximately 0.3-m (1-ft) grid pattern overlaid on the structure. Precise vertical and horizontal measurements were obtained at the intersections of the grid. An example of a point plot map showing elevations on the breakwater is shown in Figure 9. Areas where no elevations are shown are shadowed areas, or voids between the armor units. Contour maps of the breakwater, developed from the DTM, for a 0.3-m (1-ft) contour interval are shown in Appendix A. In addition, using the analytical stereoplotter and DTM grid, cross sections of the breakwater were developed along the trunk of the breakwater at 15.2-m (50-ft) intervals and around the head of the structure at 0.26-rad (15-deg) intervals as shown in Figure 10. These cross sections are presented in Appendix B.

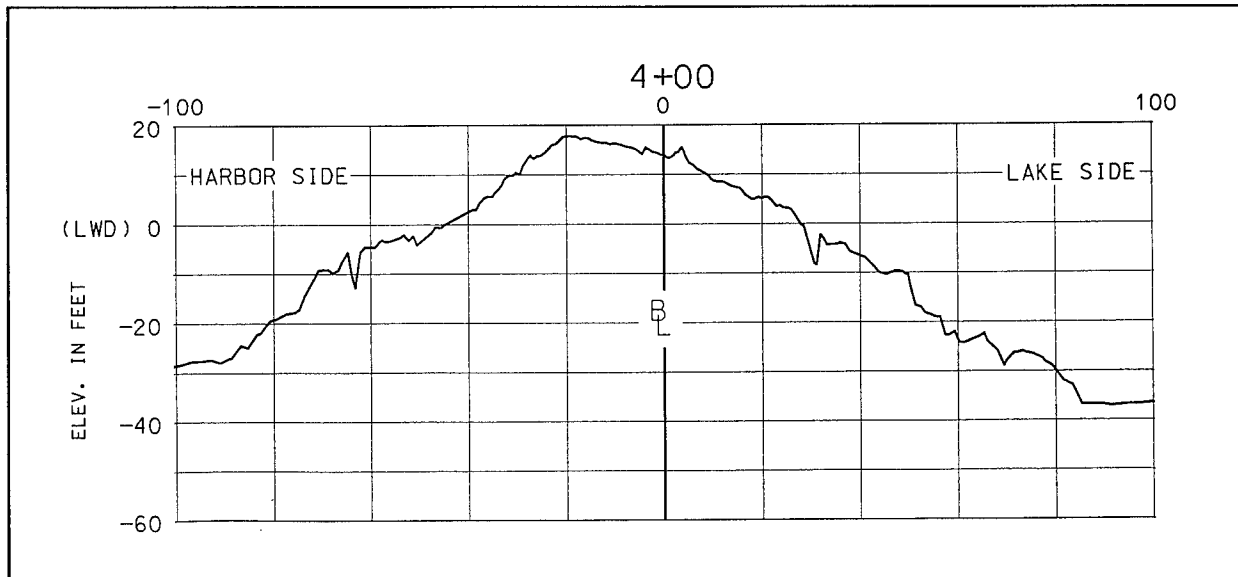
Figure 11. Example of breakwater cross section after merging surface and subsurface surveys

Data provided in Appendixes A and B include the above-water portion of the breakwater developed during the photogrammetric analysis. These data will be used for comparisons in subsequent surveys under the Periodic Inspections Work Unit. As stated earlier, the Chicago District funded work that also included underwater surveys of the breakwater and merging of the subsurface and surface data to develop cross sections of the entire structure. An example of one of the merged cross sections is shown in Figure 11.

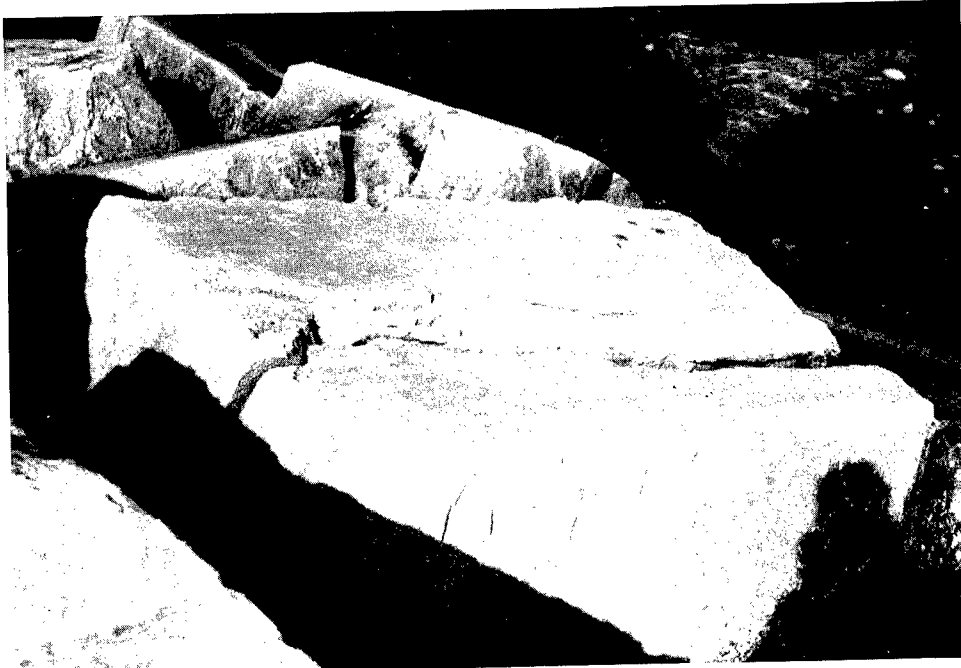
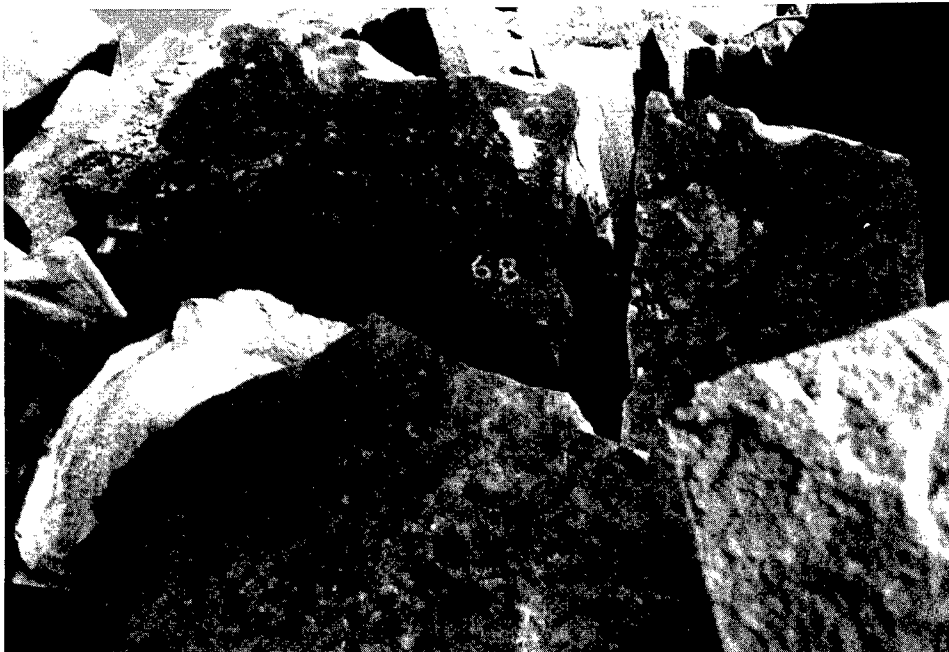
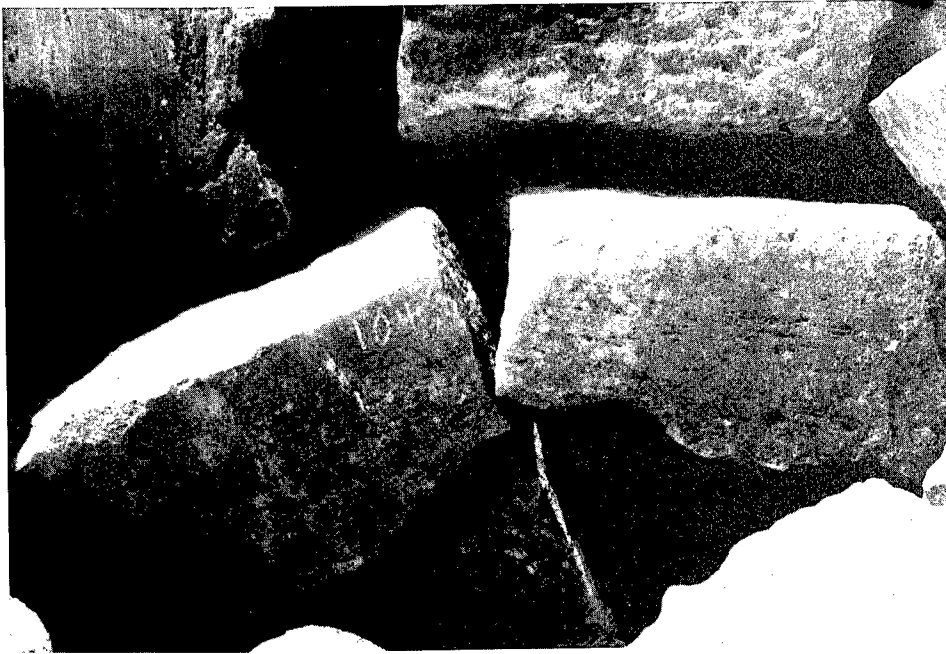
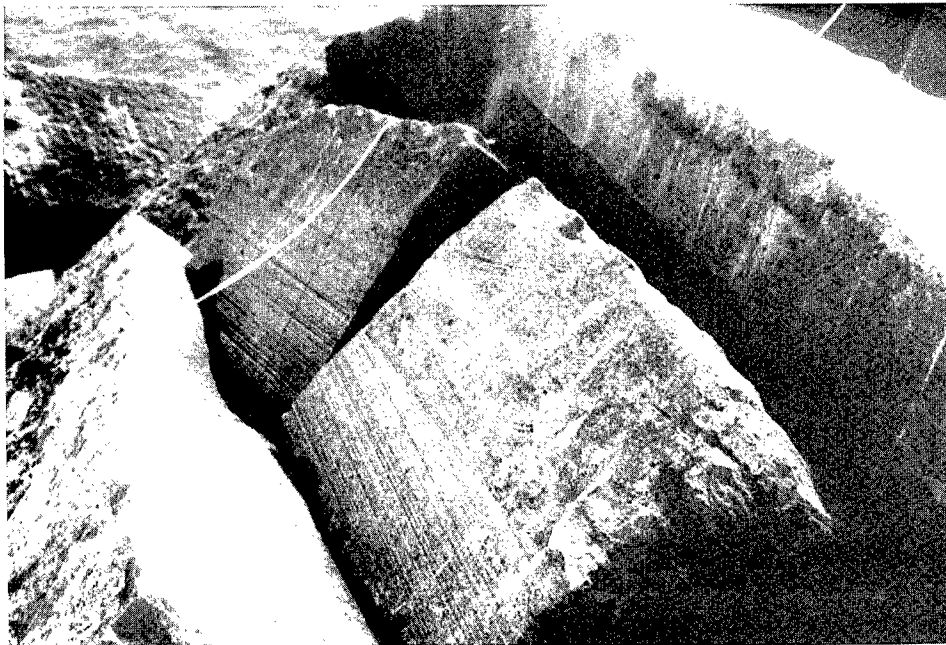
Figure 12. View of broken armor stone on North Breakwater (Continued)

During the period 25-26 July 1995, a survey of broken/cracked armor stone above the waterline on the 1,414-m- (4,640-ft-) long Burns Harbor North Breakwater was conducted. During the inspection, each broken armor stone was identified and photographed, and its approximate location relative to breakwater station and distance from a baseline was recorded. The baseline was the approximate center line of the structure. Armor stones with hairline cracks were not counted, only those that were cracked all the way through. Views of representative types of breaks are shown in Figure 12. The water was relatively clear during the survey, and the lake level was +0.6 m (+2.0 ft) lwd. The data recorded during the broken armor stone inventory are listed in Table 1.

The survey revealed a total of 165 broken or cracked armor stones above the waterline. Of the 165 stones, 26 were located along the breakwater crest, 95 on the lakeside slope, and 44 on the harbor side slope. No broken armor stones were observed around the head of the structure. The distribution of broken armor stones along the breakwater trunk as a function of station number and offset from the baseline is shown in Figure 13. As shown, broken stones occurred along the entire North Breakwater trunk, but in general, high concentrations were found along the easternmost portion of the structure. About 50 percent of the broken units (82 units) were located on the eastern one third (457 m (1,500 ft)) of the structure. The distribution of broken/cracked armor stones relative to offset from the baseline is shown in Figure 14. The majority of the broken armor stones along the structure (57 percent) were located on the lakeward face of the structure in the active wave zone. About 16 percent of the broken armor units were on the crest of the breakwater and 27 percent were on the harbor side of the structure. Detailed data obtained during the survey will allow for an accurate indication of new breaks when the structure is revisited at some point in the future.

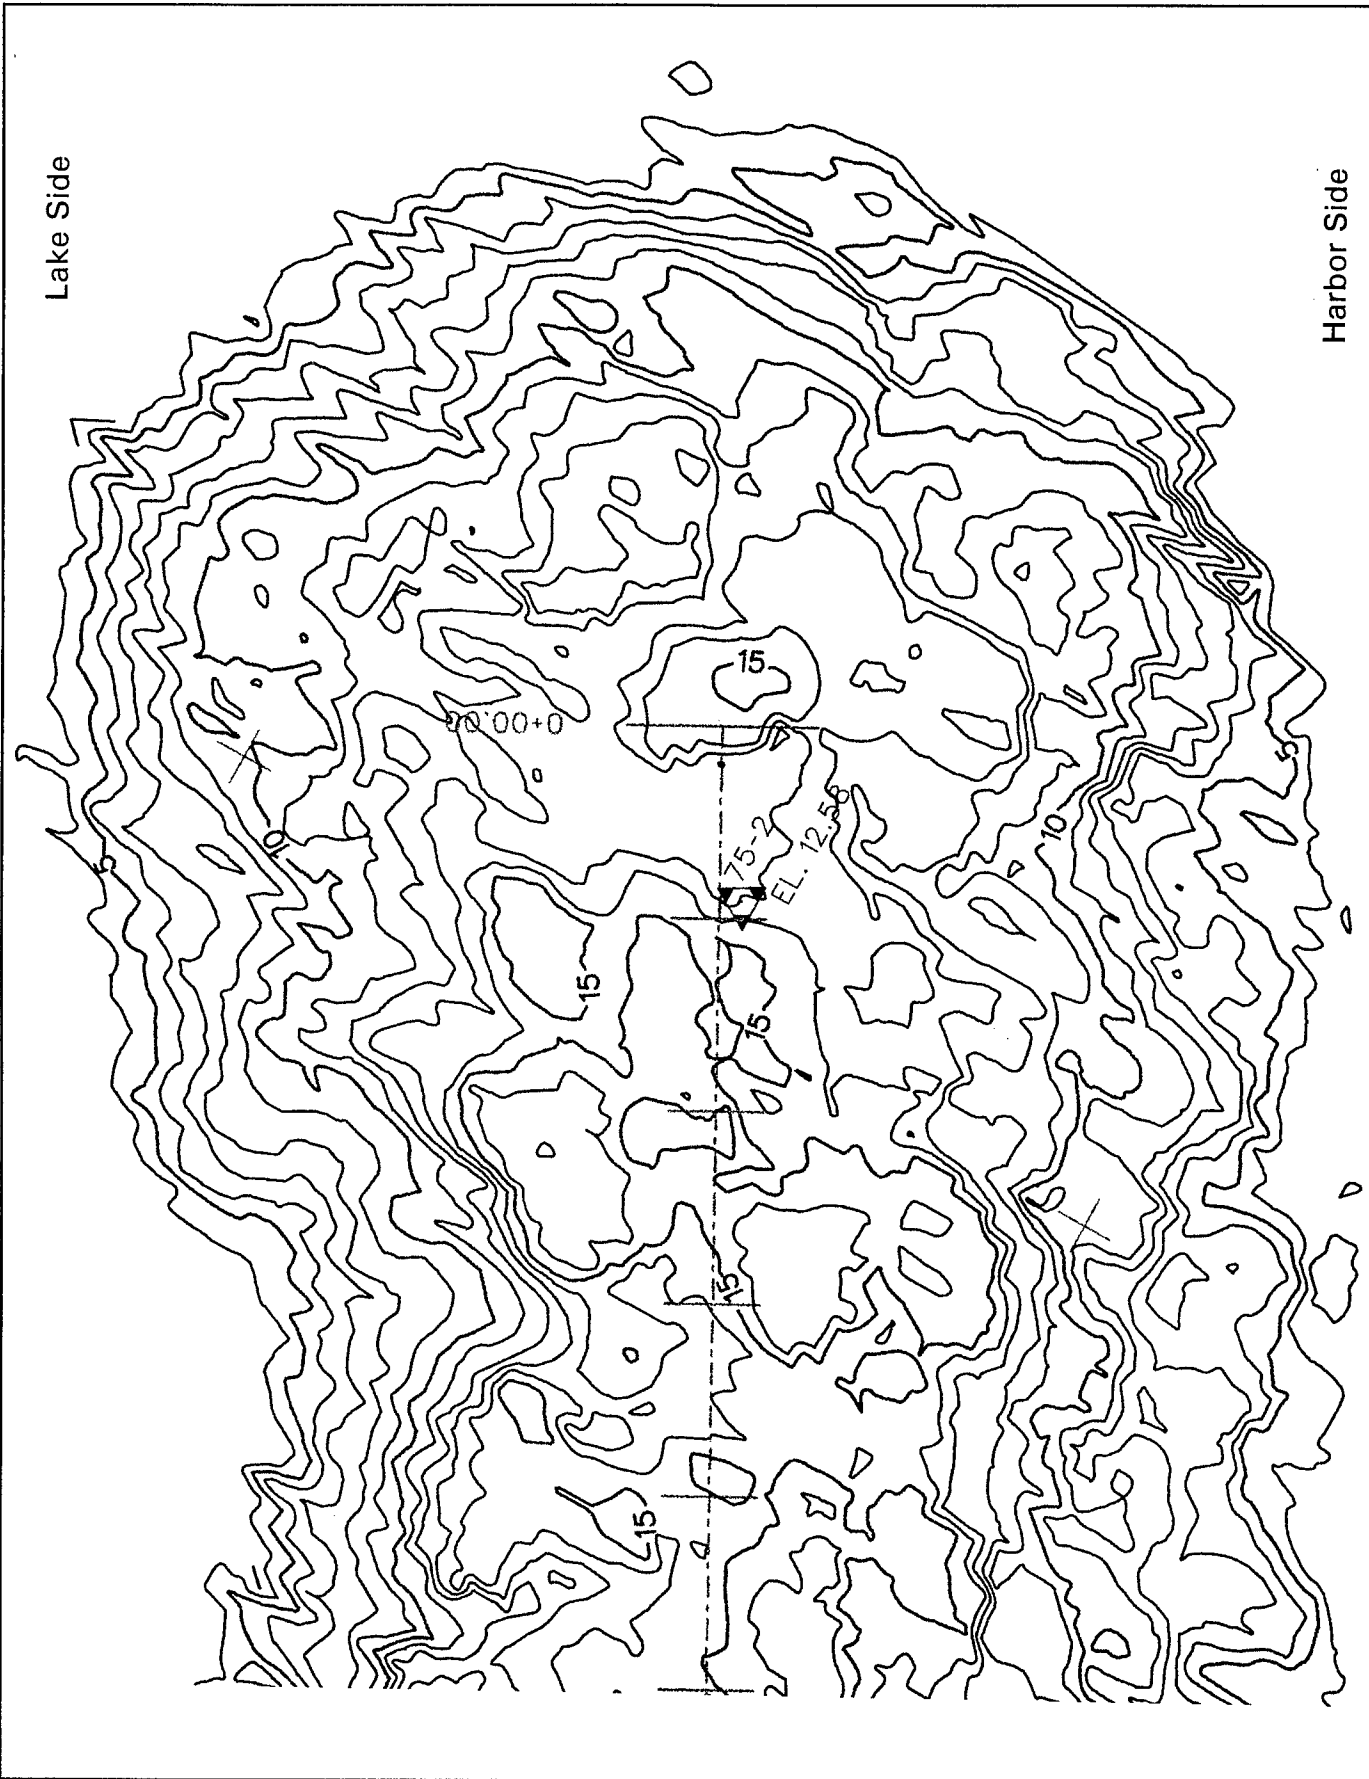
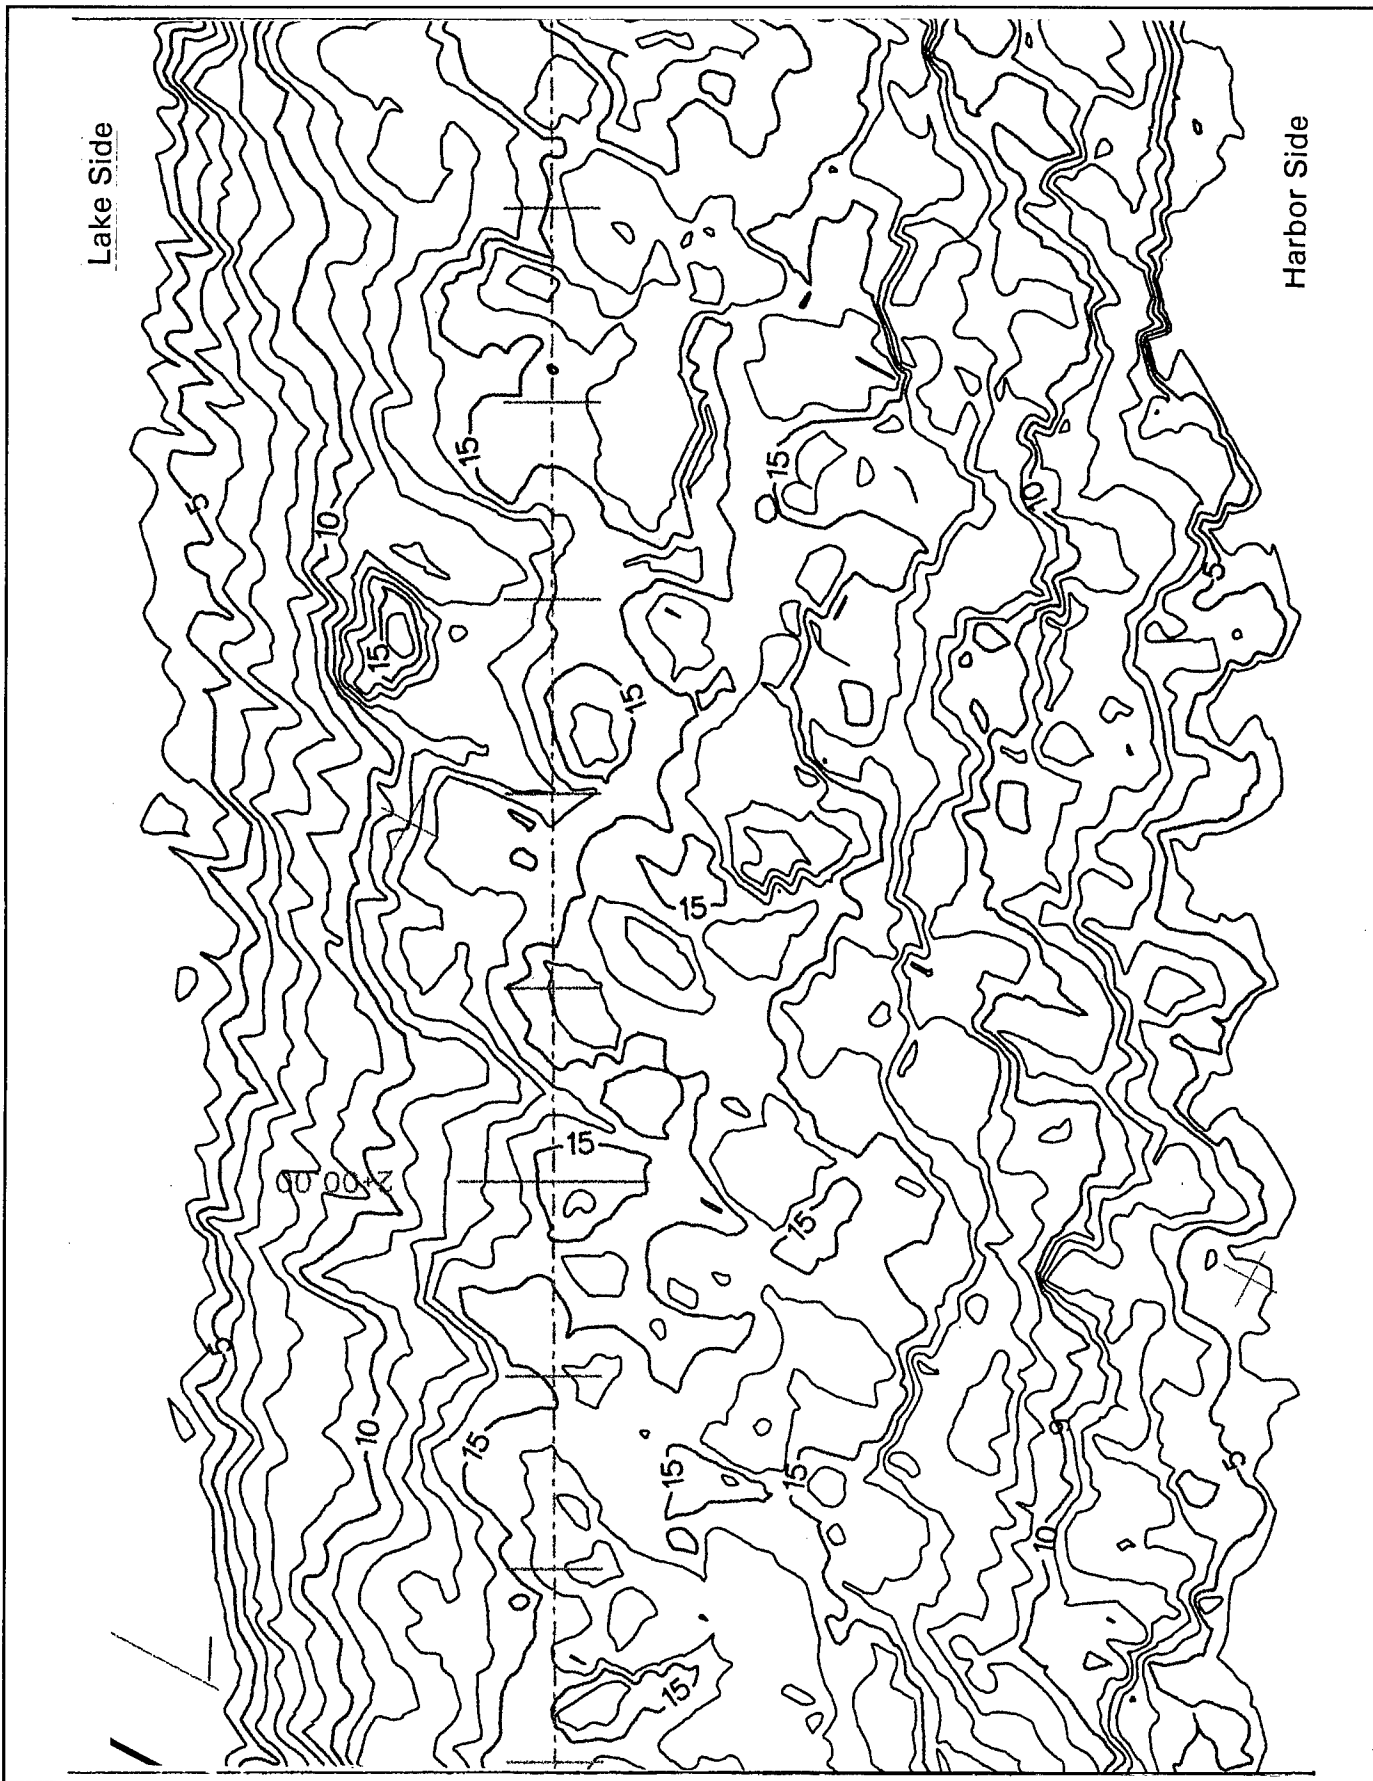
This appendix presents contour maps of the Burns Harbor North Breakwater. Topography was developed using the digital terrain model (DTM) as stated in the main text of this report. The breakwater topography is shown on a 0.3-m (1.0-ft) contour interval. Elevations shown are in feet referred to low water datum (lwd). To convert them to meters, multiply by 0.3048. Station numbering on the contour maps is from east to west (right to left). The scale of the maps is 25.4 mm = 3.05 m (1 in = 10 ft).

An examination of the breakwater topography and cross-section data (Appendixes A and B) reveals low areas along much of the breakwater. Cumulatively, about 344 linear m (1,130 linear ft), or 24 percent of the total length, of the breakwater is below the design crest el of +4.3 (+14).

Most of these low areas range in elevation from +3.7 to +4.3 (+12 to +14). Only about 66 linear m (215 linear ft) cumulative length of the breakwater (4.6 percent) is below the +3.7-m (+10-ft) elevation. Low areas in the structure appear to be concentrated between sta 12+20-15+00 and sta 30+80-37+50. These data also reveal that the design crest width of 5.2 m (17 ft) is not maintained in many areas. In addition, on some portions of the structure, the slope on the harbor side of the breakwater is steeper than the original 1V:1.5H design.

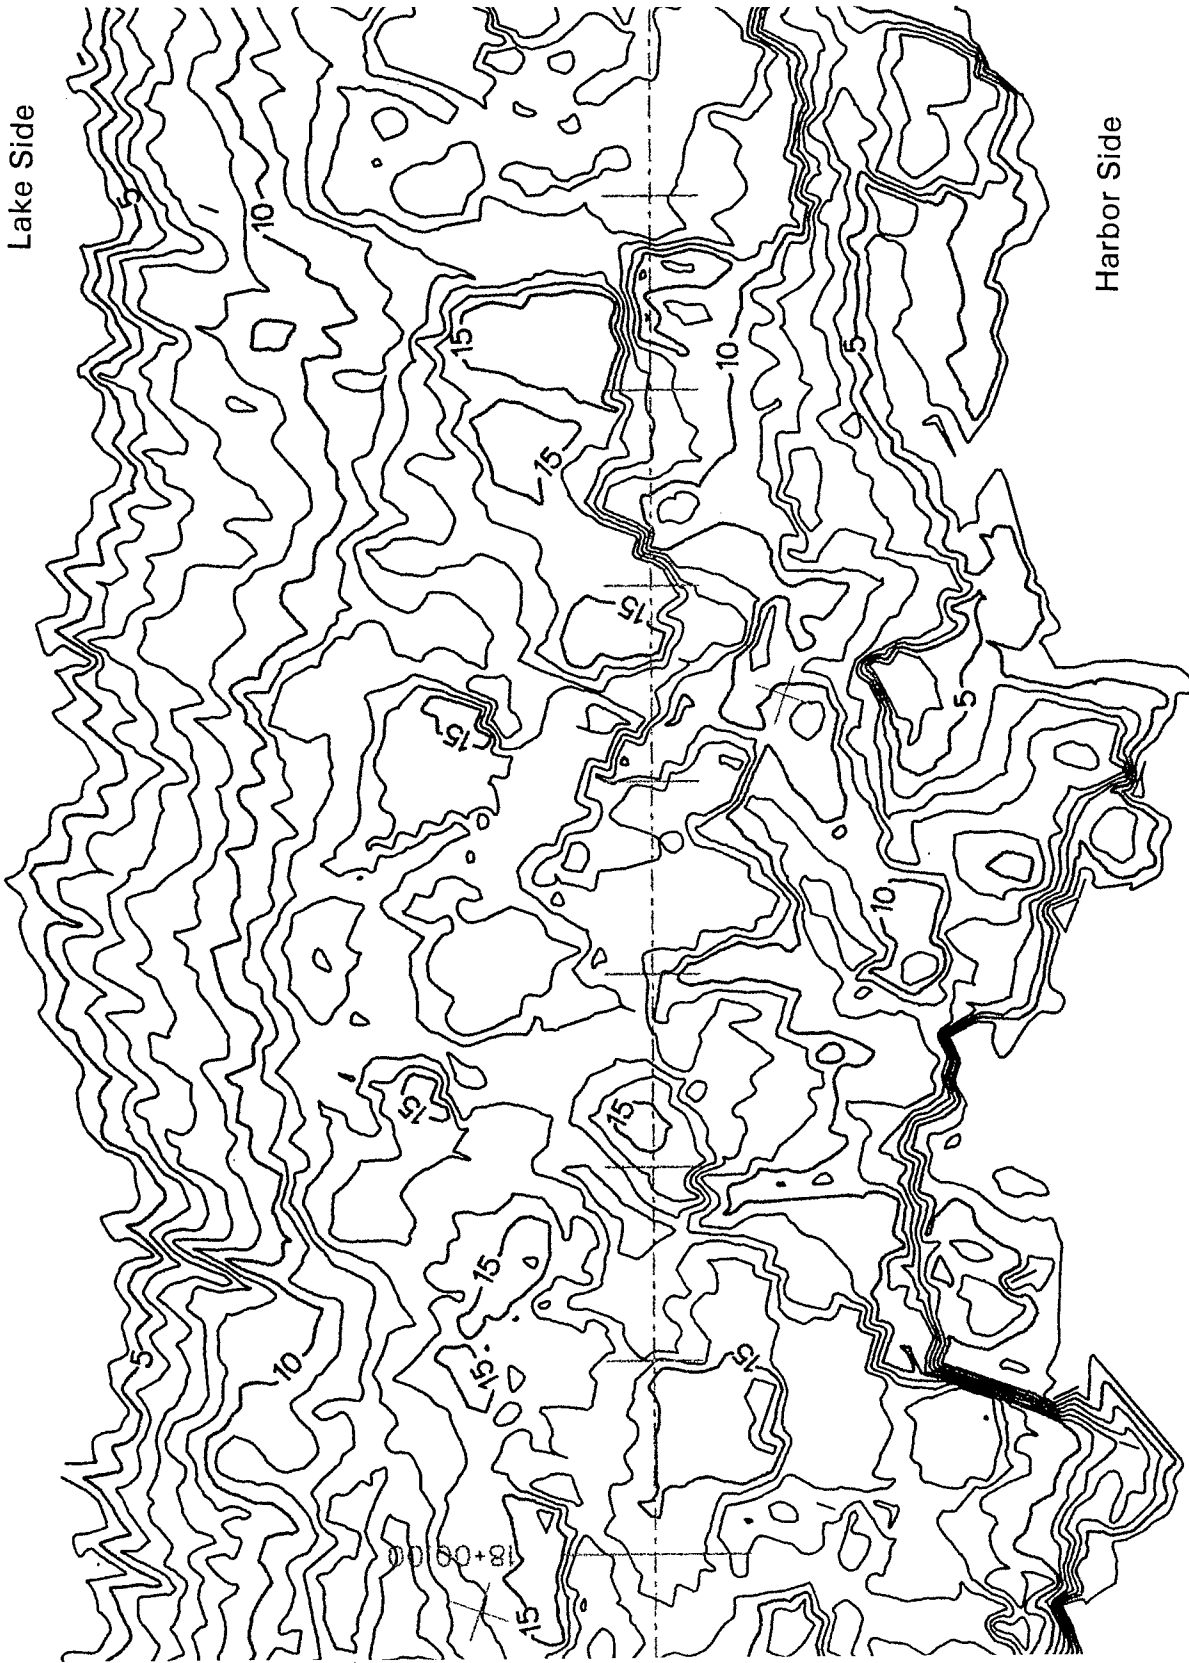
Figure A21. Topography of Burns Harbor North Breakwater, sta 17+20-18+05
