# **Periodic Inspection of Burns Harbor North Breakwater, Indiana**

## **Report 1 Base Conditions**

by *Robert R. Bottin, Jr., WES*  
*Erik W. Matthews, Chicago District*

Technical Report CERC-96-8  
September 1996

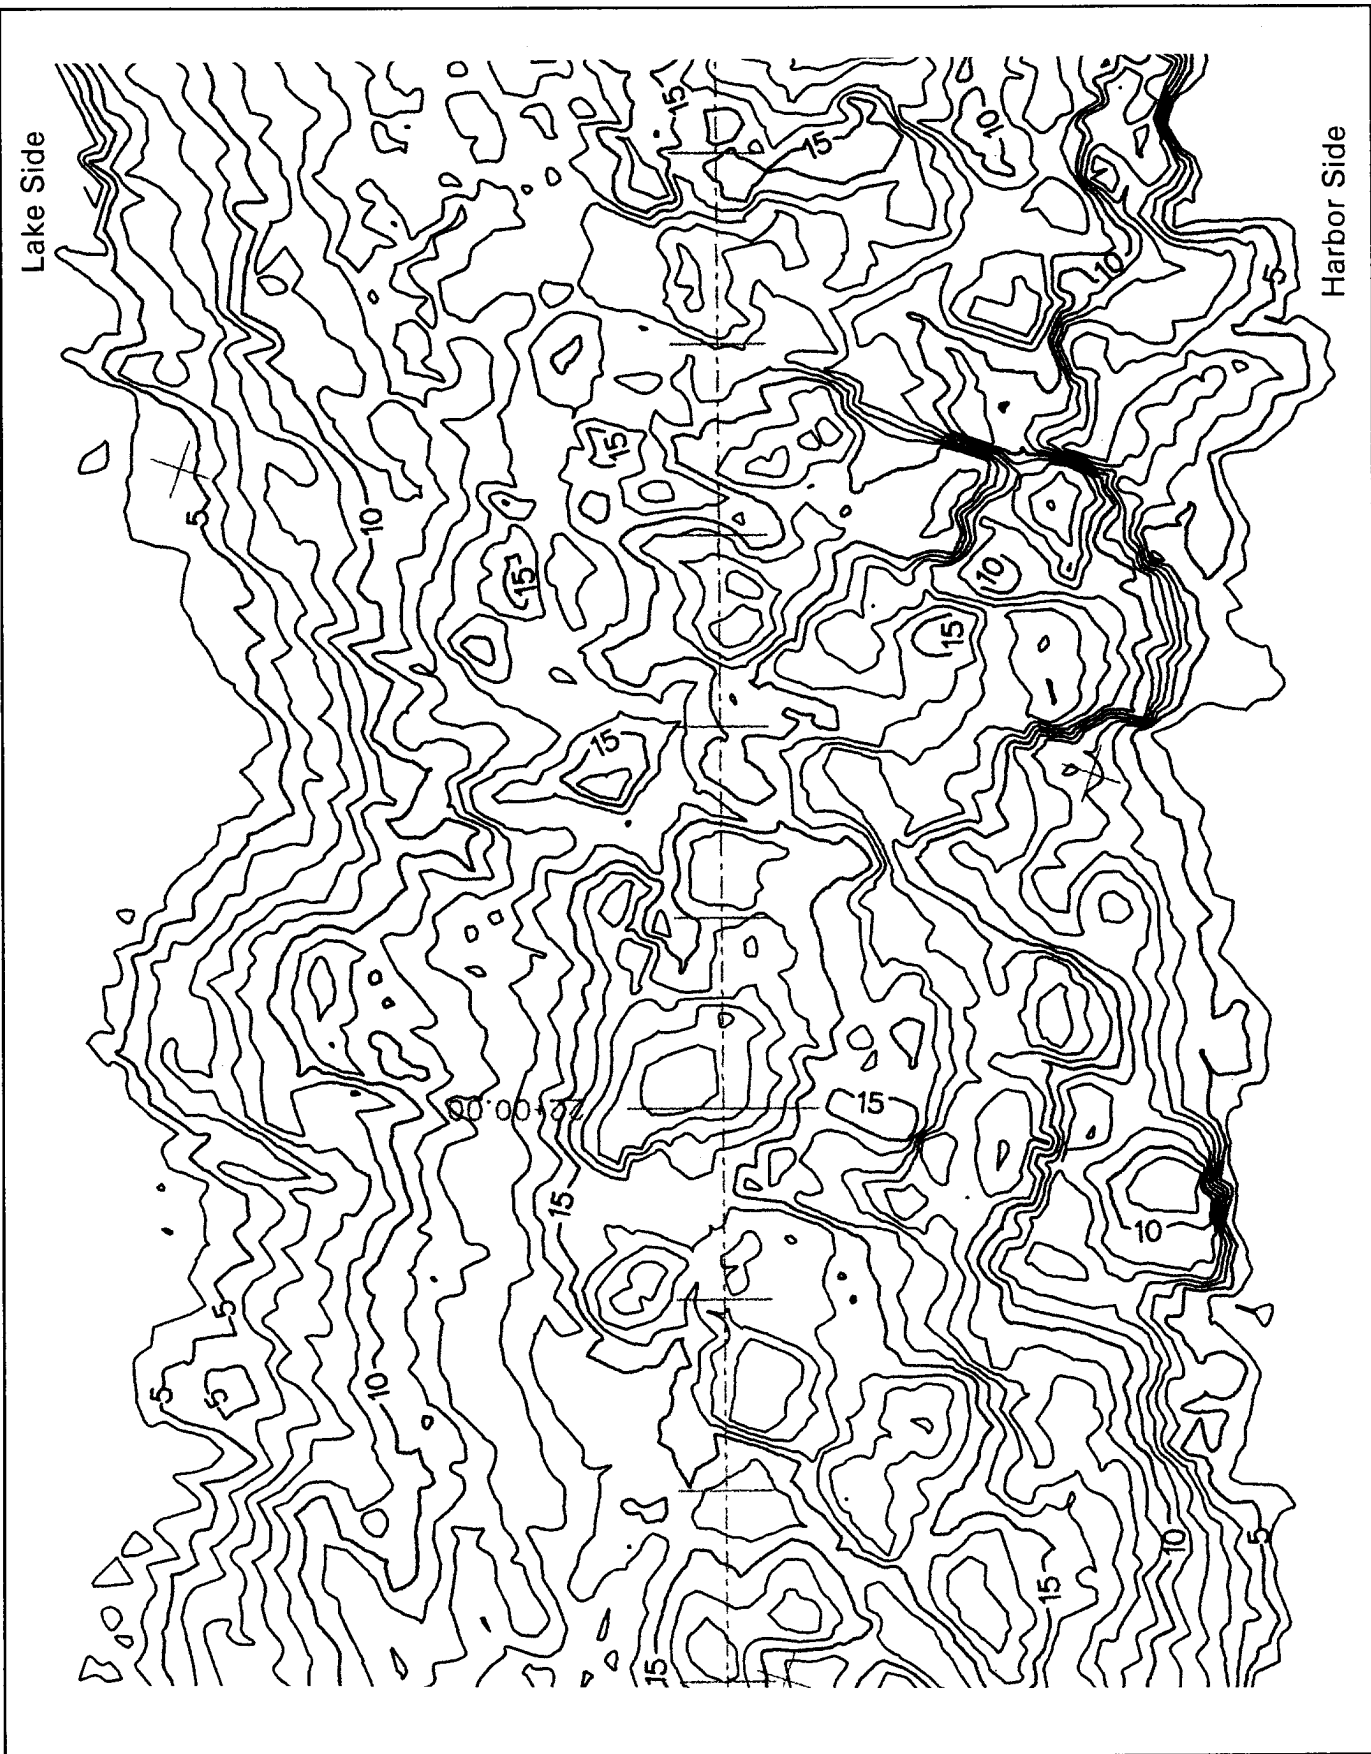
Figure A26. Topography of Burns Harbor North Breakwater, sta 21+45-22+30

This appendix presents contour maps of the Burns Harbor North Breakwater. Topography was developed using the digital terrain model (DTM) as stated in the main text of this report. The breakwater topography is shown on a 0.3-m (1.0-ft) contour interval. Elevations shown are in feet referred to low water datum (lwd). To convert them to meters, multiply by 0.3048. Station numbering on the contour maps is from east to west (right to left). The scale of the maps is 25.4 mm = 3.05 m (1 in = 10 ft).

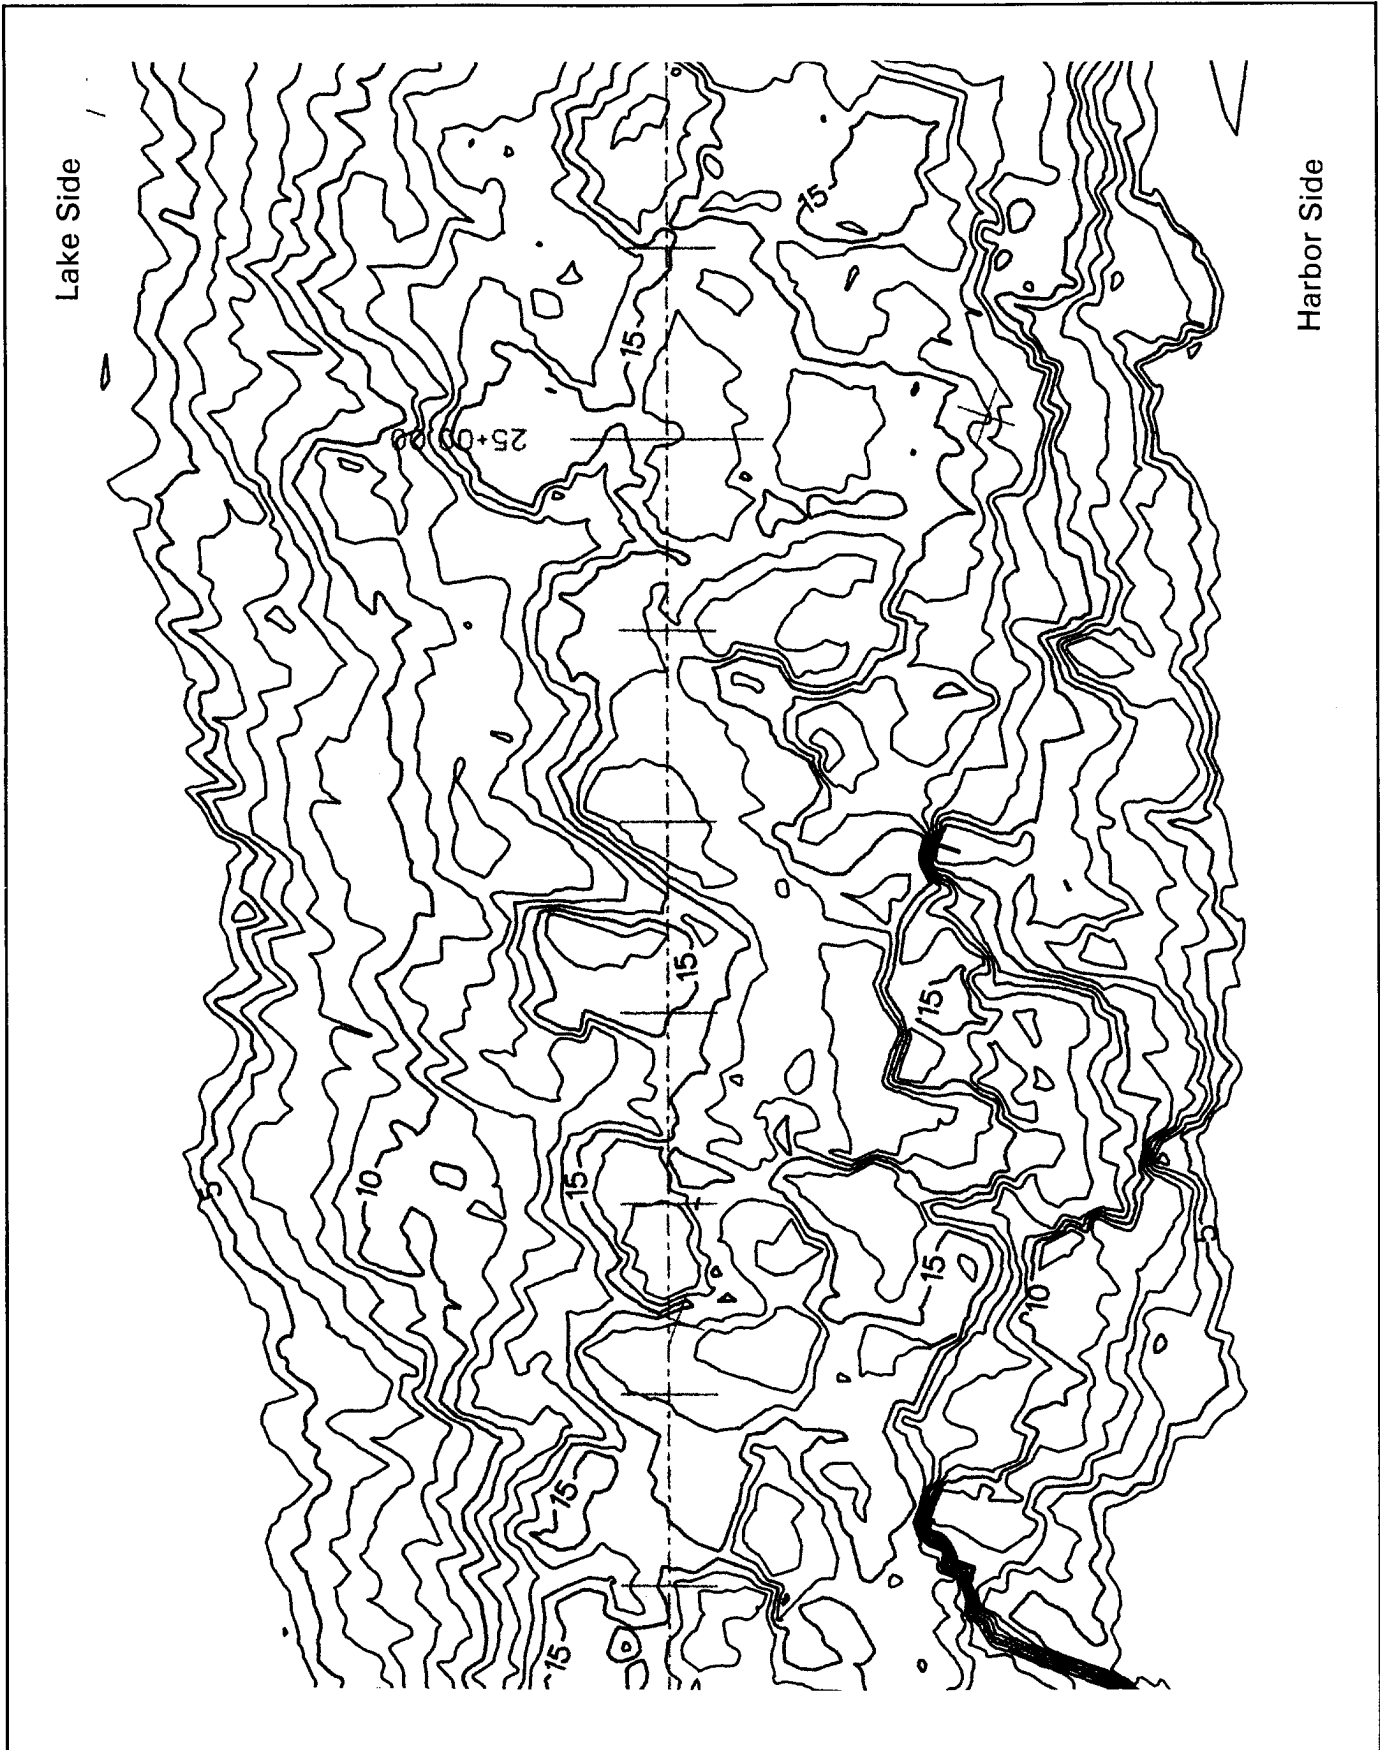
Figure A30. Topography of Burns Harbor North Breakwater, sta 24+80-25+65

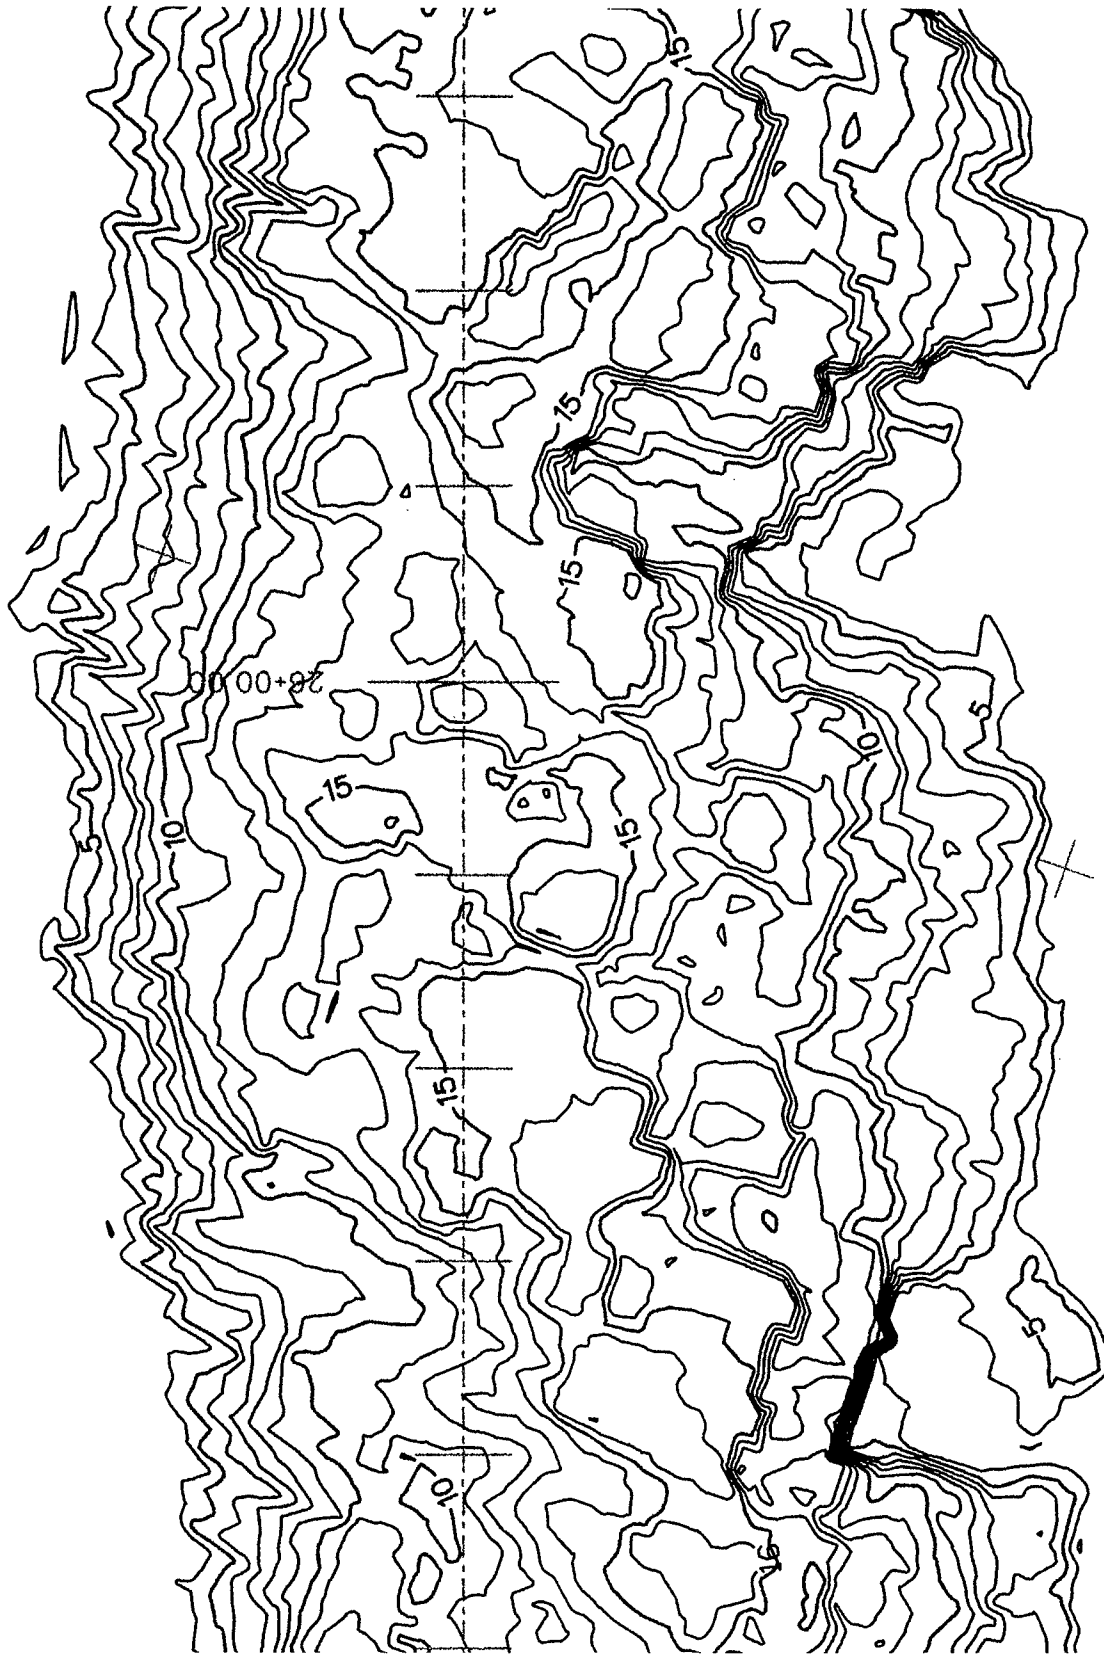
Figure A31. Topography of Burns Harbor North Breakwater, sta 25+65-26+50

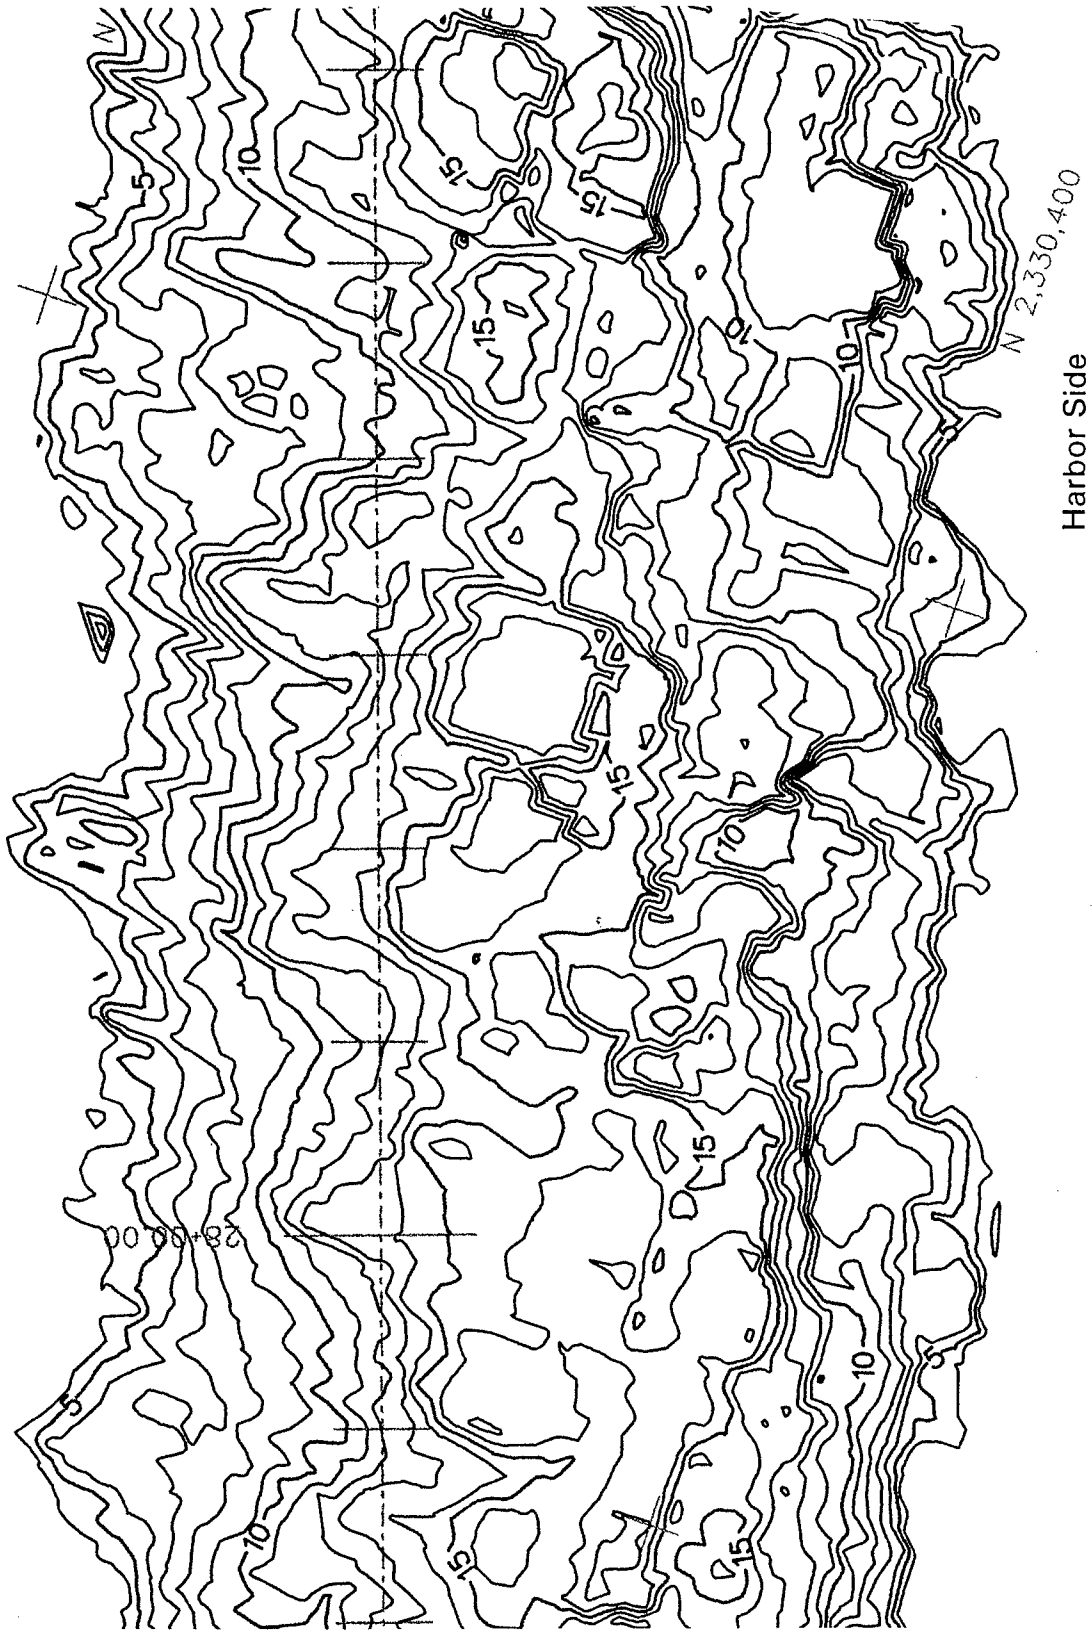
Figure A33. Topography of Burns Harbor North Breakwater, sta 27--36-28+20

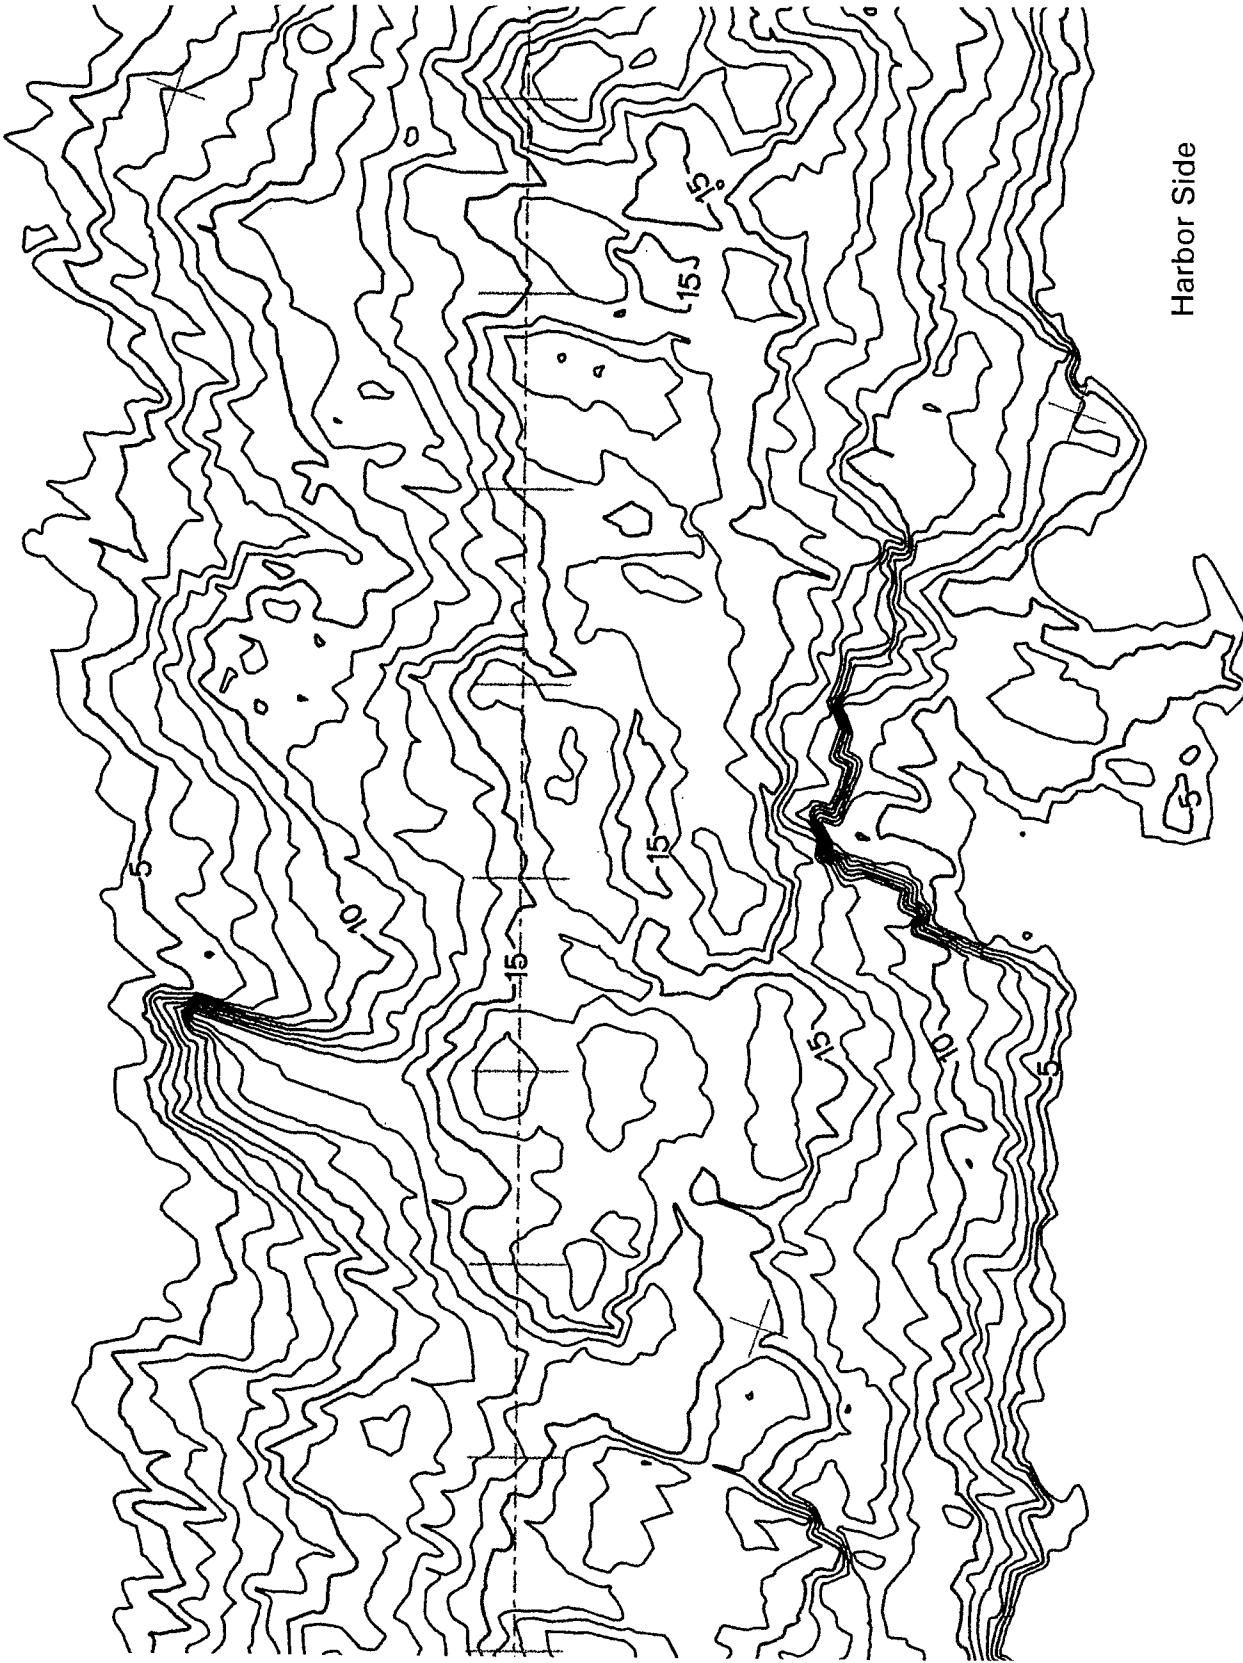
Figure A35. Topography of Burns Harbor North Breakwater, sta 29+05-29+90

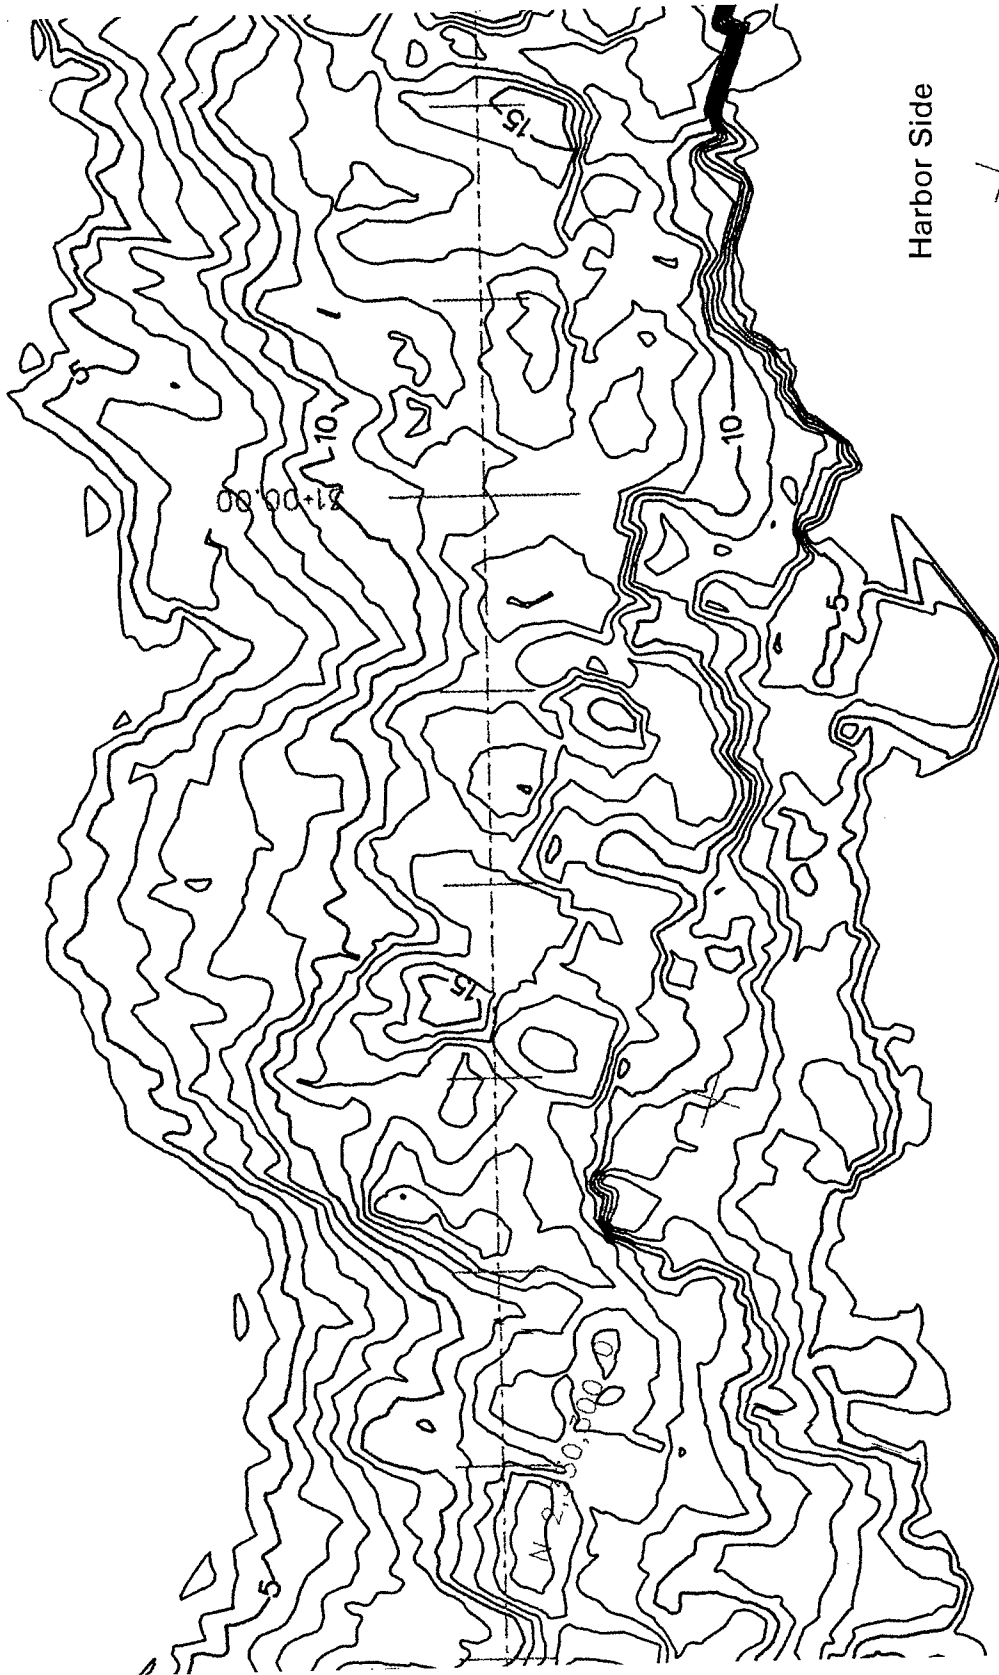
Figure A37. Topography of Burns Harbor North Breakwater, sta 30+75-31+60

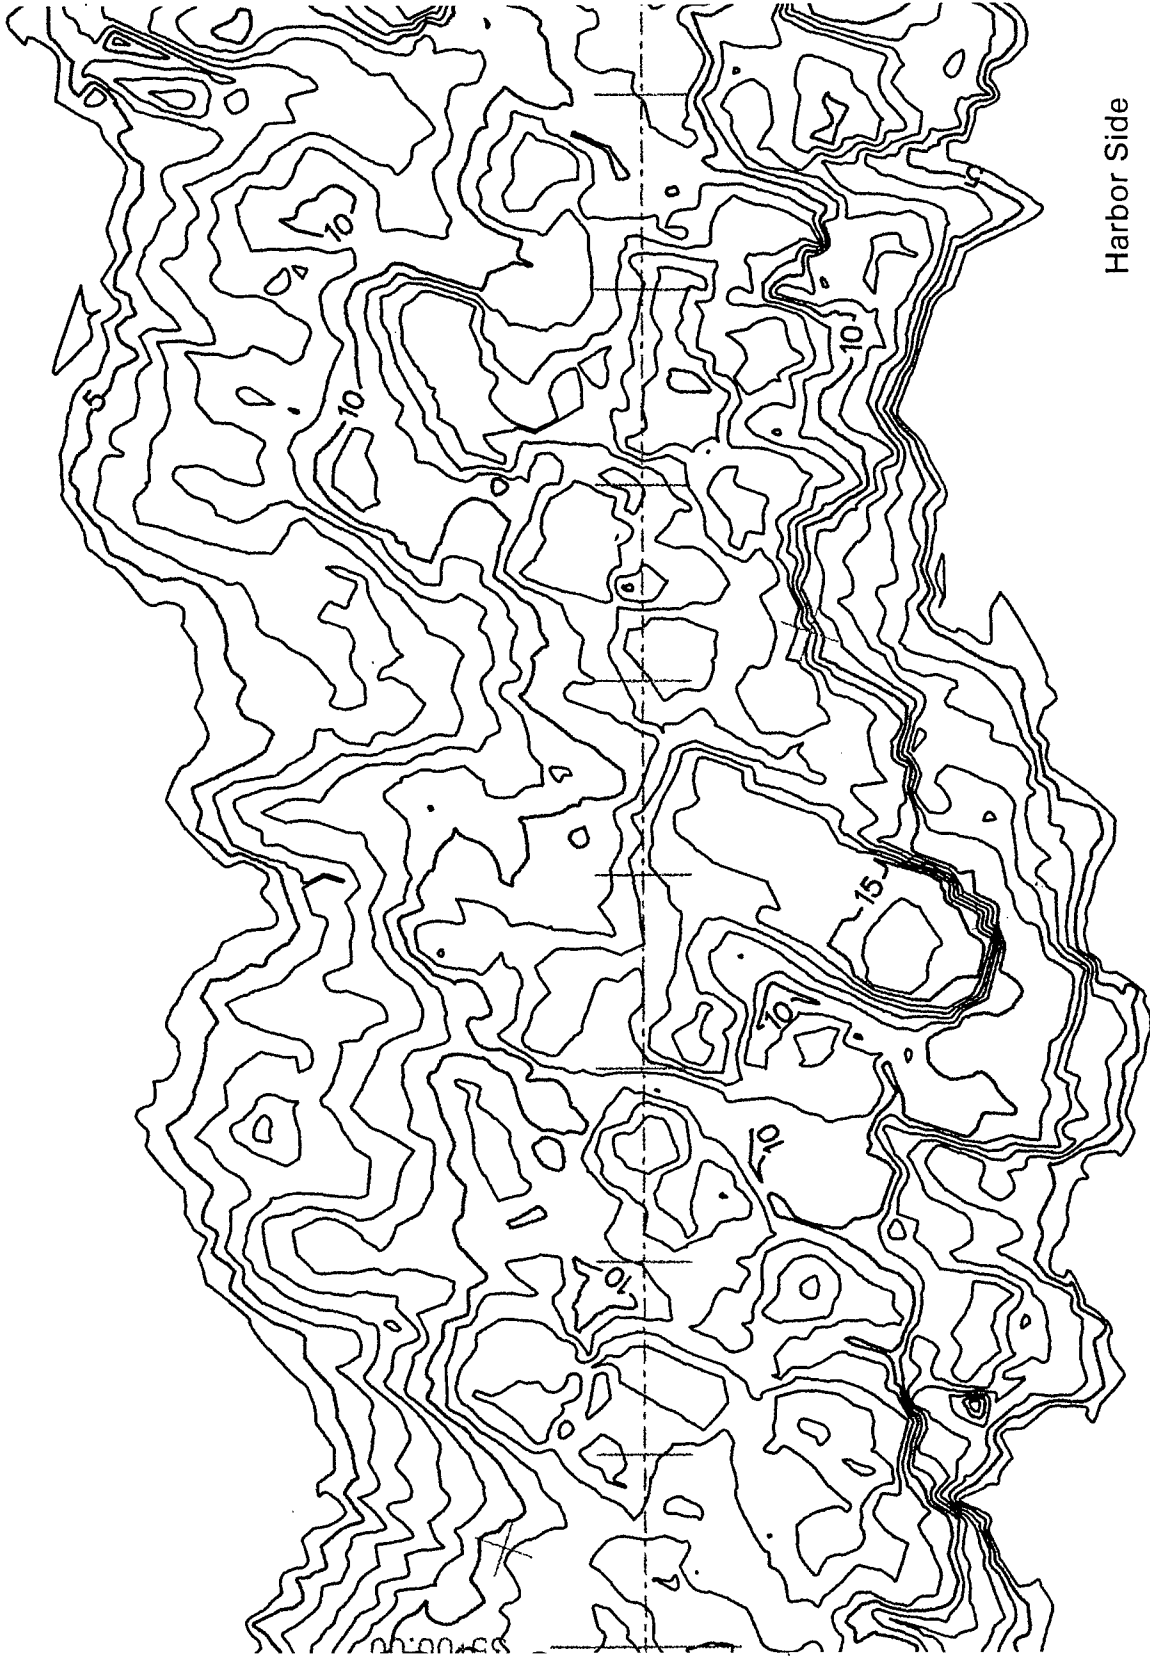
Figure A41. Topography of Burns Harbor North Breakwater, sta 34+15-35+00

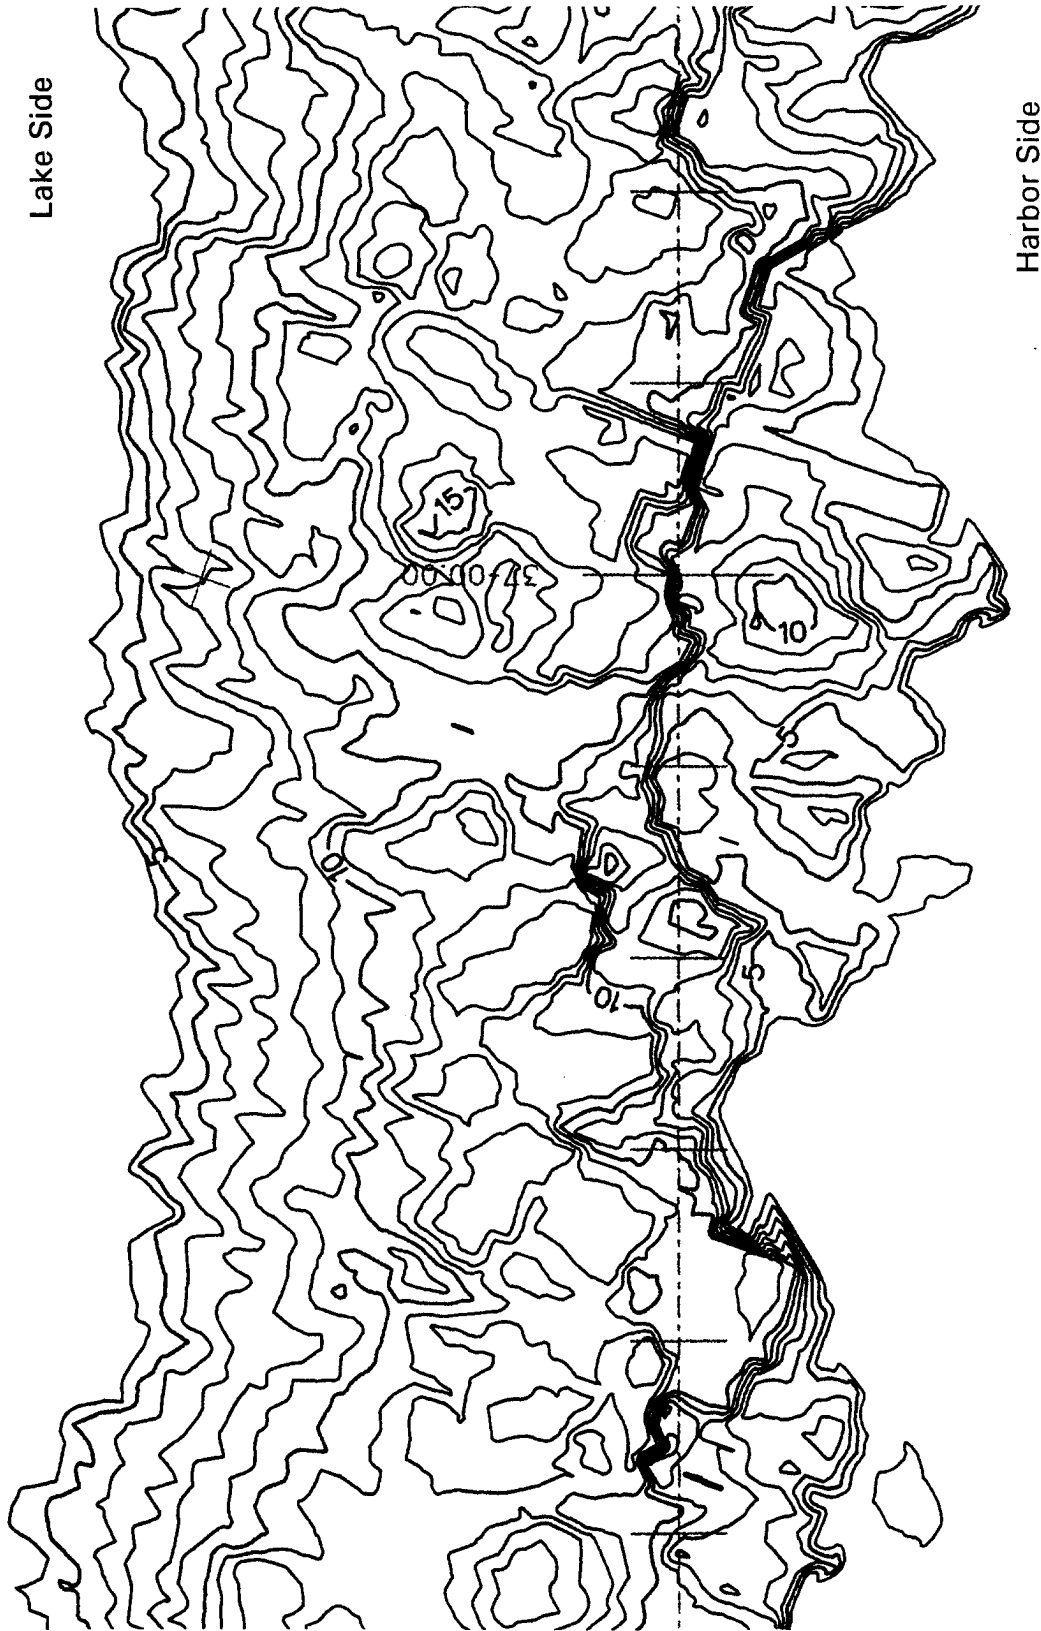
Figure A44. Topography of Burns Harbor North Breakwater, sta 36+70-37+55

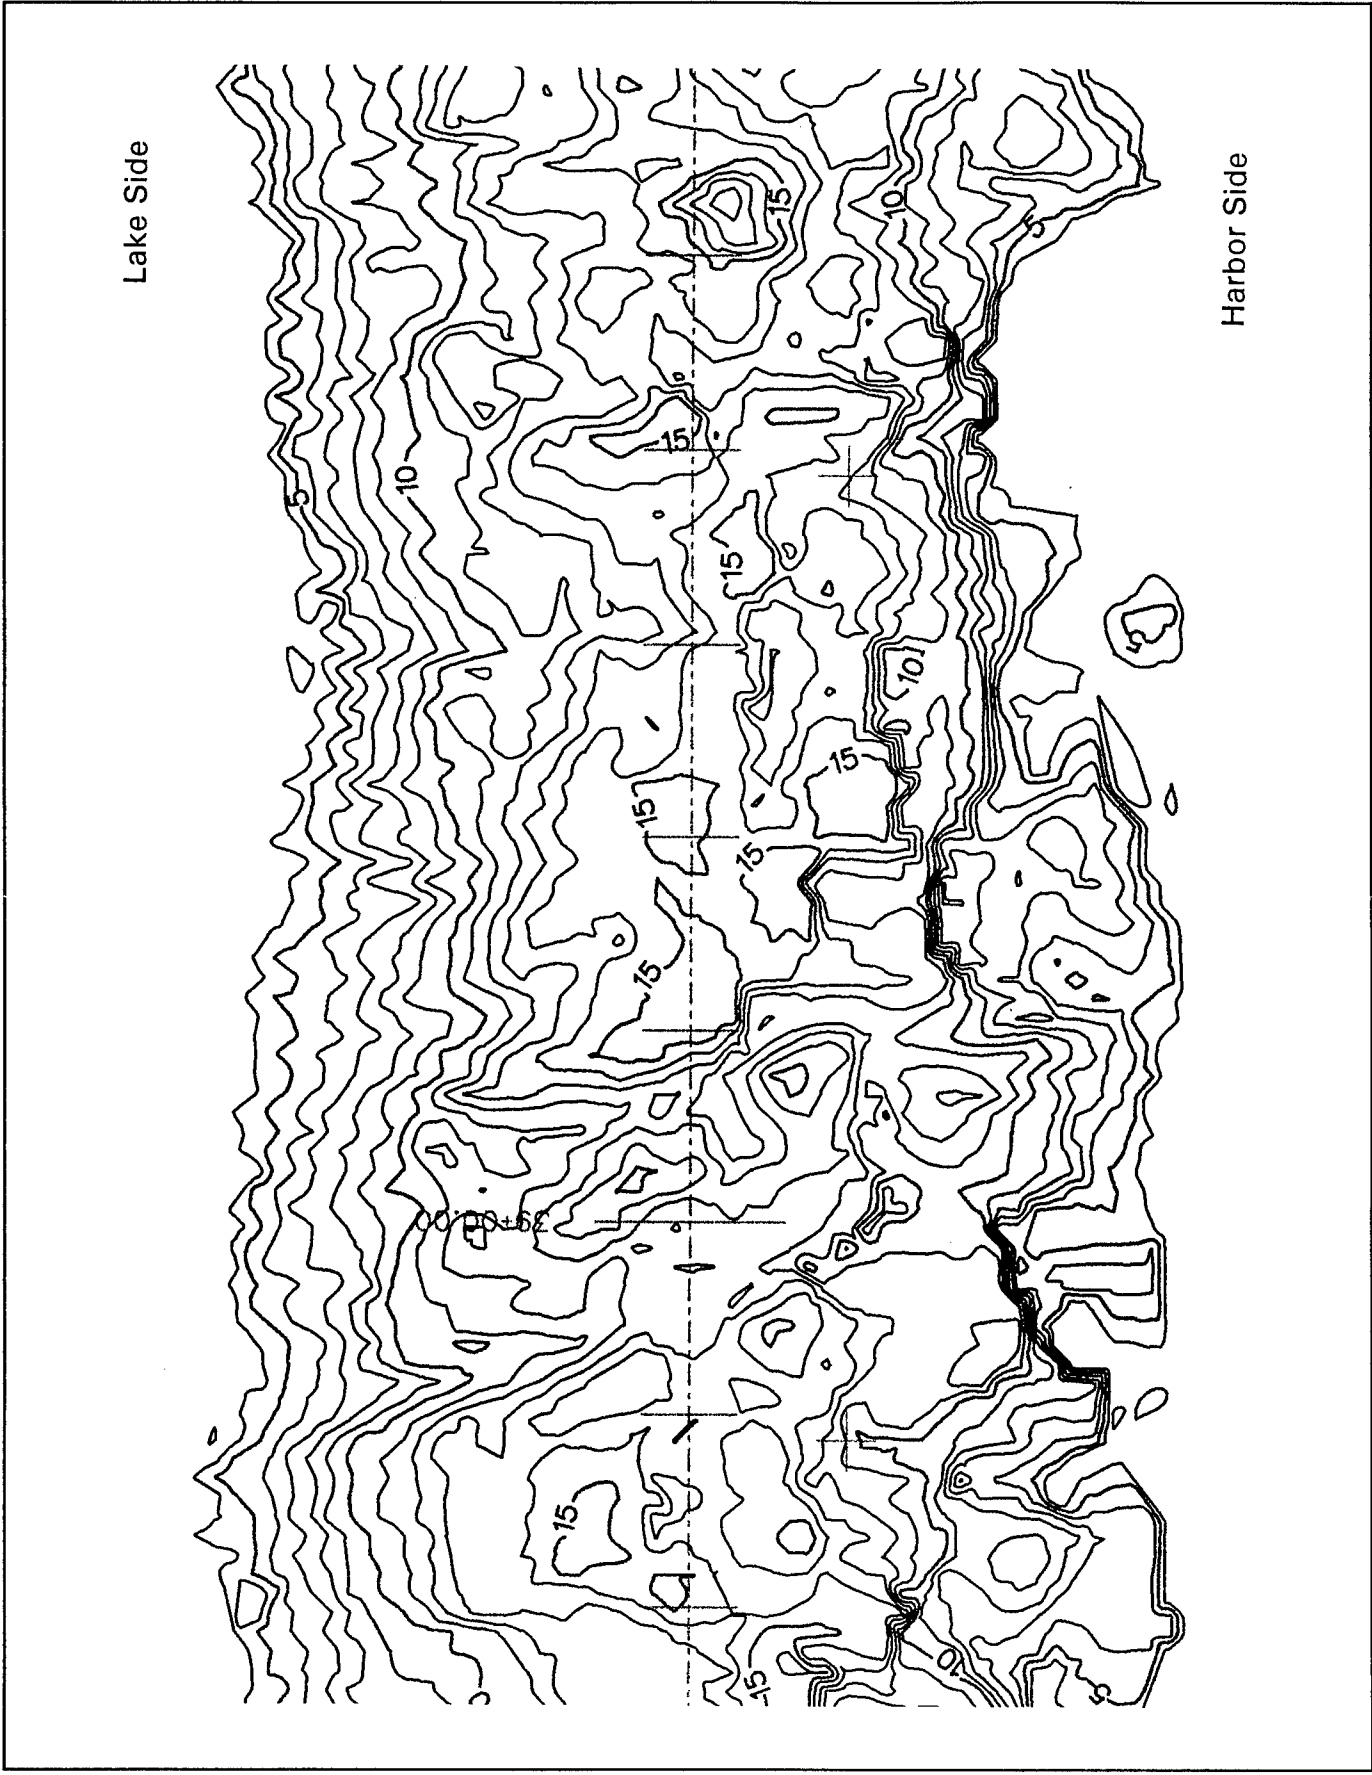
Figure A46. Topography of Burns Harbor North Breakwater, sta 38+40-39+25

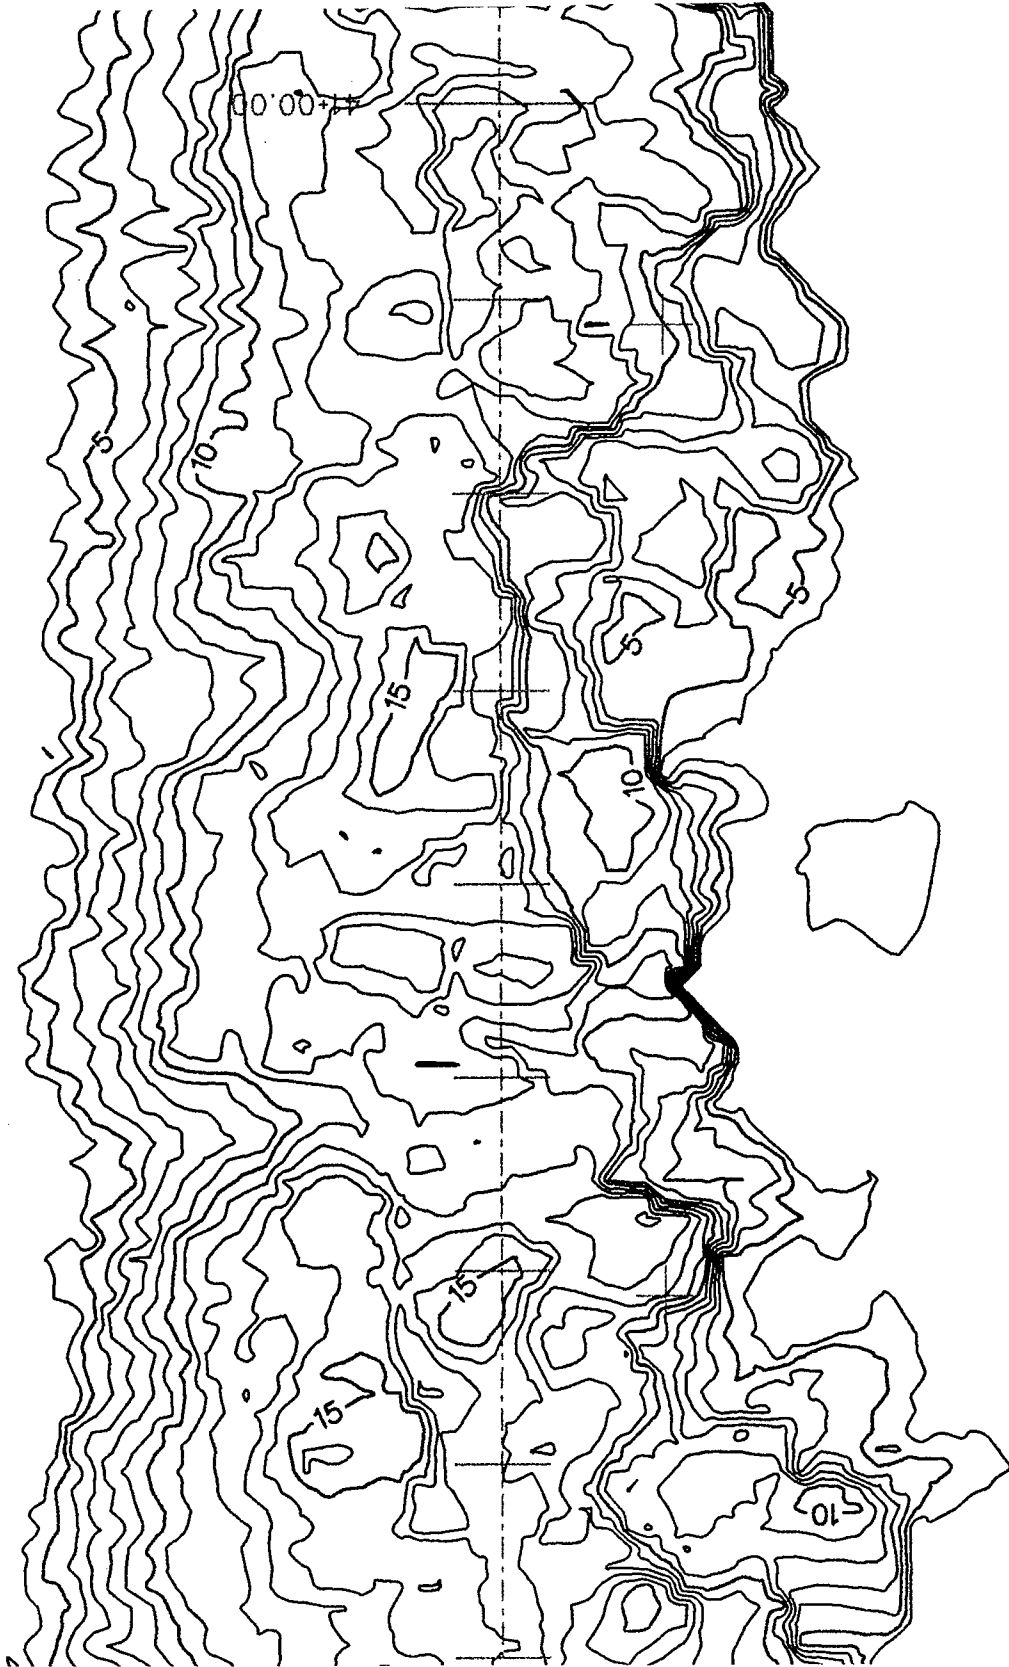
Figure A49. Topography of Burns Harbor North Breakwater, sta 40+95-41+80

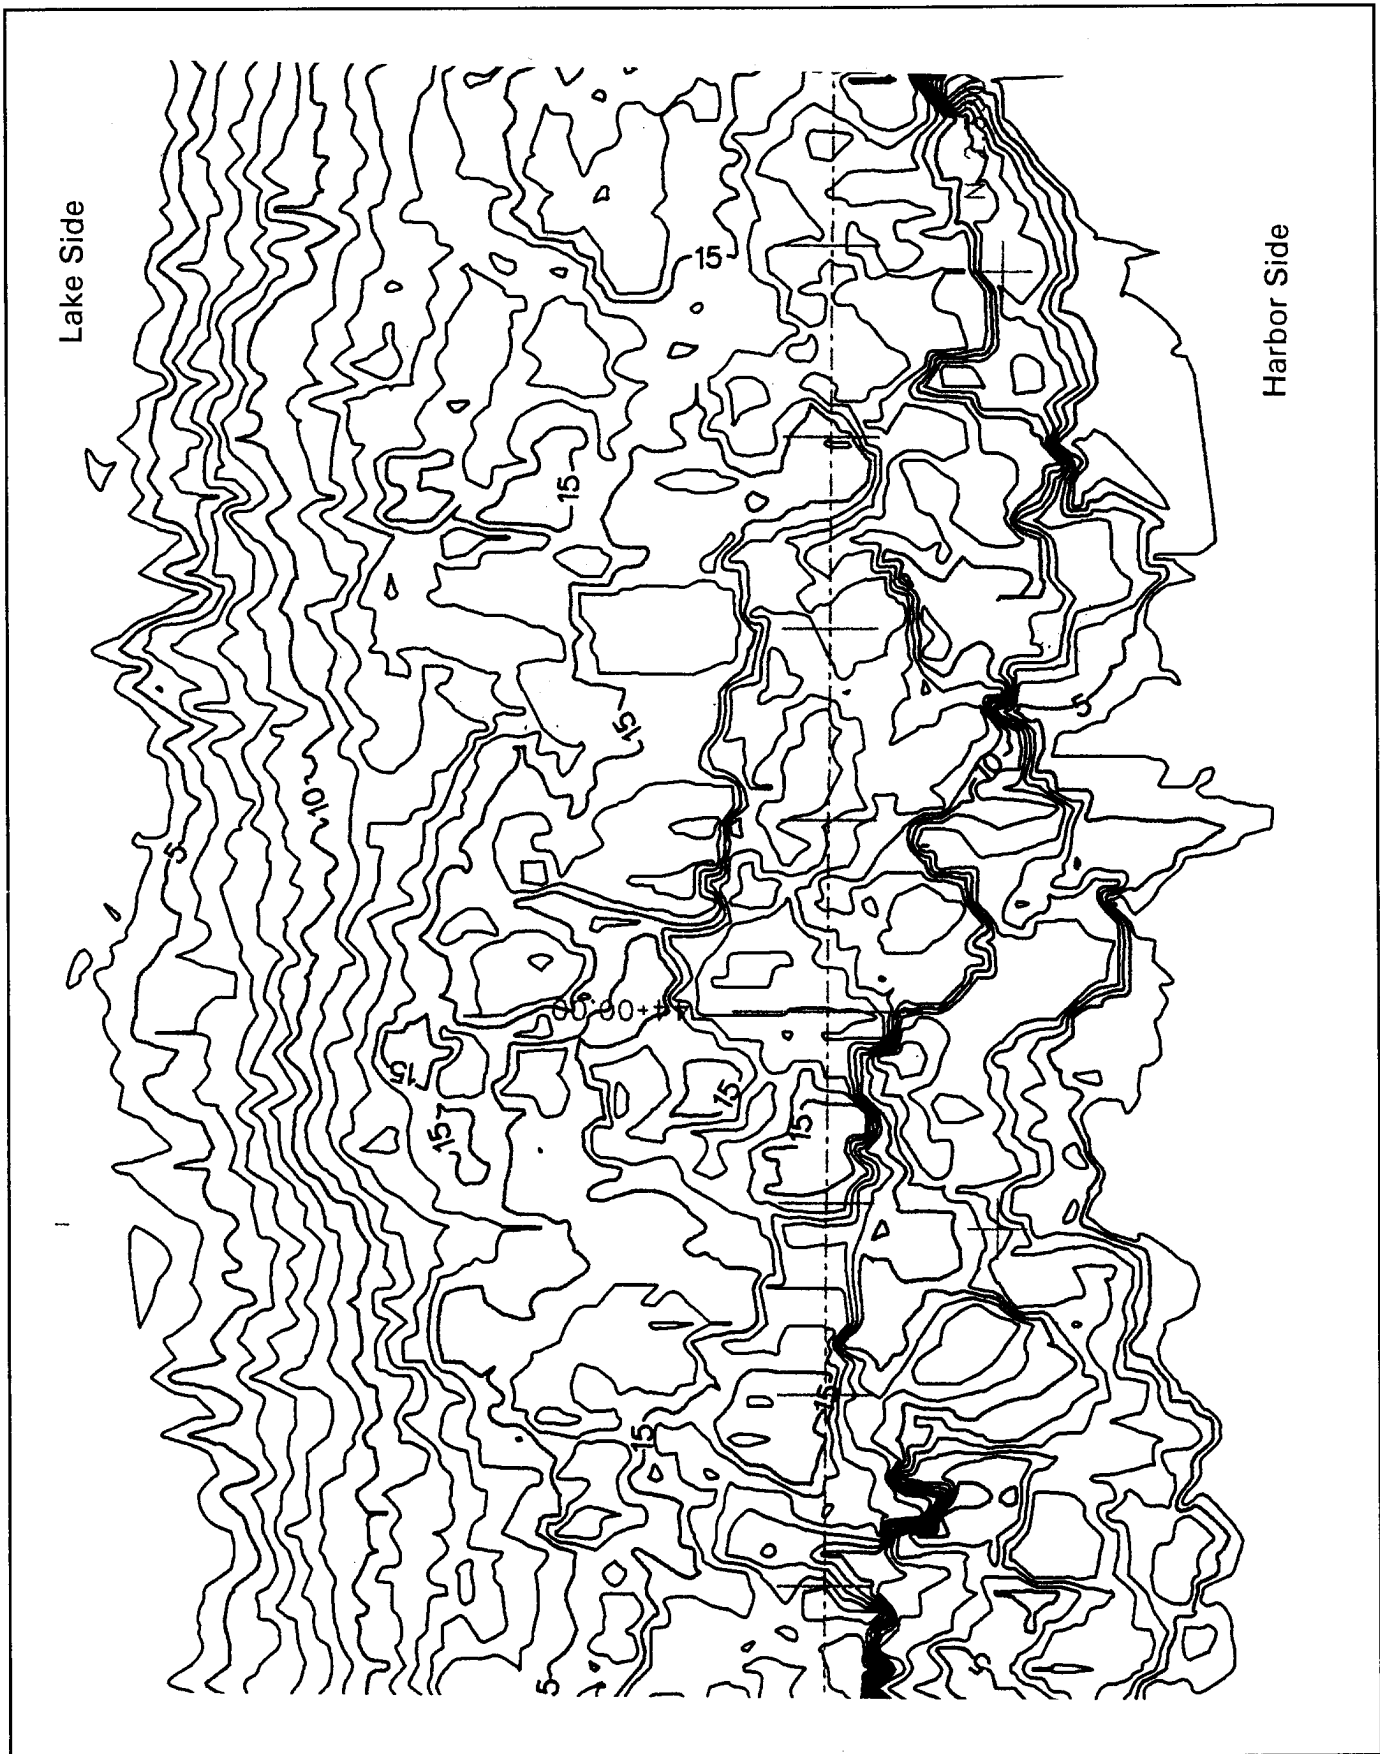
Figure A52. Topography of Burns Harbor North Breakwater, sta 43+51-44+36
