# **Periodic Inspection of Burns Harbor North Breakwater, Indiana**

## **Report 1 Base Conditions**

by *Robert R. Bottin, Jr., WES*  
*Erik W. Matthews, Chicago District*

Technical Report CERC-96-8  
September 1996

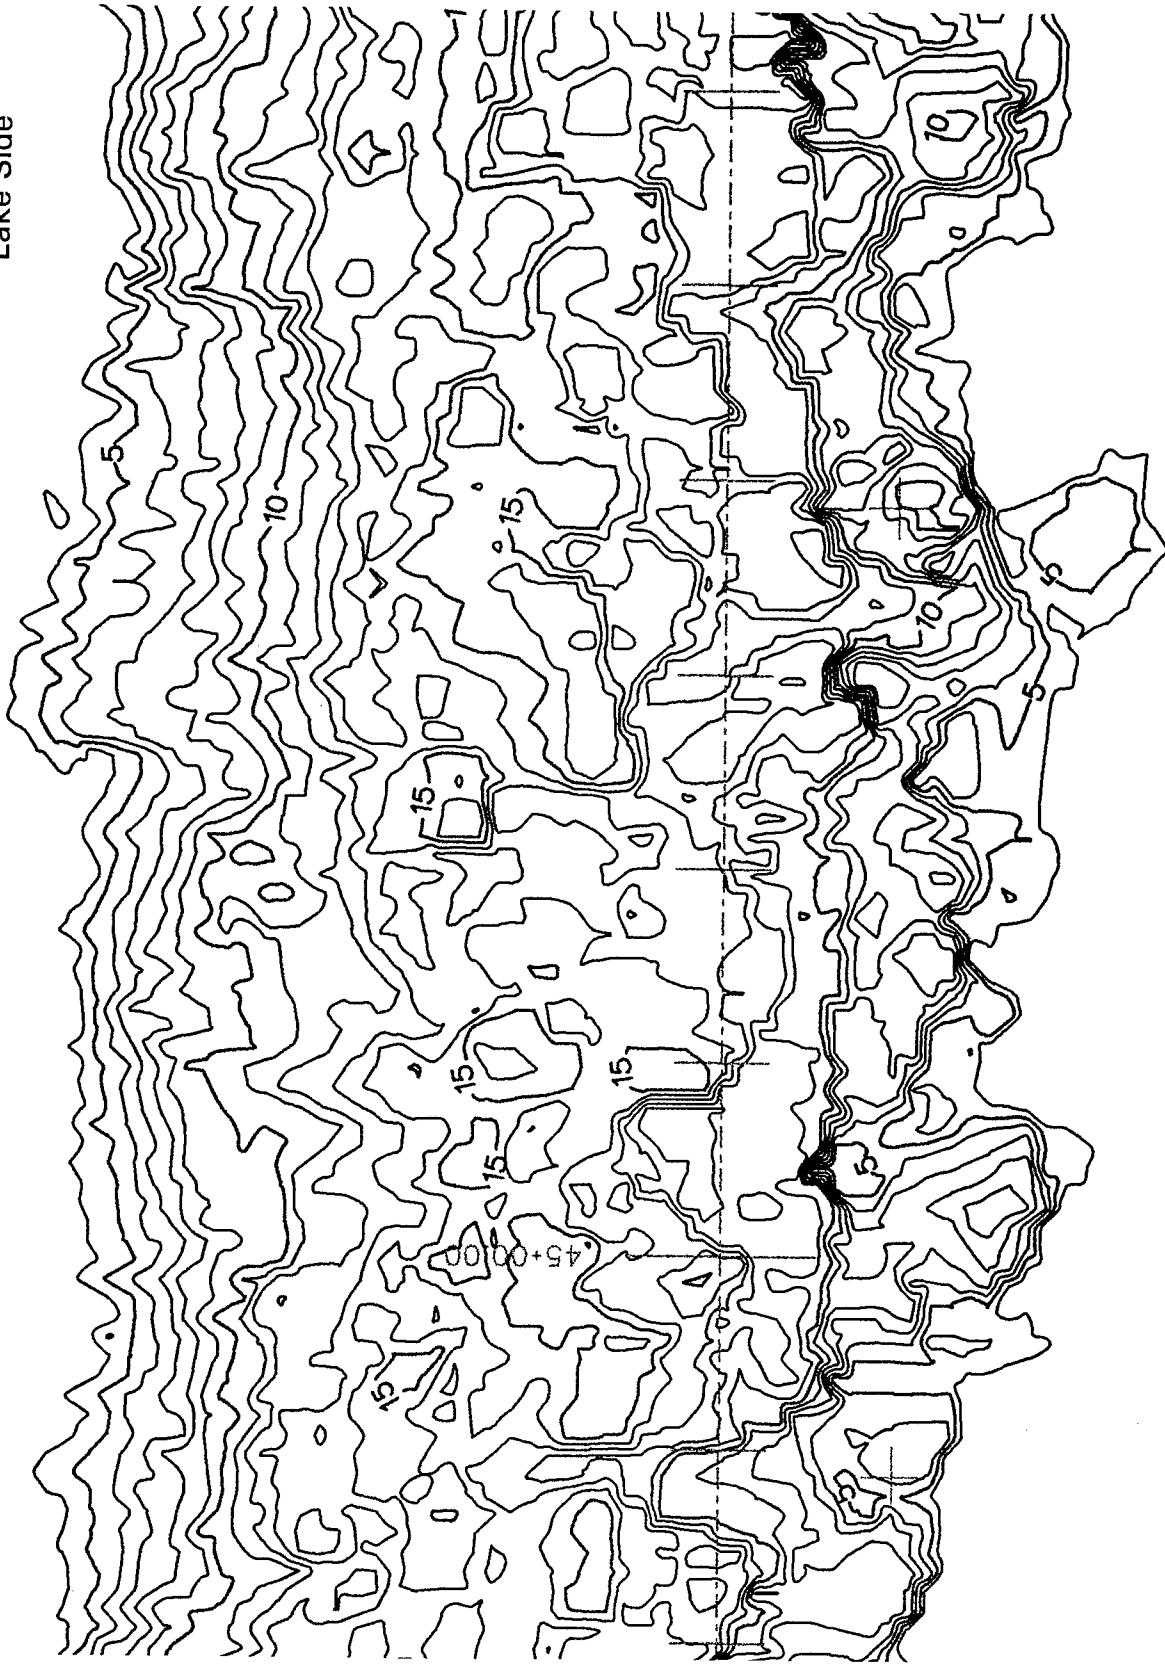
Figure A53. Topography of Burns Harbor North Breakwater, sta 44+36-45+21

This appendix presents contour maps of the Burns Harbor North Breakwater. Topography was developed using the digital terrain model (DTM) as stated in the main text of this report. The breakwater topography is shown on a 0.3-m (1.0-ft) contour interval. Elevations shown are in feet referred to low water datum (lwd). To convert them to meters, multiply by 0.3048. Station numbering on the contour maps is from east to west (right to left). The scale of the maps is 25.4 mm = 3.05 m (1 in = 10 ft).

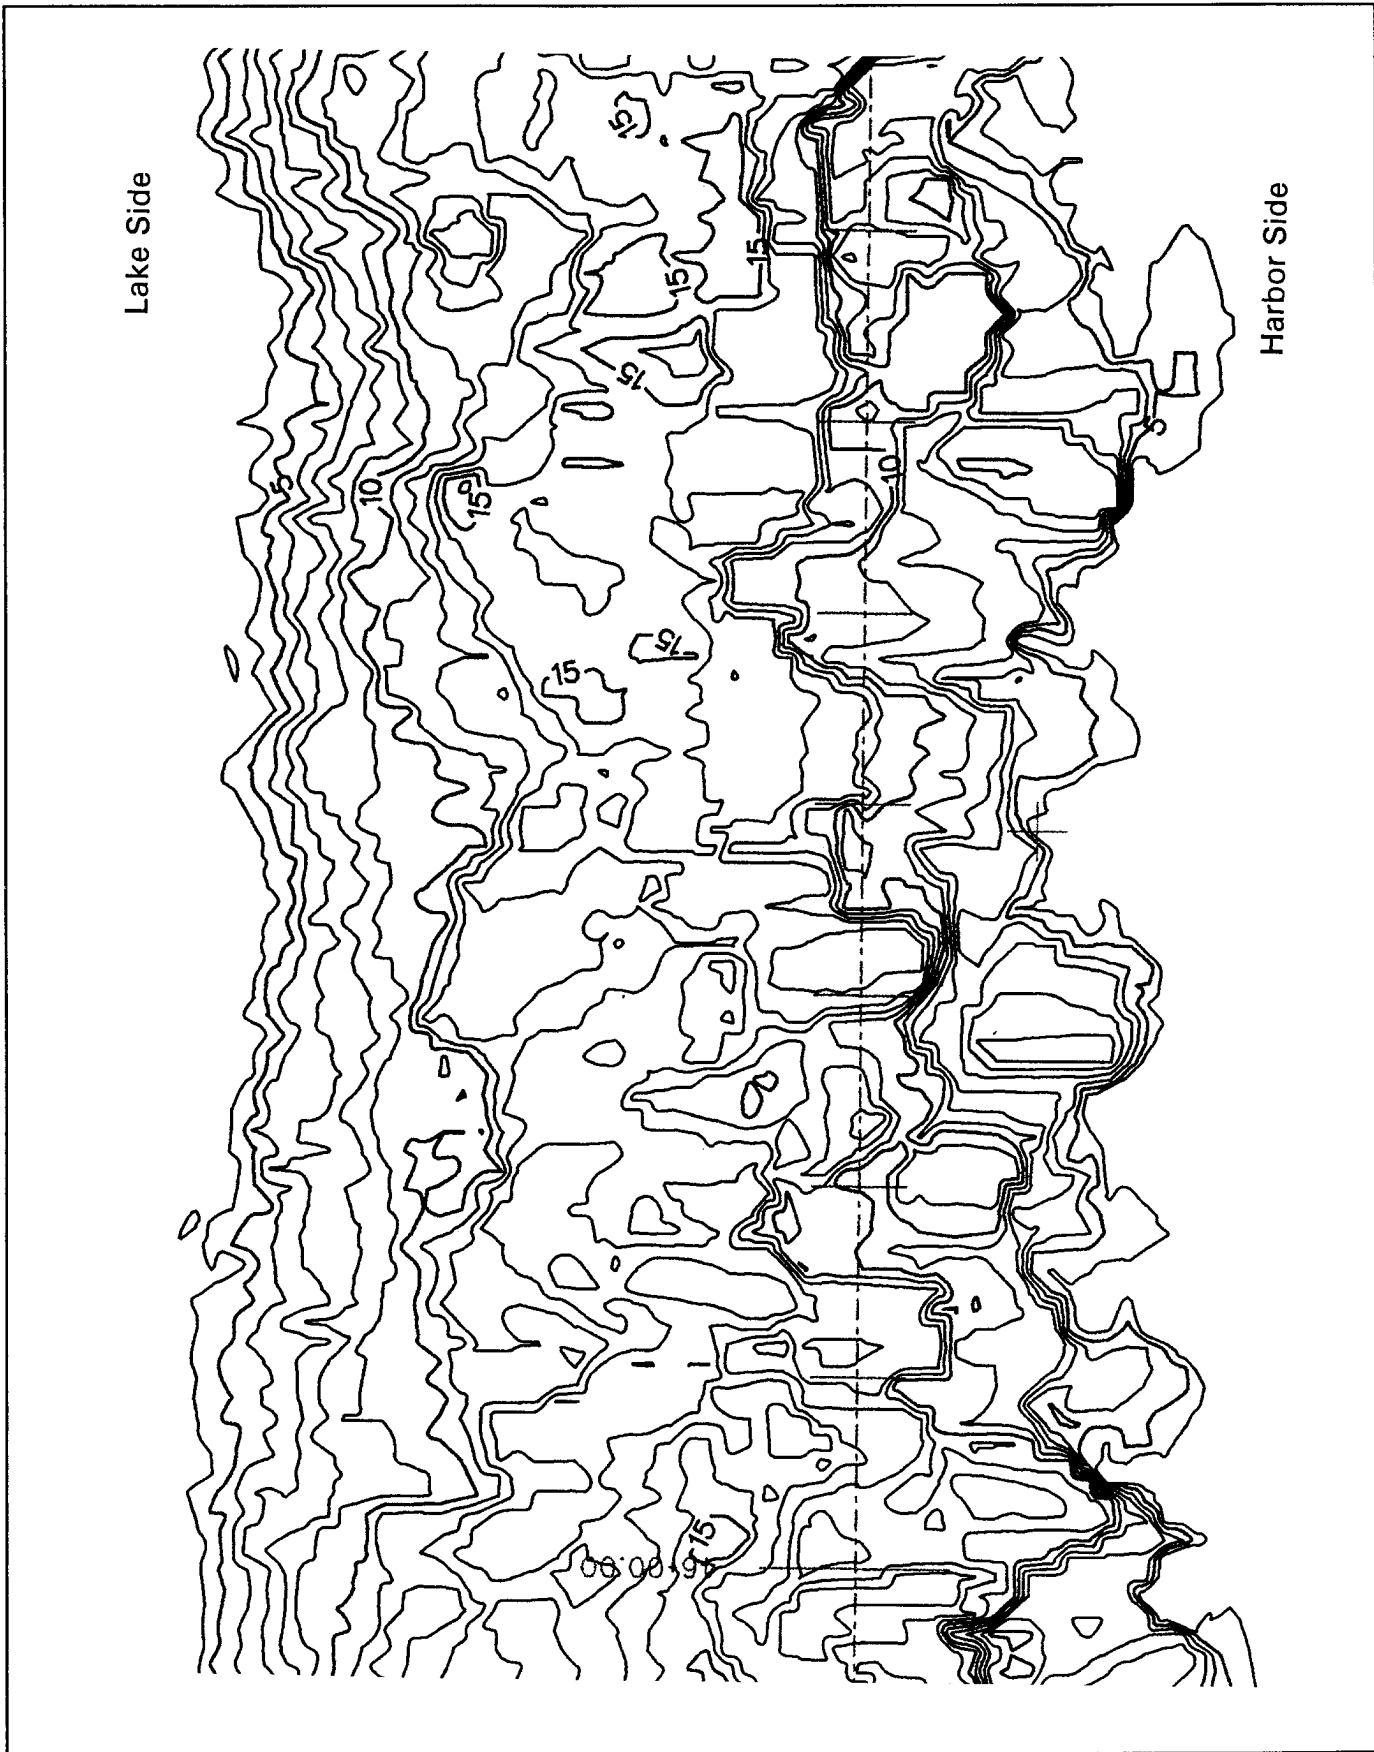
Figure A54. Topography of Burns Harbor North Breakwater, sta 45+21-46+06

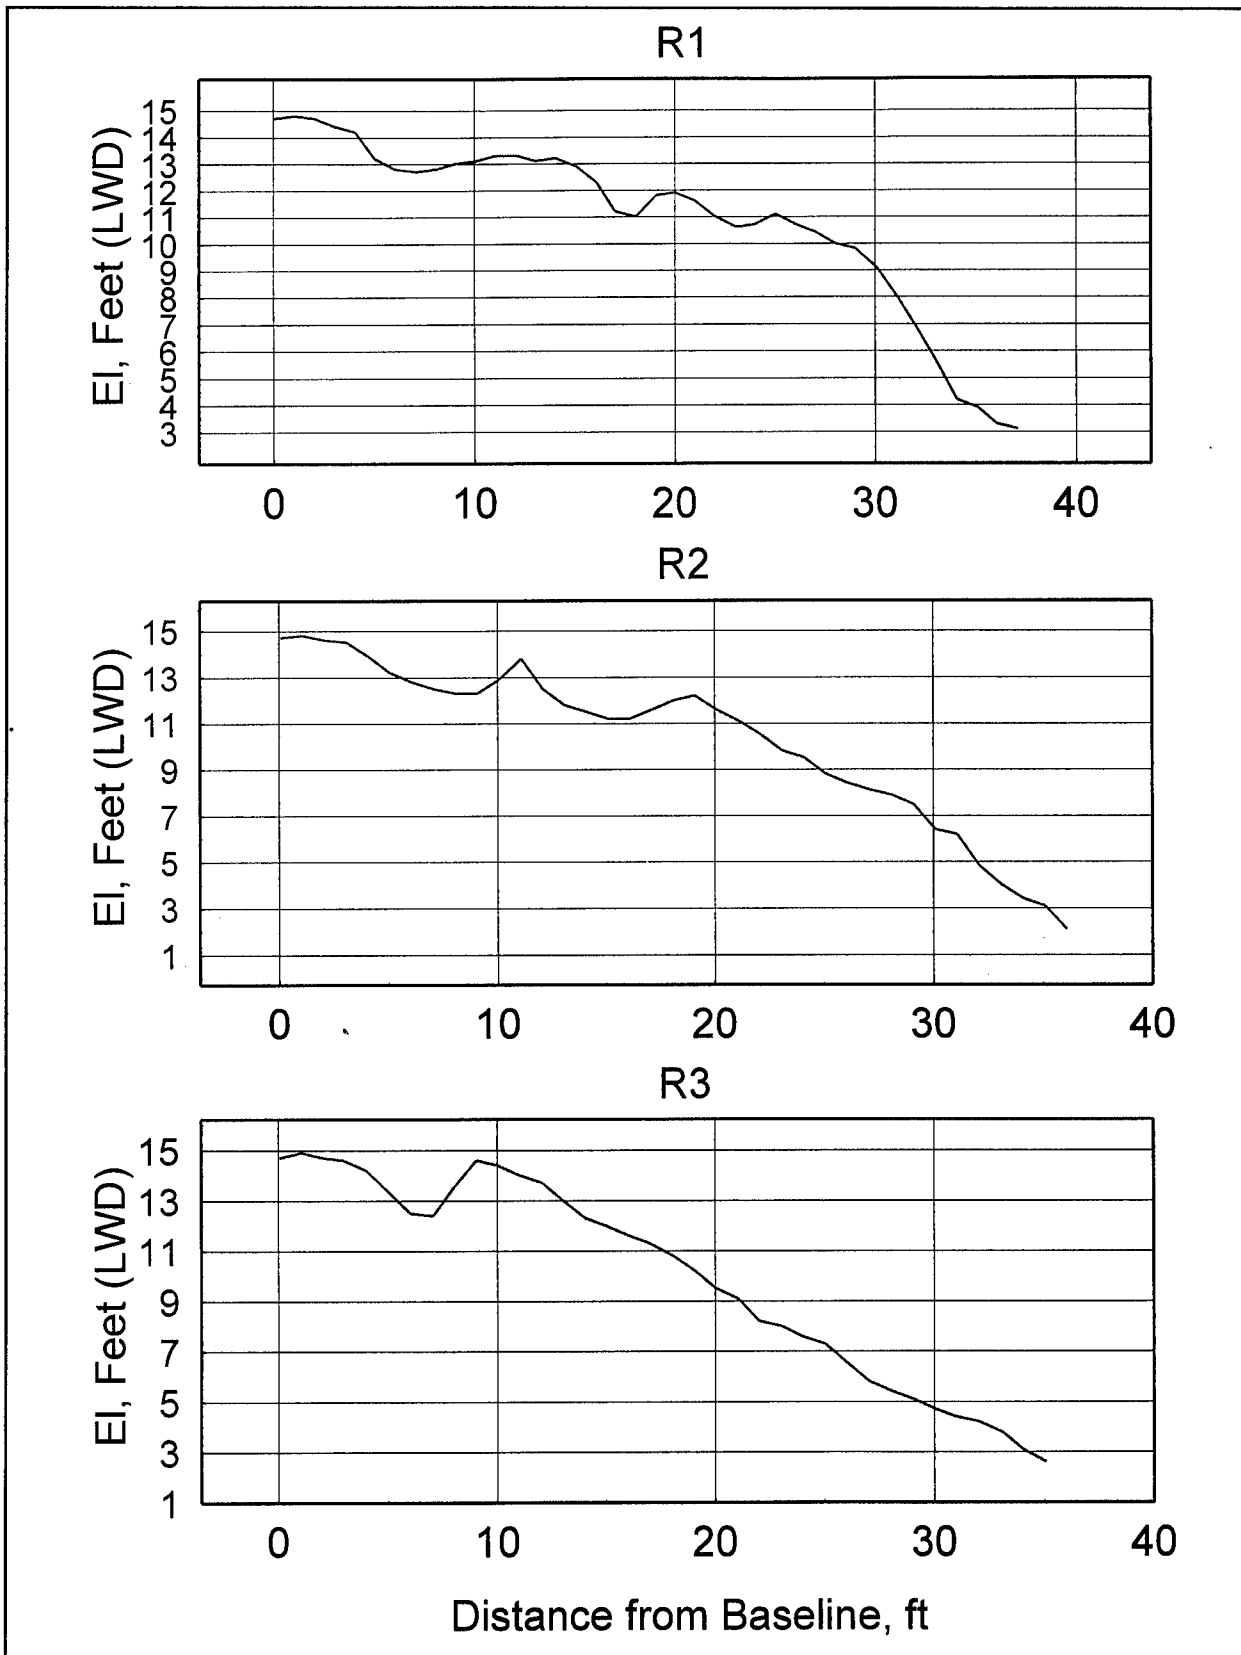
Figure B1. Cross sections of Burns Harbor North Breakwater, sta R1, R2, and R3

This appendix presents cross sections of the Burns Harbor North Breakwater. Cross sections were developed using the digital terrain model (DTM) grid as stated in the main text of this report. They were obtained at 0.3-rad (15-deg) intervals around the head of the breakwater and 15.2-m (50-ft) intervals along the trunk as shown in Figure 10 in the main text of this report. Elevations shown are in feet referred to low water datum (lwd). To convert them to meters, multiply by 0.3048. Distances from the baseline also are shown in feet and may be converted to meters using the same factor. The baseline established was the approximate center line of the breakwater. Negative distances are measured relative to the harbor side of the baseline and positive distances are measured relative to the lake side of the baseline.

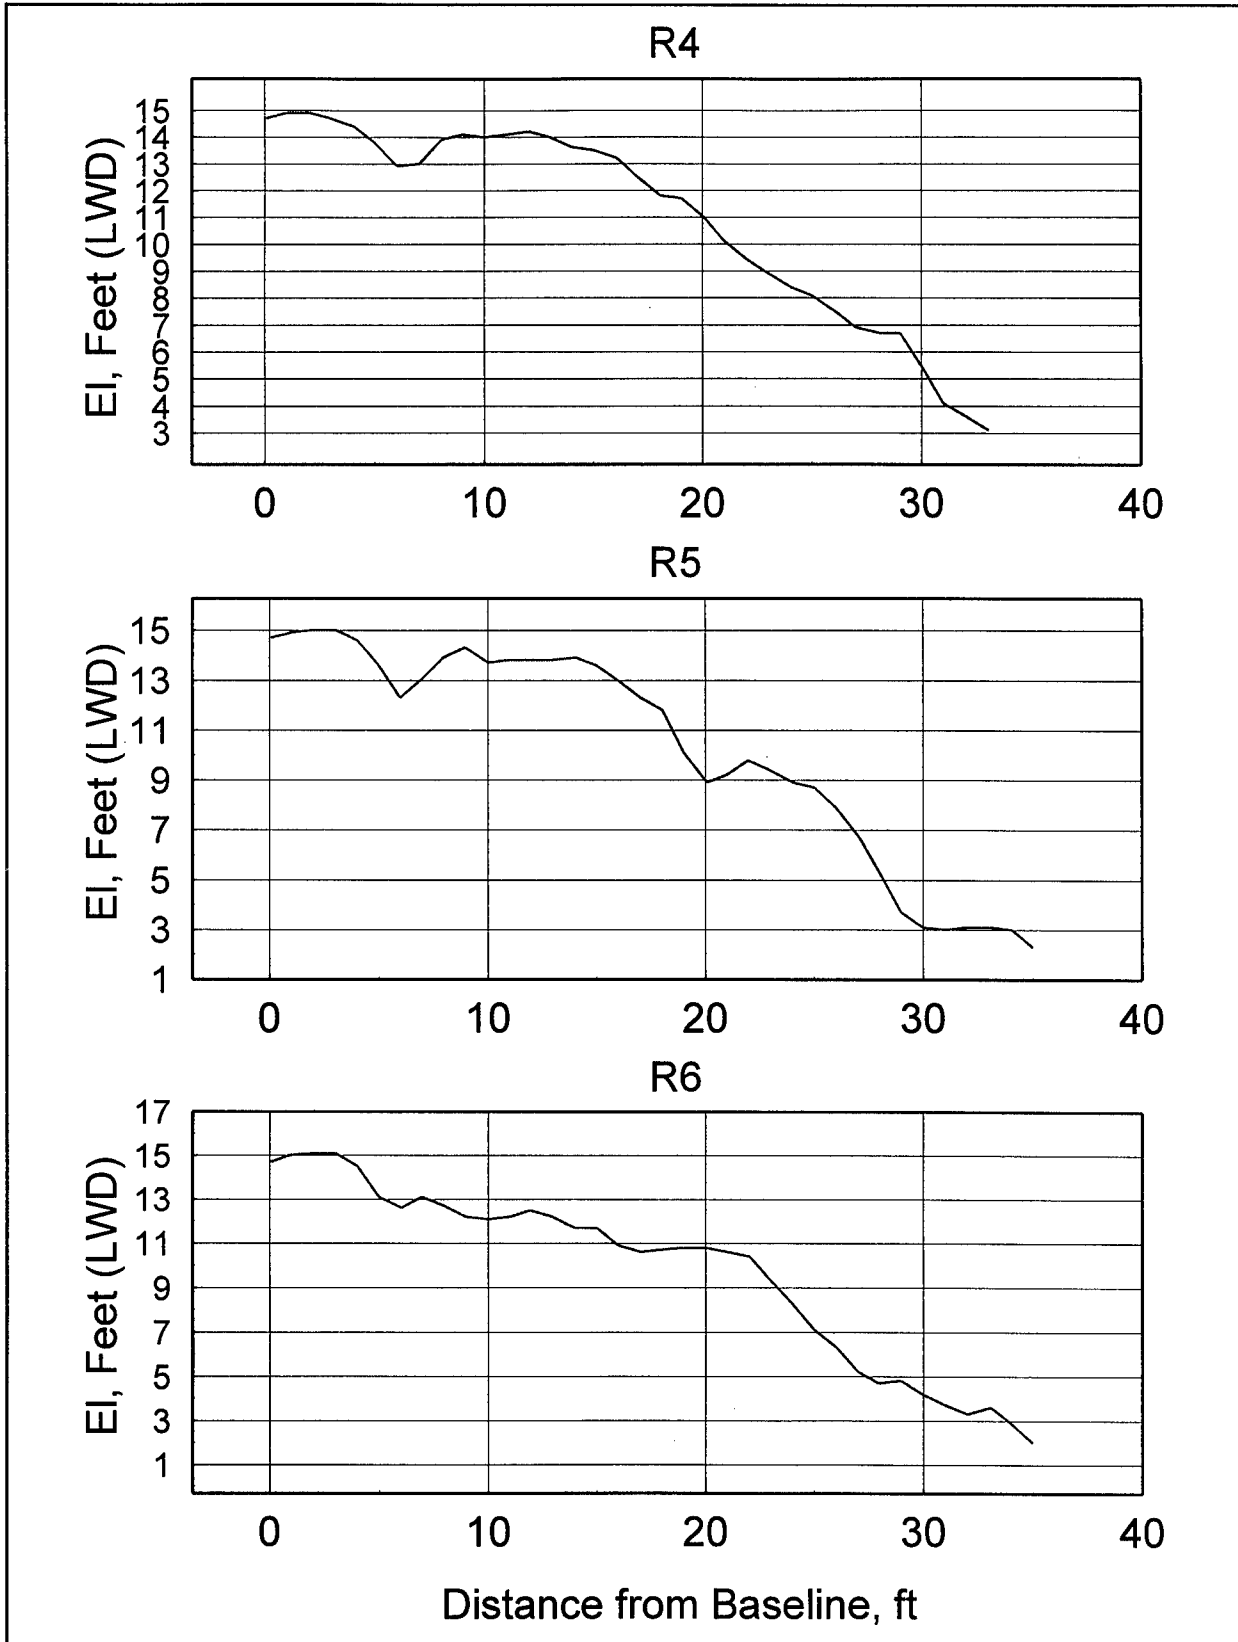
Figure B2. Cross sections of Burns Harbor North Breakwater, sta R4, R5, and R6

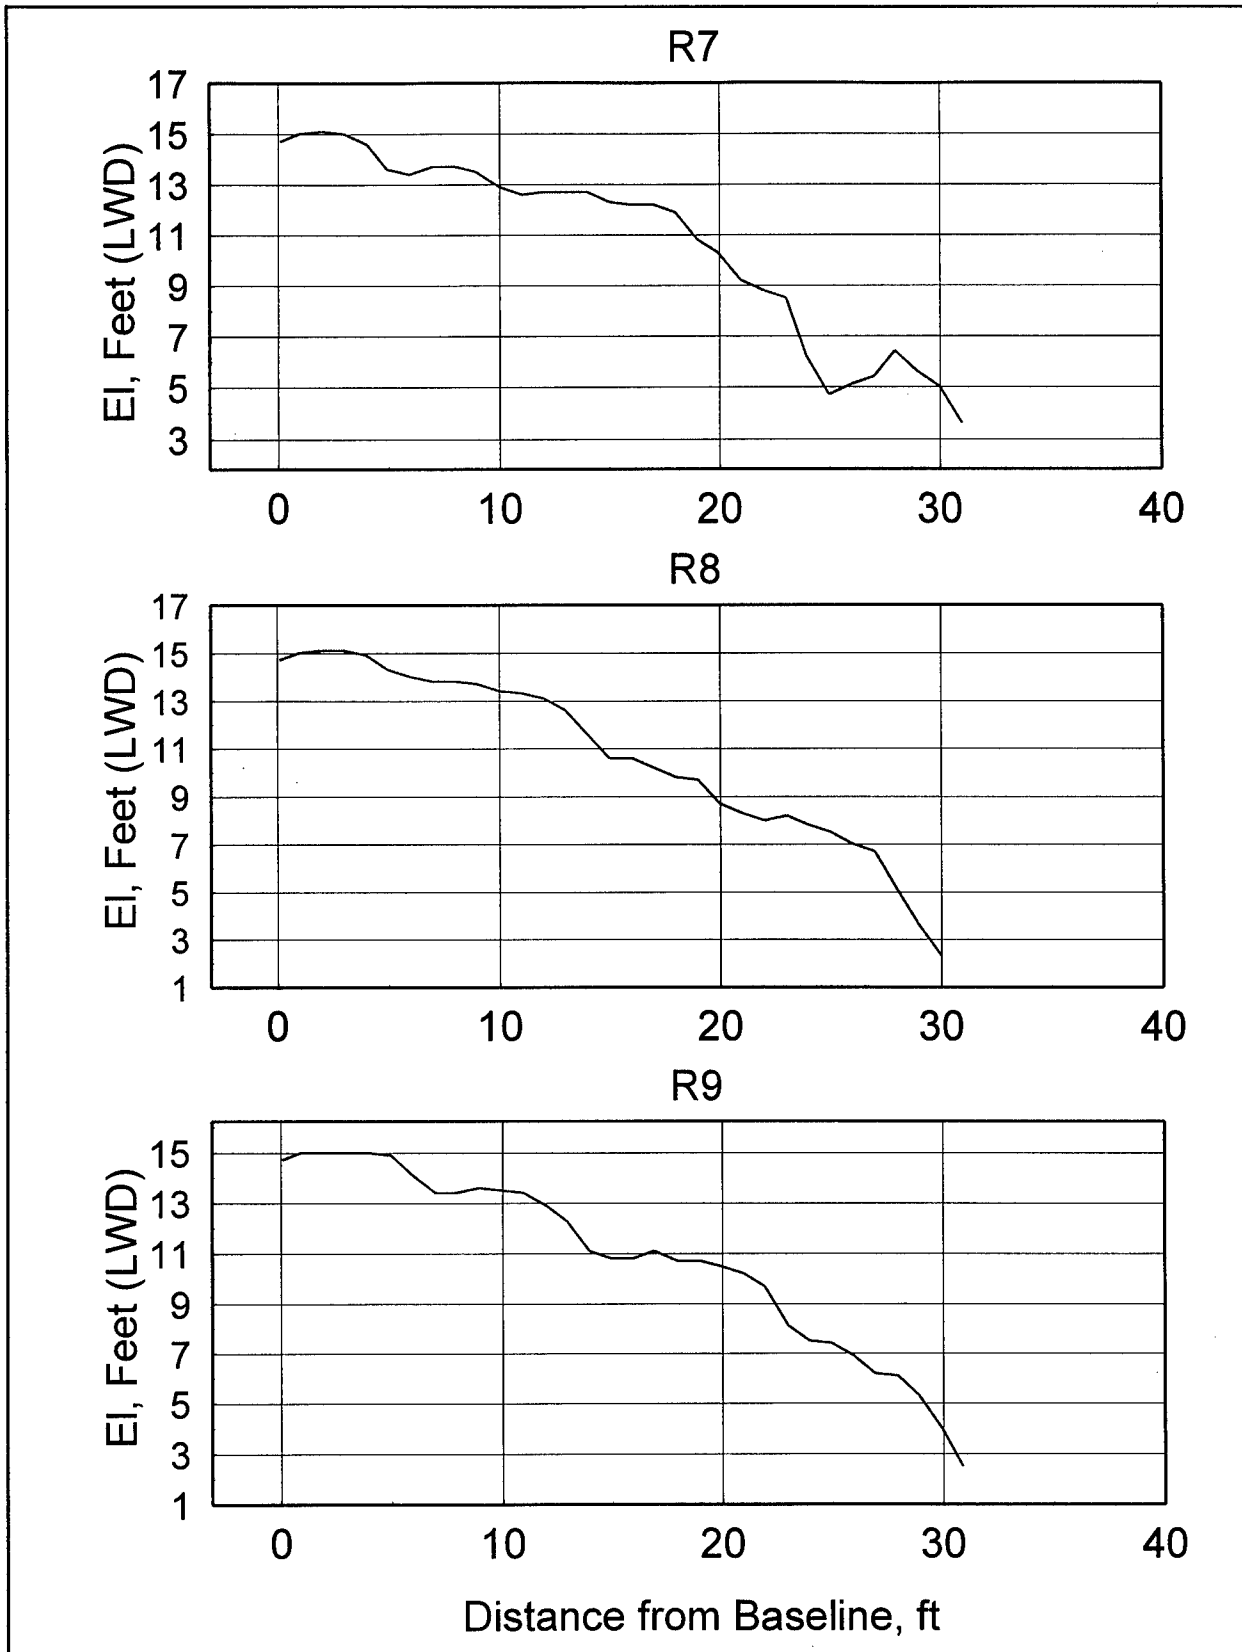
Figure B3. Cross sections of Burns Harbor North Breakwater, sta R7, R8, and R9

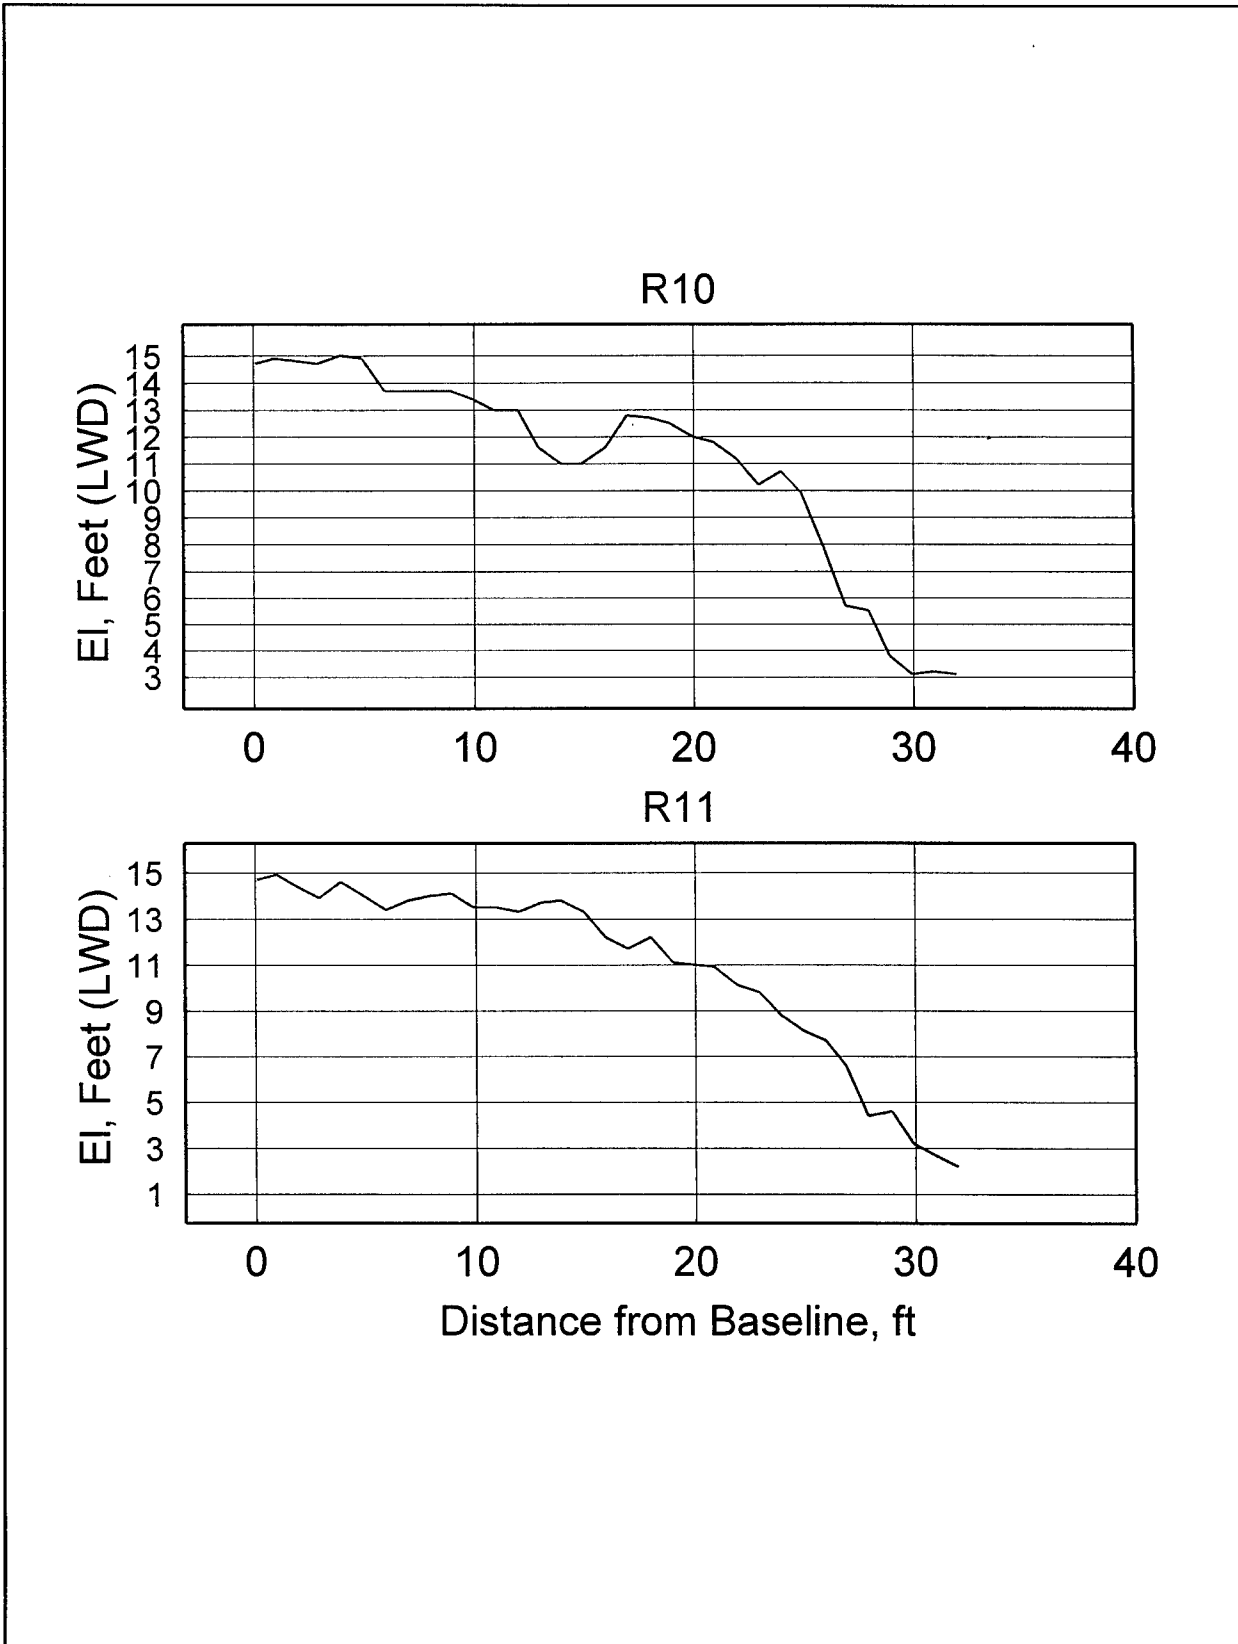
Figure B4. Cross sections of Burns Harbor North Breakwater, sta R10 and R11
