NRL/MR/6180--96-7902

Evaluation of Damage Control Tactics and Equipment - Phase I, Baseline Tests

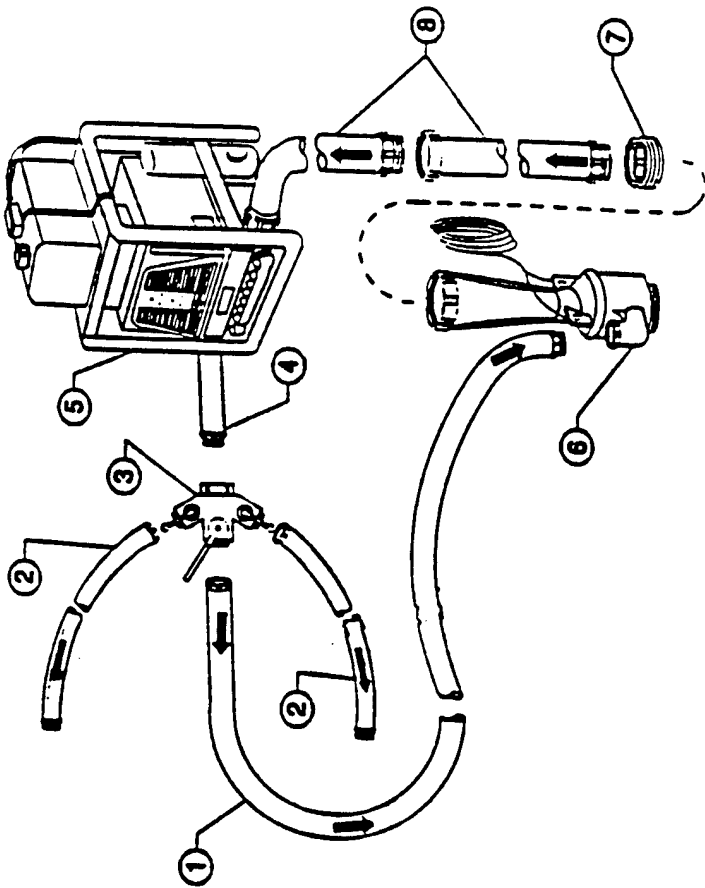
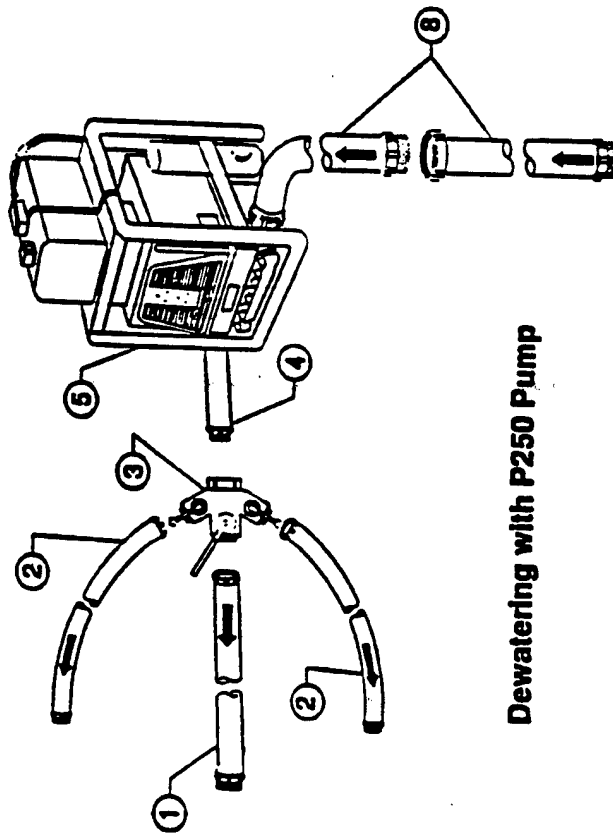
Dewatering with Combination of Eductor and P250 Pump

Dewatering with P250 Pump

Fig. 9 - P250/P100 pump configurations for suction lifts under 6.1 m (20 ft)

When personnel dewatered with the suction hose and foot valve, the P-250/P-100 pump and hoses were positioned on the weather deck. The suction hose and foot valve were lowered through a scuttle (QAS 1-93-2) to the flooded compartment. This resulted in a lift of approximately 3.0 m (10 ft). The pump was rigged as shown in Figure 9. After the suction hose was primed on the P-250, the pump was started. To conserve water, the pumped water was discharged to designated ballast tanks instead of overboard.

When personnel dewatered with the 38.1 mm (1.5 in.) eductor, the pump was connected to the foot valve as described in section 6.4.1, however, the pump discharge was connected via a fire hose to the eductor. A discharge hose was connected to the eductor and lowered into the compartment with the foot valve. The suction hose was primed prior to starting the pump and the pumped water was discharged into a ballast tank. This configuration is shown in Figure 9.
