**COMPRESSOR RESEARCH
FACILITY COMPUTER SYSTEM
SUPPORT AND MAINTENANCE**

**BATTELLE MEMORIAL INSTITUTE
APPLIED TECHNICAL COMPUTER GROUP
WRIGHT-PATTERSON AFB OH 45433-7650**

DECEMBER 1996

FINAL REPORT FOR PERIOD DECEMBER 1990 - AUGUST 1996

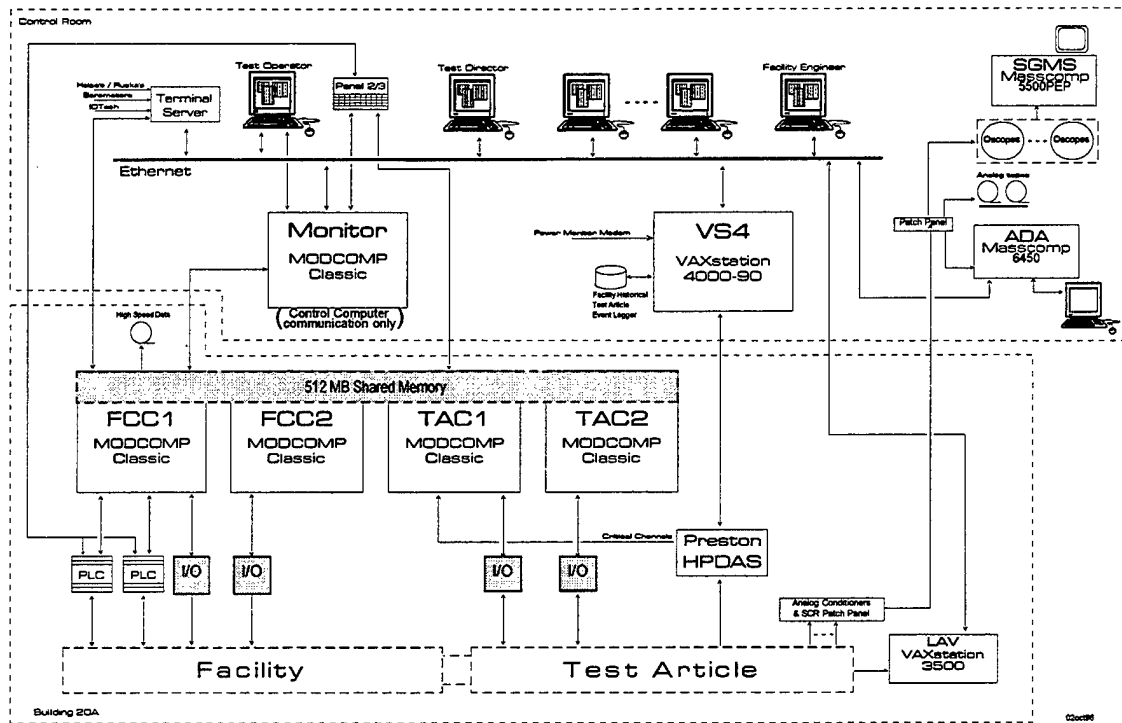
Current CRF Online Computers – Control and Data Flow

See the Current CRF Online Computers Control and Data Flow diagram for the computer network layout.

VS4 is the heart of the data acquisition system. It accepts instructions from the Test Operator, controls the High Performance Data Acquisition System (HPDAS), and acquires, processes, stores and displays all non-control digital data in near real time. Eight hundred forty-eight digital test article data channels are acquired through the HPDAS. A test article database provides necessary test article and facility information to allow calculation and display of individual measurements, statistical calculations, measurement corrections, and performance calculations. Facility and test article related digital data is acquired from the Control computers. Enough data is processed in real time to allow Xterminals to display updating test article and facility display information in near real time.
