# THE REMR BULLETIN

## Development of a Geomembrane System for Underwater Repair of Concrete Structures

# Repair of Failed Waterstops: An Evaluation of Products and Techniques

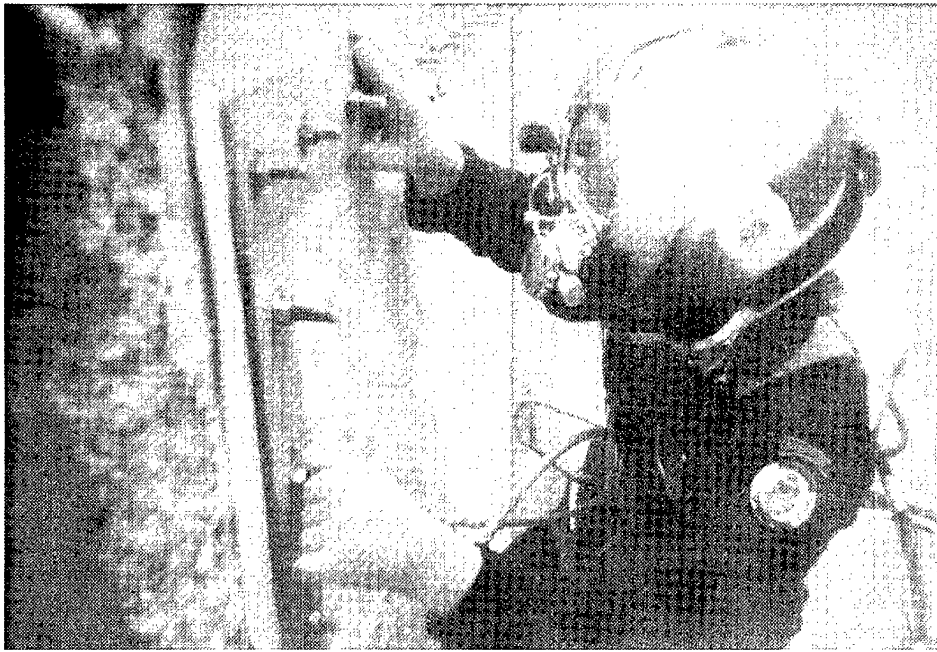
Figure 8. Membrane tightly conformed to the substrate

membrane remained tightly conformed to the wall (Figure 8), indicating that seepage through the repair system was extremely slow. During one of the underwater installations, five anchor bolts that used a combination of two-part epoxy and a glass-encapsulated resin cartridge were used. These five bolts loosened as the nuts were tightened. Failure was later attributed to the installation technique.
