SPECIAL REPORT

97-7

Shallow Insulated Foundation at Galena, Alaska

A Case Study

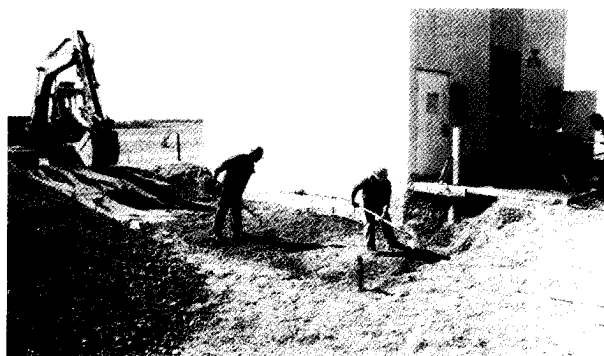
Figure 6. Excavation of foundation.

Construction of the SIF is similar to a conventional foundation and is very straightforward. Figure 6 depicts the excavation along the east side of the addition. The laborers are leveling the bottom of the excavation; the footings will be placed at this elevation. In Figure 7 the footing and stem wall have been poured and the excavation has been backfilled to the top of the footing. (The man
