**ENERGY ENGINEERING
ANALYSIS PROGRAM (EEAP)**

**BASSETT ARMY COMMUNITY
HOSPITAL
FORT WAINWRIGHT, ALASKA**

FINAL SUBMITTAL

ENERGY SURVEYS OF ARMY HOSPITALS
ENERGY ENGINEERING ANALYSIS PROGRAM (EEAP)
BASSETT ARMY COMMUNITY HOSPITAL
FORT WAINWRIGHT, ALASKA

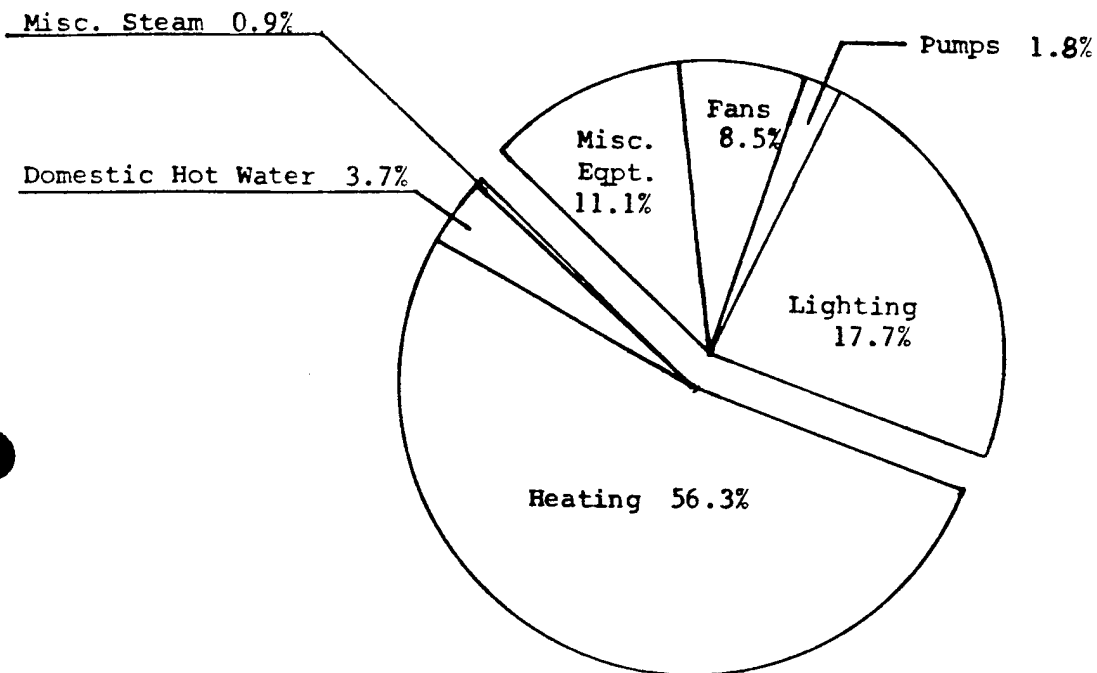
ELECTRICAL CONSUMPTION

STEAM CONSUMPTION

FIGURE 1
Bassett Army Hospital
Breakdown of Annual Energy Consumption

- 2.0.02 Figure 1 on the following page is a graphical breakdown of the relative energy consumption by component in Building 4065. As can be seen, the 56.3% of the energy consumption goes to heat the building. The next largest consumer of energy is the lighting at 17.7%. Miscellaneous electrical equipment accounts for 11.1 %, fans for 8.5% and Domestic Hot Water for 3.7%.

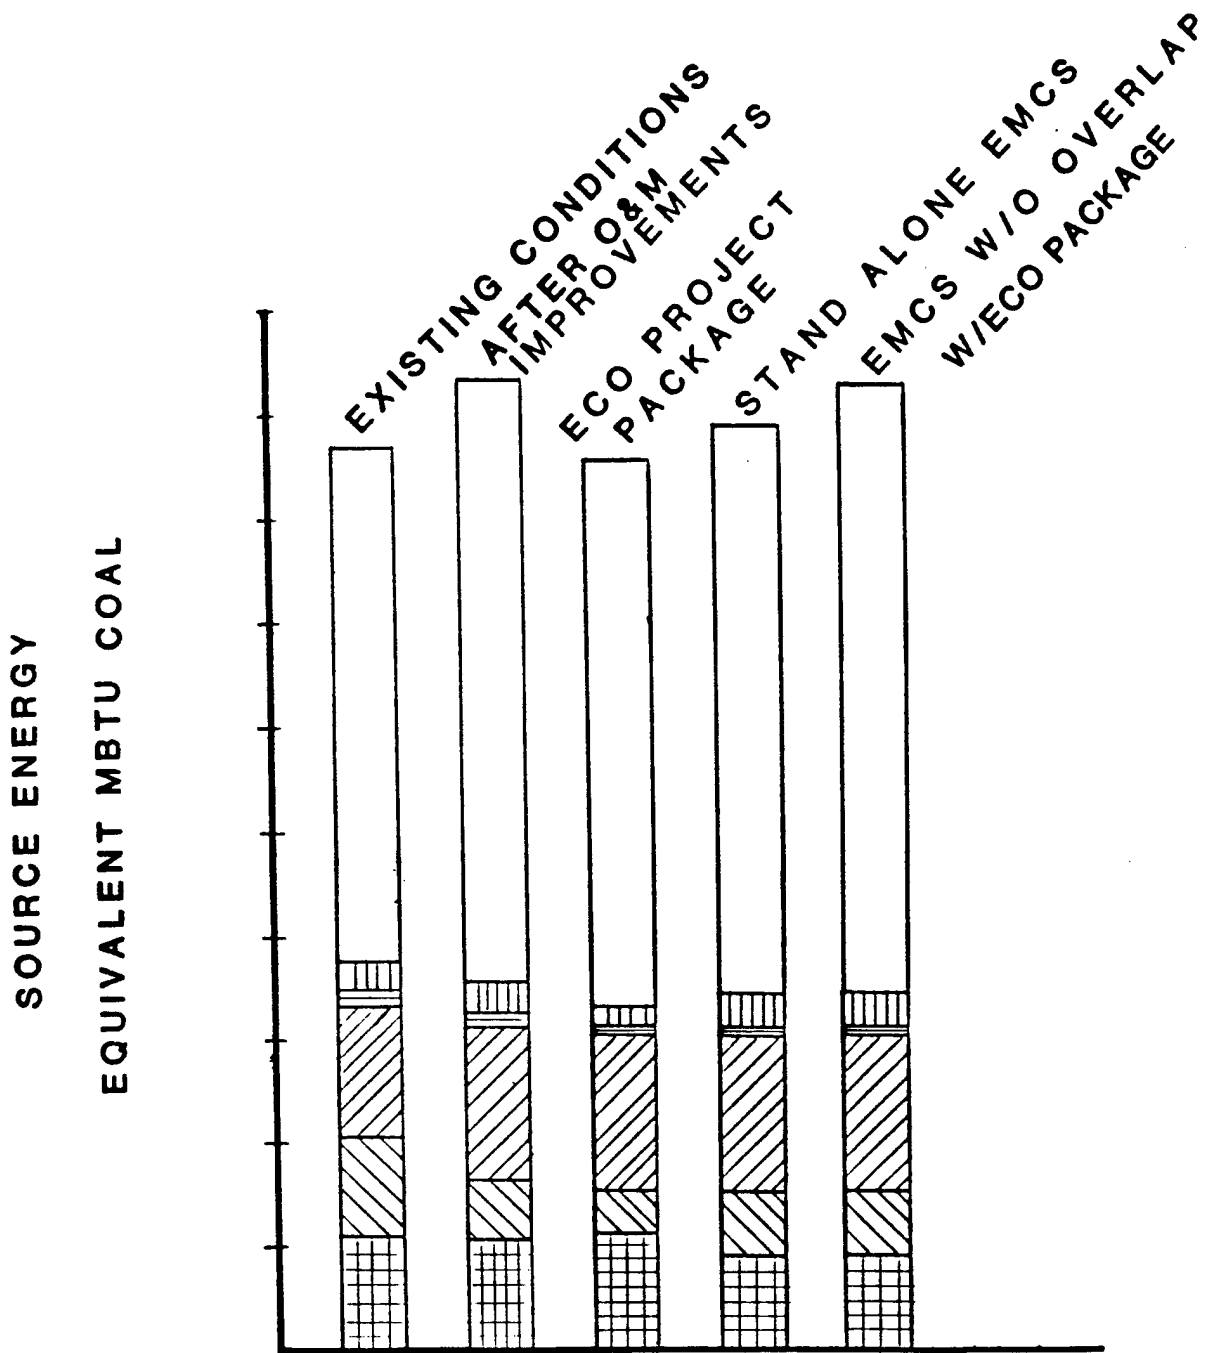
FIGURE 2 - COMPARISON OF ENERGY SAVING PACKAGES

6.1 Figure 2 on the following page is a bar chart representation of cumulative savings of alternatives studied. These savings are documented and tabulated in Tables I and II following.

7.0 Incorporation of all recommended ECO packages will result in a net savings of 8,830 MBTU per year, or \$32,318 per year. Total building energy consumption is reduced from the O & M incorporated base case of 93,749 MBTUs per year to 84,918 MBTUs per year, representing a reduction of more than 9 percent of the total energy consumption.
