# NAVAL POSTGRADUATE SCHOOL MONTEREY, CALIFORNIA

## THESIS

### ANALYZING AND PREDICTING UNDERWATER HULL COATING SYSTEM WEAR

James R. Wimmer

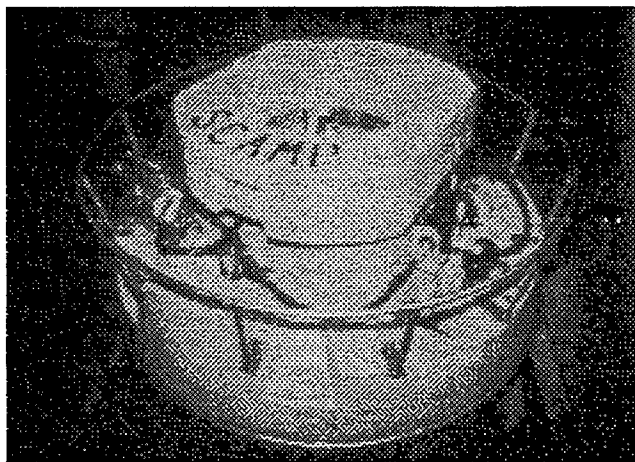
Hull cleanings are conducted to remove the heavy slime and marine growth from a ship's hull and propellers while ships are between drydockings. The SCAMP Hull Cleaning System, shown in Figure 11, is used exclusively to perform hull cleanings on all US Navy ships. The SCAMP is a diver operated device that attaches itself to the hull of a ship by impeller-produced suction and scrubs the coating system with rotating brushes.

**Figure 11. SCAMP Hull Cleaning System.**

Divers direct the SCAMP similarly to a self-propelled lawn mower along the bulk of the hull, scrubbing the entire hull coating system. Hard to reach places and the ships propellers are cleaned by hand held rotary brushes.
