# Bioremediation of Hydrocarbon-Contaminated Soils and Groundwater in Northern Climates

Charles M. Reynolds, W. Alan Braley, Michael D. Travis,  
Lawrence B. Perry, and Iskandar K. Iskandar

March 1998

**Abstract:** A field demonstration and research project was conducted in Fairbanks, Alaska, to demonstrate, evaluate, and document the construction and operation of three selected bioremediation technologies—landfarming, recirculating leachbeds, and infiltration galleries. Landfarming involves adding water and nutrients to contaminated soil to stimulate microbial activity and contaminant degradation. Infiltration galleries are dynamic in-situ treatment systems designed to stimulate microbial activity and subsequent hydrocarbon degradation by circulating nutrient- and oxygen-amended water through petroleum-contaminated soil. Recirculating leachbeds, in a way similar to slurry reactors, aerate and mix nutrients with contaminated soil, and

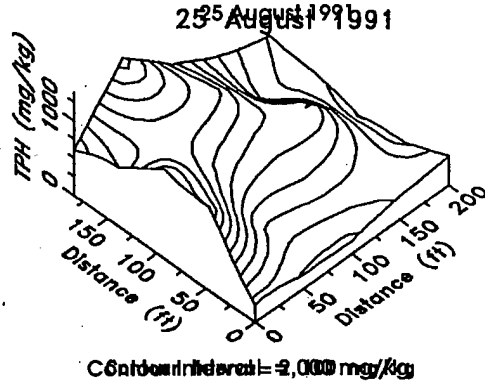
Figure 5. Soil TPH levels.

**Contaminant levels.** Soil carbon levels showed a decline in organic carbon and the TPH levels through 1991 and 1992 (Fig. 5). To address the spatial variability issue, CRREL researchers estimated biodegradation rates from a 25-point grid on a 1-acre (4047-m<sup>3</sup>) landfarm. A variety of analytical means were used. The simplest and least costly method, using dichromate oxidizable carbon, yielded estimated degradation rates that varied substantially throughout the site.
