Use of PVDF Strain Sensors for Health
Monitoring of Bonded Composite
Patches

Roger Vodicka and Steve C. Galea

DSTO-TR-0684

**Airframes and Engines Division
Aeronautical and Maritime Research Laboratory**

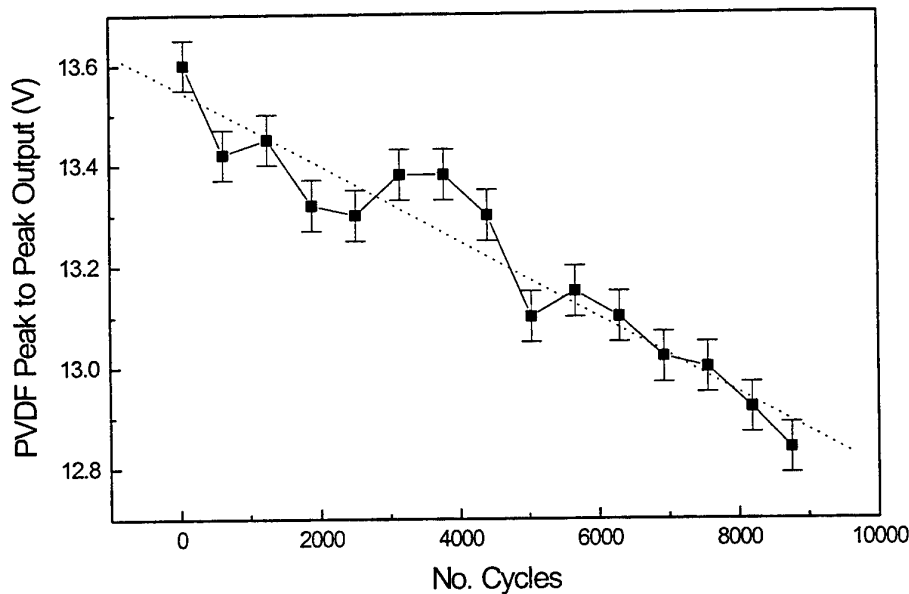
Figure 5: Reduction in PVDF sensor output (#5) with increasing number of applied constant amplitude loading cycles, indicating damage and damage growth in the specimen.

The detection of damage in the doubler specimen was made by examining the output levels of the PVDF sensors as well as the response of the strain gauges. Initial signs of damage were detected from the PVDF sensor output using the graphical display in the DASYPAB data acquisition software. The output of PVDF sensor #5 was seen to steadily decrease over the 8849 cycles made between load limits of -20kN and +6.58kN at 3 Hz. A plot of the data, i.e. PVDF peak-to-peak voltage, at this sensor location is shown in Figure 5. This figure shows a reduction of about 0.8V over the entire load case. This represents a 6% loss of signal compared to the initial value. A decrease of $260\mu\epsilon$ was measured at strain gauge B1 over the load case. At these load limits the initial peak to peak strain output is $2330\mu\epsilon$. This decrease therefore represents a 11% decrease in strain at this location. Figure 6 shows the change in strain at strain gauge location B1 with number of applied load cycles. No other gauges showed decreases in output during this loading case.

The PVDF sensors seem well suited to the task of strain and health monitoring on structures. Although a direct comparison of strain gauge values and PVDF output cannot be made the trends in results between the two are clearly seen. This is especially obvious when comparing Figures 5 and 6 which show the growth of damage in the doubler when cycling between spectrum limits. Lower levels of signal loss with increasing damage are seen by the PVDF sensors. This is due to the fact that the sensing area of the PVDF is of the order of 10 mm by 10 mm whereas the strain gauge covers a much smaller region (with about 2 mm sensing length). The use of PVDF sensors with smaller areas covering the critical regions more closely would give an even better response to any damage growth.

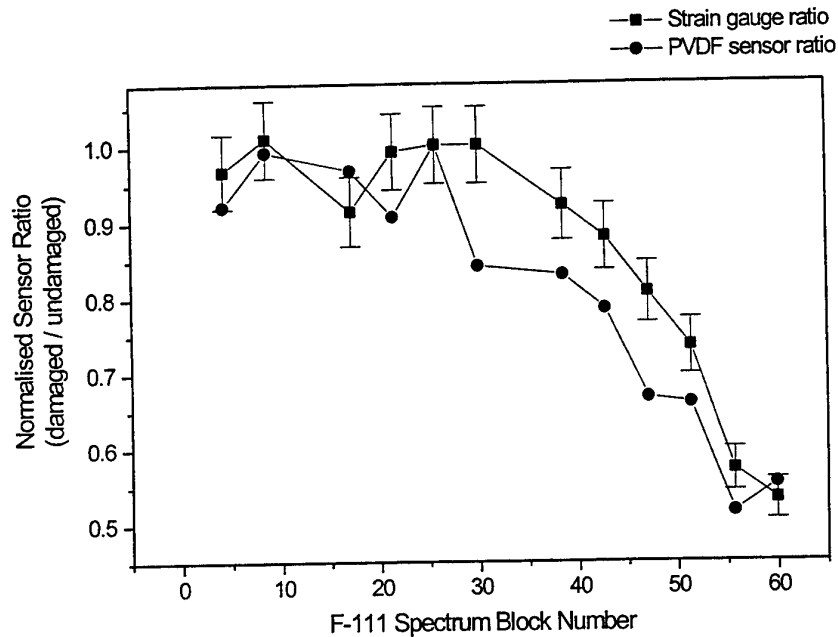
Figure 7: Variation of strain gauge and PVDF sensor output ratios (damaged/undamaged) with increasing number of applied F-111 spectrum blocks. Data is normalised with unity representing the undamaged state.

Damage growth was observed during F-111 spectrum loading at PVDF sensor #5 only. A comparison was made between PVDF sensor #5 and PVDF sensor #4 in order to produce a damage indicator which is basically a ratio of the signal at the damaged location (PVDF sensor #5) to a signal at an undamaged location (PVDF sensor #4). Comparison was then made between PVDF sensors #5/#4 and strain gauges A1/B1. This data was normalised with respect to unity representing the initial damage indicator ratio, and is plotted in Figure 7. A good correlation exists between the strain gauge and PVDF data.

Excellent correlation between the strain gauge and the PVDF sensor is achieved when the normalised ratio of strain at the critical region of the patch to the strain in the far-field is used (as shown in Figure 7). This ratio or 'damage indicator' appears to be sensor independent. A normalised sensor ratio value of unity indicates good health (ie: no damage) and a value approaching zero indicates substantial damage.
