AFRL-ML-WP-TR-1998-4127

ENHANCED LASER GENERATED ULTRASOUND

**BOEING INFORMATION, SPACE & DEFENSE SYSTEMS
P.O. BOX 3999
SEATTLE, WA 98124**

FINAL REPORT FOR DECEMBER 1996 THROUGH FEBRUARY 1998

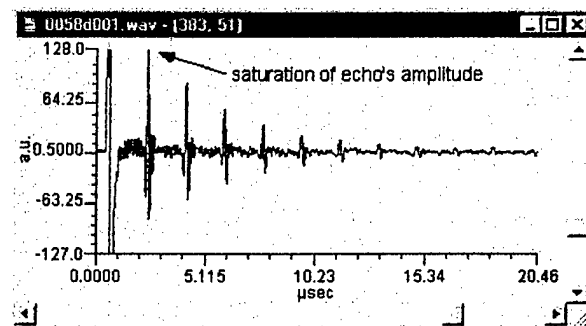
Note that, even at full scale, the amplitude of the C-scan image (gray scale image) is saturated. The saturation, shown as white pixels, occurs for inclusion defects near the surface of the part. The saturation occurred during the acquisition of the data, as shown in figure 4.2-9.

Unfortunately, no signal processing can be used to retrieve the information lost by saturation. If the information is needed (e.g., for attenuation measurements), the part would have to be re-scanned with the LUIS with either lower generation laser power output or with a higher digitizer scale. Note that lowering the generation laser output power could reduce significantly the signal-to-noise of the acquired waveforms and could lead to difficulty in the detection of the ultrasonic echoes in the thickest sections of the part. Also, increasing the scale setting of the digitizer would reduce the sensitivity of the inspection. At this point, the operator would have to choose, given the objective of the inspection, between saturation of the signal at some points or reduced sensitivity. It should be noted that increasing the dynamic range of the LUIS' digitizer could eliminate much of this problem. Changing the digitizer from an 8 bit A/D to a 12 bit A/d would significantly increase the dynamic range of the system. The operator would then have access to both sensitivity and dynamic range.

Figure 4.2-9. saturation in waveform

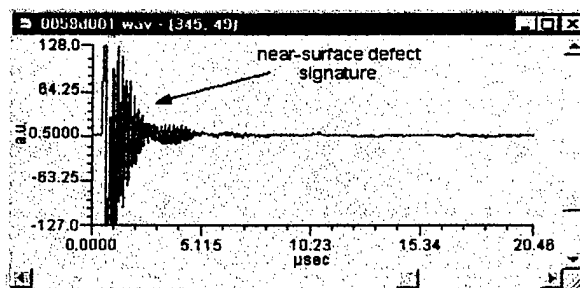
In the time-of-flight C-scan image there are some “black zones”. By using the cursor, the operator can identify that these zones correspond to inclusions near the surface of the part (see figure 4.2-10 and 4.2-11). The exact depth of the defect cannot be determined from the waveform since the arrival of the first echoes is lost in the initial surface signal, as can be seen in the B-scan of figure 4.2-12. Note however that the depth of the defect could still be determined using the frequency spectrum of the waveform. The surface signal causes a “dead zone” for which no ultrasonic echoes can be observed. For the near surface defects of the inspected part, the reverberation between the inclusions and the surface of the part is strong enough to be seen after this “dead zone”. It is difficult to reduce the “dead zone” with signal processing as it is caused by both the physical process of the surface signal and the electronic analog filters used during the acquisition of the waveform by the LUIS. To reduce its impact would require changes to the acquisition hardware of the present LUIS system. Other optical demodulators, such as the novel photorefractive device developed at the National Research Council of Canada, does not require as much electronic filtering and thus has a much more reduced “dead zone”.

Figure 4.2-11. Waveform for near surface defect

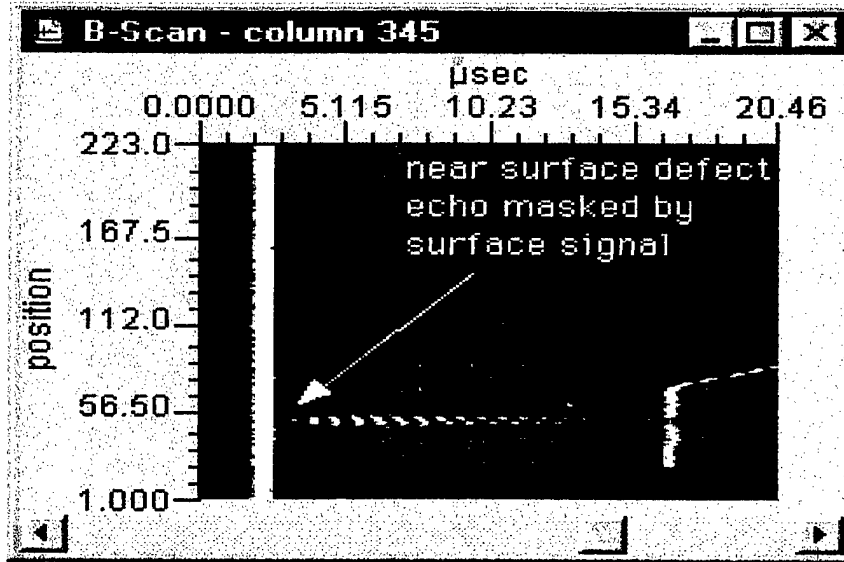
Figure 4.2-12. Near surface defect seen in vertical B-scan

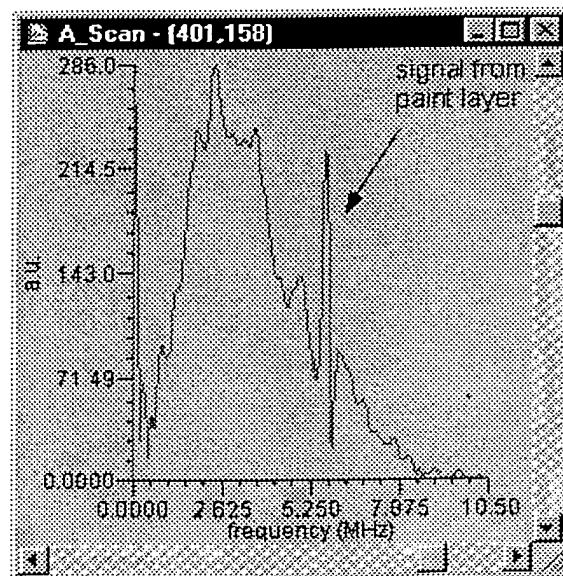
Figure 4.2-16 -Power spectrum of waveform in figure 4.2-14

Generally, a band pass filter is used for processing the waveform. The low pass cut-off frequency is chosen as to be as high as possible in order to conserve the largest possible bandwidth (and hence the maximum depth resolution), while still eliminating the paint "ringing" in the waveform. The results of a low pass filter with a low cut-off frequency of 5 MHz is shown in figure 4.2-17.

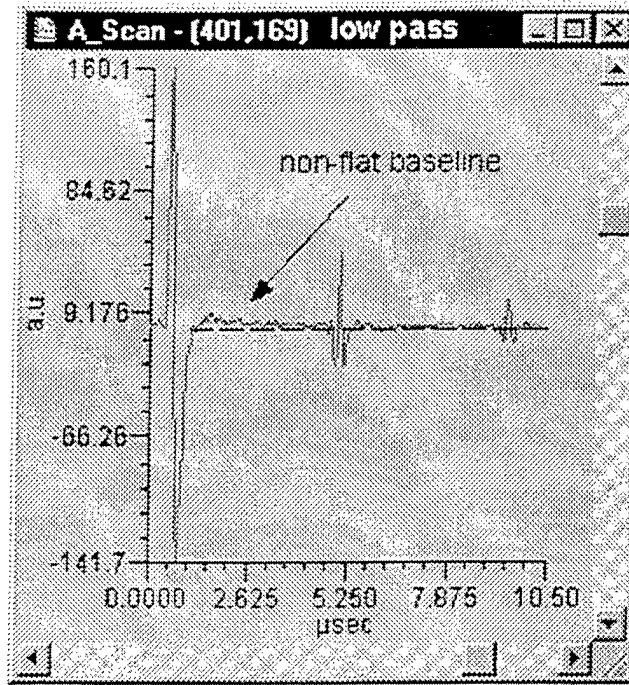
Figure 4.2-17. Waveform with non-flat baseline

When using a low pass filter only (i.e., band-pass filter with high pass cut-off at 0 MHz), the lower frequency fluctuation appears as a non-flat baseline in the waveform. A flat baseline in the waveform allows for a better dynamic range in the amplitude since the bottom of the gate can be set at its lowest level. A flat baseline may also be needed for attenuation measurement, such as for porosity detection. These low frequency fluctuation can also cause the same kind of "marking" problems as do the "ringing" signal from the paint layer in the time-of-flight C-scan images. To eliminate these fluctuation, a band pass filter is used with a typical high-pass cut-off frequency of 500 kHz to 1MHz, depending on the level of fluctuations. Note that using a sharp band pass filter, i.e. a low value of cut-off slope such as 1 MHz^{-1} , will increase the size of the "dead zone" by producing a sharp rise or "bump" in the waveform near the surface signal, as can be seen in figure 4.2-18. This bump is the tail section of the surface signal. To reduce this impact, a high value of cut-off slope, typical 3 MHz^{-1} , is used instead. The resulting waveform, shown in figure 4.2-19, has a flat baseline, no ringing signal from the paint, and a "dead zone" nearly equal to the un-filtered "dead zone".

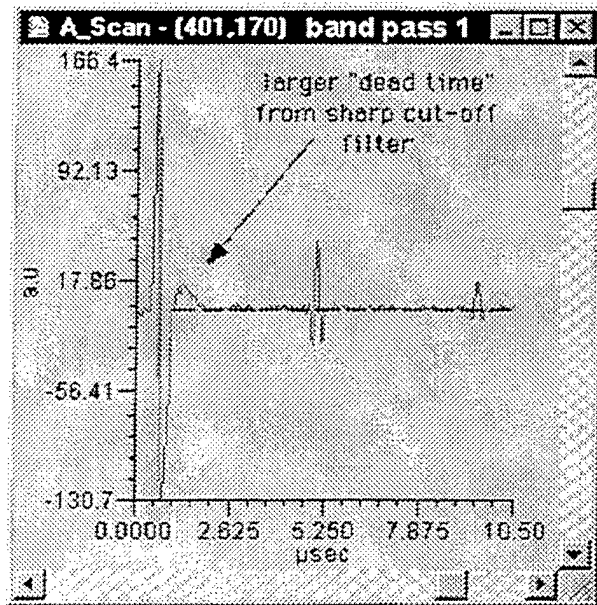
Figure 4.2-18. Waveform filtered with sharp cut-off

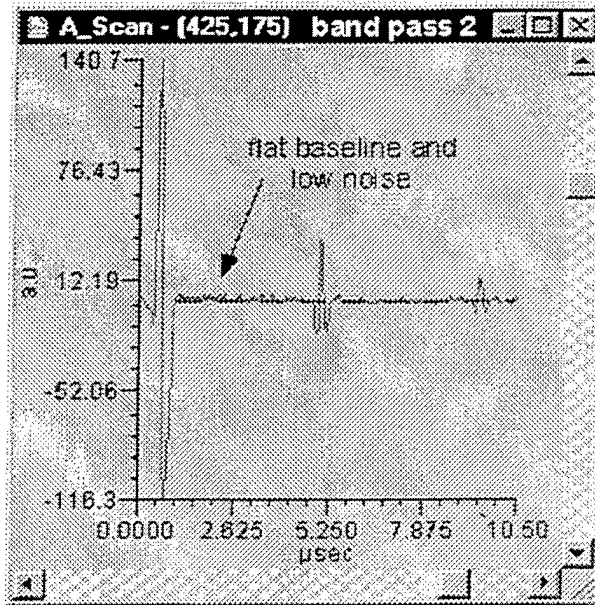
Figure 4.2-19. Waveform filtered with slow cut-off

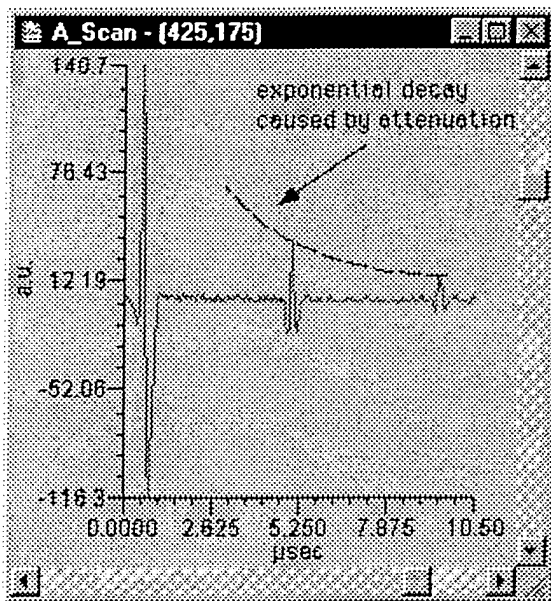
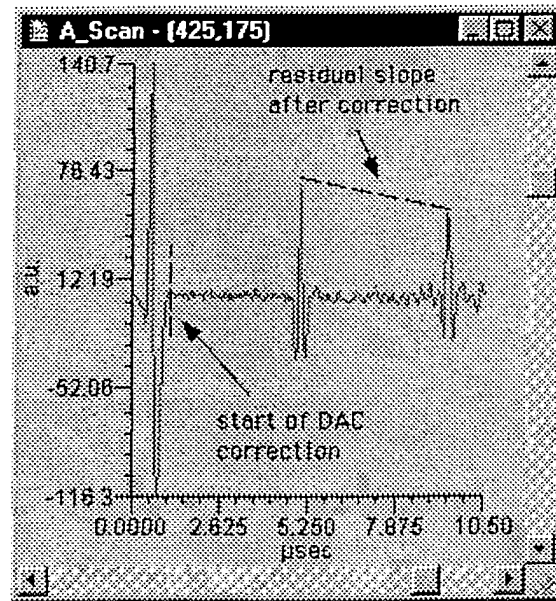
Figure 4.2-22. Exponential decay in waveform Figure 4.2-23. Correction of waveform with numerical DAC

correction (DAC), is done by multiplying the waveform by an inverse exponential function whose parameters are set by the operator. The objective is to find the values corresponding to the exponential decay observed in the waveform (see figure 4.2-22) in order to remove this

attenuation from the waveform. The DAC is set with two values: the start position of the correction function and the maximum amplification scale at the end of the waveform. Notice that this approach in parameters allows the use of exponential, linear or parabolic type functions for corrections (all three are available with the imaging software). The start point is generally set at the beginning of the gate, since there is no point in correcting the data outside of the gate. The maximum scaling factor is adjusted to have the multiple echoes from the back wall having nearly the same amplitude once corrected. Notice that the parameters are adjusted to have a slight residual linear decrease in the amplitude of the multiple echoes, as shown in figure 4.2-23. The residual decrease is left so that the gate selects the first echo of the series for the mapping of the time-of-flight C-scan images. The objective of the DAC correction is not to totally eliminate the effect of attenuation but to increase the contrast in the detection of defect in the thickest section of the part.

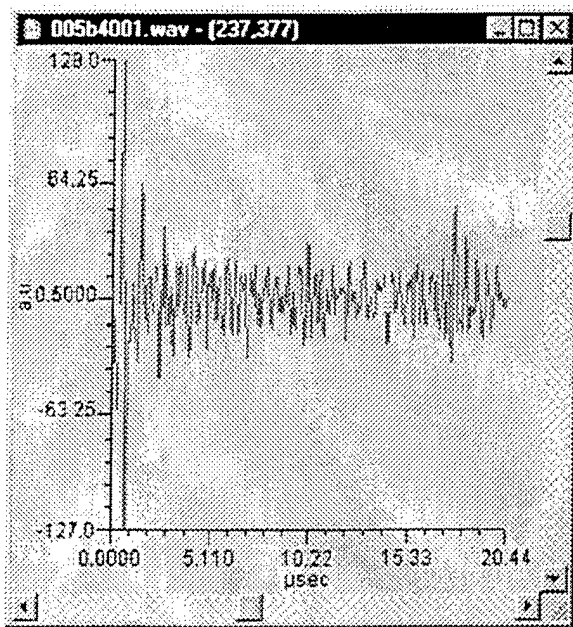
Figure 4.2-29. Typical waveform from thick sample (A6 near/far test sample)

Finally, when the initial signal-to-noise ratio is low, spatial averaging can be using. The imaging software allows the operator to calculate, at each position in the map, the average value of the waveforms of the N nearest neighbor to the selected position. This is particularly useful for thick samples where the signal to noise ratio is known to be low. Figure 4.2-29 and 4.2-30 shows the same waveform before and after spatial averaging. By adding the waveforms for the N nearest

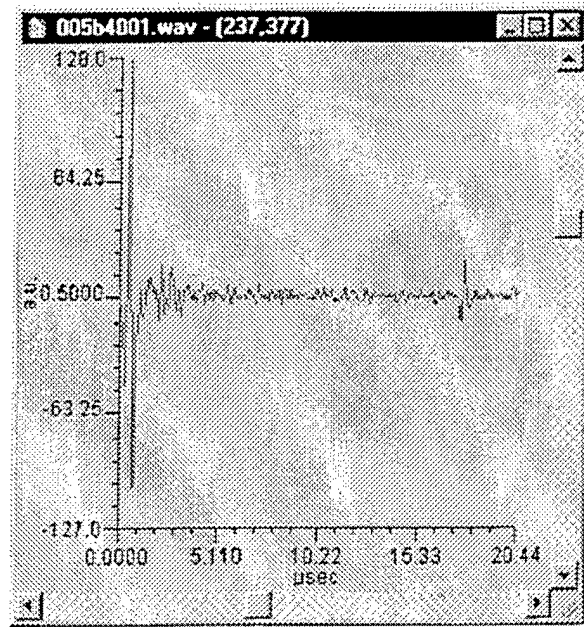
Figure 4.2-30. Waveform from thick sample after spatial averaging (A6 near/far test sample)

neighbors, the signal-to-noise is generally increased by a factor of $(N+1)^{1/2}$. The procedure is highly efficient but reduces the spatial resolution and significantly increases the time to produce an image, in particular if numerical filtering is used. The procedure would be more efficient if such spatial averaging would be possible during the acquisition of the data. Typically, for an average size scan (250 MB of data), using spatial averaging will increase the processing time by a factor of 60, from 2 minutes to 2 hours !

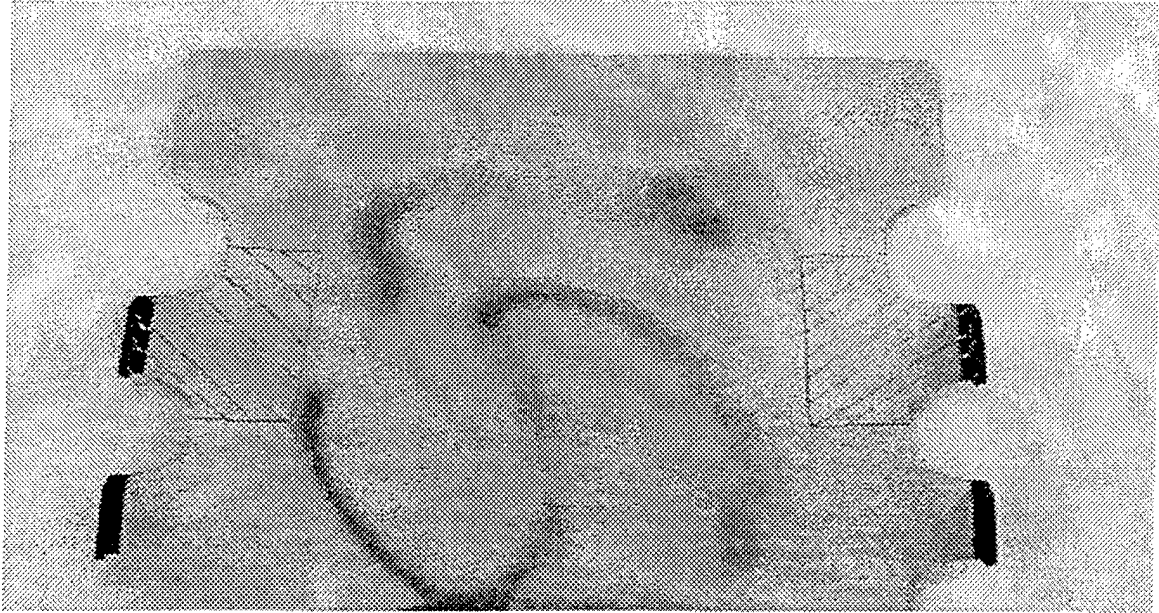
Figure 5.1.5-1. Photograph of 777 graphite composite rib with foreign materials

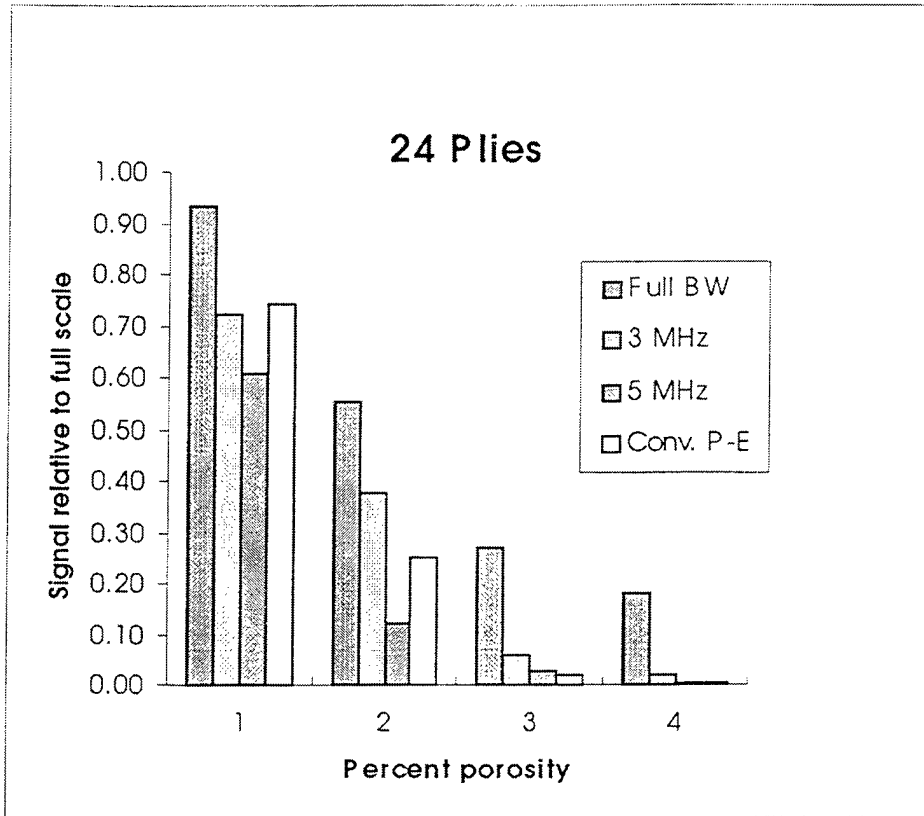
Figure 5.1.13-7. Signal levels for 24-ply thick composite panels with varying levels of porosity

In general, Figures 5.1.13-7 and 5.1.13-8 show that the signal for all bandwidth cases falls with increasing porosity as expected. Signal levels for the LUIS data are consistent with data from the 3.5 MHz conventional transducer. The LUIS 3 MHz centered signal has reasonable correlation to the conventional 3.5 MHz signal, at least at low porosity values. The LUIS full bandwidth signal provides a consistently greater return signal out to the highest porosity values sampled.

Comparison of the C-scans is somewhat complicated by different thresholds, gray levels and ranges in the data. After NIH Image computed the counts per gray scale level for each panel, the average gray scale value was computed for each set of data conditions and for each panel. That is, an average value was computed for the LUIS full bandwidth data and the 1 MHz bandwidth results. The results are shown in charts for 24 ply panels and 32 ply panels as percentages of a computed full, unattenuated signal amplitude.

All 9 panels were scanned at the same set-up conditions. For conventional scans, the instrument gain was set to make the strongest received signal roughly 80% of full screen. For LUIS images, software gates were set to achieve the same purpose.

Software thresholds were set so that the signal from the 1% porosity, 24-ply panel was roughly 90% of "full screen." The same settings were used throughout, resulting in somewhat lower values for the 3 and 5 MHz filtered LUIS images.

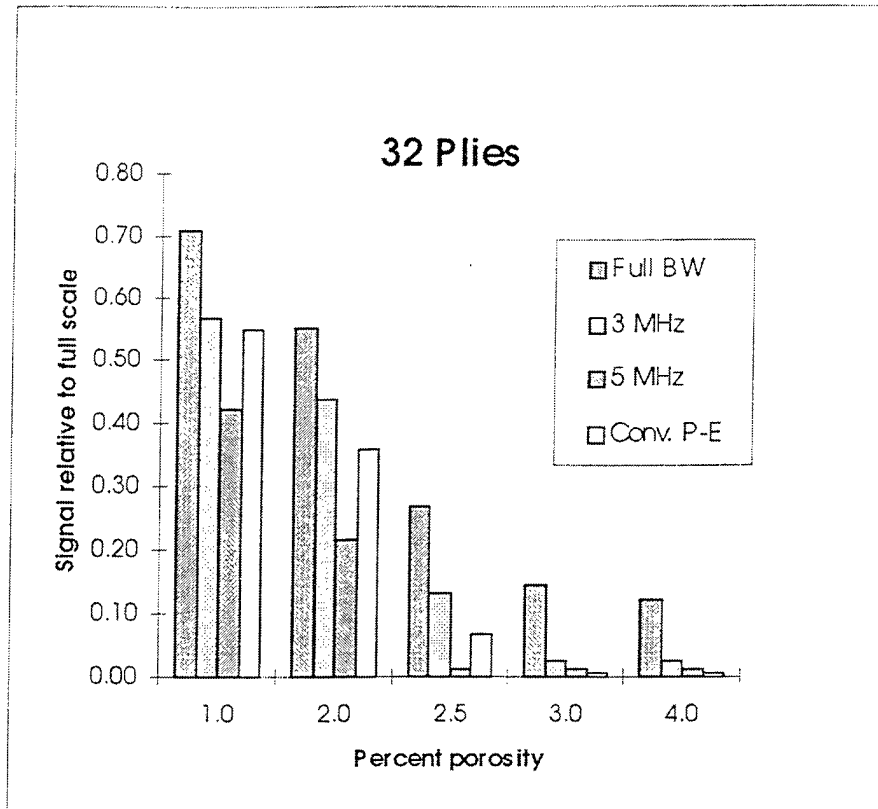
Figure 5.1.13-8. Signal levels for 32-ply thick composite panels with varying levels of porosity.

These results provide confidence that the LUIS can provide reasonable and reliable porosity indications.

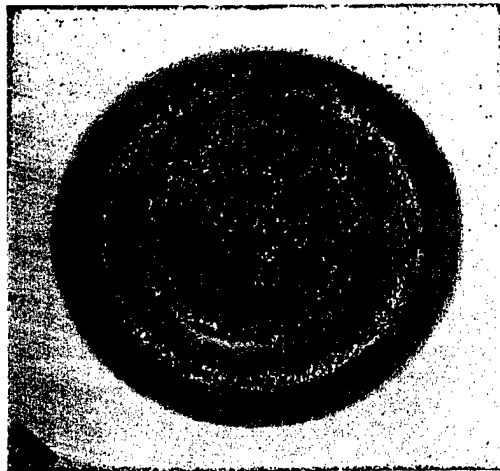
Figure 5.2.11-3 is a TOF image of the standard. This image shows the large insert placed at roughly 9 o'clock between the core and the tool side skin, as well as a smaller one at 6 o'clock. In addition, it shows a small flaw at 8 o'clock, of the same size as the one at 2 o'clock shown in figure 1, which may also be seen in this figure as well. Two larger inserts on the scarf are seen at 4 o'clock and 10 o'clock.

Figure 5.2.11-3. LUIS TOF image of repair standard

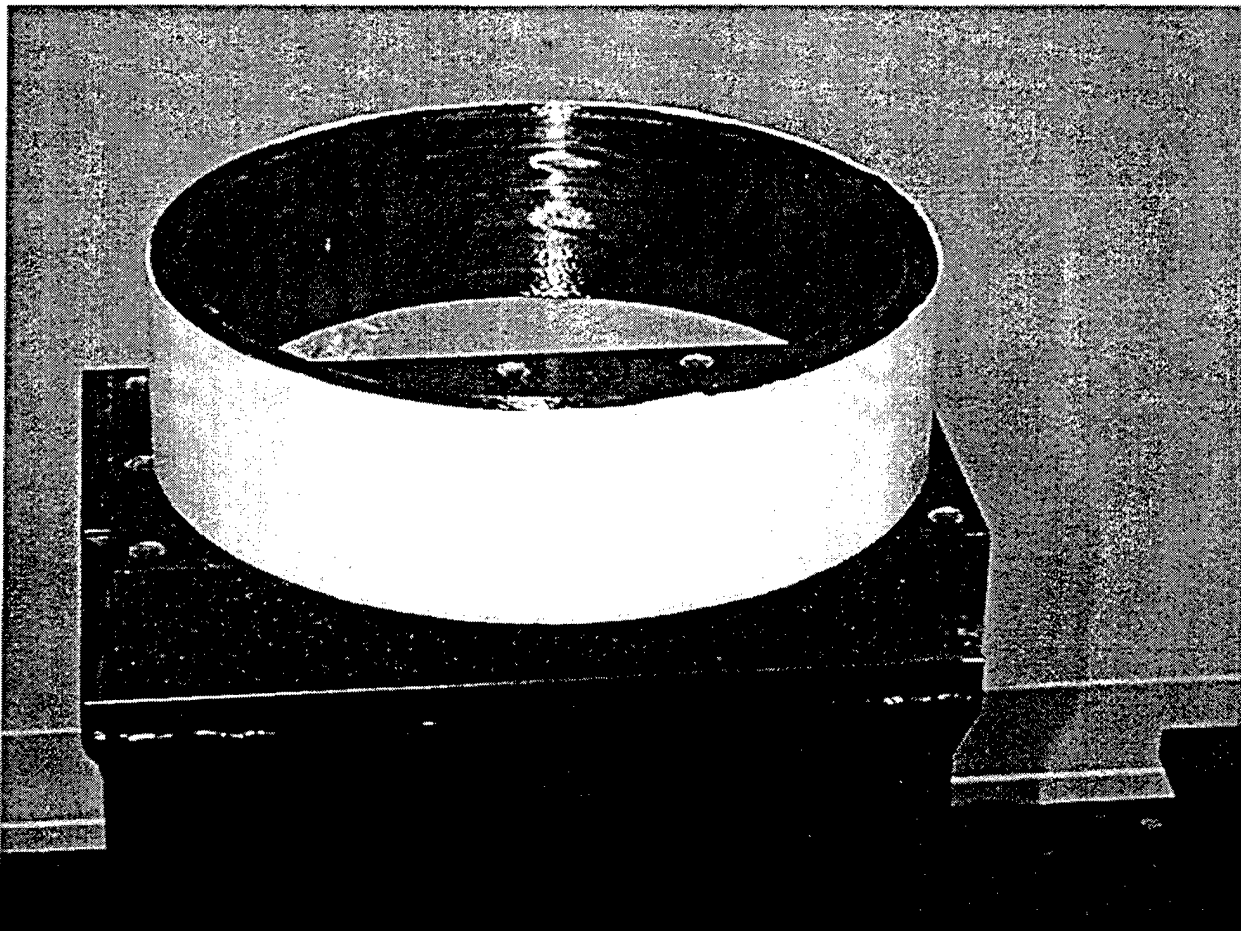
This part was constructed for purposes of storing energy on spacecraft. It is an annular ring approximately 16 inches in diameter, 5 inches in length, and $\frac{3}{4}$ inch thick. It is made up like a roll of tape as one continuous piece of prepreg material, which is cured as it is rolled. This particular specimen showed several regions of delamination when inspected by computed tomography. A photograph of the flywheel positioned for scanning with the LUIS flywheel is shown in Figure 5.2.16-1.

Figure 5.2.16-1 Composite Flywheel

An initial scan of the ring showed that the LUIS provided poor UT generation efficiency for this part. Despite this fact, scanning was completed to demonstrate the geometric versatility of the LUIS. As seen in the photograph, it is possible to scan the outer surface of the near portion of the

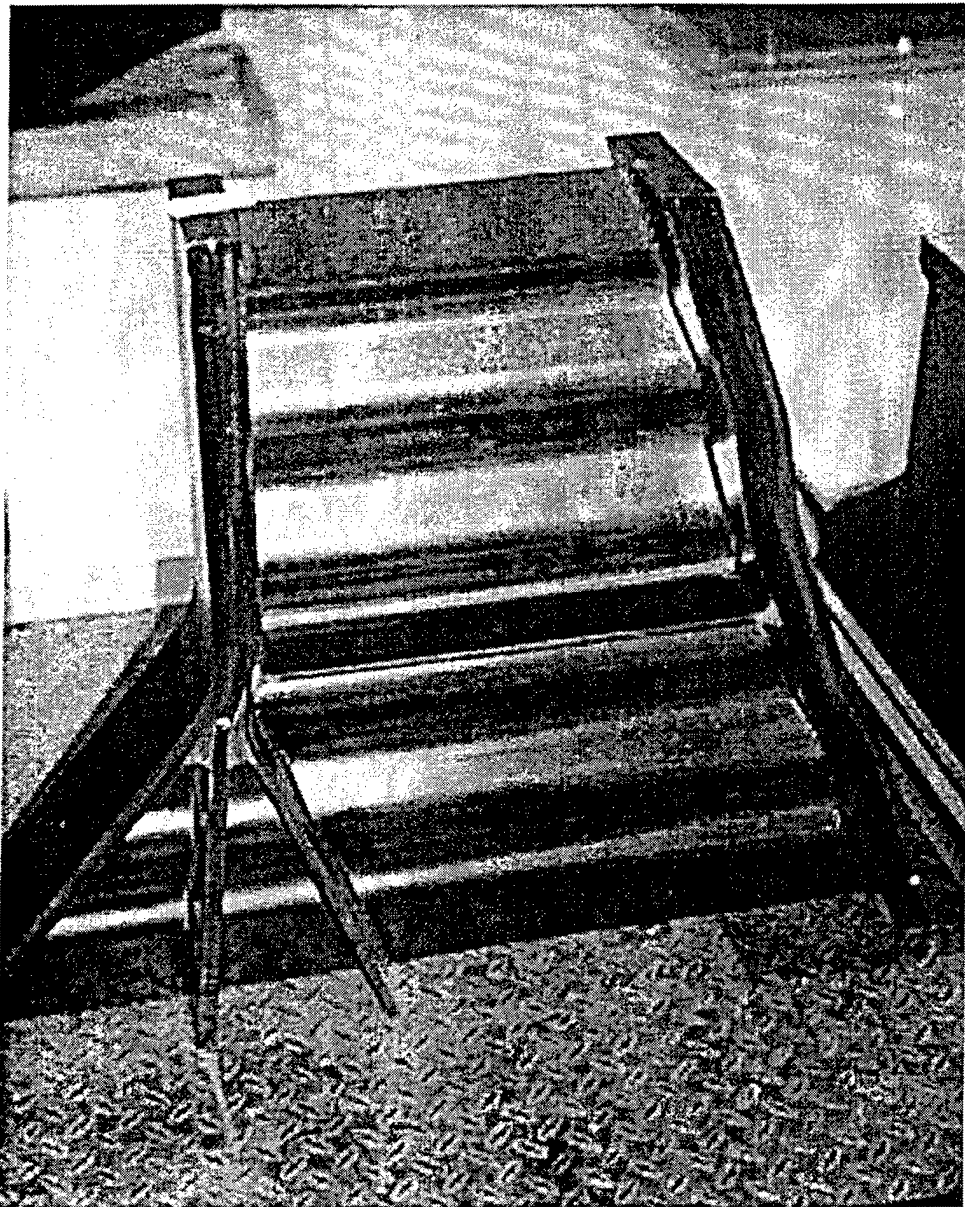
This highly unique part is shown in Figure 5.2.19-1. It is a section of a larger prototype structure for the F-22 program. A quick glance shows the complication of scanning such a part with any sort of device. Only a non-contact method such as Laser UT has a chance of scanning the whole part. There are widely varying thicknesses, two different thicknesses of sine wave webbing, various angles, complex bond lines, and at least two tight vertices of about 30 degrees.

Figure 5.2.19-1. A section of a larger prototype structure for the F-22 program

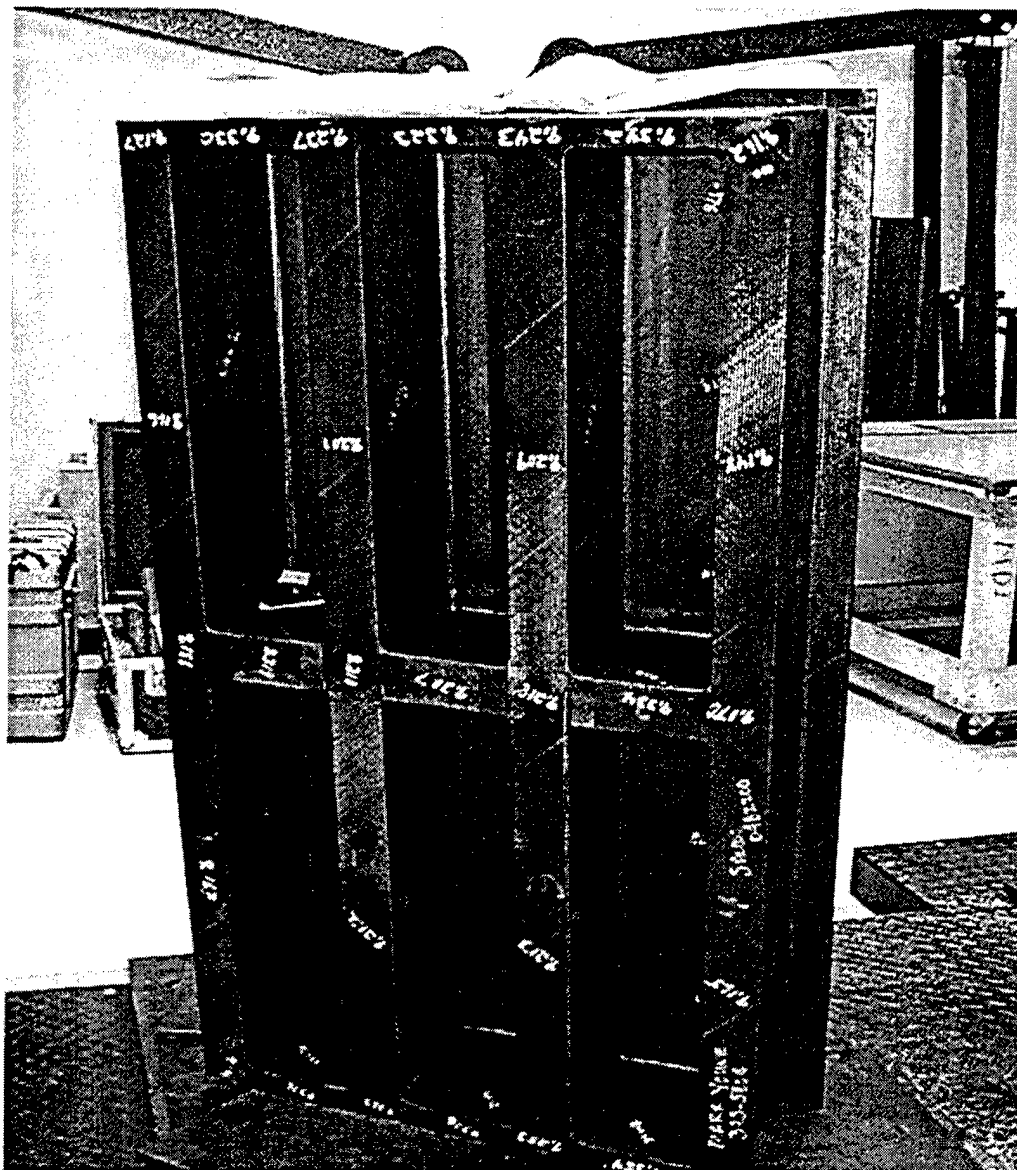
Figure 5.2.20-1. Integral wing box prototype

Current trends are towards making larger and larger composite portions of airframes. The prototype one piece wing box pictured in figure 5.2.20-1 is a good example demonstrating this trend. The entire part is cured as one piece. This of course causes more dependence on quick and comprehensive NDE. It is easy to see the large number of scans required of a hand held or robotically controlled scanner. There are 48 interior three-dimensional corners, 48 interior right angle intersection lines, 11 panels, and the back surface that would need to be inspected.

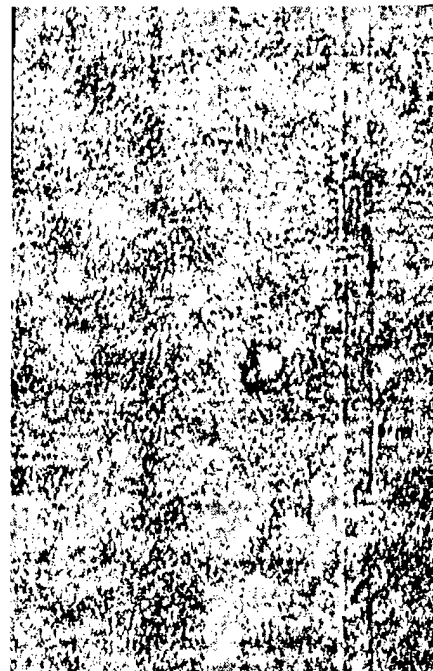
Figure 5.2.23-1. LUIS amplitude C-scan Figure 5.2.23-2. production amplitude C-scan

This sample is a "half pipe" section of a cylinder about three feet in diameter, and one and one half feet high. It is made of fiberglass skin about one eighth inch thick, with a special honeycomb core made of a brittle glass-like material called "e glass. The section was given two different types of damage. In one place it was hit with a hammer and in another it was subjected to compression through its thickness with a C-clamp. An amplitude C-scan of the area including the damage is shown in figure 5.2.23-1. It is easy to see the larger hammer blow, which is the lower of the two features. Around this blow is a dashed line made of marking chalk. This has been picked up also in the LUIS scan, as the chalk has a different ultrasound generation efficiency than the fiberglass skin. Figure 5.2.23-2 is a Boeing production scan of the same damage area for comparison.

The upper feature is really the chalk mark around the supposed damage resulting from the compression with the c-clamp. It appears to possibly be damage. However, when the B-scans are inspected, it is clear that all that is seen is the chalk marks. This can be seen by inspecting a series of B-scans shown as figures 5.2.23-3, 5.2.23-4, and 5.2.23-5. Figure 5.2.23-3 is a scan

Finally, figure 5.2.23-6 shows a B-scan taken along a line through a point near the middle of the hammer blow damage (the lower feature in figure 5.2.23-1). This also clearly shows the chalk mark “blips” at the top of the figure.

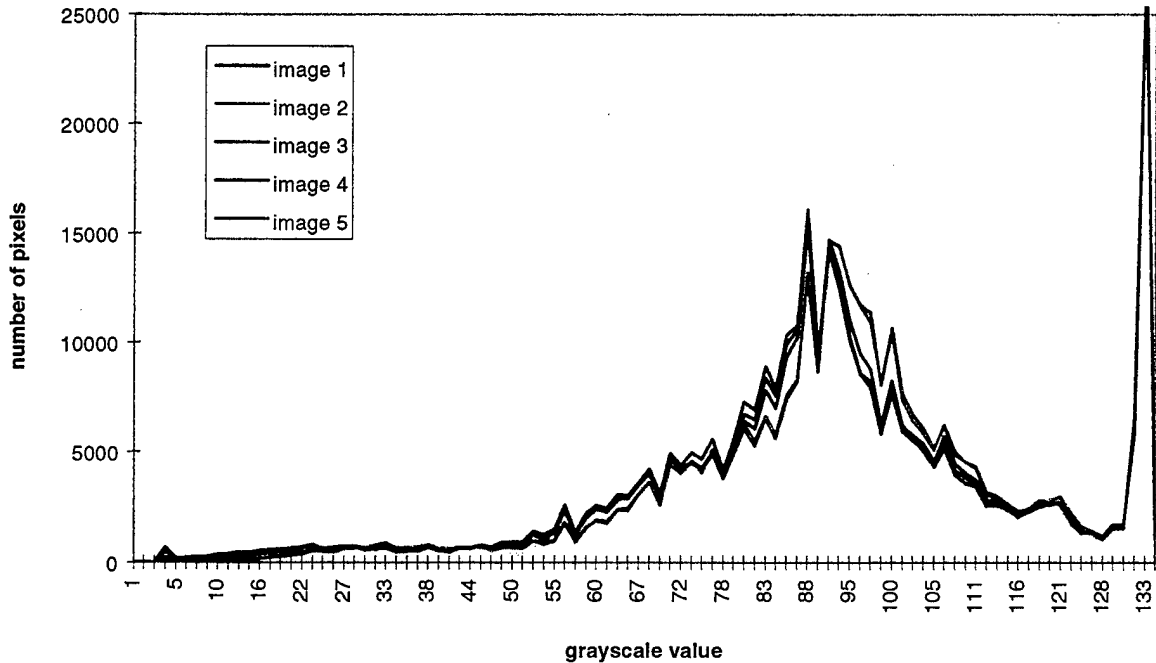
Figure 6.3-6. Histogram of Pixel Gray Scales for Figures 6.3-1 through -5

The eye can pick out some differences in the images in figures 6.3-1 through 6.3-5, but further processing can assist this evaluation. The U.S. Government program NIH Image was used to evaluate the LUIS data images in the figures. NIH Image uses a 256 level gray scale image. The software version employed for this evaluation uses a value of 0 to indicate white and a value of 255 to indicate black. NIH Image provides the ability to count the number of pixels in each gray scale level. This count was taken for each of the 5 images and the gray scale count for each is plotted in Figure 6.3-6. Figure 6.3-6 shows that the gray scale counts are very similar to one another. Although the gray scale of NIH Image extends from 0 to 255, the LUIS images included gray scale values only up to 134 as seen in Figure 6.3-6. This means that no data were taken that were represented by very dark pixels.

The large peak at 133 is due to the large number of pixels representing the dark background outside of the scanned part in the images. Table 6.3-1 shows the mean, standard deviation and range of gray scale counts for each image. These comparisons show that the data collected were remarkably similar, at least in terms of the response for raw numbers of pixels. While this fact is interesting, it is meaningless unless the comparison is among corresponding pixels in each image.
