**THE EFFECT OF DISSOLVED OZONE ON THE CORROSION BEHAVIOR  
OF MONEL 400, MONEL K-500, CDA 706, AND CDA 715 IN  
SEAWATER**

J.H. Stevens and D.J. Duquette  
Rensselaer Polytechnic Institute  
Troy, New York 12180

October 1998

Report No. 5 to the Office of Naval Research  
Contract No. N00014-94-1-0093

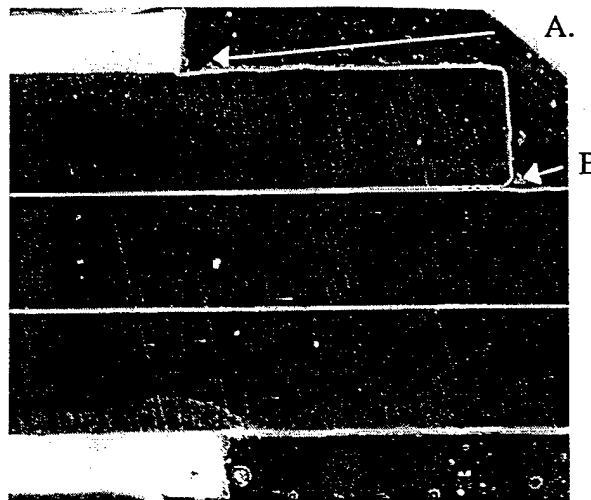
Figure 74 shows the attack typically seen on this alloy, and other alloys in this group. The small trench, at the mouth of both the metal-metal and metal-nonmetal

crevice, seen in this alloy is typical of the localized attack seen in this group of alloys. The white areas are the PTFE washers used to create the metal-nonmetal crevice and isolate the crevice assembly from the bolt and nut, preventing galvanic attack.

Figure 74. Cross section of C-22 crevice assembly exposed for sixty days to ozonated seawater. White areas are PTFE washers while the rest of the areas shown are C-22. A. and B. show attack at the mouths of the crevice. 14X
