Final Phase Runway Visual Range (RVR) /Automated Surface Observing System (ASOS) Interface Operational Test and Evaluation (OT&E) Report

September 1998

DOT/FAA/CT-TN98/18

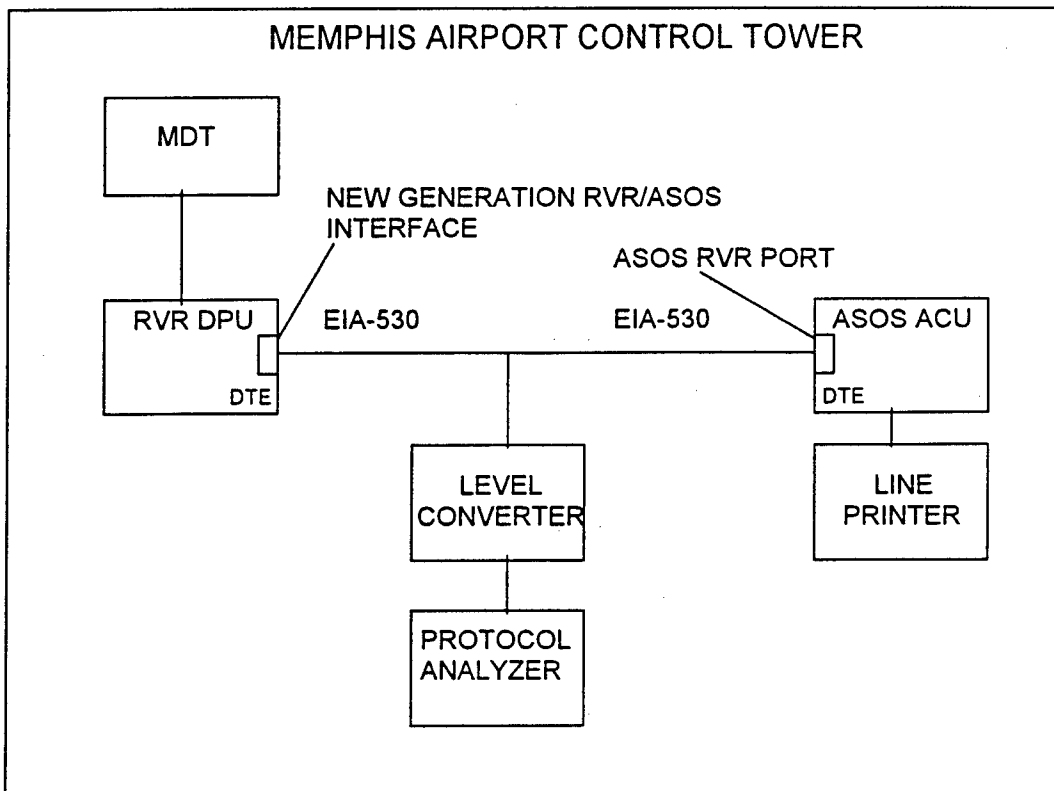
FIGURE 4.5.2.2.1-1. OPERATIONAL PROCEDURE TEST SETUP

Data collection devices, test equipment, and the RVR/ASOS interface were connected as shown in figure 4.5.2.2.1-1.

Test setup for Operational Procedure Test Part 2 remained as shown in figure 4.5.2.2.1-1.

Test setup remained as indicated in the Operational Procedure Test Part 2; however, a protocol analyzer was not required, and as a result, not used.

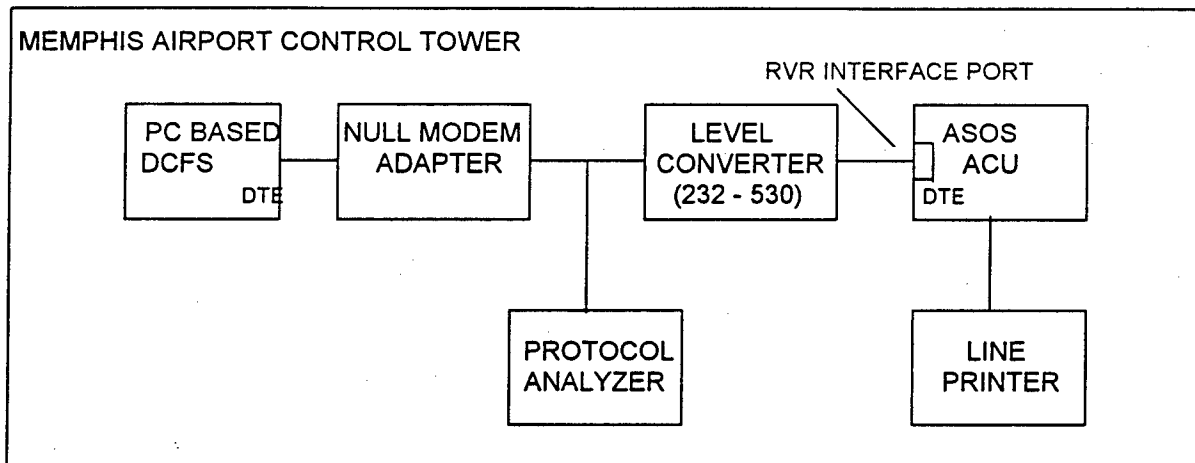
FIGURE 4.5.3.2-1. DATA COMMUNICATION FAILURE TEST SETUP

A PC-based Data Communication Fault Simulator was connected to ASOS as shown in figure 4.5.3.2-1.
