LABORATORY INVESTIGATION OF SCOUR AROUND BRIDGE PIERS

**MRD HYDRAULIC LABORATORY SERIES
REPORT NO. 14**

**MEAD HYDRAULIC LABORATORY
MEAD, NEBRASKA**

**US Army Corps
of Engineers**
Missouri River Division

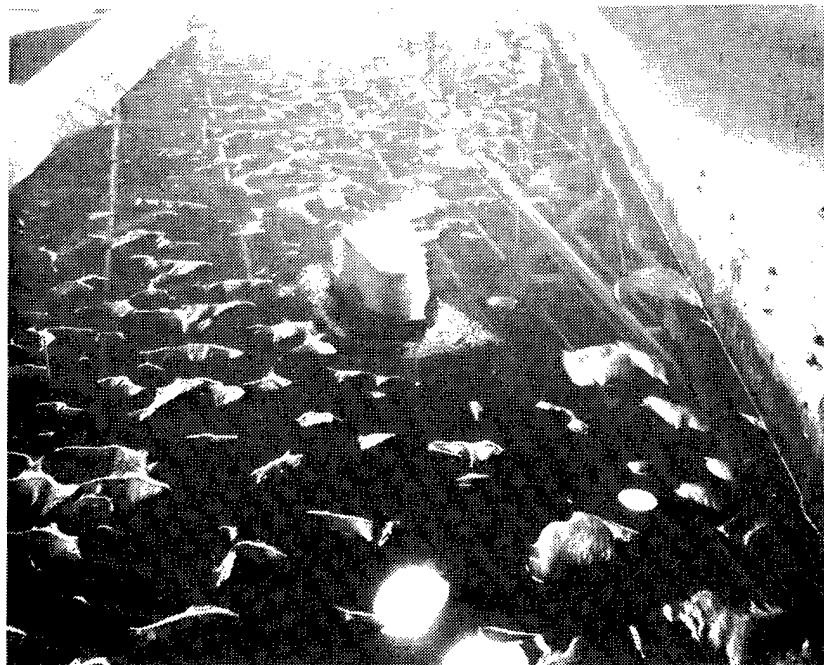
Photo 4. Run 23 looking downstream showing bed configuration at end of run. Bed armor placed at elevation 1.1 or 0.1 ft. below bed level. Note large bar behind pier and exposed stone.

1. Photo 1 - Run 11 looking from the left bank showing bed configuration at end of run with 1:25 horizontal scale pier at 25° angle to the flow.
2. Photo 2 - Run 12 looking downstream showing stone blanket flush with bed (elevation 1.2) before run was started.
3. Photo 3 - Run 13 looking upstream showing bed configuration at the end of run. Bed armor around pier placed at elevation 1.0 or 0.2' below bed. Note scour down to stone and bar d/s of pier.
4. Photo 4 - Run 23 looking downstream showing bed configuration at end of run. Bed armor placed at elevation 1.1 or 0.1 below bed level. Note large bar behind pier and exposed stone.
5. Photo 5 - Run 25 looking downstream showing bed configuration at end of run. Bed armor placed at same elevation as Run 23 (Photo 4) but with velocity increased. Note deep scour on right with large bar behind pier. No failure of stone occurred.
