# **TITLE Aviation Turbine Engine Diagnostic System (ATEDS) for the OH-58D Helicopter**

**Technical Report No.: EDR 18882**

**Development and SGML-Tagging  
of  
Troubleshooting and Diagnostic  
Procedures  
for  
Rolls-Royce Allison  
T703-AD-700 and 250-C30R/3 Engines,  
and 250-C30R/3 FADEC**

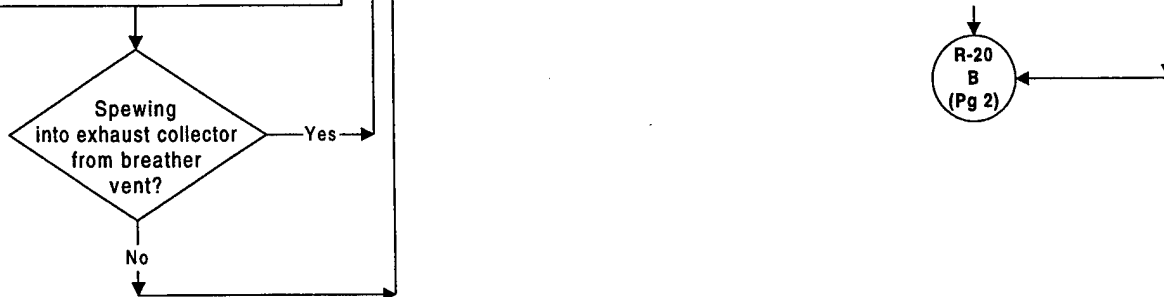
## R-20. Oil Spewing Or Seeping From Gearbox Vent And Tubing Joints

Spewing into the exhaust stream can result from leakage of the lip seal on the centrifugal breather gearshaft, which bypasses the gear and does not benefit from the separating action. Another source is excessive air leakage into the gearbox, from too high compressor seal vent pressure or from worn or damaged turbine seals in cooling air or pressure balance circuits.
