DOT/FAA/AR-99/73

A Benefit Analysis for Nitrogen Inerting of Aircraft Fuel Tanks Against Ground Fire Explosion

December 1999

Final Report

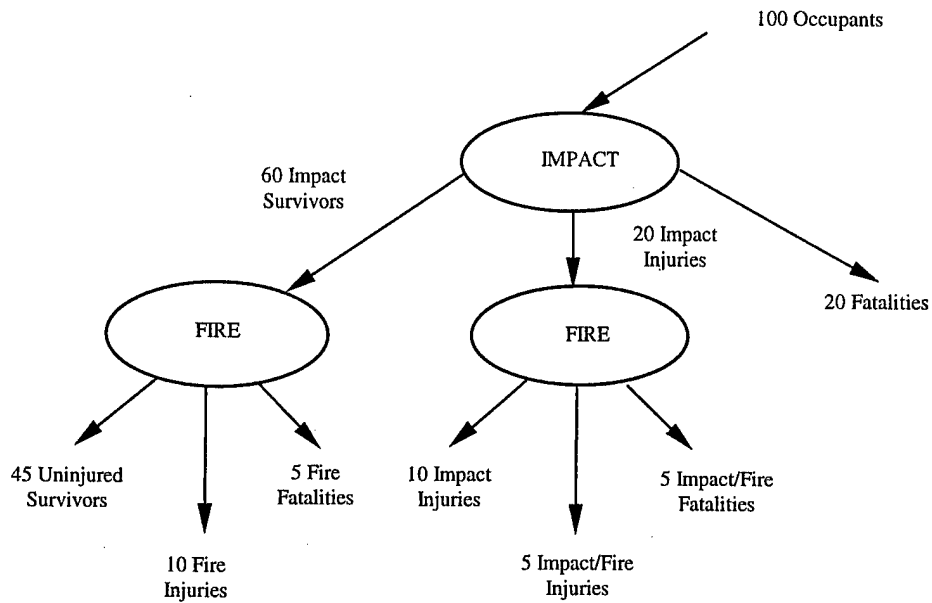
An example of the model and the effects of improvement in injuries and fatalities resulting from nitrogen inerting of fuel tanks are demonstrated in figures 1 and 2. Figure 1 gives a typical survivability chain for a survivable accident scenario.

- 45 uninjured survivors.
- 25 injuries, 10 as a result of the impact, 10 as a result of the fire, and 5 seriously injured as a result of the impact and fire.
- 30 fatalities, 20 as a result of the impact, and 10 as a result of the fire (5 of whom sustained nonfatal injuries from the impact).

FIGURE 1. EXAMPLE SURVIVABILITY CHAIN

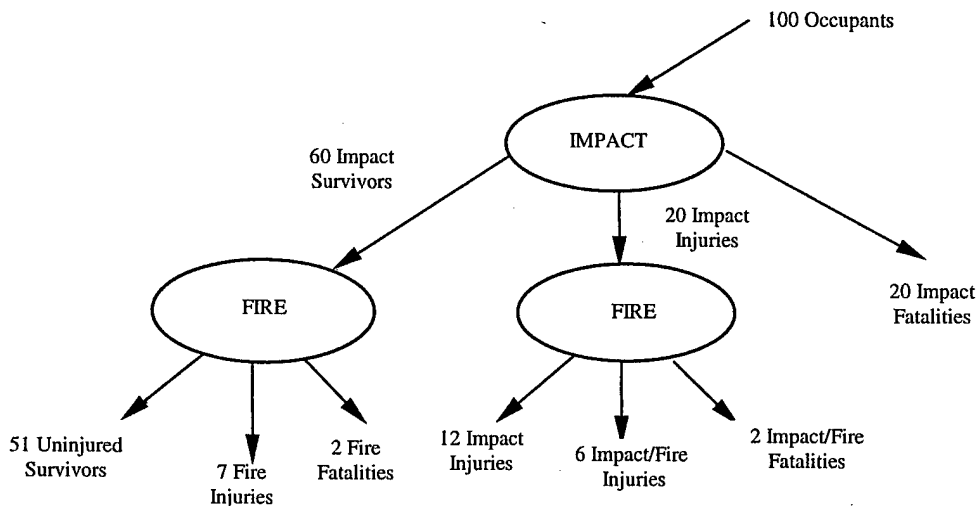
If nitrogen inerting was used in aircraft fuel tanks such that there were now only 2 fatalities and 6 seriously injured of the 20 impact injured occupants, and only 2 fatalities and 7 seriously injured of the 60 impact survivors, then the survivability chain becomes as shown in figure 2.

FIGURE 2. EXAMPLE OF SURVIVABILITY CHAIN SHOWING POSSIBLE IMPROVEMENTS IN SURVIVABILITY AS A RESULT OF NITROGEN INERTING

Therefore, the results in improvement through nitrogen inerting of fuel tanks are

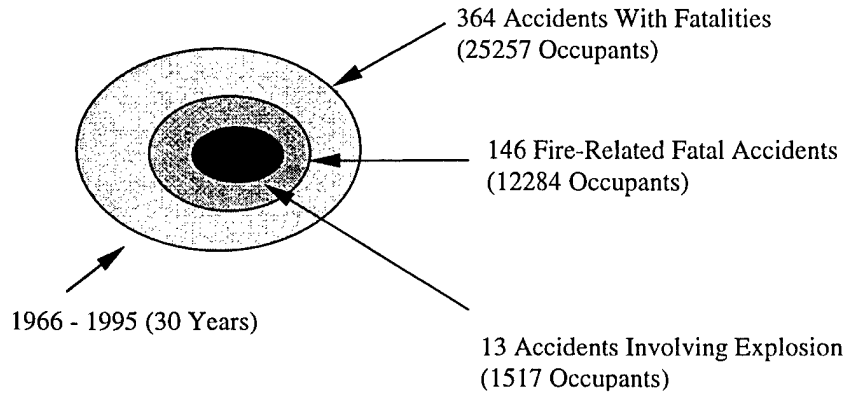
Thirteen accidents were identified as matching the selection criteria in section 3 and were considered appropriate to use for the benefit analysis. Figure 3 illustrates the relationship of these 13 accidents with respect to the 364 fatal accidents in the Survivable Accidents Database.

FIGURE 3. BREAKOUT OF FIRE AND EXPLOSION-RELATED ACCIDENTS

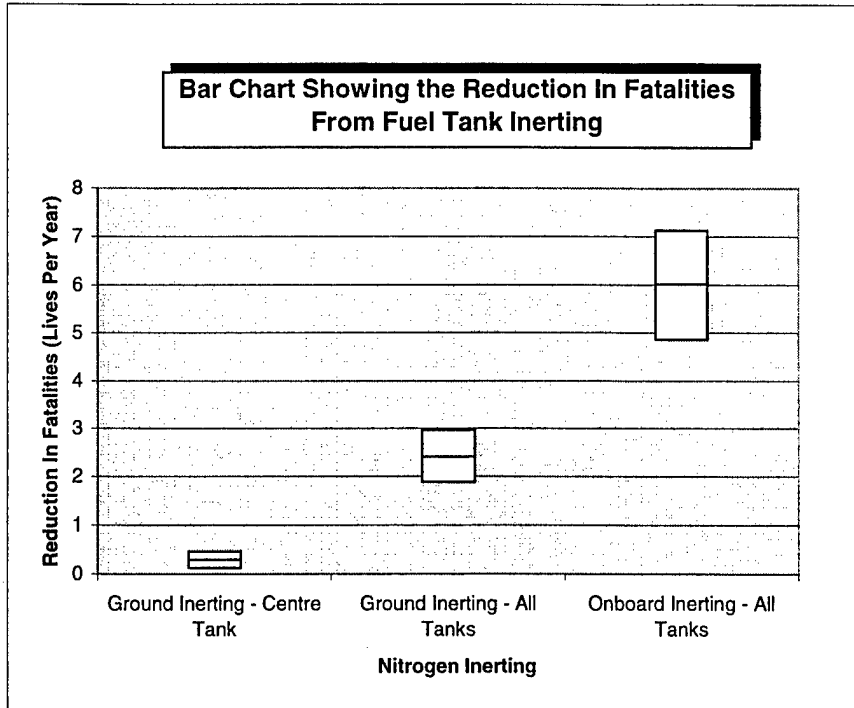
Figure 4. Shows the reduction in fatalities due to the three different nitrogen inerting methods considered together with the 95 percentile range for the prediction.

FIGURE 4. NUMBER OF LIVES SAVED PER YEAR

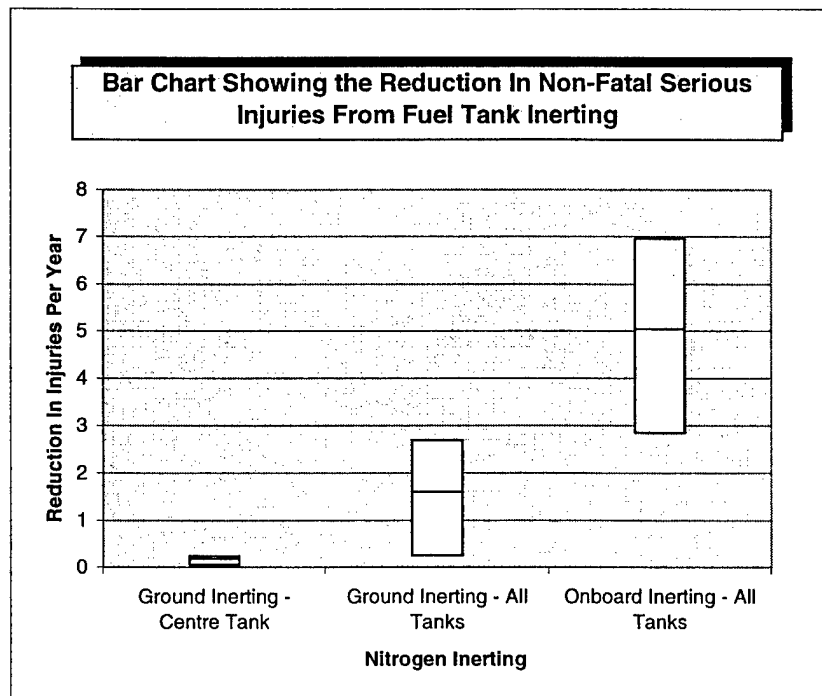
Figure 5 shows the reduction in number of injuries due to nitrogen inerting systems together with the 95 percentile range for the prediction.

FIGURE 5. REDUCTION IN FATAL AND SERIOUS INJURIES PER YEAR

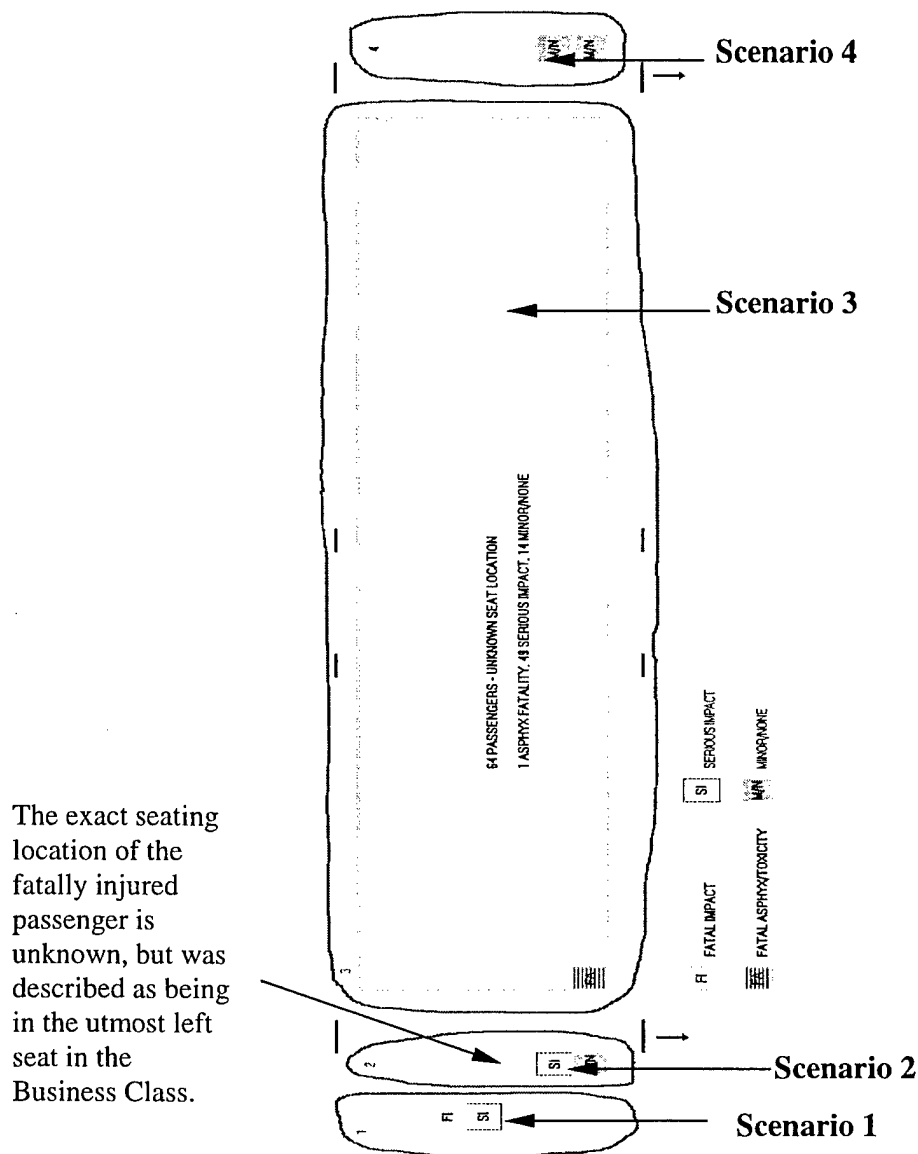
Photographs taken at the scene of the accident indicated that the centre fuel tank exploded; a large hole was created in the cabin floor at the location of the central fuel tank.

This accident is divided into four separate scenarios, as shown in figure A-1.

Figure A-1. Location of Injuries and Scenarios

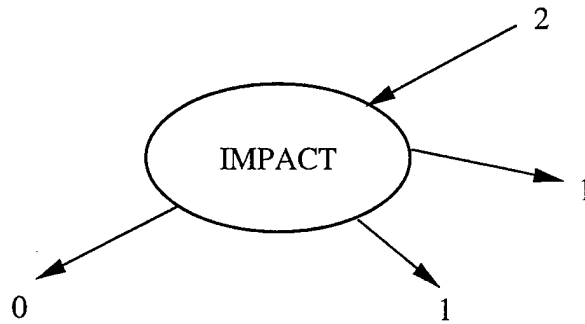
Scenario 1 contains the flight deck area where 1 flight crew died and the other sustained serious injuries from the impact.

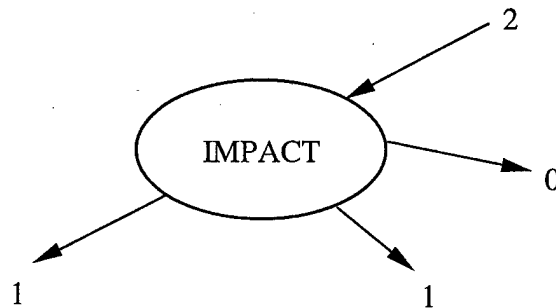
Scenario 2 contains the forward flight attendant area where only the chief steward sustained serious injuries from the impact. This scenario contains two flight attendants.

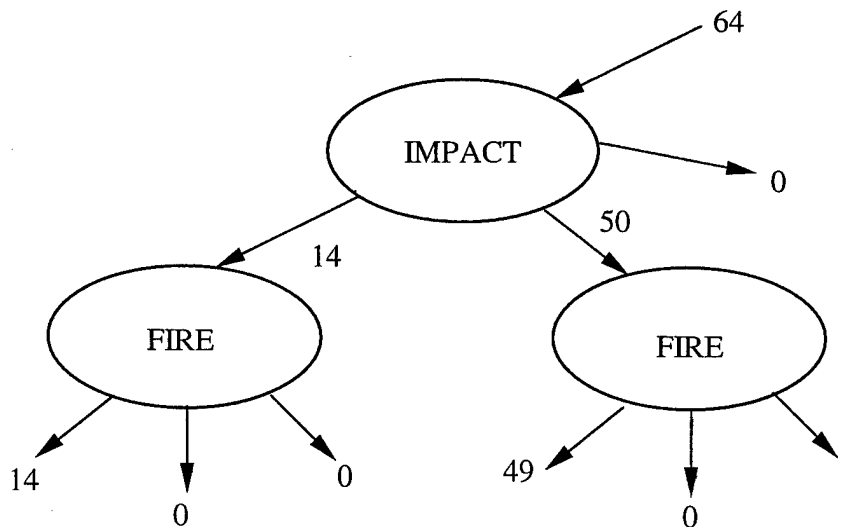
Scenario 3 contains the whole passenger cabin. This has been used because of limited detail on passenger locations during the accident. This scenario contains all 64 passengers. From the injury profile, apart from the fatally injured passenger, it was assessed that the 49 passengers received serious injuries as a result of the impact.

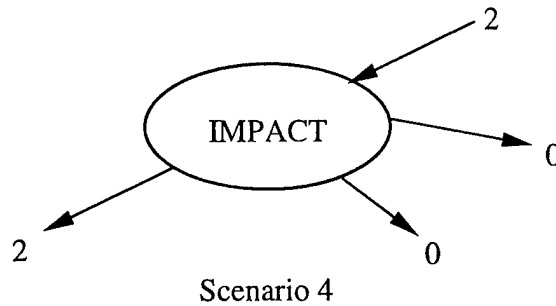
Scenario 4 contains the rear flight attendant area where the two flight attendants received minor or no injuries from the impact.

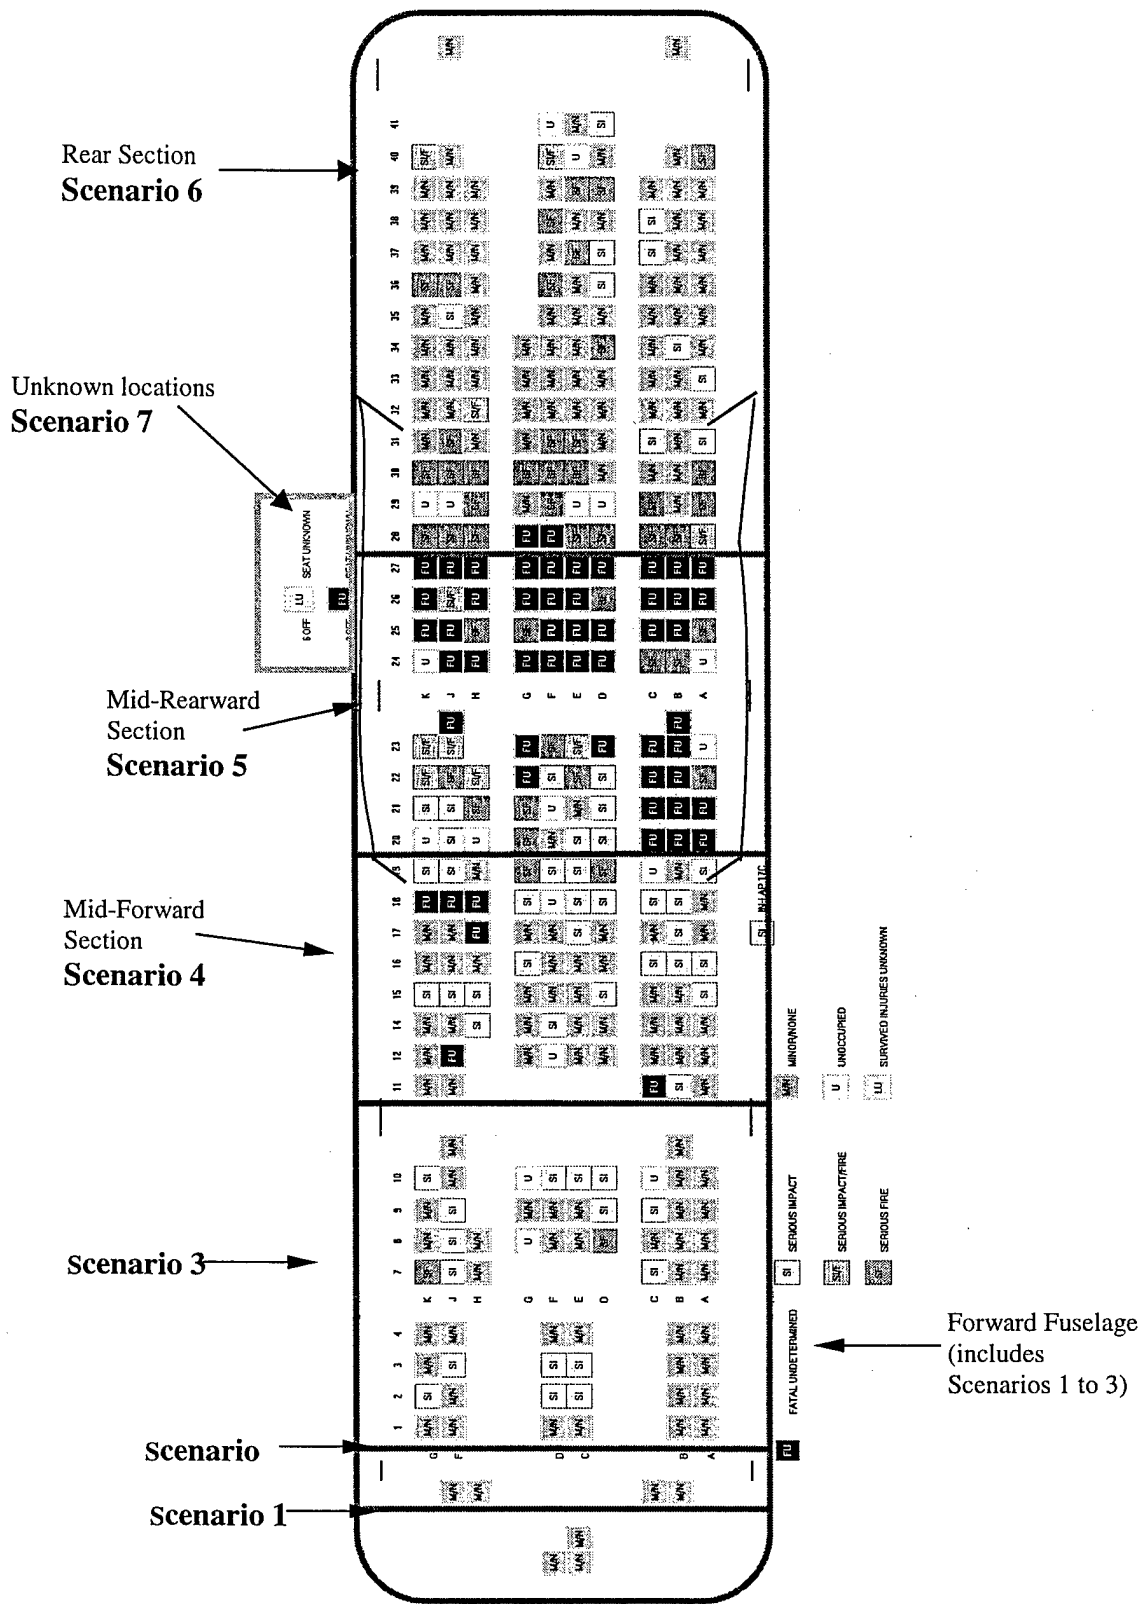
This accident is divided into six separate scenarios, as shown in figure A-2. Scenarios 3 to 6 are bounded by the fuselage ruptures.

Figure A-2. Location of Injuries and Scenarios

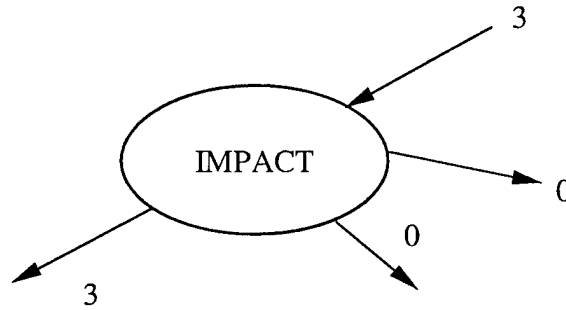
Scenario 1 contains the flight deck area which was subjected to the impact and was not fire damaged. This scenario contains the 3 flight crew.

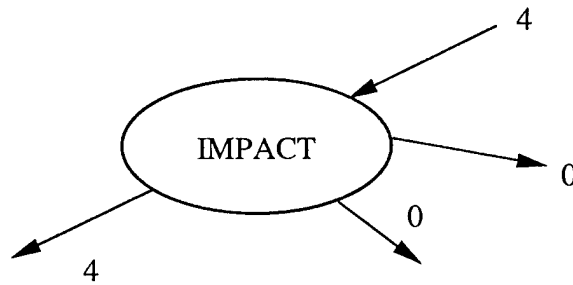
Scenario 2 contains the forward flight attendant area and encompasses four flight attendants, none of whom sustained serious or fatal injuries.

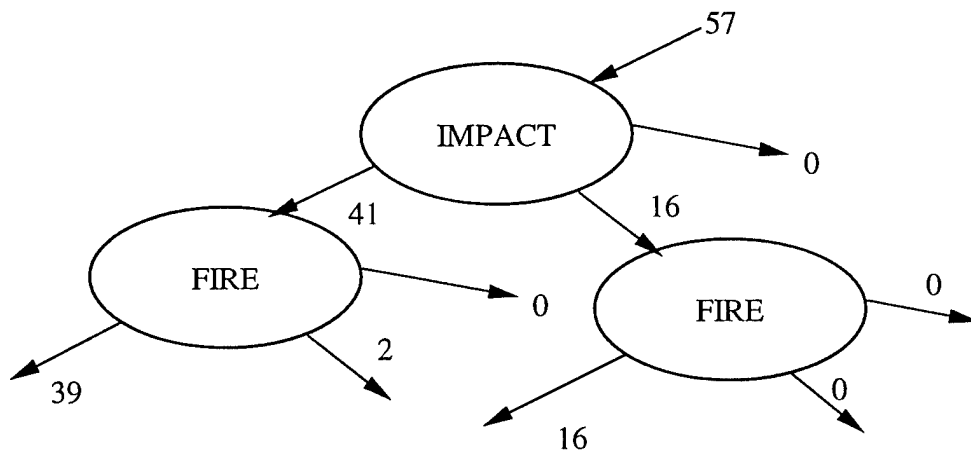
Scenario 3 contains the forward fuselage, seat rows 1 to 10, which was subjected to the impact and was not fire damaged. This scenario contains 2 crew and 55 passengers. A total of 2 passengers in this scenario sustained serious fire injuries in the accident, presumably the injuries were caused by the fire outside the cabin during the evacuation.

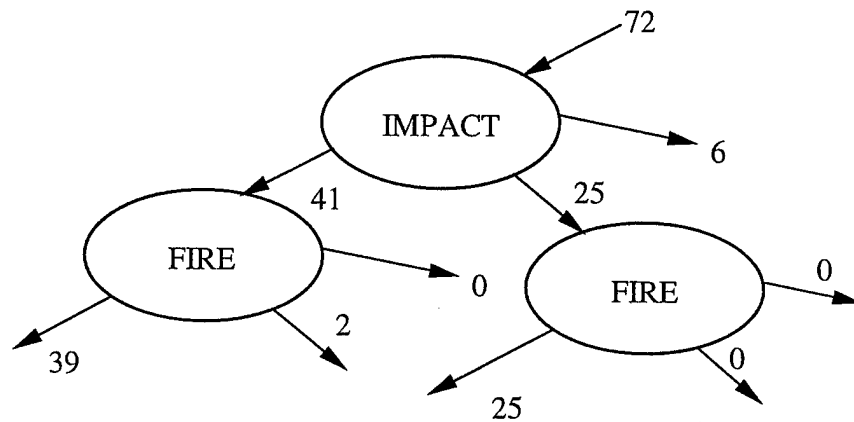
Scenario 4 contains the mid-forward section, seat rows 11 to 19, which was subjected to the impact and was not fire damaged. This scenario contains 72 passengers. This section contained no fire during the accident, therefore, it is assumed that the 6 occupants were killed by the initial impact. This is also supported by the fact that a large number of the occupants in this section were ejected during the impact. A total of 2 passengers suffered serious injuries from fire but they were located at a fuselage break and it is assessed that either the fire spread locally across the join or they sustained injuries during egress.

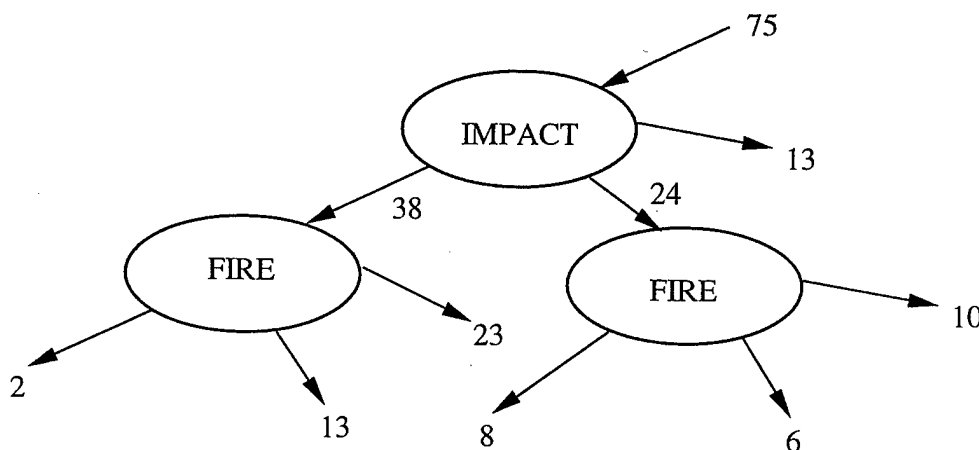
Scenario 5 contains the mid-rearward section, seat rows 20 to 27, which suffered explosion and fire after the initial impact. This scenario contains 2 crew and 73 passengers. It was reported that some of the passengers died as the fuselage split, and it is therefore assumed that 13 of the undetermined fatally injured passengers, located along the joins, were killed by impact trauma or were thrown out. Of the remaining 33 fatalities, the 2 flight attendants were known to be killed from the fireball. Of the remaining 31 undetermined fatalities, it is assumed that seat rows 21 to 23 suffered impact injuries and then fire death, and seat rows 24 to 26 killed by fire only.

It was assessed that under the worst condition (high assessment) only the fatalities in rows 23 and 24 and the 2 flight attendants might have been saved. The median assessment is that the 6 passengers in rows 24 to 26 on the right-hand side succumbed to the fire that was entering in that area. The low assessment is that all fire fatalities and injuries were eliminated.

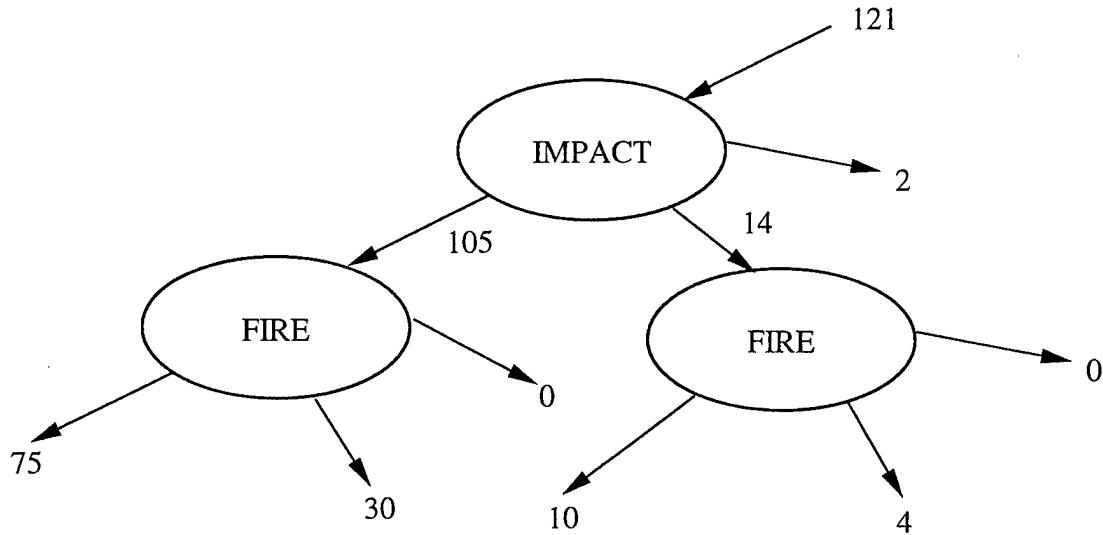
Scenario 6 contains the rear section, seat rows 28 to 41, and the rear flight attendant area, which was subjected to fire after the initial impact. The scenario contains the 2 crew and 119 passengers. It is assumed that the 2 occupants seated in row 28F and G were killed by impact trauma as the fuselage split into sections.

It was assessed that under the worst condition (high assessment) only the fire injured in seat rows 28 to 31 might have been saved. The low assessment is that all the fire injured would have suffered lesser injuries. The median assessment is taken the average of the high and the low.

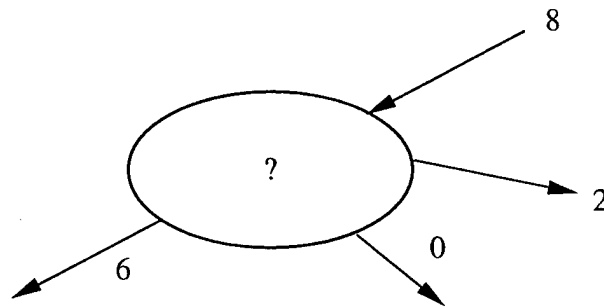
Scenario 7 contains the 8 occupants for which seat location and injury was unknown. Absence of information resulted in the following simplified survivability chain. The 6 unknown injuries have been assumed minor or none since they were not significant enough to be reported officially. It is not possible to determine the cause of death for the 2 fatalities.

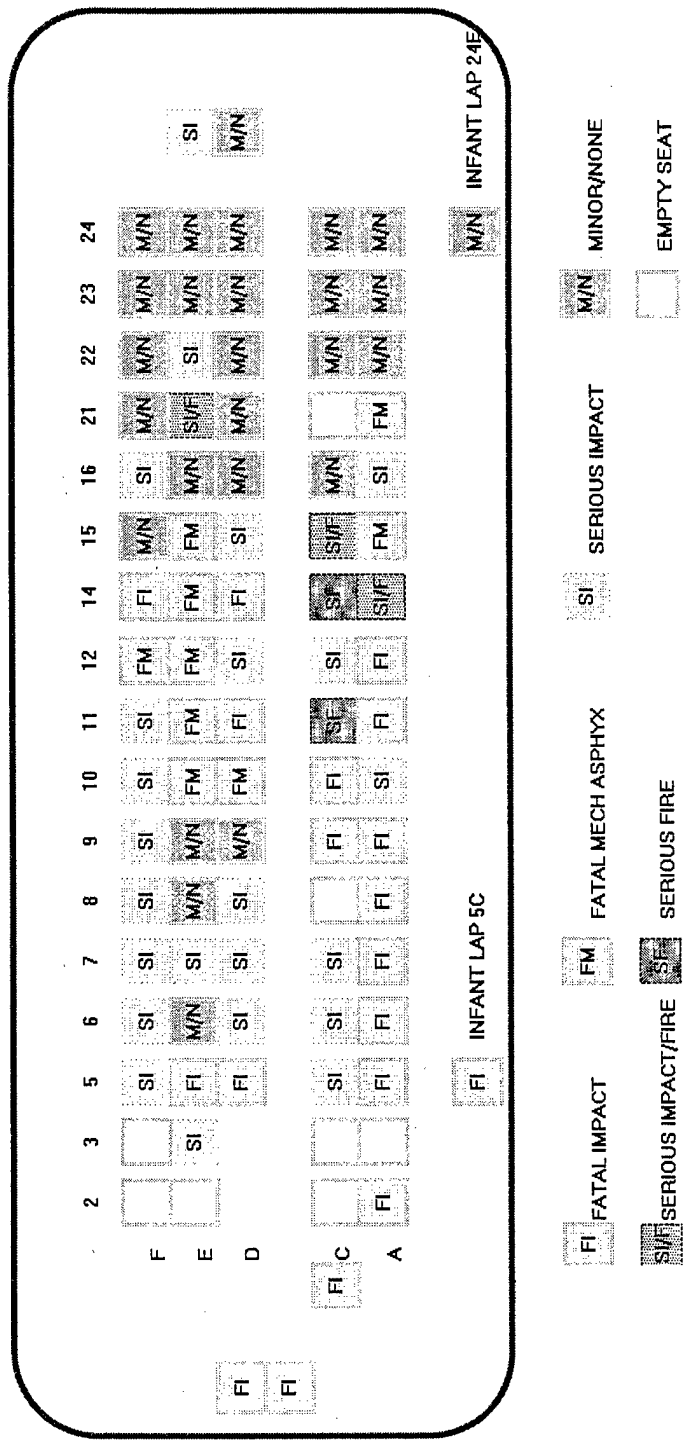
The injury location diagram is shown in figure A-3. All fatalities were as a result of the impact, some of the passengers sustained burns to varying degrees. Whilst this accident could be broken into many scenarios for simplicity, the survivability chain has been drawn for all occupants.

Figure A-3. Location of Injuries and Scenarios

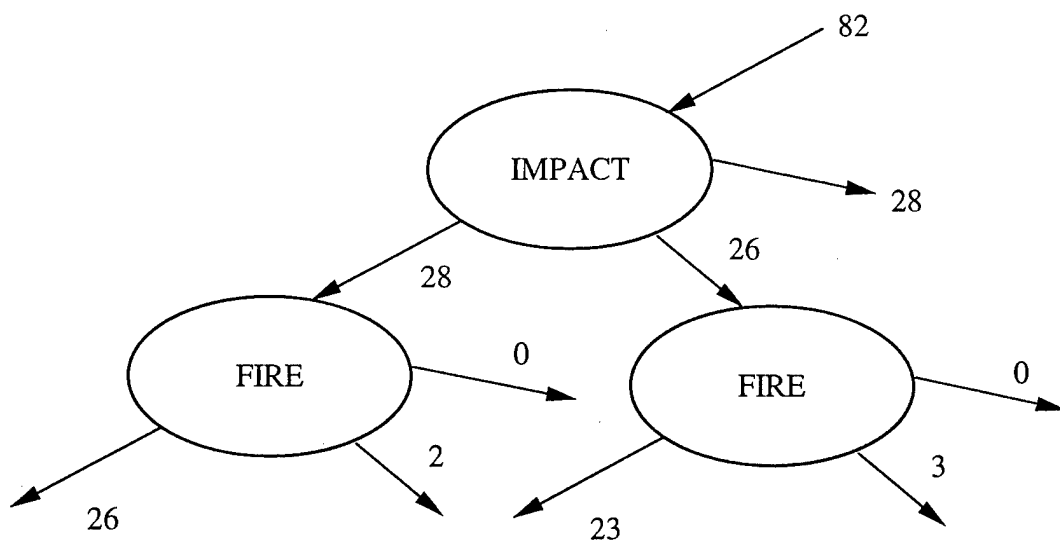
The aircraft and its occupants were subjected to initial impact followed by postcrash fire. There were 5 crew and 77 passengers onboard the aircraft.

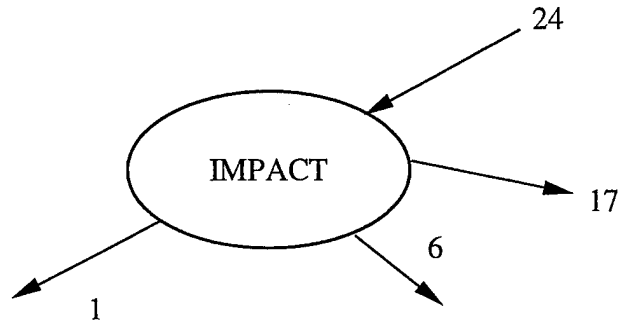
The aircraft and its occupants were subjected to impact followed by a postcrash fire. It was assessed that the 6 seriously injured passengers received their injuries from impact rather than ground fire, since they all had been thrown out of the cabin. In addition, the main fuselage, aft of the wings, and the tail empennage were not damaged by the postimpact fire. There were 2 flight crew, 1 cabin crew, and 21 passengers onboard the aircraft.

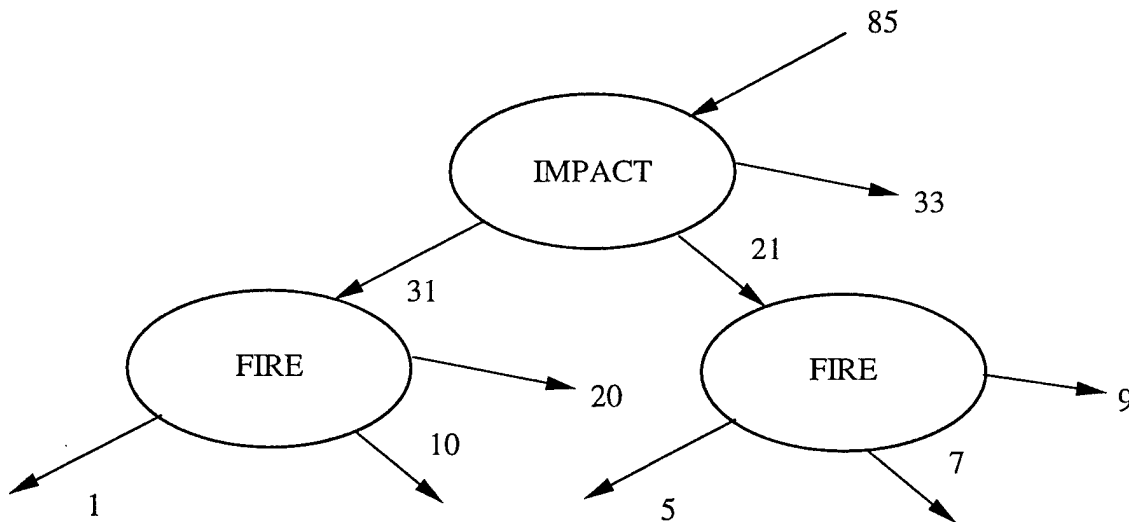
The aircraft and its occupants were subjected to impact followed by postimpact fire. There were 2 flight crew, 2 cabin crew, and 81 passengers onboard the aircraft. It was reported that 20 passengers died from burns and smoke inhalation, 31 passengers and 2 crew died from impact trauma, and 9 passengers sustained impact trauma combined with burning or smoke inhalation. Of the 21 surviving passengers, 4 sustained impact injuries, 10 sustained burn injuries, and 7 sustained a combination of impact and burn injuries. 1 crewmember suffered serious impact injuries. Therefore, the survivability chain is:

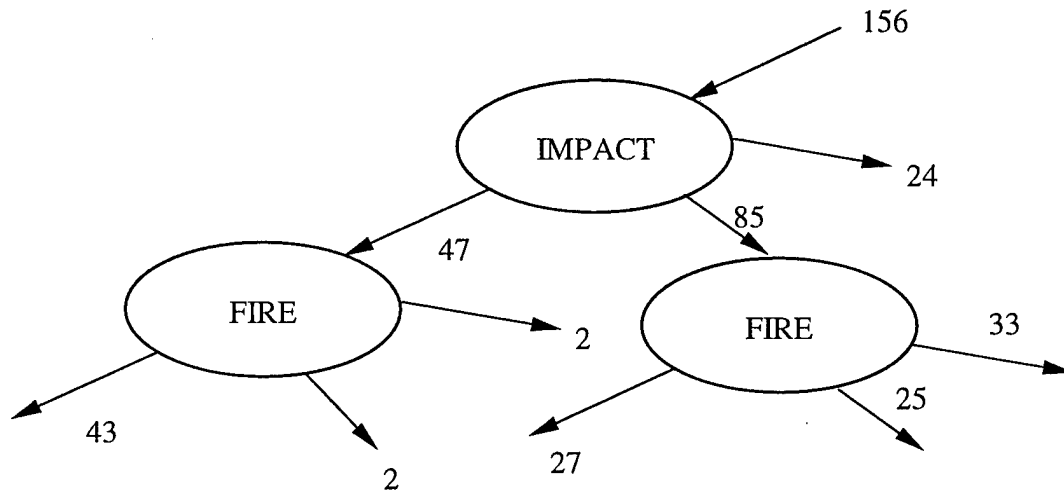
The aircraft and its occupants were subjected to impact followed by postimpact fire. There were 3 flight crew, 14 cabin crew, and 139 passengers onboard the aircraft. Due to the absence of information on the 45 seriously injured passengers, their injuries have been assessed as in the same proportions as known deaths, i.e., impact : impact and fire : fire = 24 : 33 : 2. This results in 18 injured by impact and fire and 2 injured by fire alone.

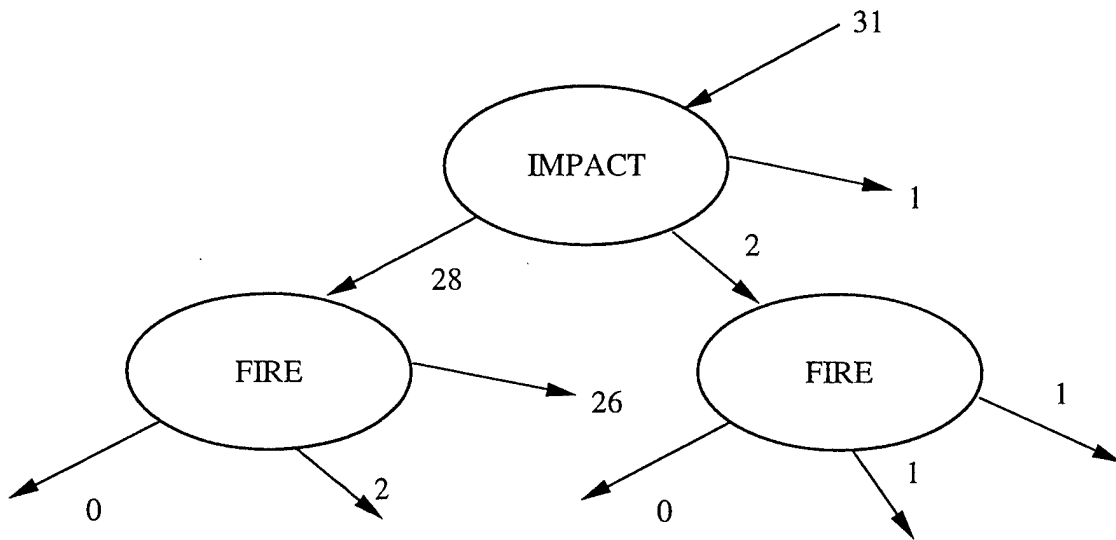
The aircraft was subjected to impact followed by a postimpact fire. There were 2 flight crew, 1 cabin crew, and 28 passengers onboard the aircraft.

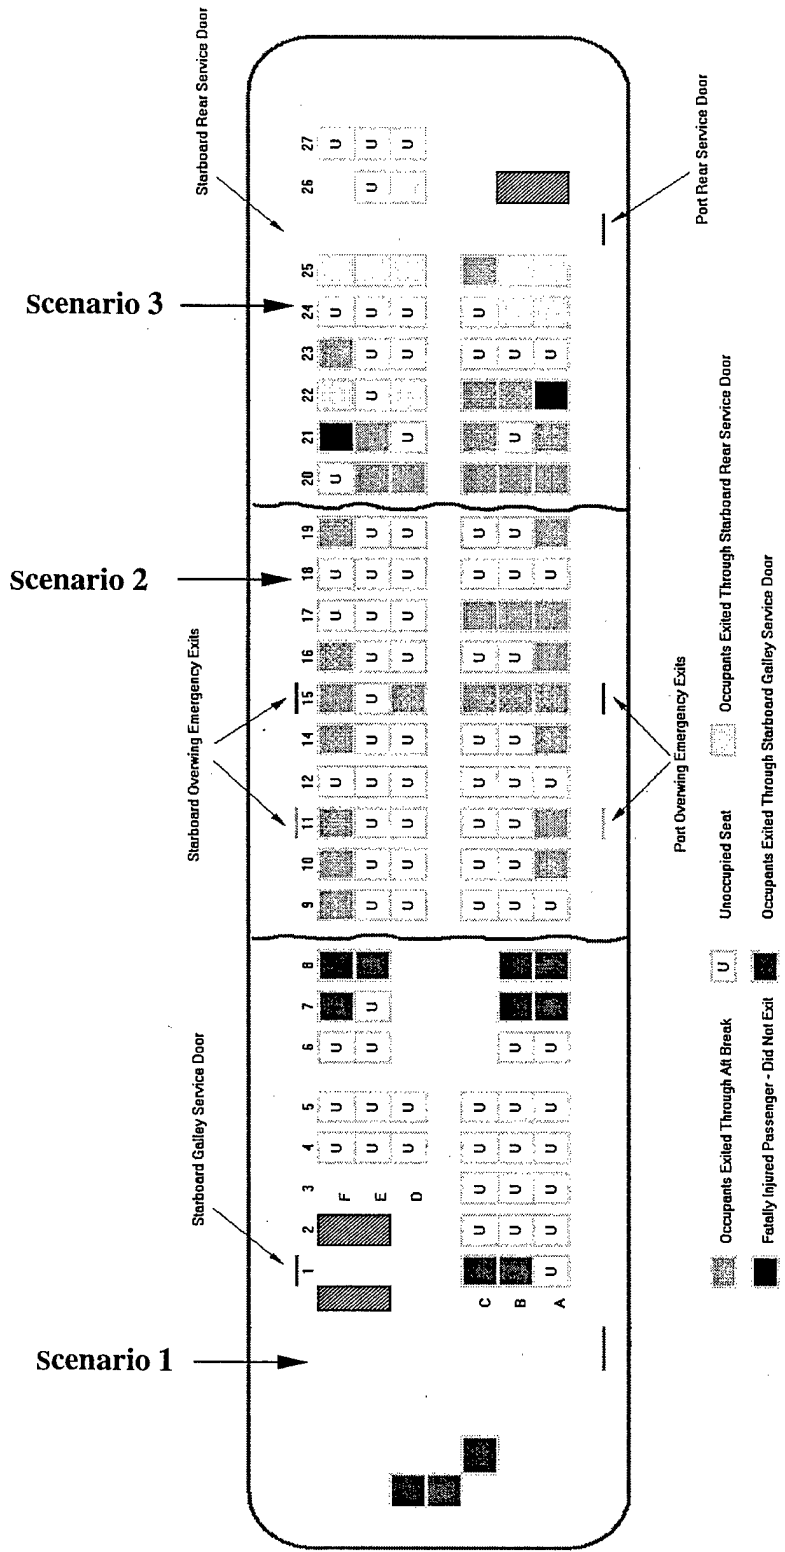
Due to lack of information on injuries to occupants, figure A-4 is the only data available which shows their seat allocation and exit use in the evacuation. Based on this information the accident is considered as three scenarios.

Figure A-4. Occupants Seat Allocation and Exit Use Chart

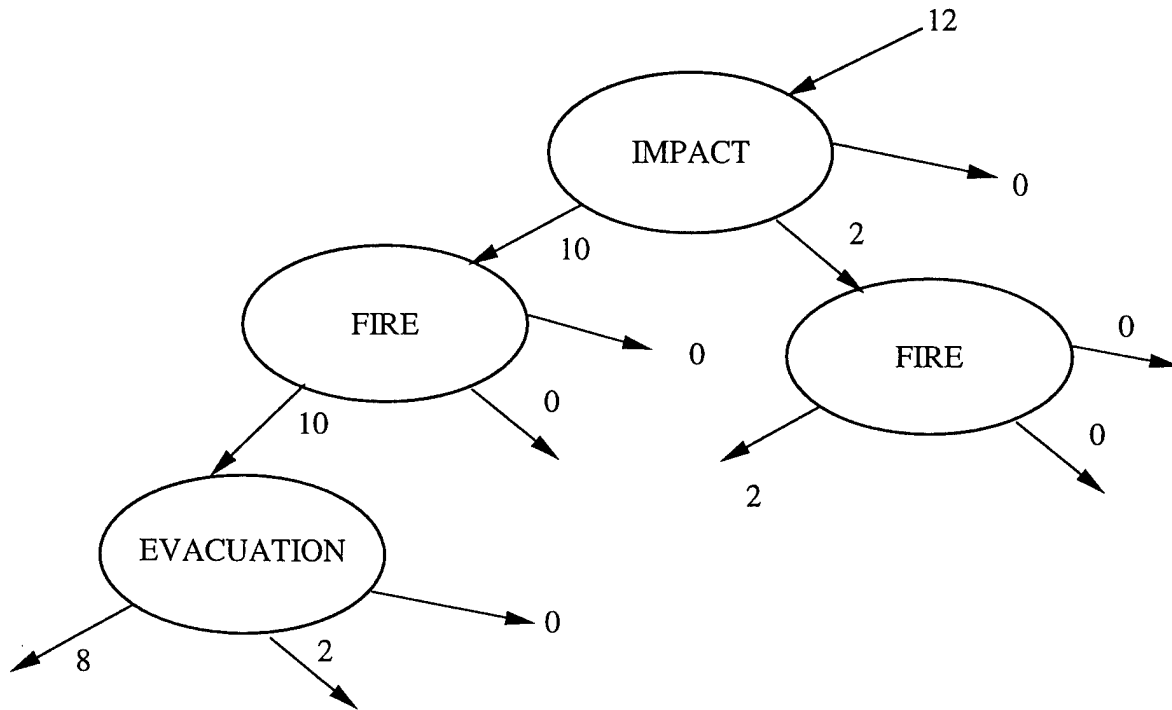
Scenario 1 contains the flight deck area and seat rows 1 to 8. It was subjected to impact and postimpact fire. The scenario contains the 3 flight crew, 2 cabin crew, and 7 passengers. All occupants escaped before a small fire developed into a general conflagration, hence no injuries were due to fire.

The captain and flight engineer suffered serious impact injuries and at least 1 passenger sustained serious injury during the evacuation. It is therefore assumed that 2 passengers were seriously injured during the evacuation when they were using the slide at the forward galley door which was about 6 feet above the ground at the lower end.

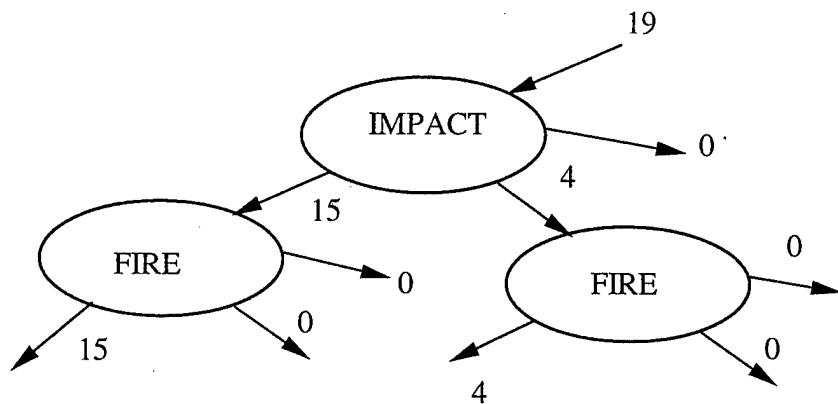
Scenario 2 contains seat rows 9 to 19 which was subjected to impact and postimpact fire. The scenario contains 19 passengers. All occupants escaped before fire hampered the evacuation; therefore, it is assumed that all injuries were as a result of impact forces. Further, seat failures were reported in this area which is consistent with the impact injuries. There were 8 seriously injured passengers between scenarios 2 and 3 which had a similar number of occupants. It is therefore assumed that half (4) of the seriously injured passengers were in each scenario.

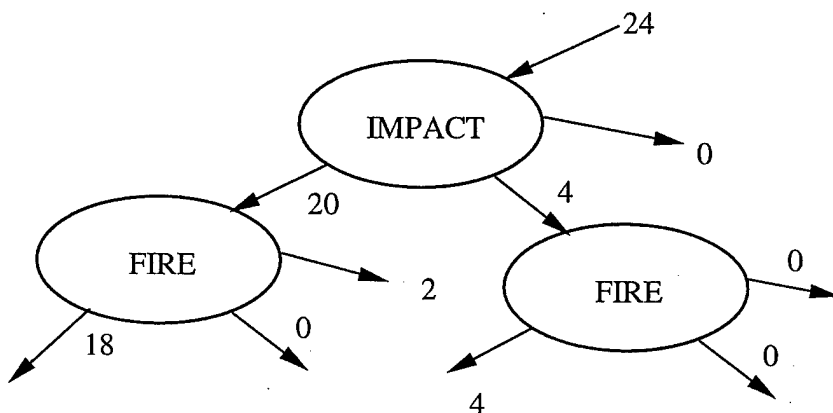
Scenario 3 contains seat row 20 to the end of the aircraft. It was subjected to impact and postimpact fire. The scenario contains the 2 cabin crew and 22 passengers. 2 passengers suffered fatal burns. Following the same logic of Scenario 2, it is assumed that 4 passengers received serious injuries as a result of impact forces.

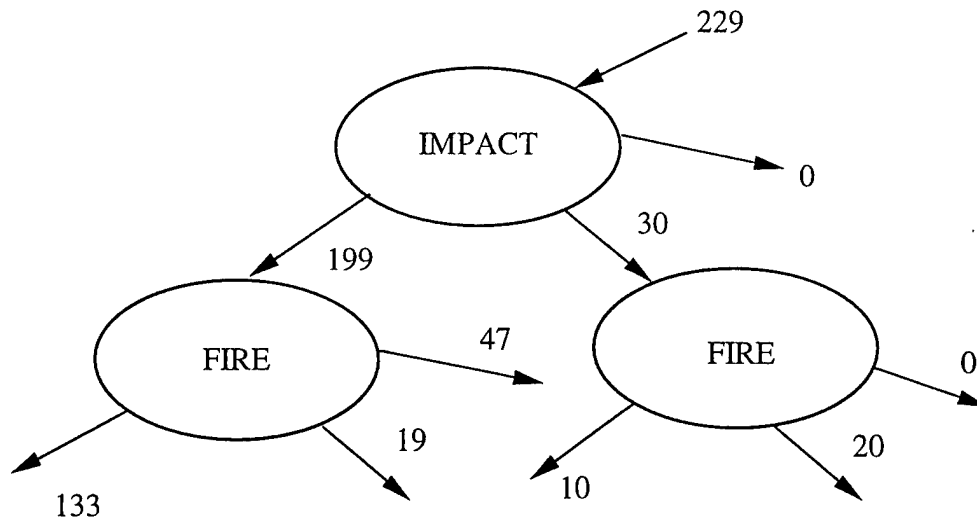
The aircraft and its occupants were subjected to impact followed by postcrash fire. There were 4 flight crew, 6 cabin crew, and 219 passengers onboard the aircraft. 1 flight attendant suffered serious injuries during the impact being thrown from her seat. Some (taken as 4) passengers, having got out of their seats and moving away from the fire, were thrown forward and injured during the impact. 5 passengers were thrown out of the aircraft while still in their seats and are assumed to have suffered serious impact injuries. This leaves 34 passengers and 5 crew with undetermined serious injuries. In the absence of detailed information, it is assumed that half of these suffered burns and half were injured by the impact as well as suffering burns. This results in 17 passengers and 2 crew suffering burns and 17 passengers and 3 crew suffering impact and burn injuries.

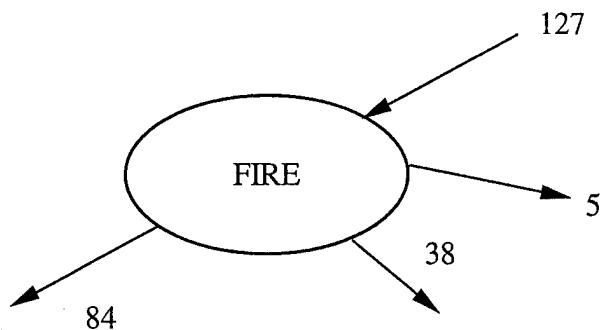
The aircraft and its occupants were not subjected to any impact but fire entered at the rear and propagated forward. There were 5 flight crew, 6 cabin crew, and 116 passengers onboard the aircraft. Because of the extent of the fire on the ground external to the aircraft, it is assessed that all serious injuries suffered during the evacuation were sustained from the fire.

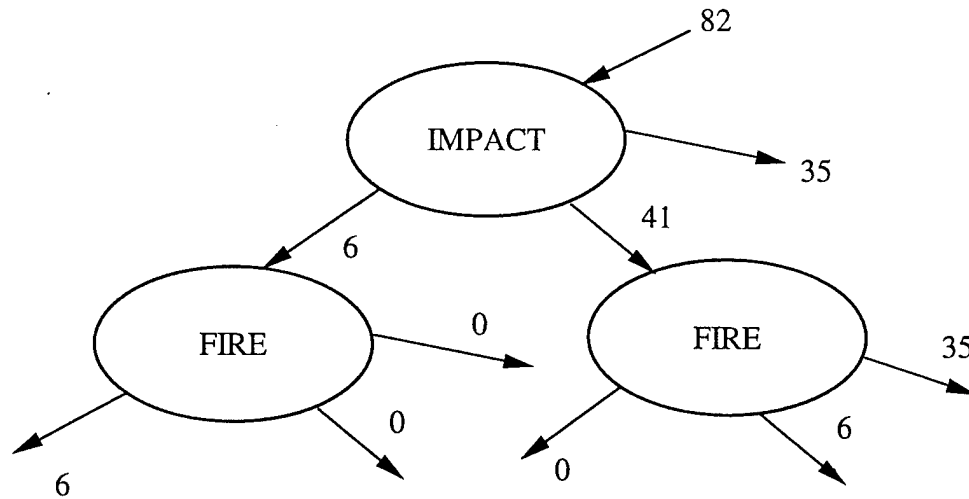
- half of the 70 fatalities died from impact – the aircraft impacted trees and ground several times.
- half of the 70 fatalities died from impact and fire.
- 6 occupants received minor or no injuries – 2 cabin attendants and 4 passengers were interviewed shortly after the accident.
- 6 of the seriously injured occupants received impact and burn injuries (physical condition precluded them from being interviewed).

The survivability chain is therefore:

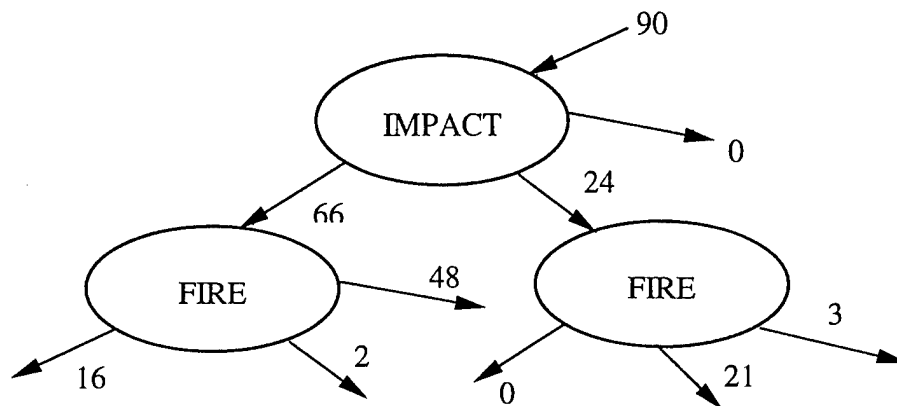
The aircraft and its occupants were subjected to impact followed by postcrash fire. There were 9 flight crew, 10 cabin crew, and 71 passengers onboard the aircraft. A few occupants (taken as 3) suffered impact injuries before they succumbed to the fire, the rest (taken as 48) died as a direct result of the fire only. Of the seriously injured, 21 reportedly suffered impact injuries and burns, the remaining 2 are assumed to have suffered burns only.

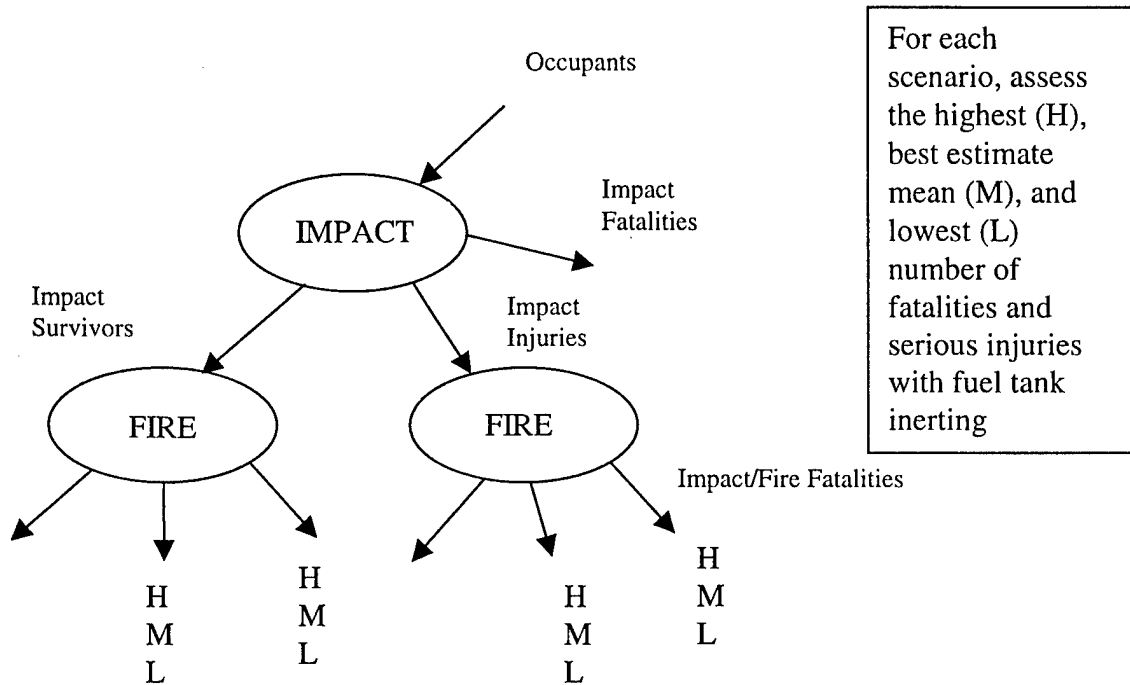
Figure B-1. Statistical Modelling Process, Stage 1

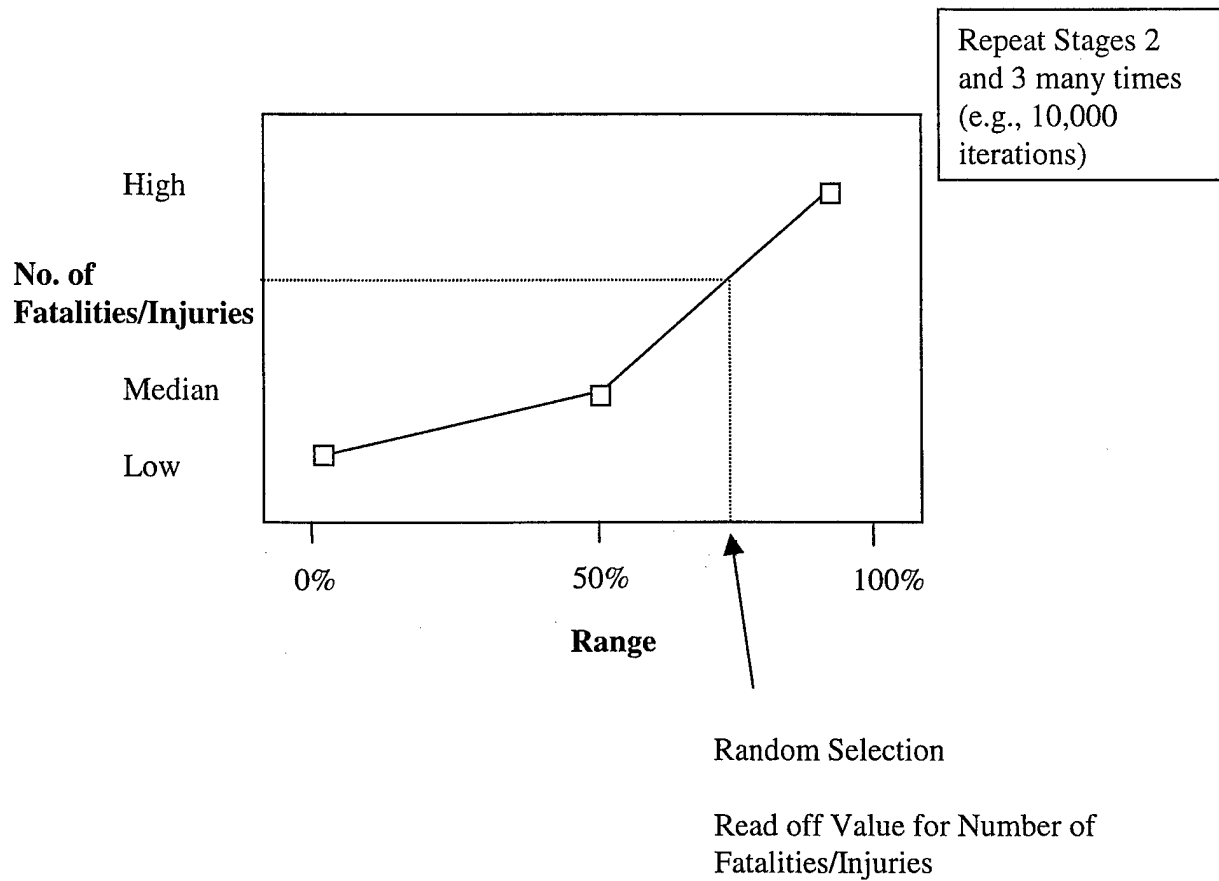
Figure B-2. Statistical Modelling Process, Stage 2

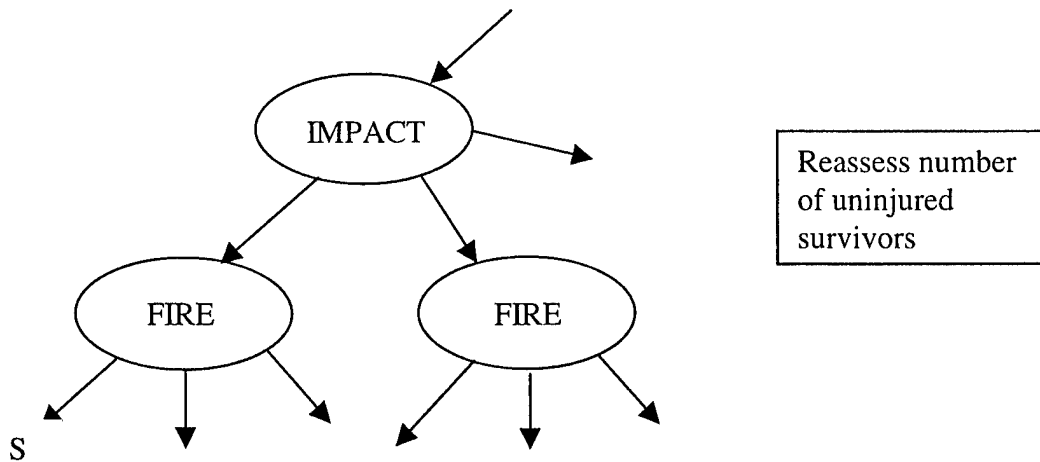
Evaluate injury rate improvement using:

$$S_F = \frac{S_B - S}{T}$$

Figure B-3. Statistical Modelling Process, Stage 3
