DOT/FAA/AR-99/73

A Benefit Analysis for Nitrogen Inerting of Aircraft Fuel Tanks Against Ground Fire Explosion

December 1999

Final Report

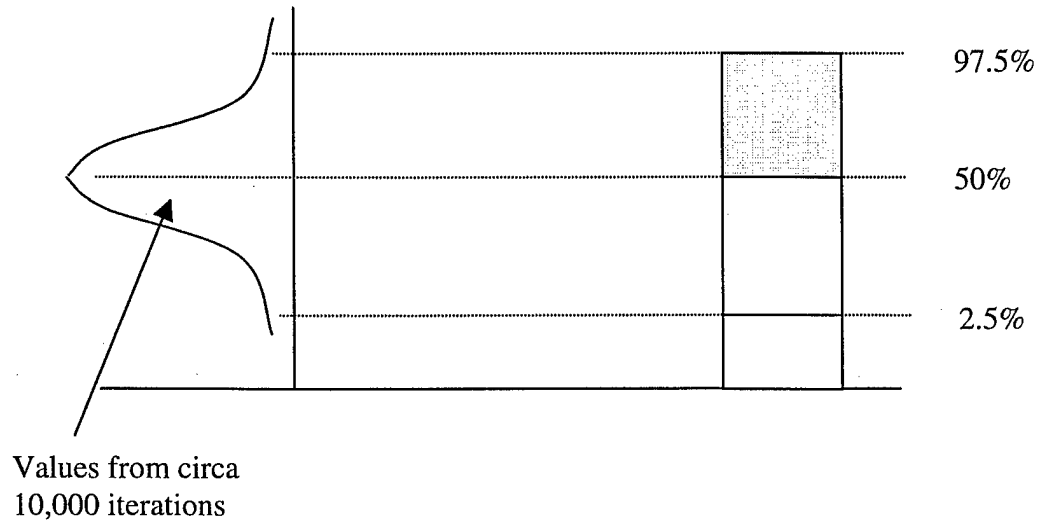
From statistical distribution, read off 97.5, 50, and 2.5 percentiles.

Figure B-4. Statistical Modelling Process, Stage 4

Stage 4 of the process is simply to determine the 2.5, 50 and 97.5 percentiles from the resulting distributions to ascertain a mean and likely range for the prediction.
