**DOT/FAA/AR-00/13**

# **Benefit Analysis for Aircraft 16-g Dynamic Seats**

April 2000

Final Report

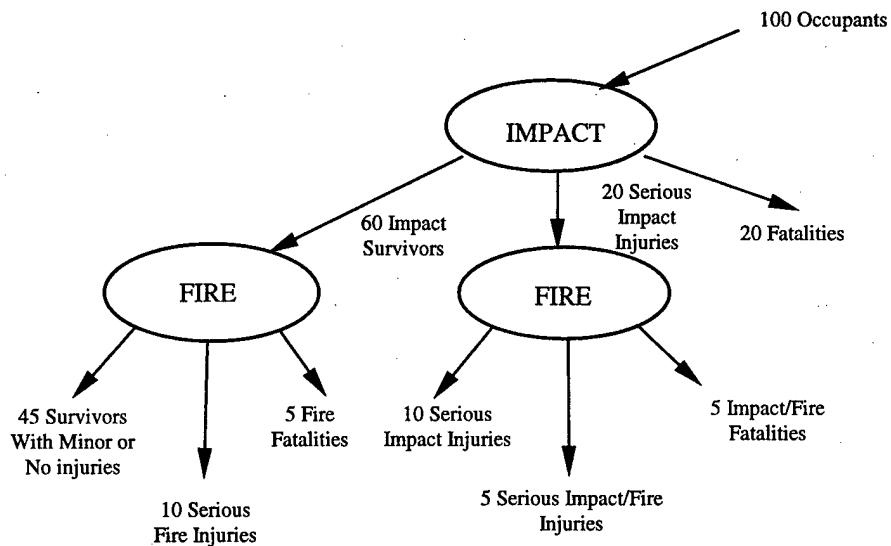
FIGURE 1. EXAMPLE OF SURVIVABILITY CHAIN FOR AN ACCIDENT SCENARIO

In this example, of the 100 occupants in the scenario there are:

- 45 uninjured survivors.
- 25 serious injuries, 10 as a result of the impact, 10 as a result of the fire, and 5 seriously injured as a result of the impact and fire.
- 30 fatalities, 20 as a result of the impact, and 10 as a result of the fire (5 of whom sustained nonfatal injuries from the impact).

A mathematical model, known as a Survivability Chain (see figure 1) has been developed, by RGW Cherry & Associates Ltd. It enables an assessment to be made of the overall effect on survivability, from improvements made to survivability factors, taking into account injuries that may be sustained by occupants. In this case, the survivability factor is 16-g dynamic seats.

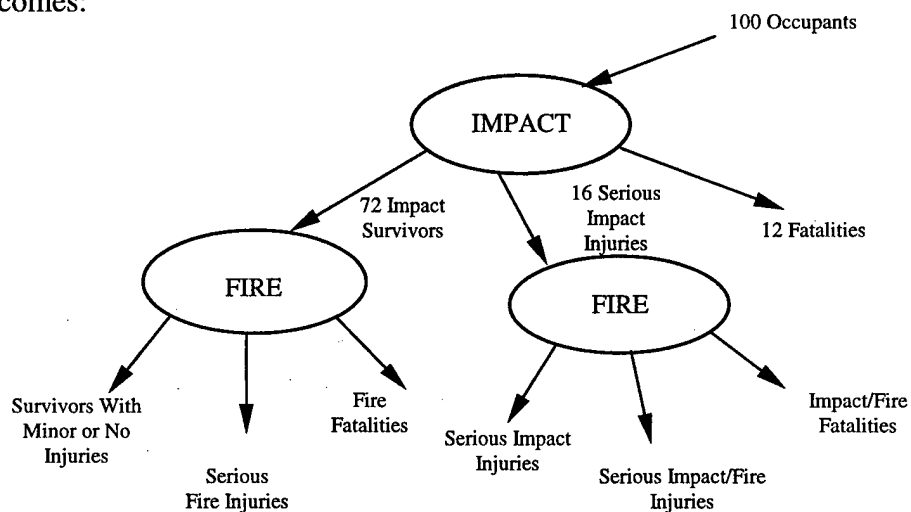
If improvements are made to an impact-related survivability factor, such that there are only 12 fatalities and 16 seriously injured of the 100 occupants, the Survivability Chain then becomes:

FIGURE 2. EXAMPLE OF SURVIVABILITY CHAIN SHOWING POSSIBLE IMPROVEMENTS IN IMPACT-RELATED SURVIVABILITY FACTOR

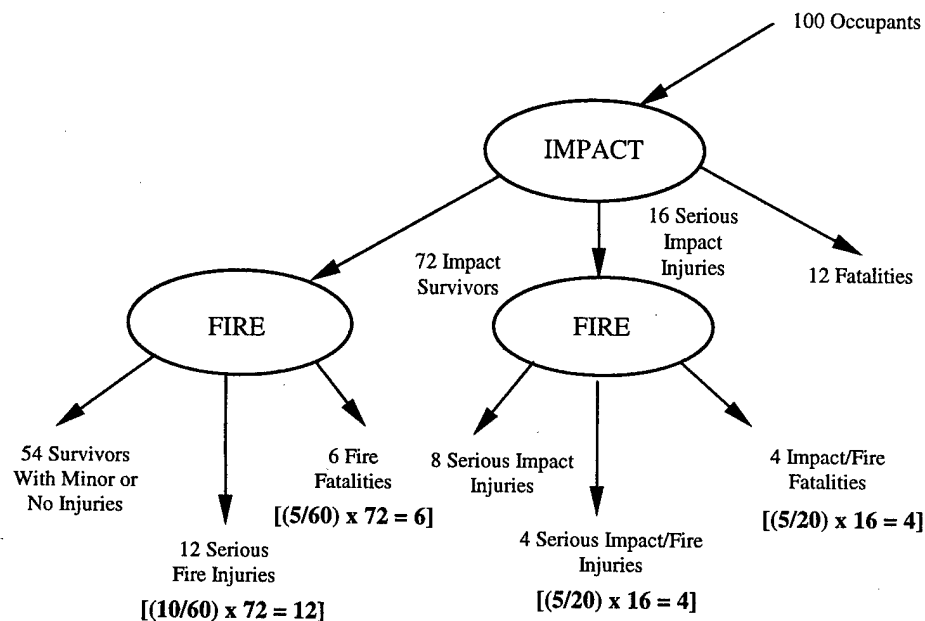
It is known from the accident that 5/60<sup>th</sup> of those that survive the impact uninjured and 5/20<sup>th</sup> of those that sustain injuries from the impact subsequently died because of the fire. Furthermore, 10/60<sup>th</sup> of those that survive the impact are seriously injured due to fire and 5/20<sup>th</sup> of those that sustain serious injuries from the impact also sustain serious injuries because of the fire. It is assumed that these ratios are constant for this particular scenario.

On this basis an assessment of the numbers of fatalities and injuries may be made as follows:

FIGURE 3. EXAMPLE OF SURVIVABILITY CHAIN SHOWING THE OVERALL IMPROVEMENTS IN SURVIVABILITY

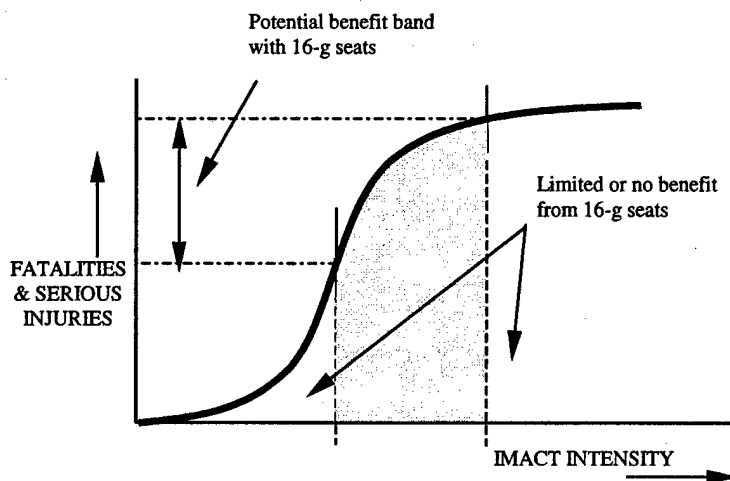
From a previous study [1], it was suggested that the proportion of fatal and serious injuries in an accident scenario was of a form similar to that shown in figure 4. It is evident that there will not be any benefit from the introduction of 16-g seats when the impact intensity is beyond their level of resilience. Furthermore, at impact intensities below those sustainable by 9-g seats, there would be little benefit beyond that afforded by improvements to seat design associated with the enhanced Head Injury Criteria.

FIGURE 4. POTENTIAL LIVES SAVING WITH 16-g SEATS

This limits the number of ground impact related accidents that would benefit from the introduction of 16-g seats.

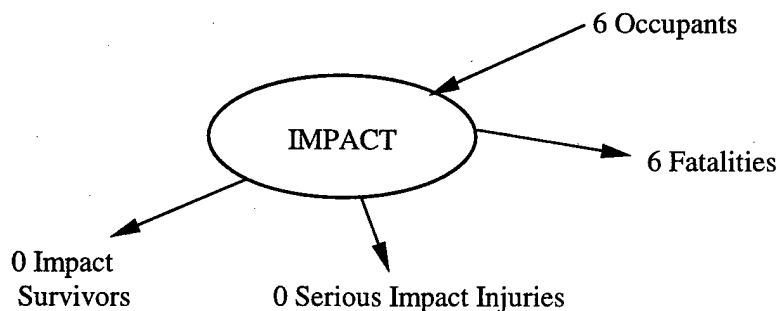
SCENARIO 1

**Scenario 1** is the area occupied by the flight and cabin crew. It is assumed that all perished as a direct result of the impact.

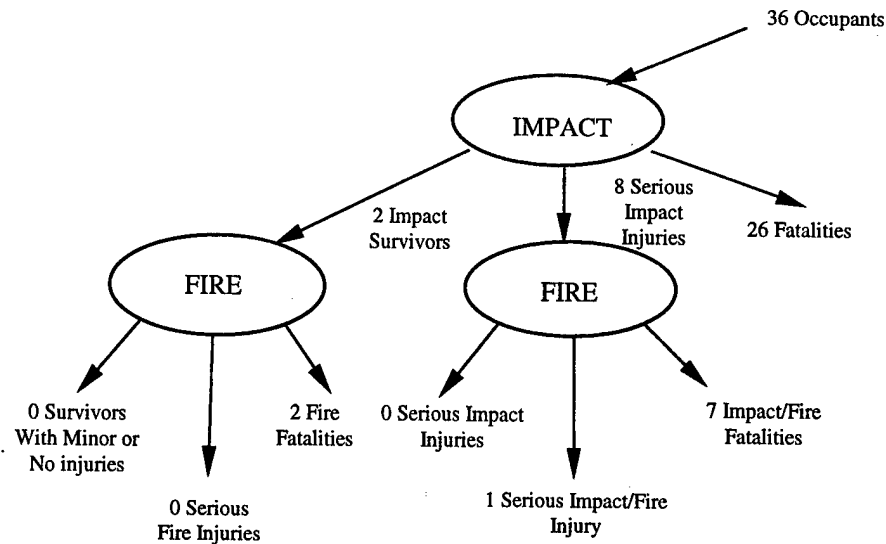
## SCENARIO 2

**Scenario 2** is the forward part of the passenger cabin in which it is assessed there were 36 passengers. Based on the statements in the accident report the survivability chain is as follows:

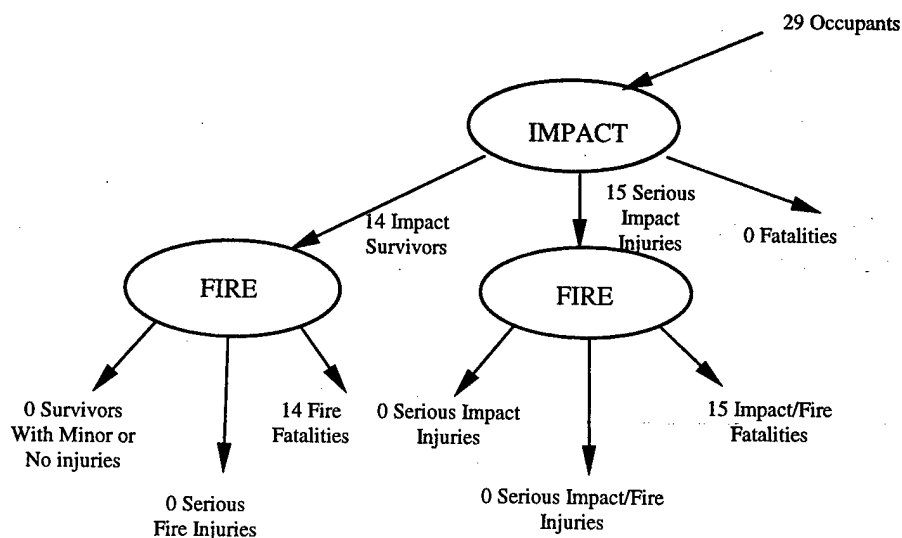
## SCENARIO 3

**Scenario 3** is the aft part of the passenger cabin in which it is assessed that the remaining 29 passengers were located. Based on the statements in the accident report the survivability chain is as follows:

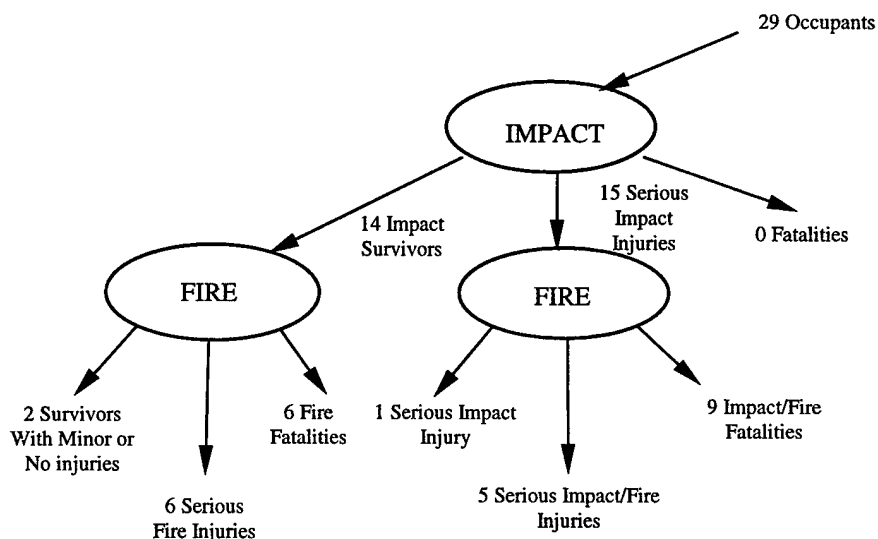
SCENARIO 3

On this basis had the aircraft been configured to the latest standard of fireworthiness requirements the survivability chain for this scenario would be as follows:

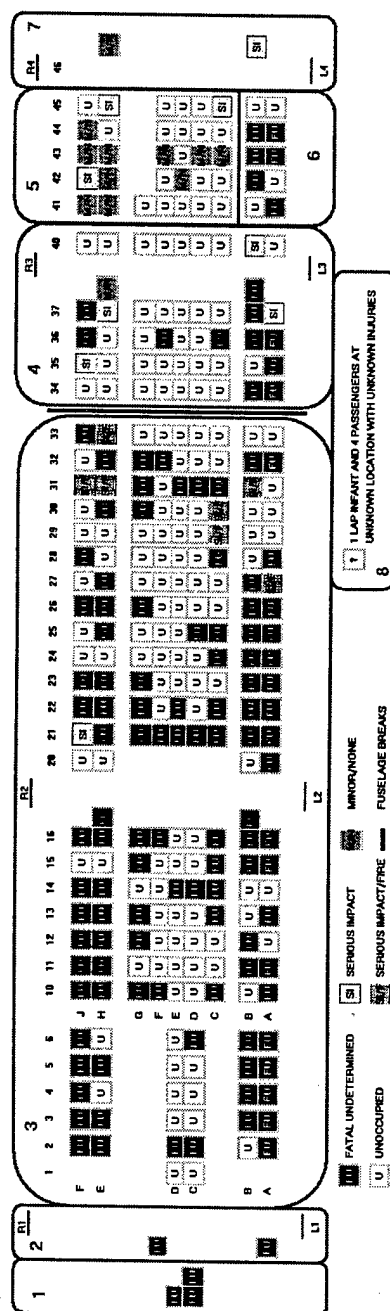
This accident is considered as having eight scenarios, as shown in figure A-1.

FIGURE A-1. LOCATION OF INJURIES AND SCENARIOS

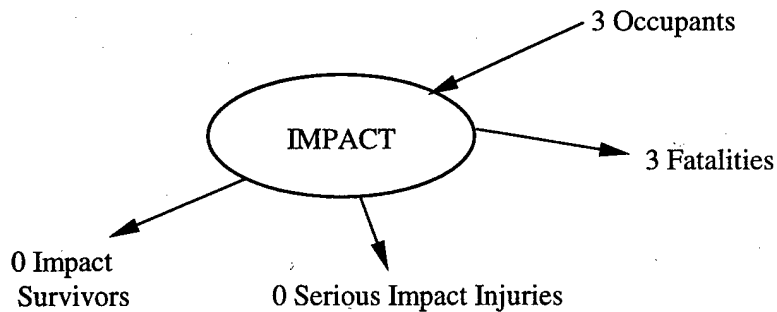
SCENARIO 1

**Scenario 1** represents the cockpit area containing three flight crewmembers. Since fire was reported only in the mid-section, it has been assumed that the flight crew suffered fatal injuries in the impact.

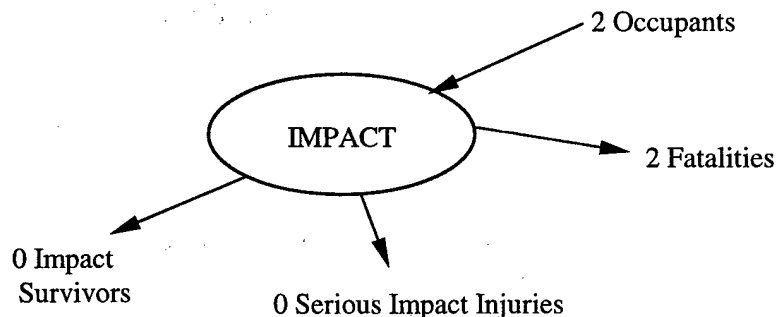
SCENARIO 2

**Scenario 2** represents the area occupied by the two forward flight attendants. Since fire was reported only in the mid-section, it has been assumed that the forward flight attendants suffered fatal injuries in the impact.

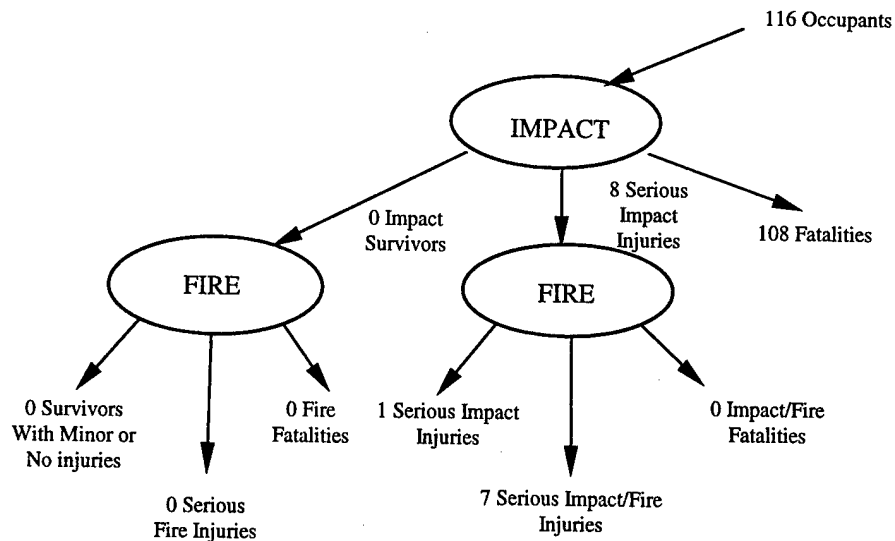
### SCENARIO 3

**Scenario 3** represents the main cabin from seat row 1 to seat row 33 where the fuselage break occurred. Full details of occupant injury are not known but this area disintegrated after the aircraft struck water tanks and there is unlikely to be any benefit from the introduction of 16-g seats. Therefore the breakdown of injuries will have no bearing on the outcome of this analysis and all fatalities have been assumed to be from impact forces.

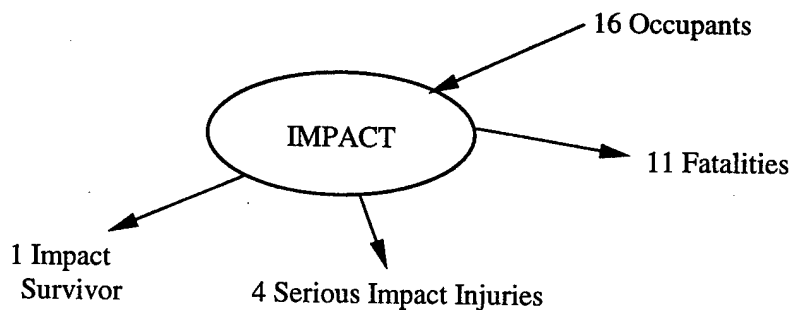
### SCENARIO 4

**Scenario 4** represents seat row 34 to seat row 40, located at the front of the rear section and subjected to massive disruption of cabin floor, walls, and ceiling. Full details of occupant injury are not known but due to the extent of the cabin disintegration there is unlikely to be any benefit from the introduction of 16-g seats. Therefore the breakdown of injuries will have no bearing on the outcome of this analysis and all fatalities have been assumed to be from impact forces.

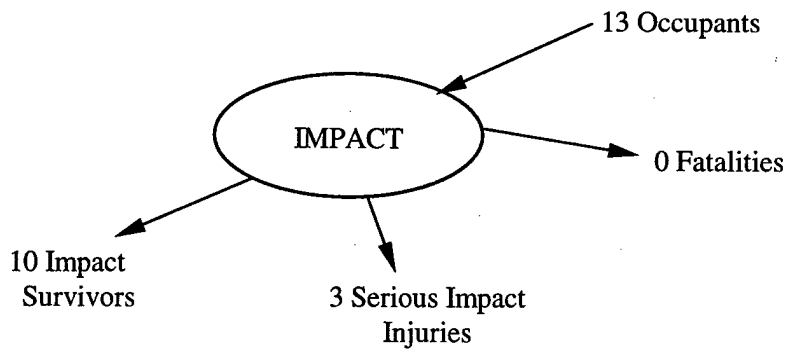
SCENARIO 5

**Scenario 5** represents the middle and right side sections of seat rows 41 to 45, which were relatively undamaged. Three occupants could not escape due to their impact injuries and were removed by fellow passengers and rescue personnel. Ten occupants reported minor or no injuries.

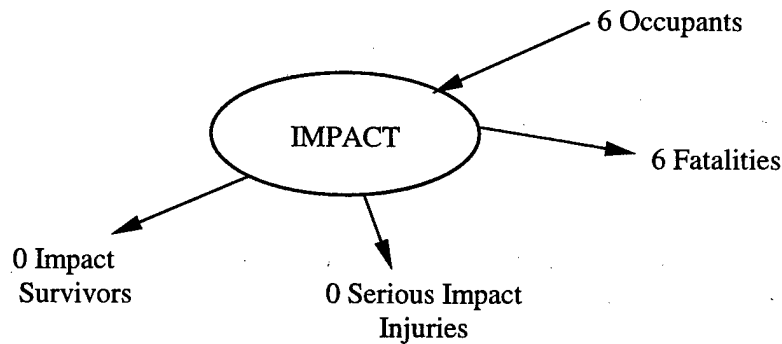
SCENARIO 6

**Scenario 6** represents the left side of seat rows 41 to 45. The left wall was missing and the six occupants who were seated next to the wall suffered fatal injuries and these have assumed to have been caused by the impact forces that removed the wall.

The six fatalities located against the missing side wall are assumed to have been killed by the impact that removed the wall and therefore no benefit was assessed for the use of 16-g seats in this area.

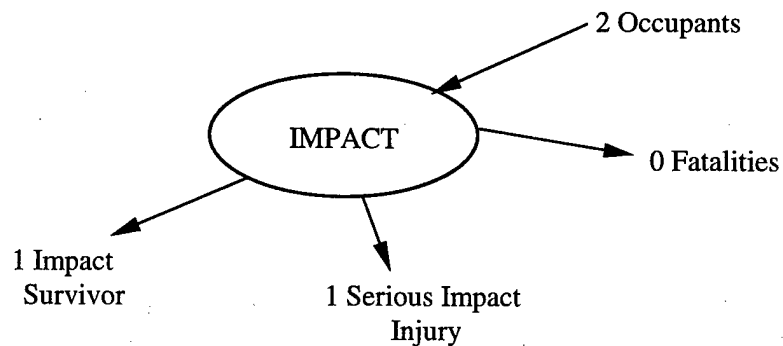
SCENARIO 7

**Scenario 7** represents the area containing the two rear flight attendants. One suffered serious injuries due to the impact and the other escaped with minor or no injuries.

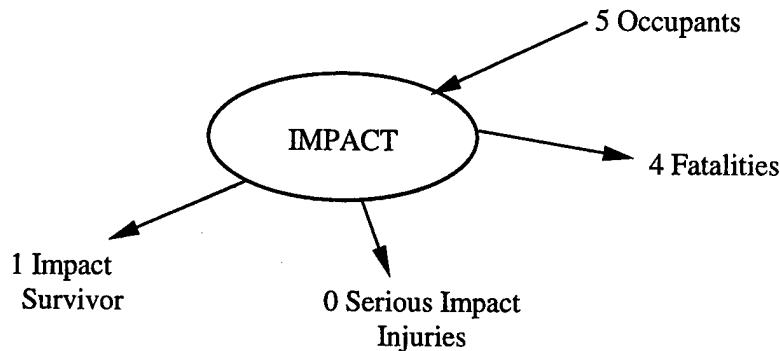
SCENARIO 8

**Scenario 8** contains the five occupants for which seat location and injury were unknown. Absence of information results in the following simplified survivability chain. It was reported that 26 passengers and 3 cabin attendants survived the accident. However in figure A-1 the injury location diagram only identified 25 passengers and 3 cabin attendants. Therefore, 1 of the unknown seat location passengers must have received minor or no injuries since it was not significant enough to be reported officially.

The four unknown seat location passengers have been assumed to have died from the impact. This is consistent with the destruction of the aircraft.

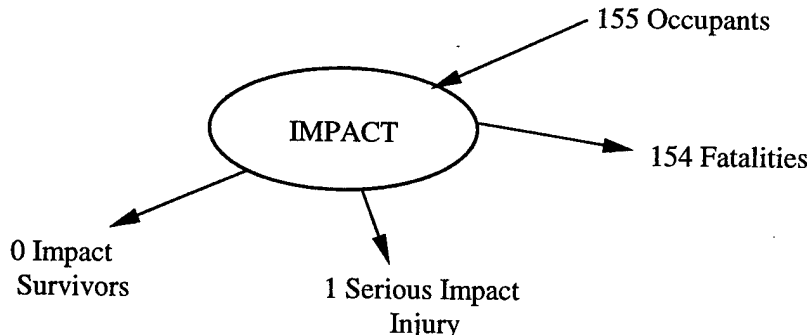
Due to the massive disintegration of the fuselage structure, this accident was considered as a single scenario, encompassing the whole cabin.

This accident involved a considerable impact and the cabin area disintegrated during the crash sequence. It was reported that all of the passenger seats were separated from the fuselage and were scattered along the wreckage path. In addition, external examination of the occupants showed that all had sustained multiple injuries. Therefore, due to this large amount of structural disruption, it is assessed that the introduction of 16-g seats would not have provided any additional benefit in this accident.

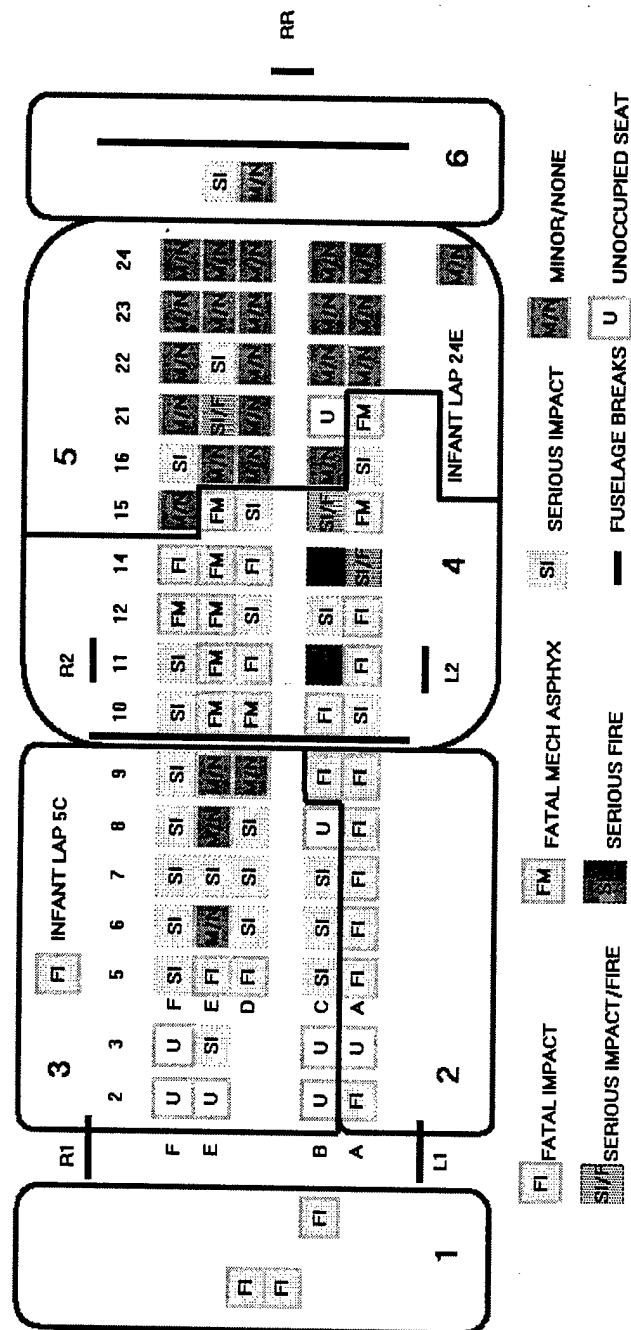
This accident is divided into six separate scenarios, as shown in figure A-2.

FIGURE A-2. LOCATION OF INJURIES AND SCENARIOS

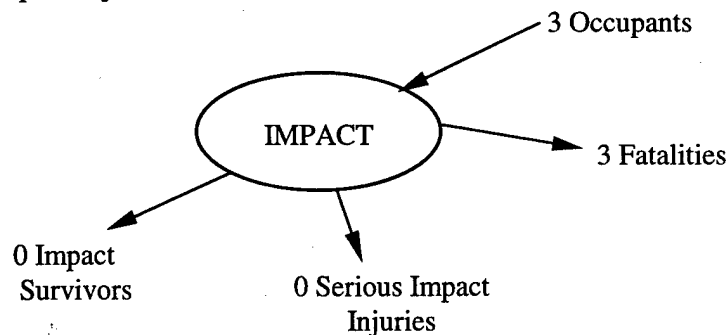
**SCENARIO 1**

**Scenario 1** contains the flight deck and the vestibule where two flight crew and one cabin attendant died from impact injuries.

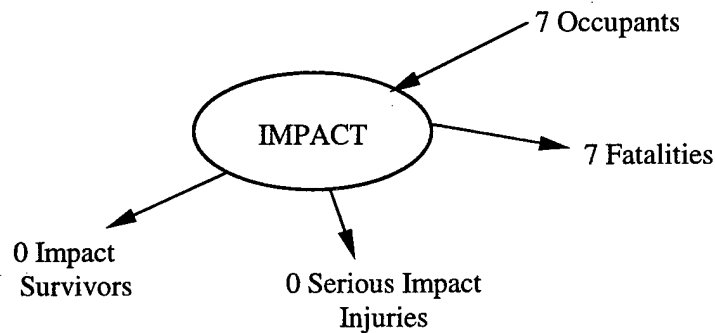
**SCENARIO 2**

**Scenario 2** contains the forward left side of the fuselage, seats 2A to 9A and 9C, where there were seven impact fatalities. Conditions for passengers seated in these seats are considered nonsurvivable due to the severe damage in this area. The forward fuselage came to rest on its left side and it was badly damaged. This included loss of some areas of the floor and ceiling. Much of the exterior skin and underlying structure was torn away and found along the wreckage path.

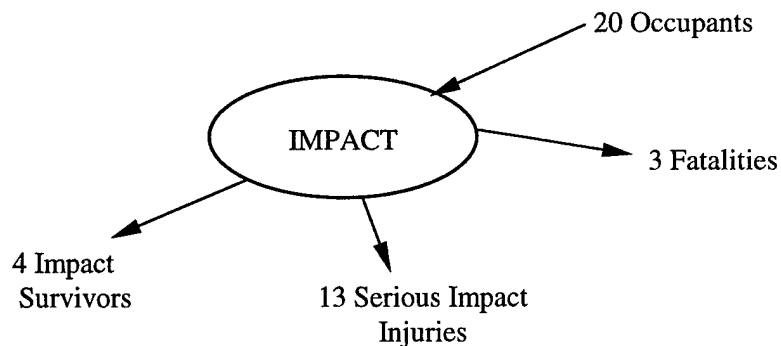
**SCENARIO 3**

**Scenario 3** contains rows 2 to 9 on the right side and seats 2B to 8B. The right side of the fuselage was distorted and dented in several places near the forward baggage door. Some passengers were thrown out of the cabin. There were 20 passengers in this section and 2 died from impact injuries, 13 suffered serious impact injuries, and 4 received minor or no injuries.

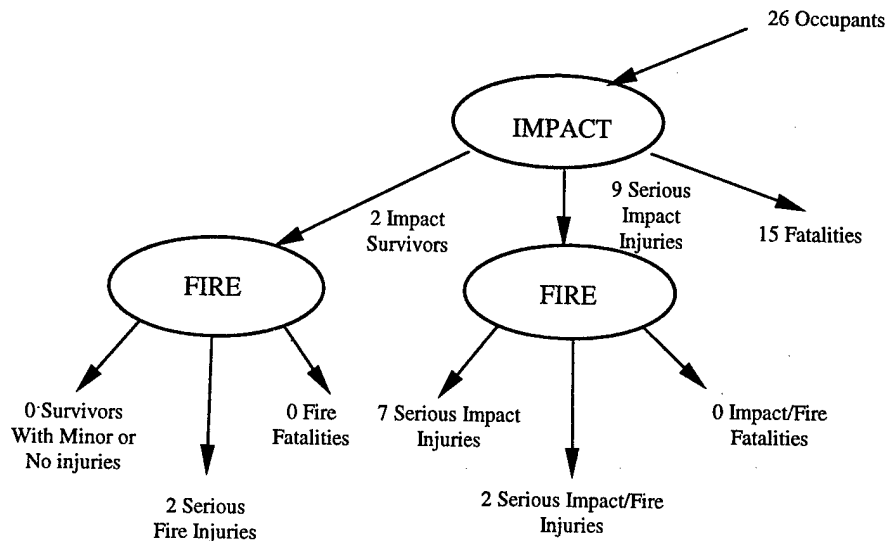
#### SCENARIO 4

**Scenario 4** contains rows 10 to 14, seats 15A, C, D, and E, 16A, and 21A. This section of the fuselage came to rest inverted. There were 26 passengers in this scenario. Nine died from mechanical asphyxiation, six died from impact injuries, seven suffered serious impact injuries, two suffered serious fire burns, and two suffered serious impact and fire burns.

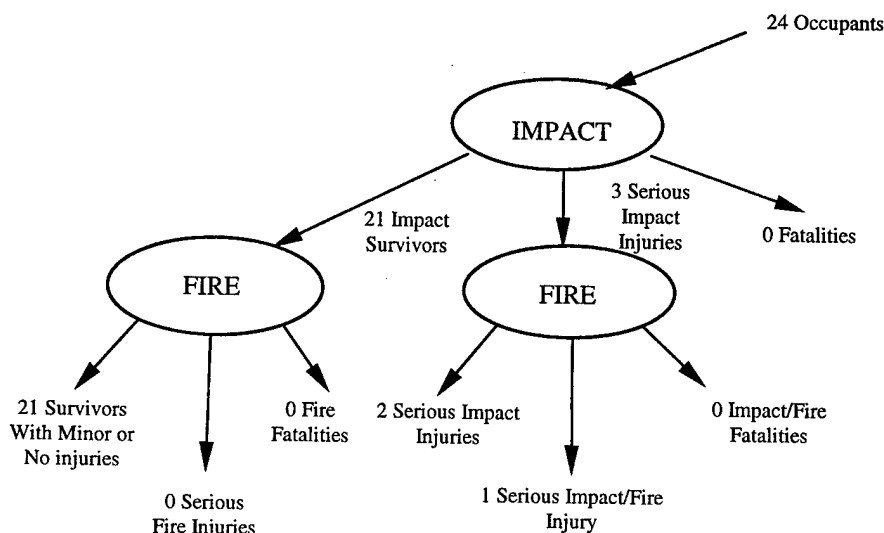
#### SCENARIO 5

**Scenario 5** contains passenger seats 15F, 16C, D, E, and F, 21C, D, E, and F and rows 22 to 24. This section of the fuselage came to rest inverted. There were 24 passengers in this scenario. Two suffered serious impact injuries, 1 suffered serious impact and fire burns, and 21 received minor or no injuries.

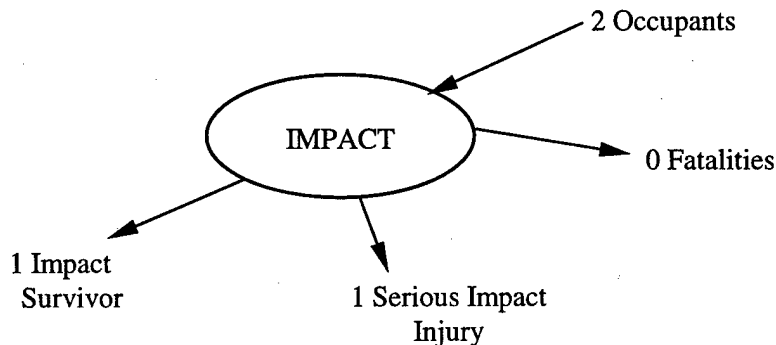
SCENARIO 6

**Scenario 6** contains the two flight attendants stationed at the rear of the aircraft. One flight attendant sustained serious impact injuries and the other received minor or no injuries.

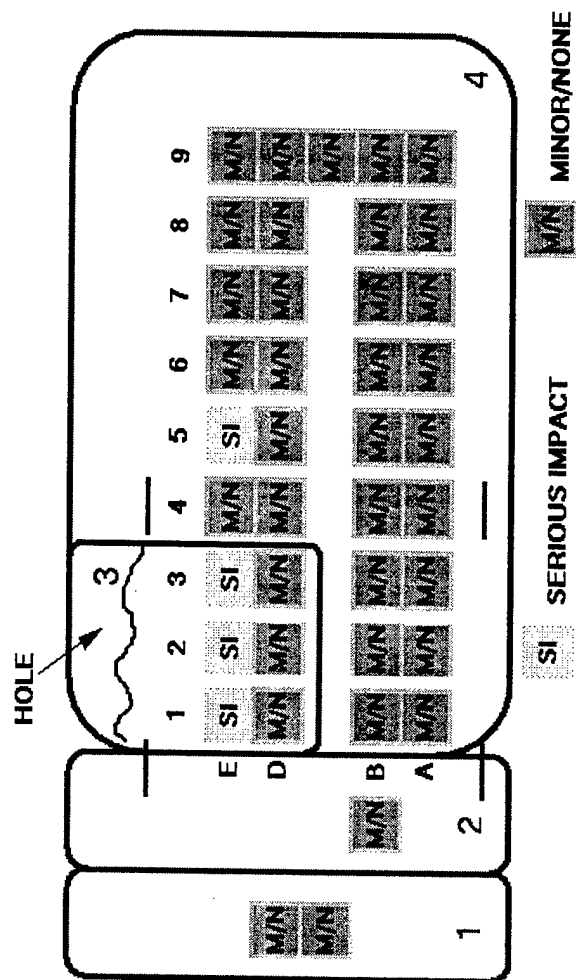
This accident is considered as having three scenarios, as shown in figure A-3.

FIGURE A-3. LOCATION OF INJURIES AND SCENARIOS

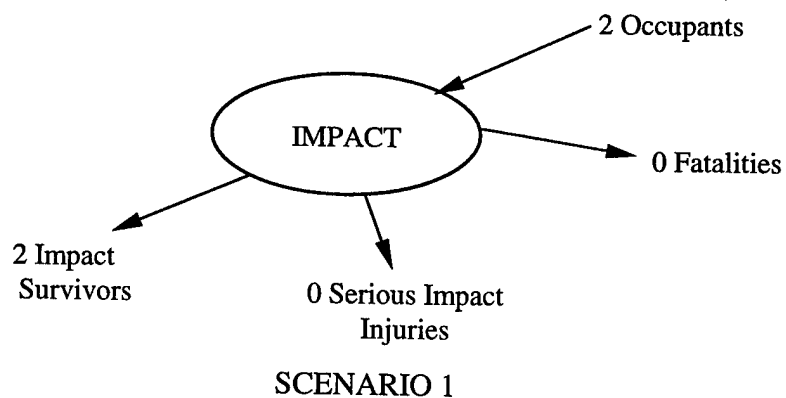
**Scenario 1** represents the cockpit area where the two flight crewmembers were located. Both flight crewmembers sustained minor or no injuries.

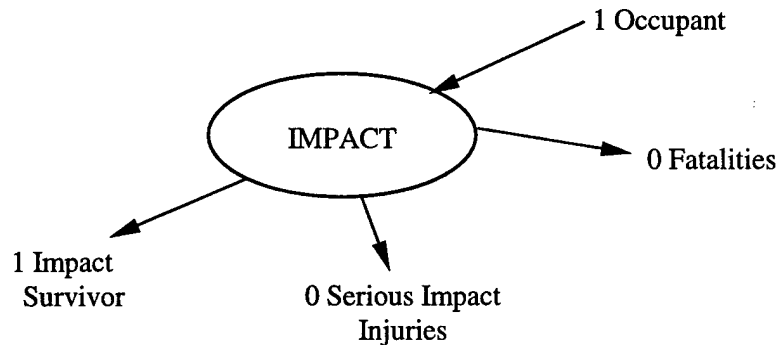
**Scenario 2** represents the forward vestibule area occupied by a flight attendant who sustained minor or no injuries.

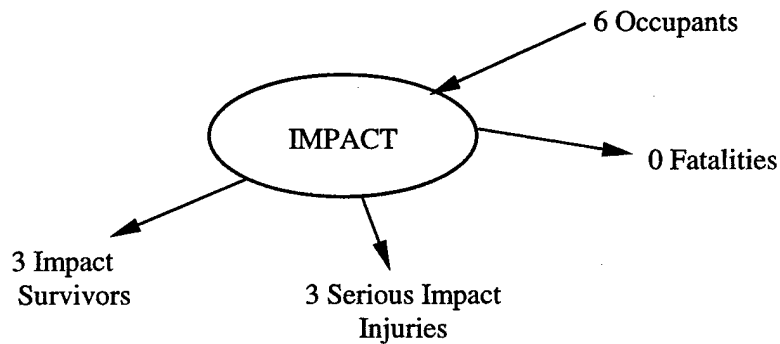
**Scenario 3** represents that portion of the passenger cabin containing seats 1DE, 2DE, and 3DE. This was reported to be the most heavily damaged area during impact with ground equipment. There were six occupants in this area, three sustained serious injuries, and three were uninjured. The survivability chain for this area is:

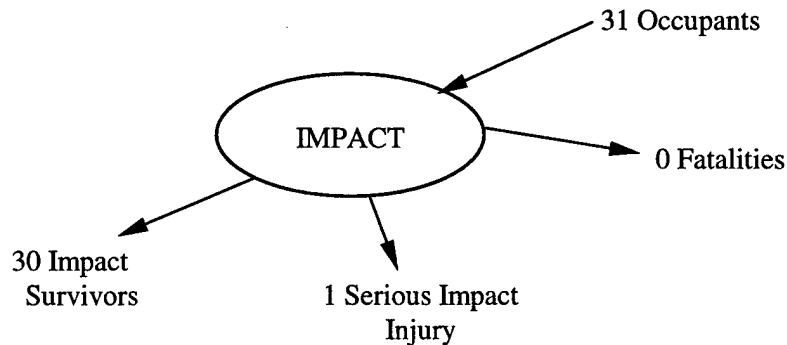
SCENARIO 4

**Scenario 4** represents the remainder of the passenger cabin. There were thirty-one occupants in this area, one sustained serious injuries, and thirty were uninjured. The survivability chain for this area is:

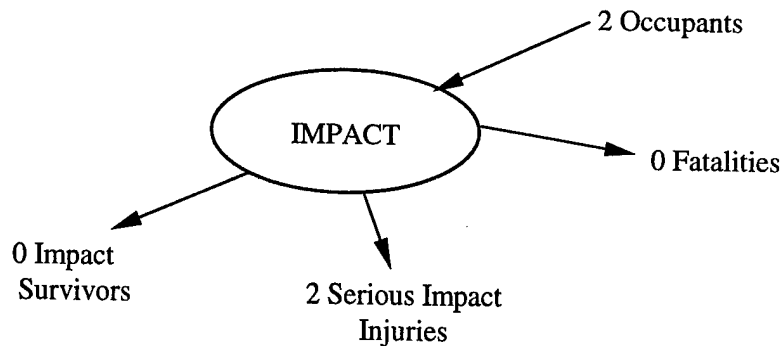
SCENARIO 1

**Scenario 1** represents the flight deck area containing two-flight crew, both of whom were seriously injured. The survivability chain for this area is:

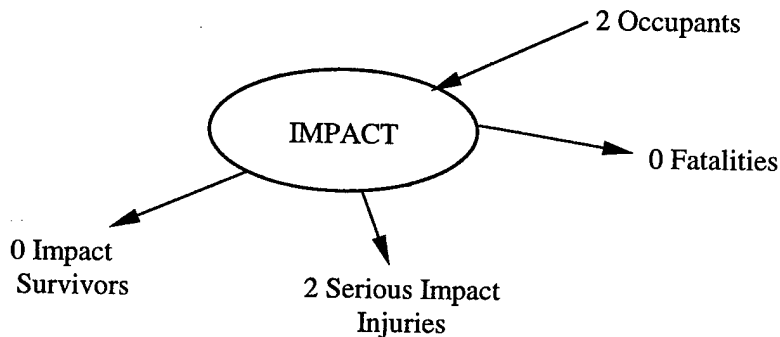
SCENARIO 2

**Scenario 2** represents that area of the cabin in which the two forward flight attendants were located, both of whom were seriously injured. The survivability chain for this area is:

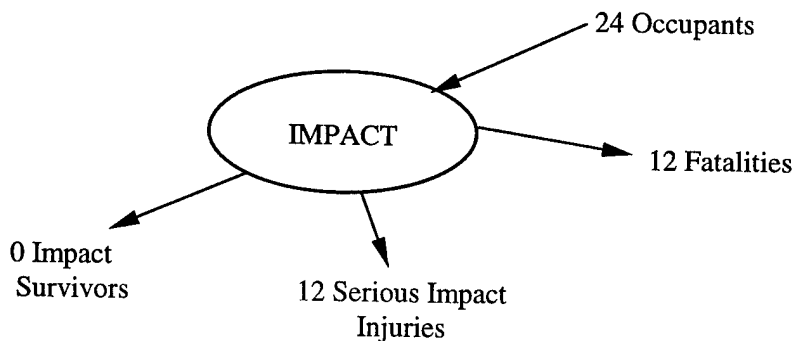
SCENARIO 3

**Scenario 3** represents that portion of the passenger cabin between seat rows 1 and 5 inclusive. There were 24 passengers in this area, 12 sustained fatal injuries and 12 were seriously injured. The survivability chain for this area is:

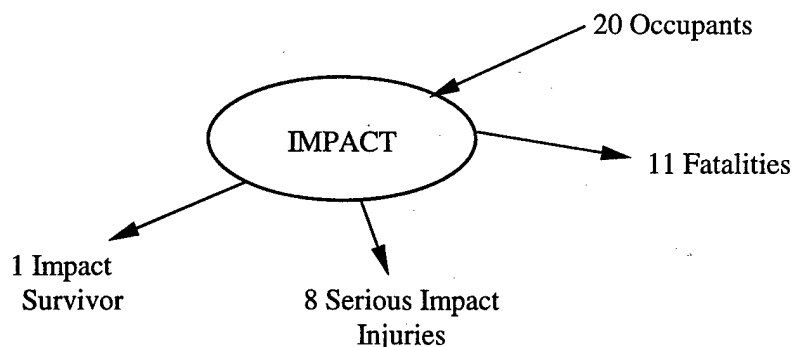
#### SCENARIO 4

**Scenario 4** represents that portion of the passenger cabin between seat rows 6 and 9 inclusive. There were 20 occupants in this area, 11 sustained fatal injuries, and 8 were seriously injured. The survivability chain for this area is:

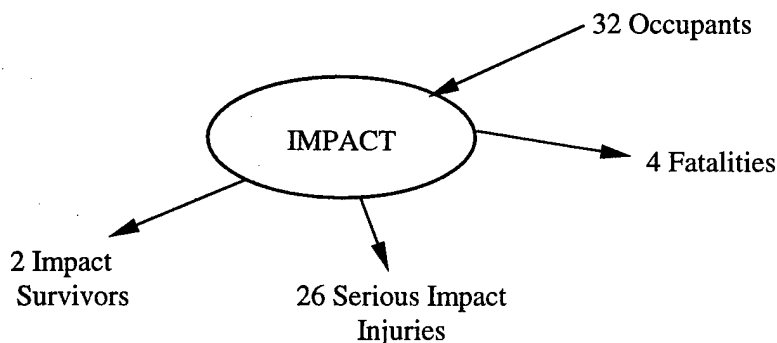
#### SCENARIO 5

**Scenario 5** represents that portion of the passenger cabin between seat rows 10 and 17 inclusive. There were 32 occupants in this area, 4 sustained fatal injuries, and 26 were seriously injured. The survivability chain for this area is:

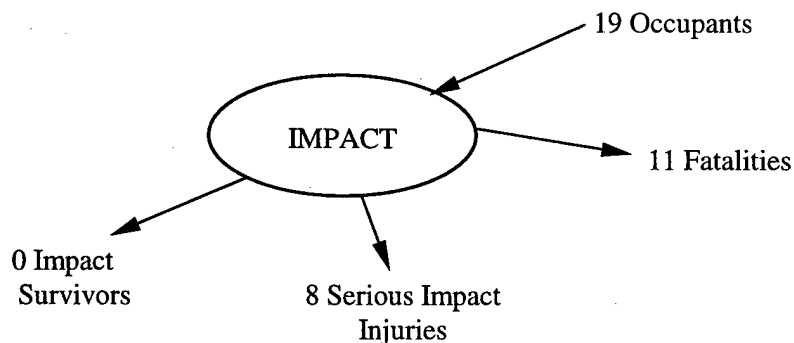
#### SCENARIO 6A

**Scenario 6A** represents that portion of the passenger cabin between seat rows 18 to 24 inclusive on the starboard side of the aircraft and the aisle seats on the port side in rows 19 to 23 inclusive. There were 19 occupants in this area, 11 sustained fatal injuries, and eight were seriously injured. The survivability chain for this area is:

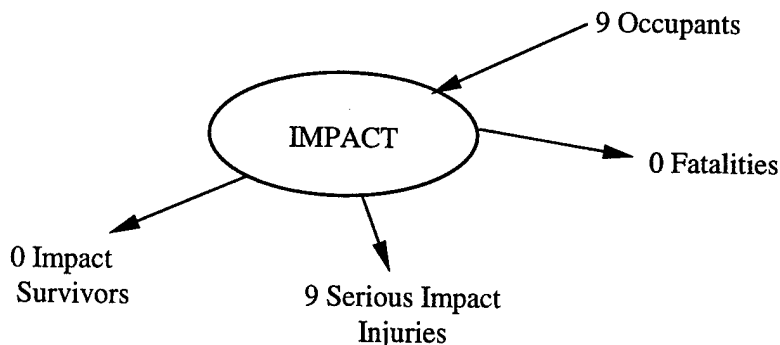
**SCENARIO 6B**

**Scenario 6B** represents that portion of the passenger cabin containing the port triple seat in row 18 and the port centre and window seats in rows 18 to 23 inclusive. There were nine occupants in this area all of who were seriously injured. The survivability chain for this area is:

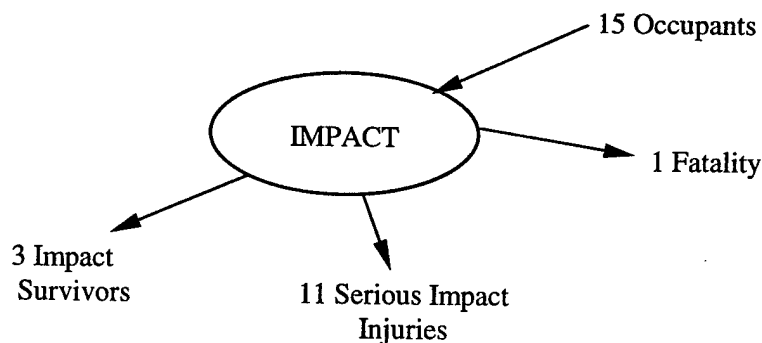
**SCENARIO 7**

**Scenario 7** represents that portion of the passenger cabin from seat rows 25 to 27 on the starboard side and seat rows 24 to 27 on the port side. There were 15 passengers in this area, 1 of whom sustained fatal injuries, and 11 were seriously injured. The survivability chain for this area is:

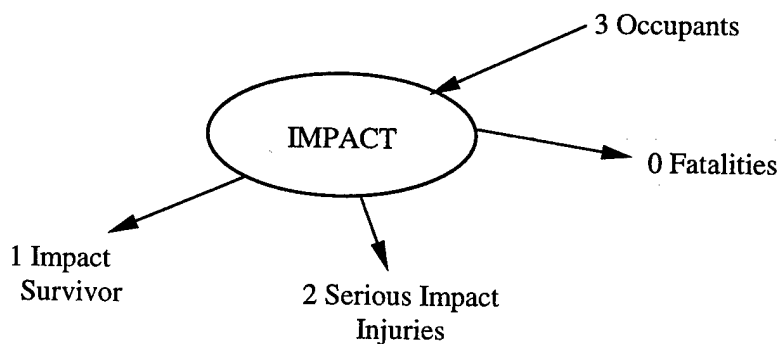
**SCENARIO 8**

**Scenario 8** represents that area of the cabin in which the three aft flight attendants were located, two of who were seriously injured and one survived uninjured. The survivability chain for this area is:

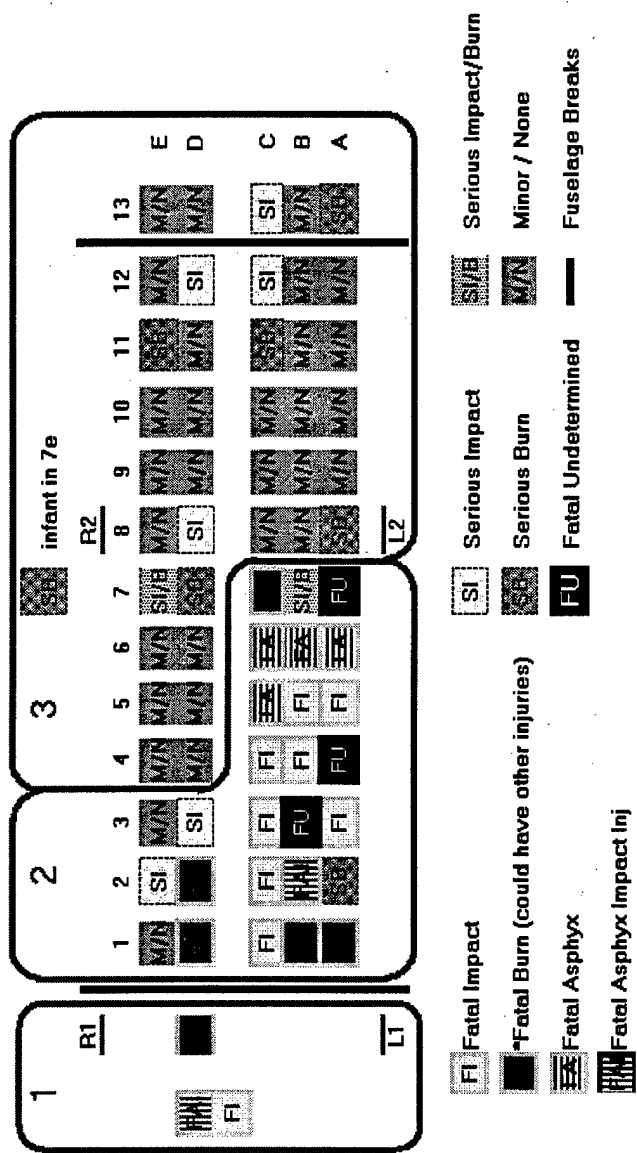
FIGURE A-5. LOCATION OF INJURIES AND SCENARIOS

This accident is divided into three separate scenarios, as shown in figure A-5.

It should be noted that since the g levels in this area were assessed to have exceeded 16 g's, no benefit is assigned from an improved seat standard. If these were not the case, scenario 2 would have been divided into smaller scenarios.

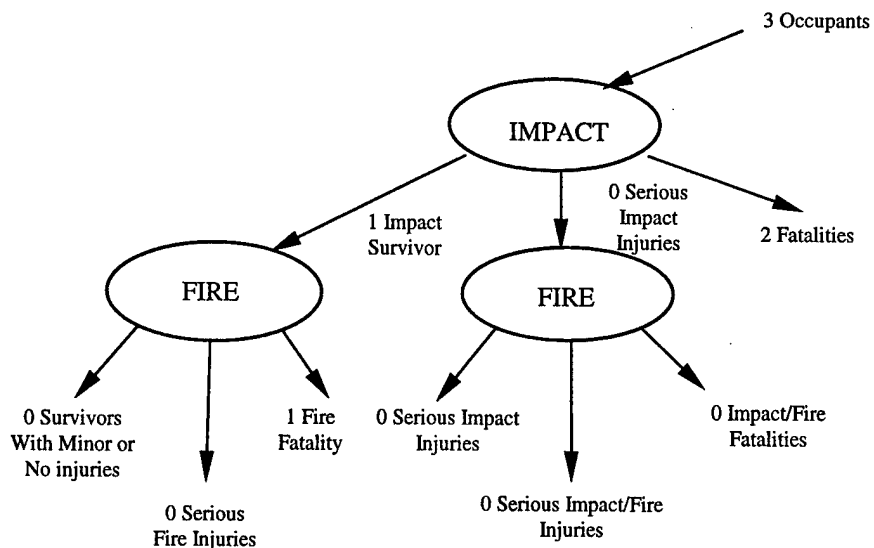
#### SCENARIO 1

**Scenario 1** contains the flight deck and vestibule where two flight crew died from impact and 1 cabin attendant died from fire burns.

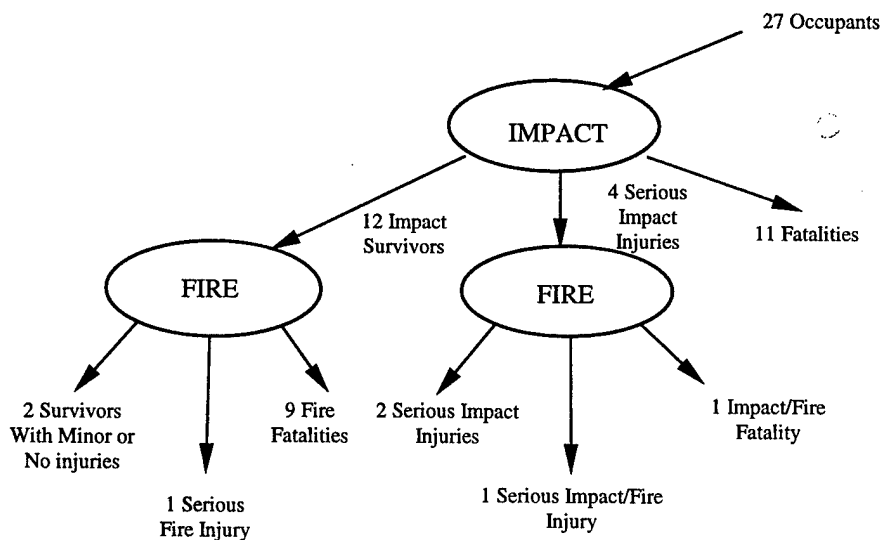
#### SCENARIO 2

**Scenario 2** contains the forward passenger cabin area (rows 1 to 3 and 4 to 7, seats A, B, and C) where there were eight impact-related fatalities, five fire burns fatalities, four asphyxiation/toxicity fatalities, one fatal impact/fire injury, three undetermined fatalities, two serious impact injuries, one serious fire injury, and one serious impact/fire injury. The aircraft accident report stated that the bodies recovered at the crash site were badly burned in the subsequent fire, which made it difficult to determine the various injuries and specific causes of death. Therefore it is assumed that those occupants who suffered fatal fire burns could have sustained other injuries before the bodies were burned; i.e., they might have died of impact but because the bodies were subsequently badly burned, the earlier injuries could not be identified.

The passenger seats in this section were severely deformed at the seat beams. The majority of these seats were subjected to deceleration forces with significant components in the sideward and downward directions during the final phase of the crash. Therefore it is assumed that the three undetermined fatal passengers died from impact injuries.

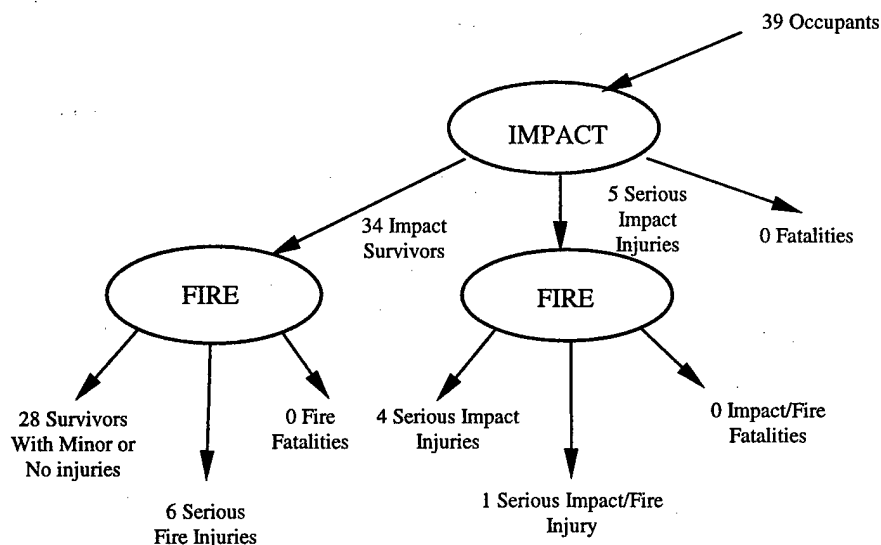
### SCENARIO 3

**Scenario 3** contains the rest of the passenger cabin – Rows 8 to 13 and 4 to 7, seats D and E. This scenario contained 38 passengers plus 1 infant. From the injury profile, 4 passengers suffered serious impact injuries, 1 passenger suffered serious impact and fire injuries, 5 passengers and 1 infant suffered serious fire burns, and 28 passengers received minor or no injuries.

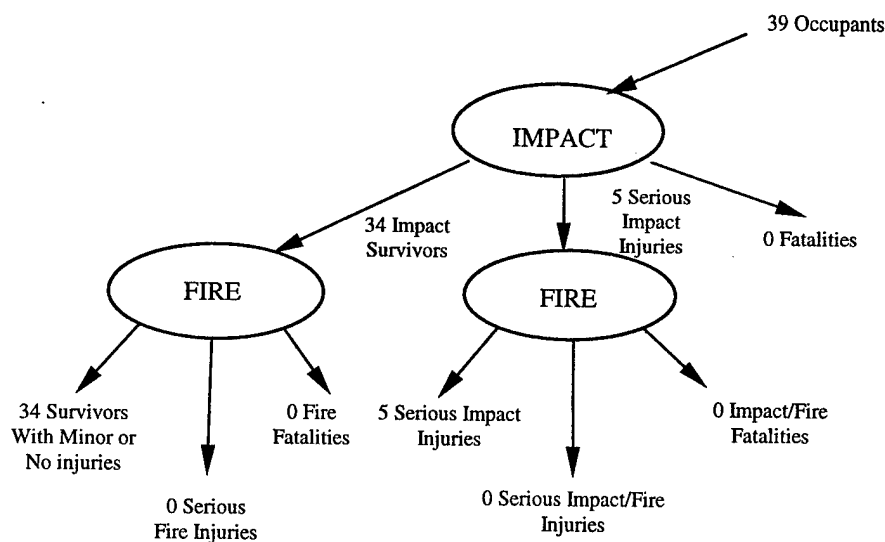
### SCENARIO 3

The aircraft was configured with fire-blocking seat cushions but the cabin materials did not meet the heat release standards required by current regulations. It is optimistically assumed that had the cabin materials met the current regulations there would have been no fire injuries in this scenario. The survivability chain is therefore modified as follows:

With 16-g seats the number of serious impact injuries in this section might have been reduced. On this basis, the best estimate is that the five passengers with serious impact injuries would have been saved.

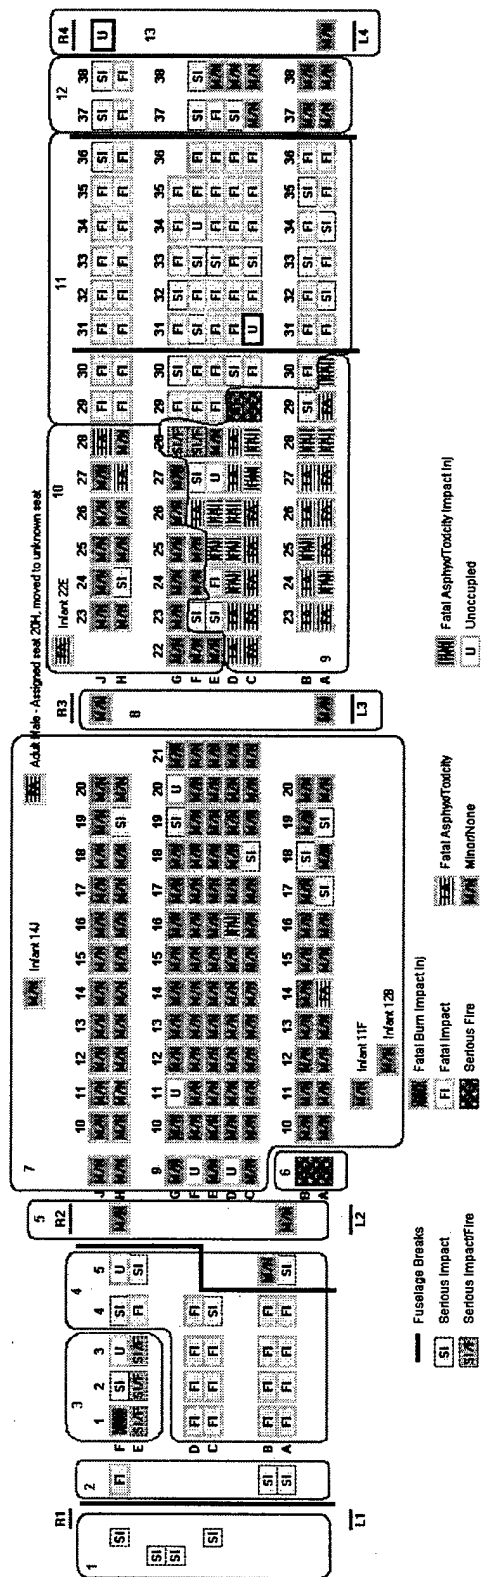
FIGURE A-6. LOCATION OF INJURIES AND SCENARIOS

This accident is considered as having thirteen scenarios, as shown in figure A-6. It should be noted that of the 285 passengers, detailed information from the accident report is provided for only 284.

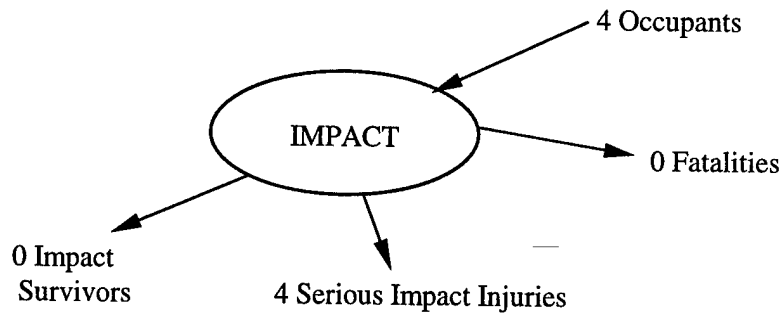
SCENARIO 1

**Scenario 1** represents the cockpit area where it is assessed that the three flight crewmembers and the occupant of the jump seat were located—all of whom survived although serious impact injuries were encountered.

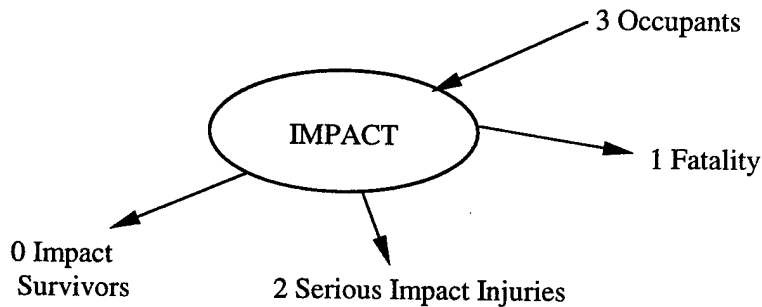
SCENARIO 2

**Scenario 2** represents the area occupied by the forward flight attendants, one of whom sustained fatal impact injuries and the remaining two sustained serious impact injuries.

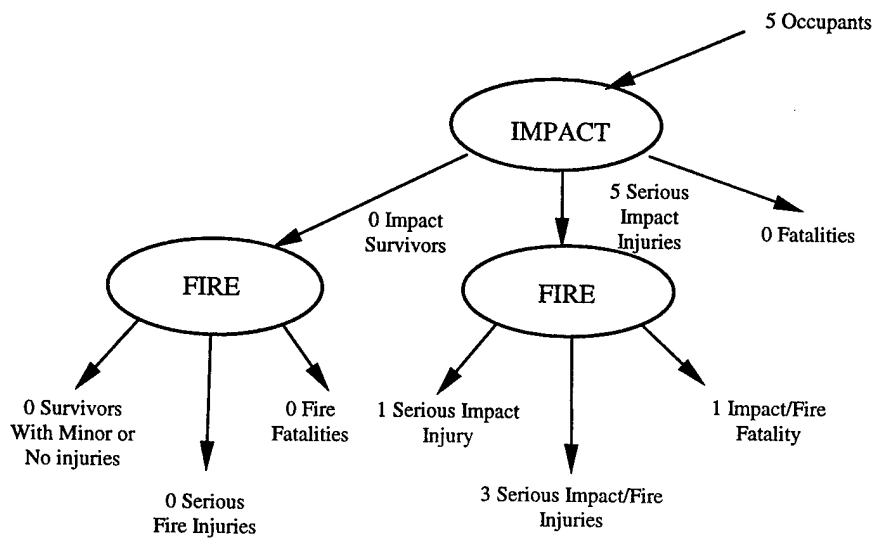
SCENARIO 3

**Scenario 3** represents seats 1E, 1F, 2E, 2F, 3E, and 3F. There were five occupants of this scenario, one of who sustained fatal injuries. The remaining four were seriously injured.

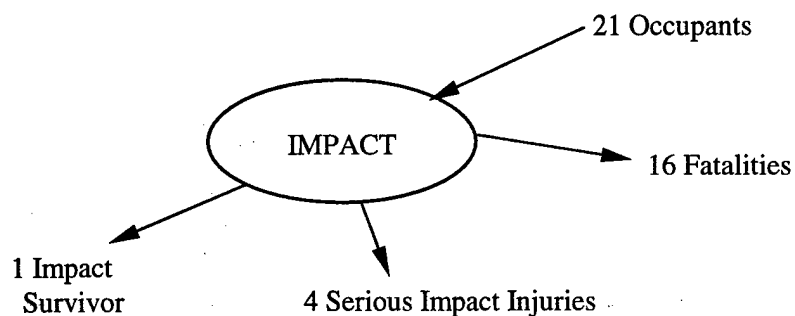
SCENARIO 4

**Scenario 4** represents the remainder of the first-class cabin. It is assessed that this portion of the cabin contained 21 occupants of whom 16 sustained fatal injuries as a result of impact trauma.
