**DOT/FAA/AR-00/13**

# **Benefit Analysis for Aircraft 16-g Dynamic Seats**

April 2000

Final Report

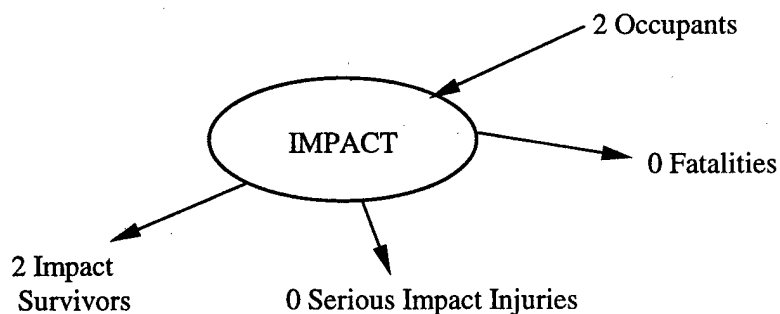
SCENARIO 5

**Scenario 5** represents the area occupied by the R2 and L2 flight attendants, both of whom escaped serious injury.

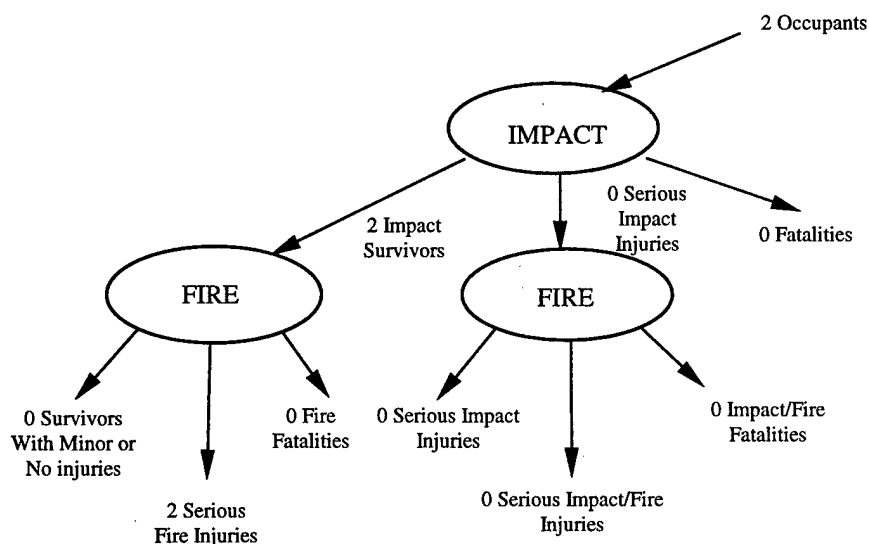
SCENARIO 6

**Scenario 6** represents the area in which seats 9A and 9B were located. The occupants of these seats both sustained serious burns.

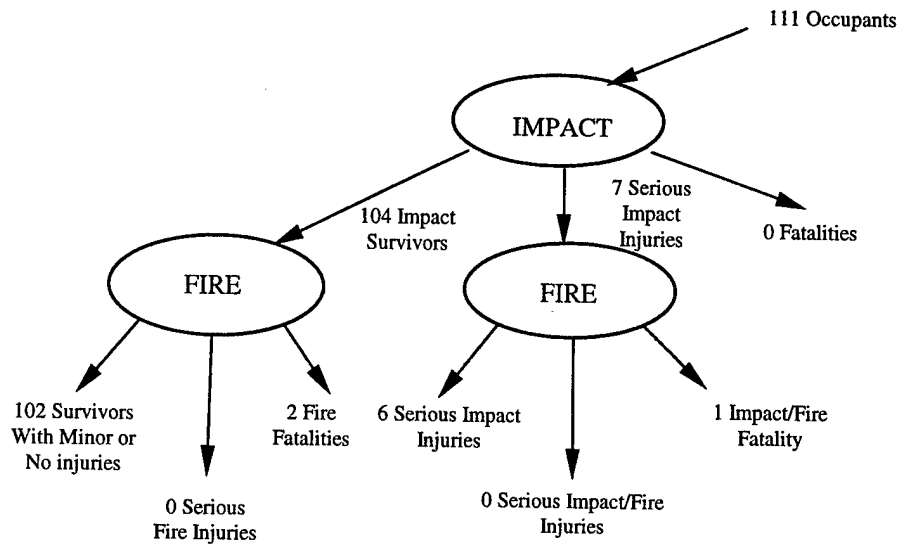
SCENARIO 7

**Scenario 7** represents the remainder of the passenger cabin from seat rows 9 to 21 inclusive. It is assessed that this portion of the cabin contained 111 occupants of which 3 were fatalities resulting from asphyxiation.

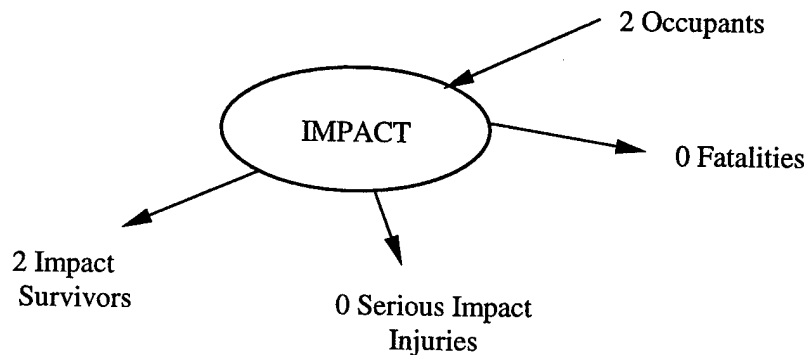
SCENARIO 8

**Scenario 8** represents the area occupied by the R3 and L3 flight attendants, both of whom escaped serious injury.

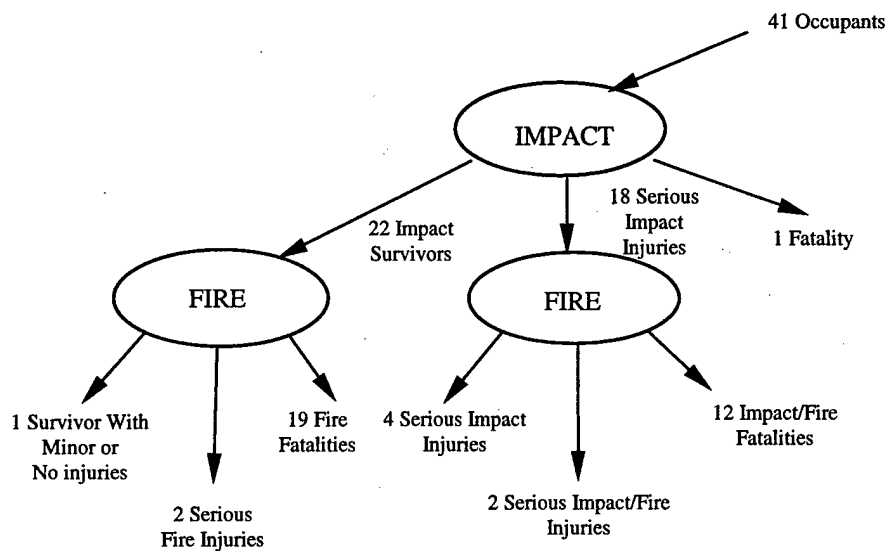
#### SCENARIO 9

**Scenario 9** represents the area of the main cabin in which the majority of occupants suffered fatal injuries from asphyxiation.

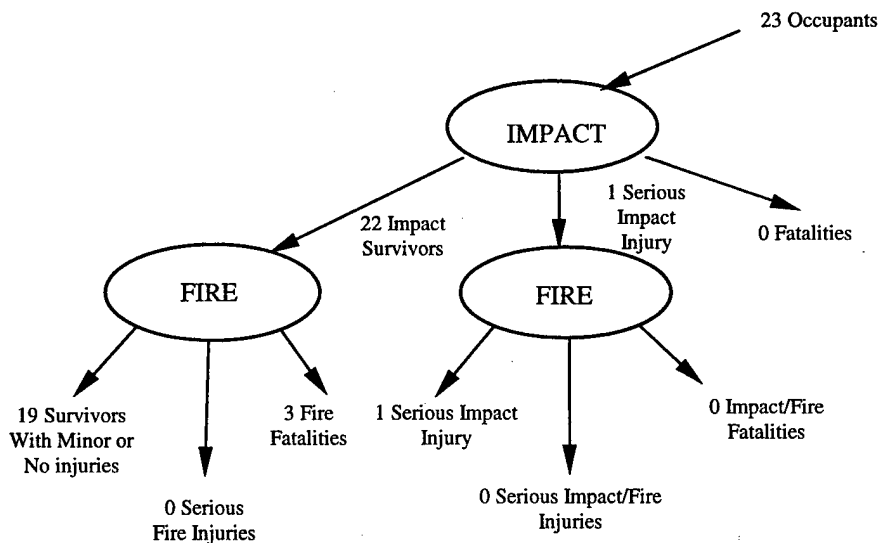
#### SCENARIO 10

**Scenario 10** represents the area of the main cabin directly opposite from Scenario 9, in which many occupants escaped with minor or no injuries.

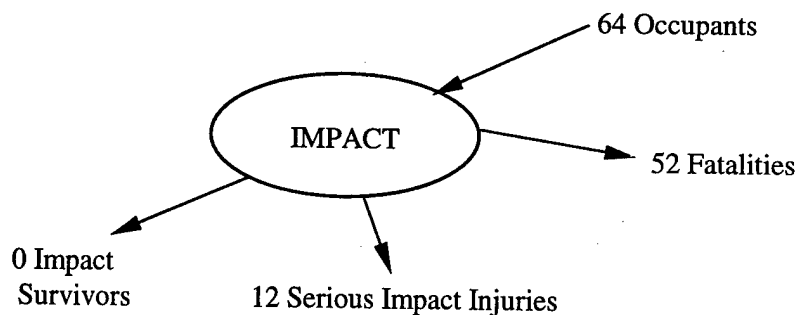
SCENARIO 11

**Scenario 11** represents the remainder of the passenger cabin aft to seat rows 36. It is assessed that this portion of the cabin contained 64 occupants of which 52 sustained fatal injuries as a result of impact trauma.

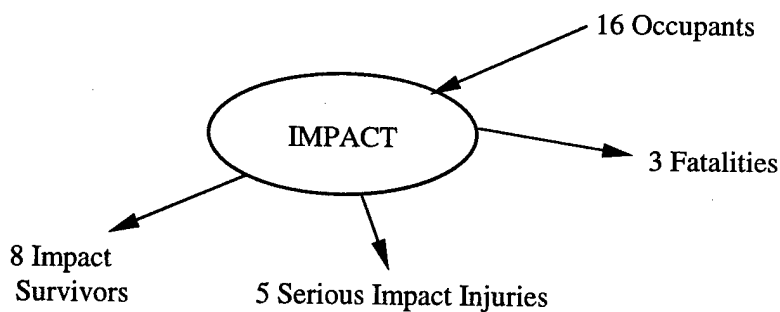
SCENARIO 12

**Scenario 12** represents the passenger cabin aft of seat row 36. It is assessed that this portion of the cabin contained 16 occupants of which 3 sustained fatal injuries as a result of impact trauma.

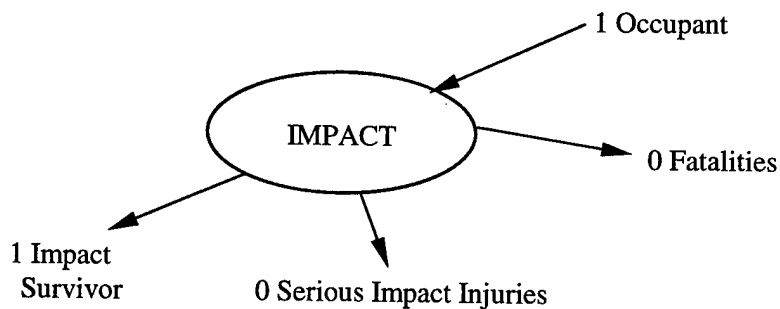
SCENARIO 13

**Scenario 13** represents the area occupied by the aft flight attendant, who escaped serious injury.

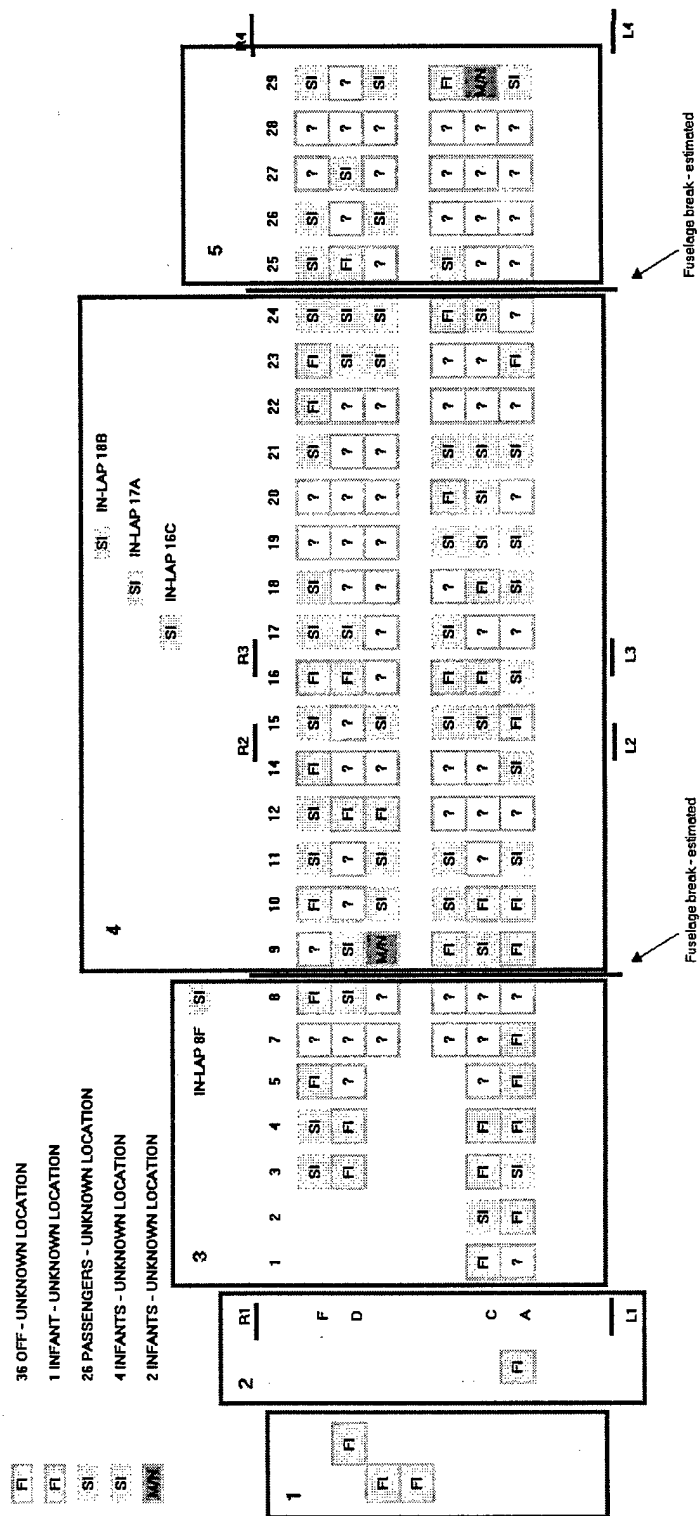
FIGURE A-7. LOCATION OF INJURIES AND SCENARIOS

This accident is considered as having five scenarios, as shown in figure A-7.

Occupants with known injuries but unknown seat locations have been added to scenarios 3, 4, and 5 based on the proportion of known injuries and seat locations.

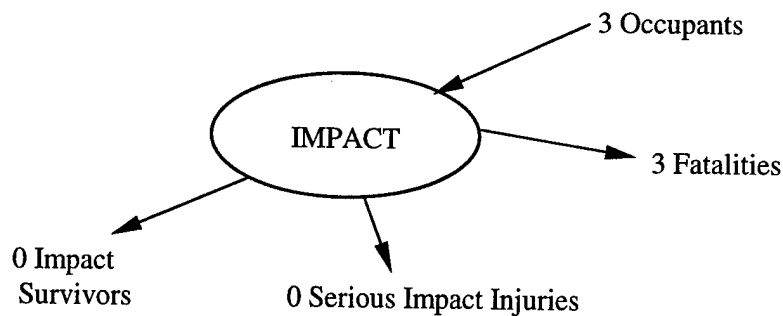
SCENARIO 1

**Scenario 1** represents the cockpit area where the three flight crewmembers were located.

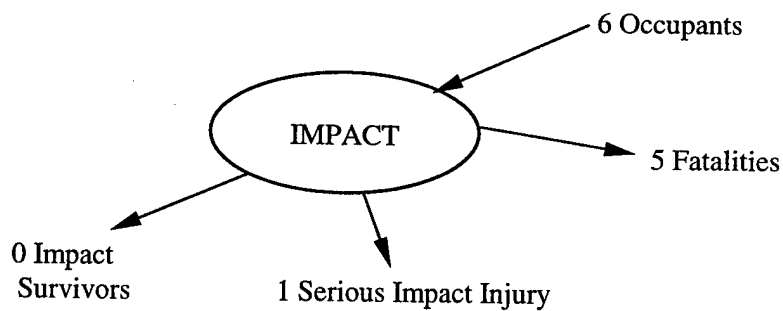
SCENARIO 2

**Scenario 2** represents the areas occupied by the flight attendants.

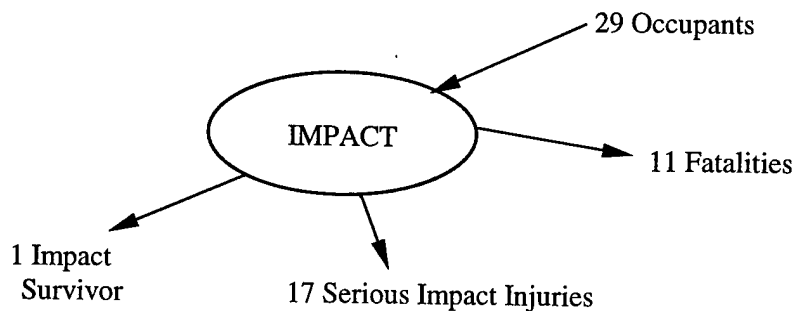
SCENARIO 3

**Scenario 3** represents passenger seat rows 1 through 8, which were located in the forward separated fuselage section.

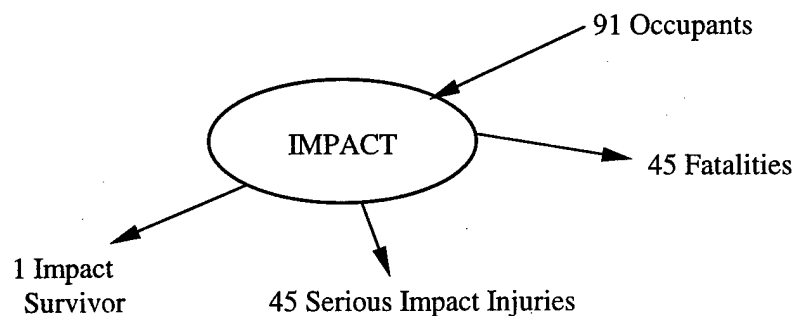
SCENARIO 4

**Scenario 4** represents passenger seat rows 9 through 24, located in the middle separated fuselage section.

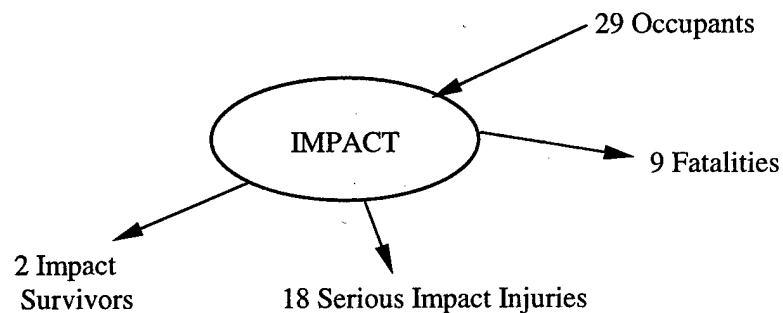
SCENARIO 5

**Scenario 5** represents passenger seat rows 25 through 29, located in the rear separated fuselage section.

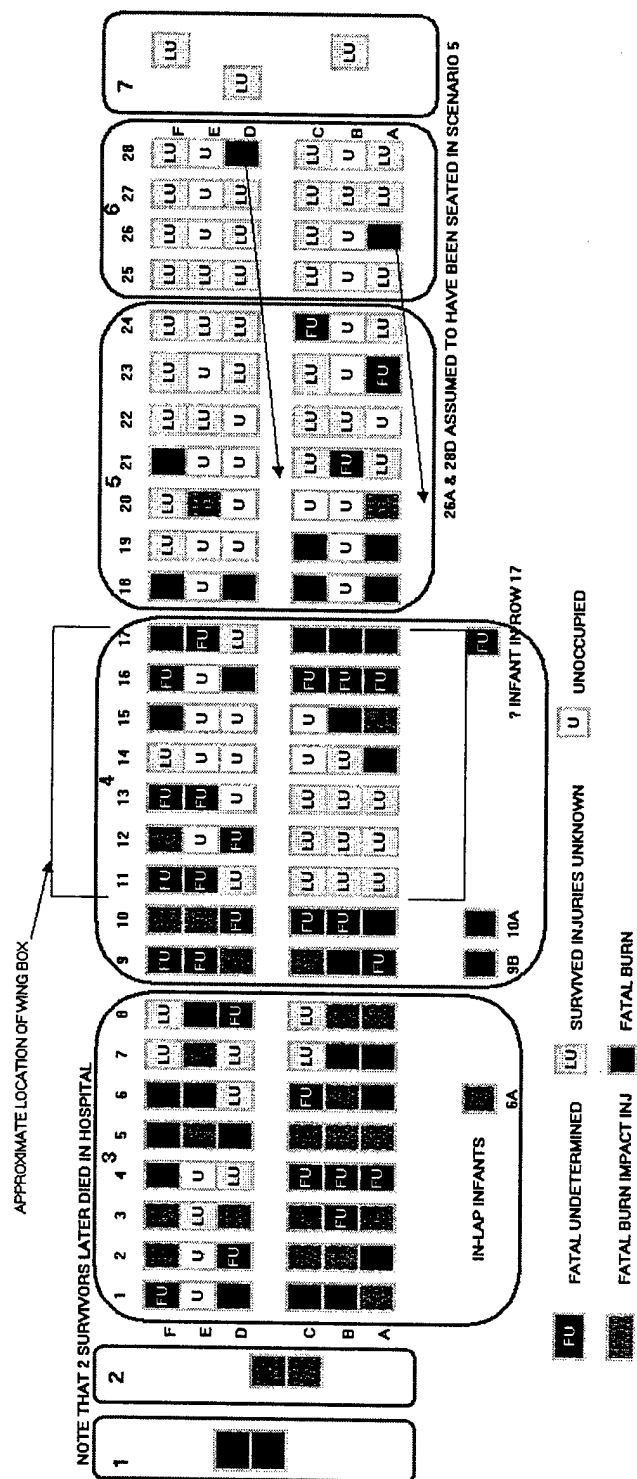
FIGURE A-8. LOCATION OF INJURIES AND SCENARIOS

This accident is considered as having seven scenarios, as shown in figure A-8.

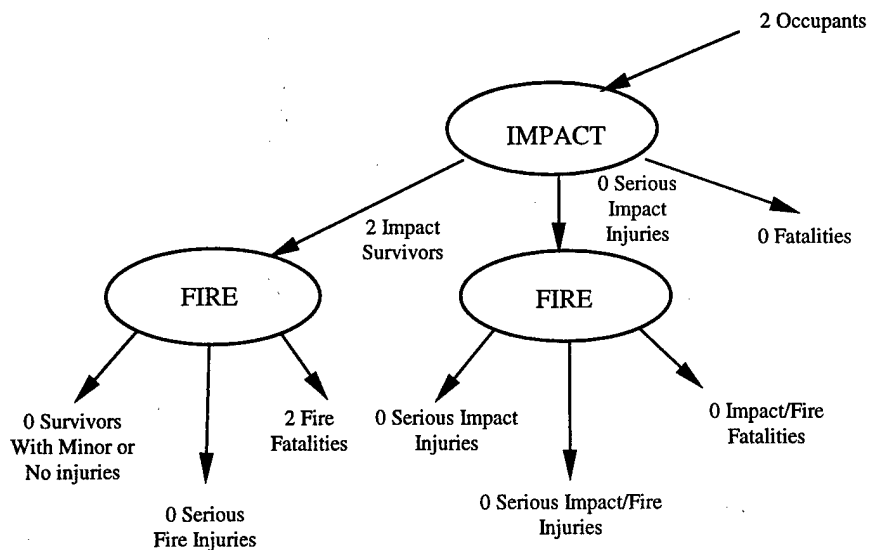
#### SCENARIO 1

**Scenario 1** represents the cockpit area containing two flight crewmembers, who suffered fatal injuries due to the fire.

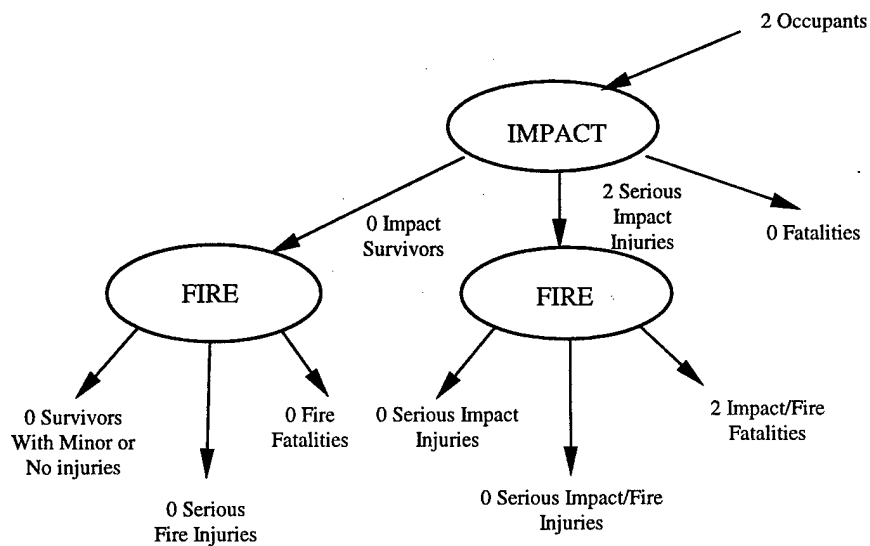
#### SCENARIO 2

**Scenario 2** represents the forward vestibule area containing two cabin crewmembers, who suffered fatal injuries due to impact and the fire.

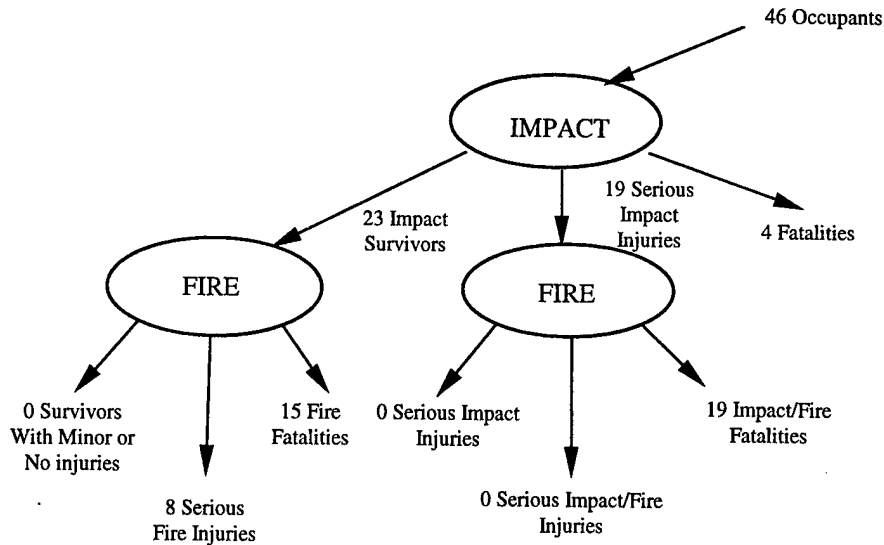
### SCENARIO 3

**Scenario 3** represents passenger seat rows 1 through 8, containing 46 passengers.

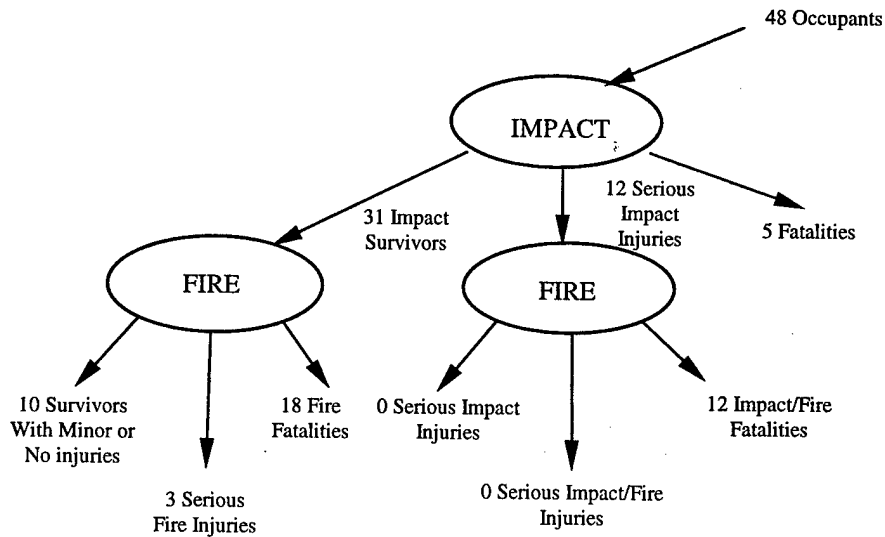
### SCENARIO 4

**Scenario 4** represents passenger seat rows 9 through 17, containing 48 passengers.

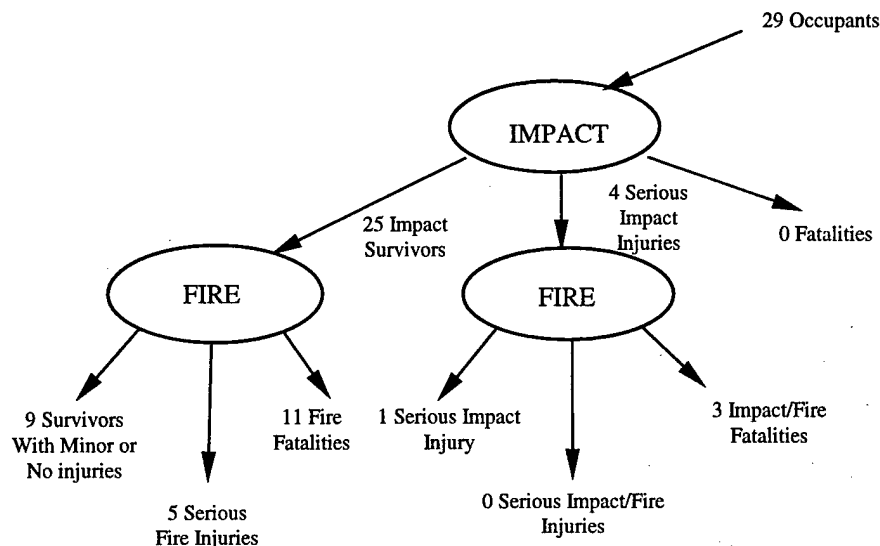
### SCENARIO 5

**Scenario 5** represents passenger seat rows 18 through 24, containing 29 passengers.

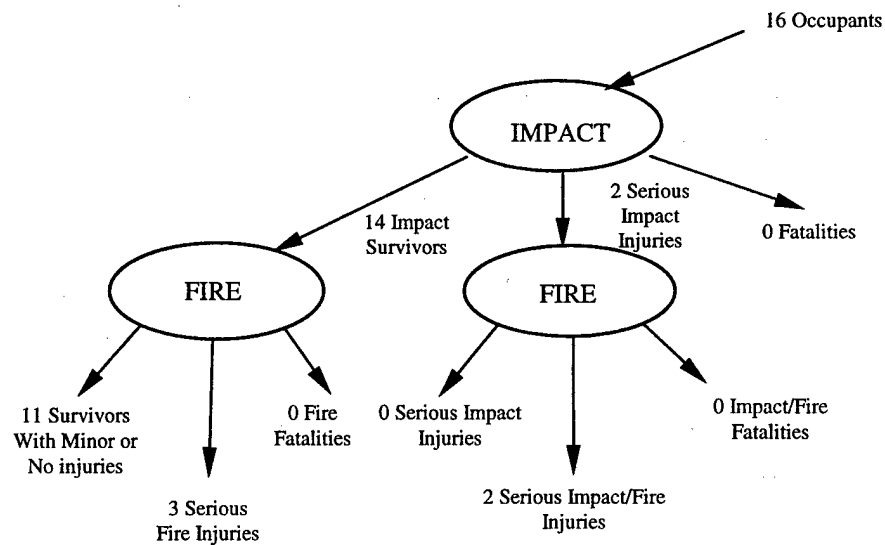
### SCENARIO 6

**Scenario 6** represents passenger seat rows 25 through 28, containing 16 passengers.

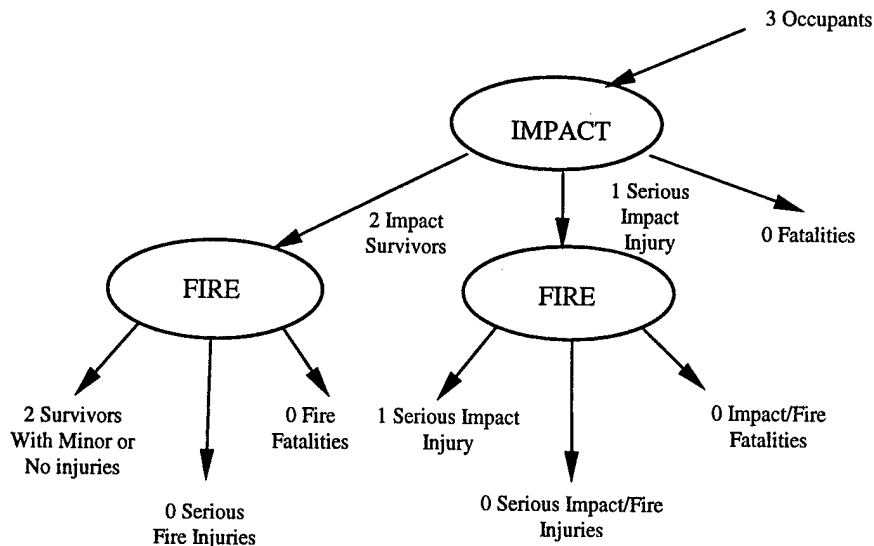
## SCENARIO 7

**Scenario 7** represents the rear cabin crewmember area containing three cabin crew, one of which suffered serious injuries when hitting her head after being thrown out of her seat.

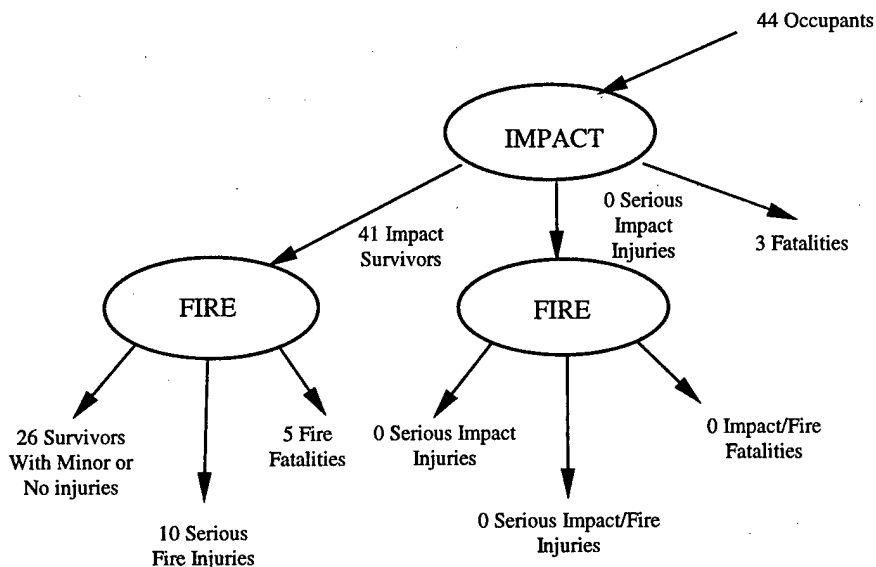
Details of seat location and injuries were available for only some of the occupants; therefore this accident was considered as a single scenario encompassing the whole cabin.

It has been assumed that the 10 serious injuries were due to the ensuing fire because the only impact forces came directly from the B727's wing penetrating the fuselage, causing impact fatalities.

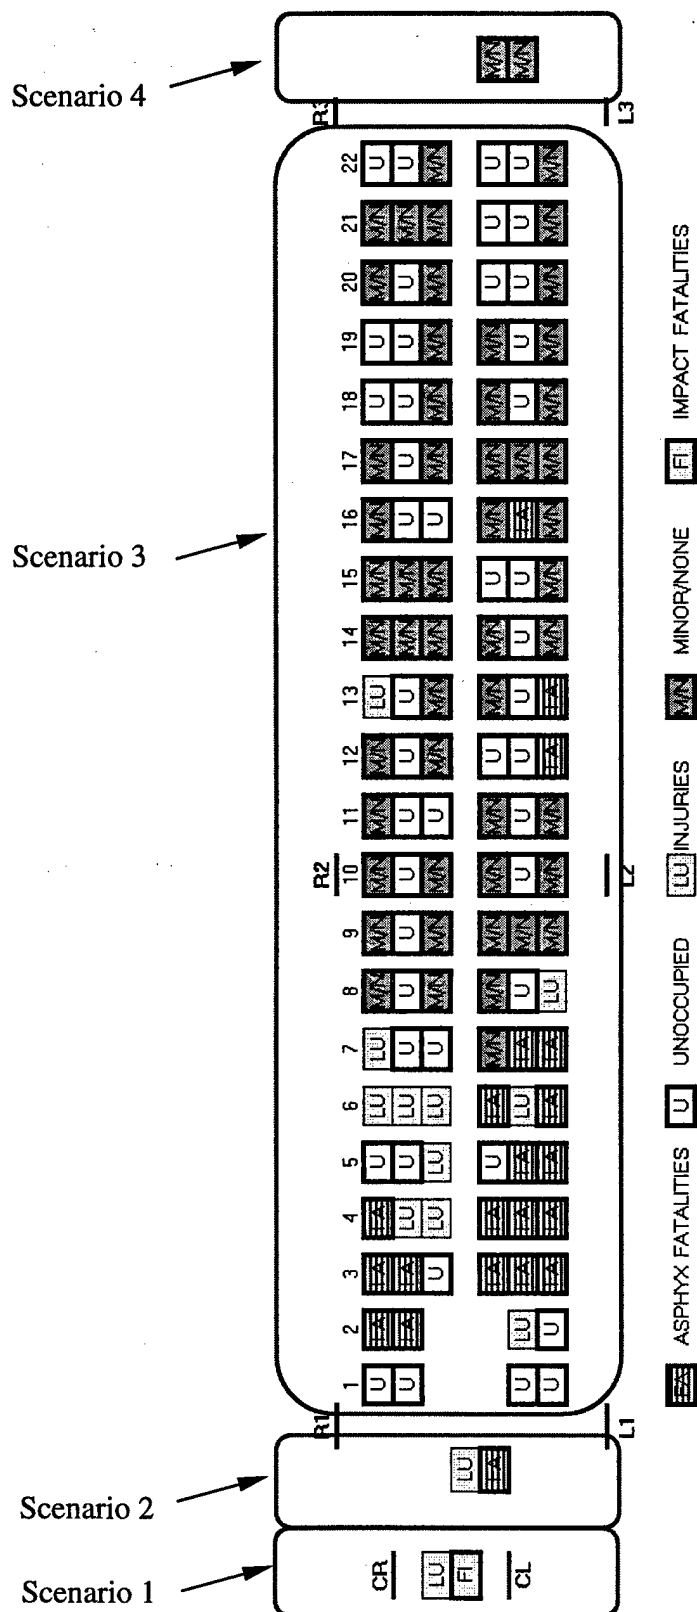
FIGURE A-9. LOCATION OF INJURIES AND SCENARIOS

The accident is considered as four separate scenarios as shown in figure A-9. The survivability chains for these scenarios are as follows:

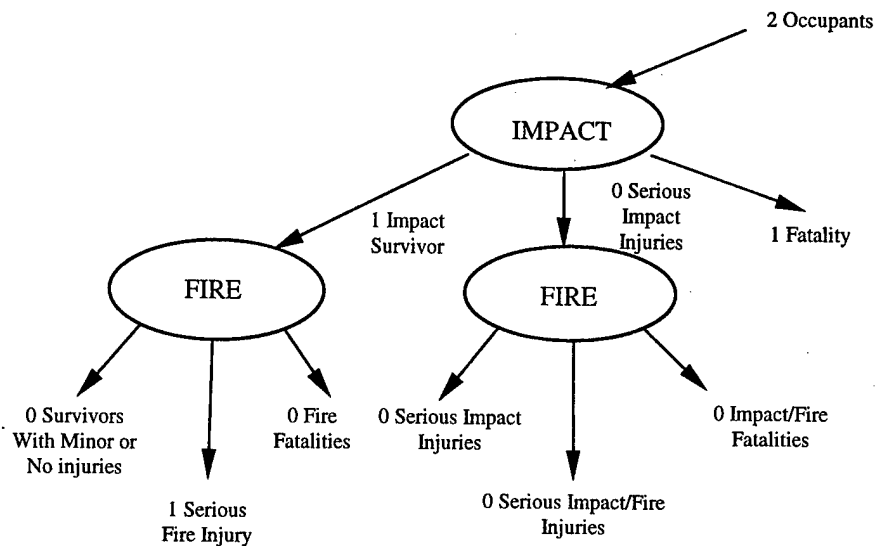
#### SCENARIO 1

**Scenario 1** represents the flight compartment area. Of the two flight crew occupying this area, the captain sustained fatal injuries as a result of the impact. The other flight crew suffered serious fire burns.

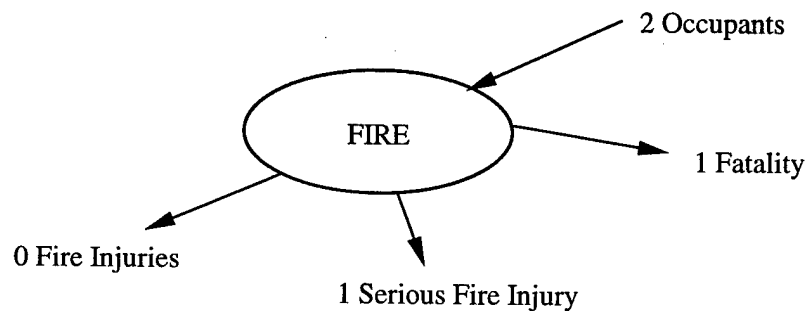
#### SCENARIO 2

**Scenario 2** represents the forward flight attendant area. One flight attendant died of asphyxia due to smoke inhalation and the other suffered serious fire burns.

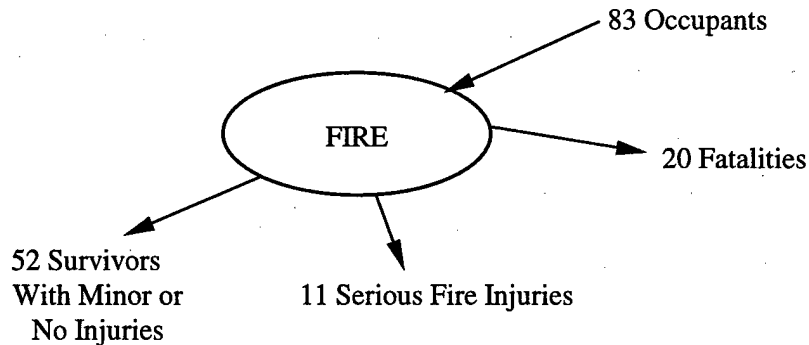
SCENARIO 3

**Scenario 3** represents the entire passenger cabin containing seat rows 1 to 22. This scenario contains 83 passengers. Nineteen passengers died of asphyxia due to smoke inhalation. One passenger died due to thermal burns. Eleven passengers suffered serious fire burns.

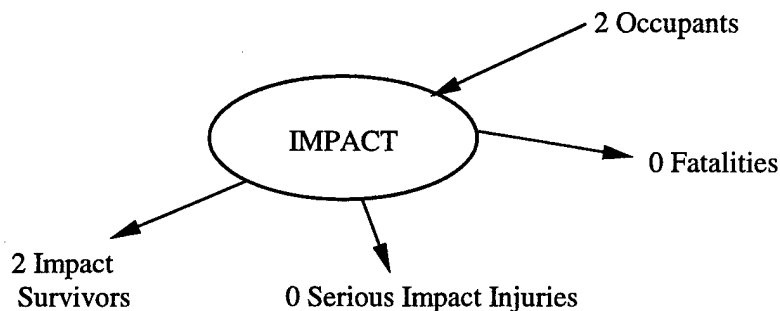
SCENARIO 4

**Scenario 4** represents the aft cabin attendant area, which contains two flight attendants. Both of them suffered minor or no injuries.

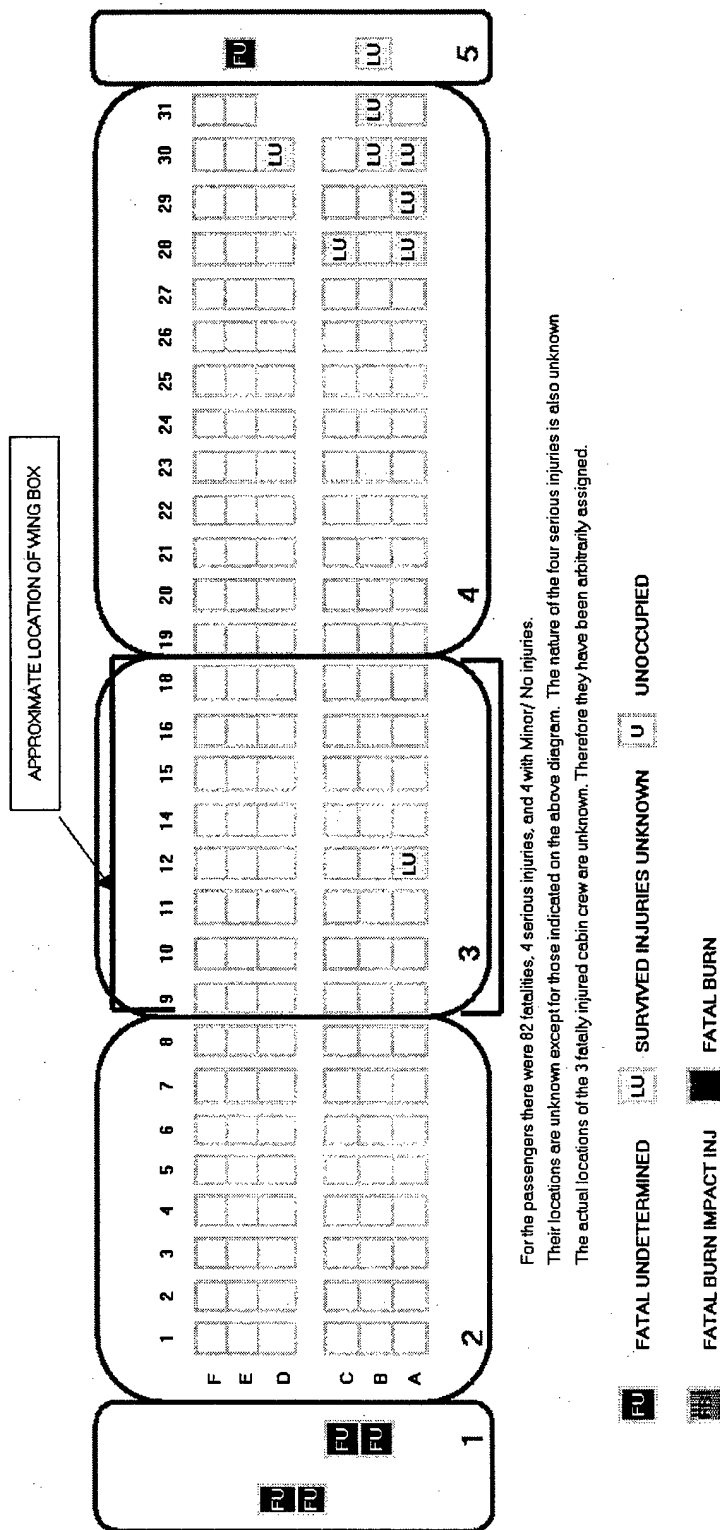
FIGURE A-10. LOCATION OF INJURIES

This accident is divided into five separate scenarios, as shown in figure A-10. Since the location of the fatally and the seriously injured occupants is unknown, it is assumed that the 90 passengers onboard the aircraft were evenly distributed in the cabin; i.e., 25 passengers in scenario 2, 25 passengers in scenario 3, and 40 passengers in scenario 4.

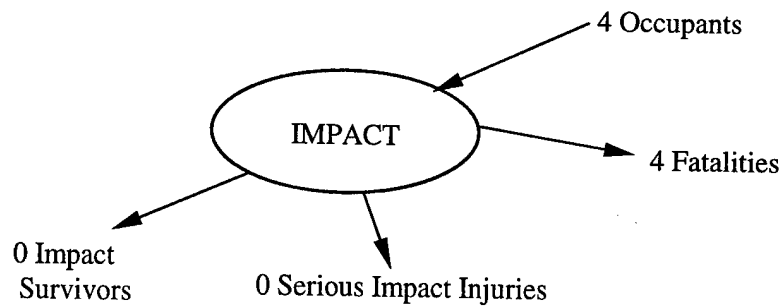
SCENARIO 1

**Scenario 1** represents the flight deck and the vestibule area containing two flight crew and two cabin crew. All four crewmembers sustained fatal impact injuries in the impact.

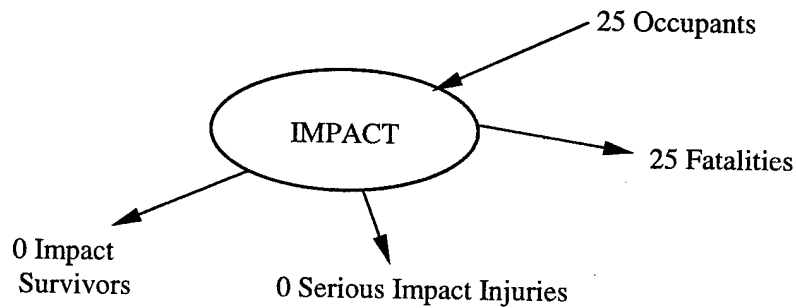
SCENARIO 2

**Scenario 2** represents seat rows 1 to 8. It is assumed that there were 25 passengers in this section and all died as a result of the impact.

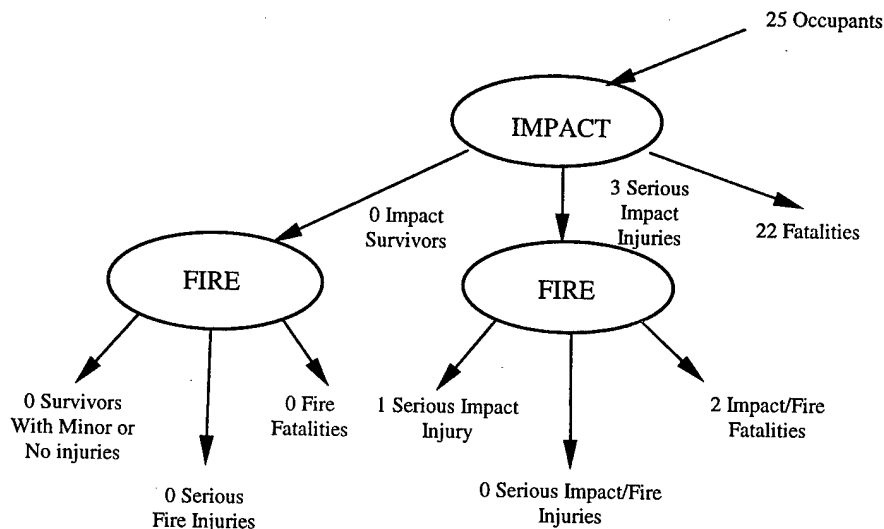
SCENARIO 3

**Scenario 3** represents seat rows 9 to 18. It is assumed that there were 25 passengers in this section and 22 of the passengers died as a result of the impact. Two passengers died as a result of impact and fire. One passenger sustained serious impact injuries. This passenger was ejected in his seat and received fractured ankles.

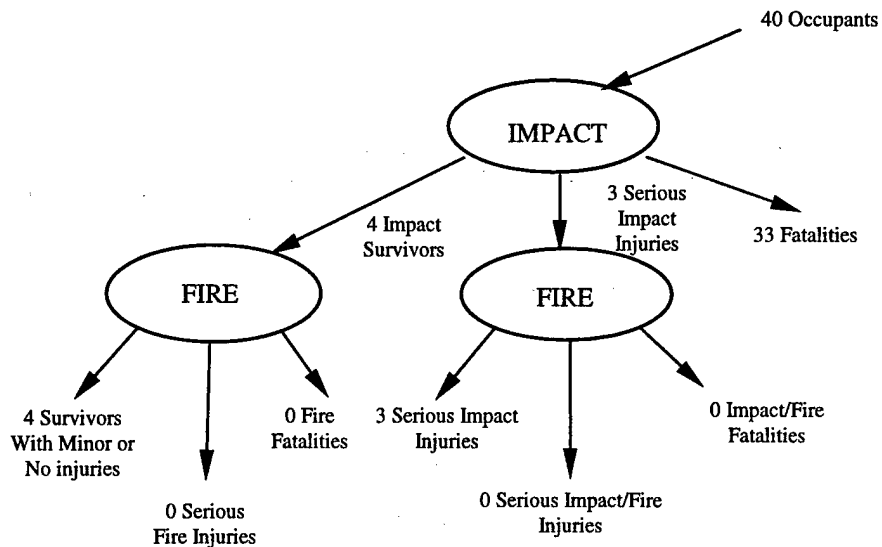
#### SCENARIO 4

**Scenario 4** contains seat rows 19 to 31. It is assumed that there were 40 passengers in this section, 33 passengers died as a result of the impact. Three passengers sustained serious impact injuries and four with minor or no injuries.

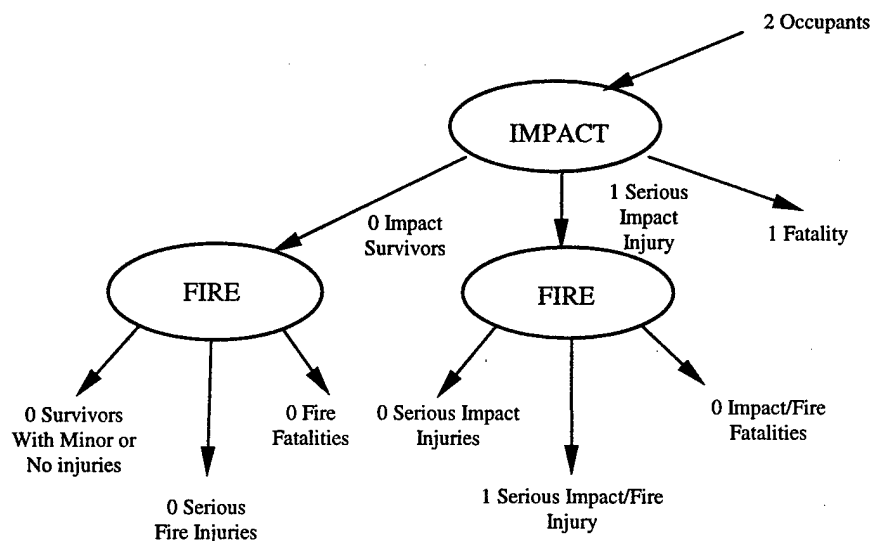
#### SCENARIO 5

**Scenario 5** represents the rear cabin crew area, containing two flight attendants. One flight attendant died as a direct result of the impact and the other flight attendant is assumed to have sustained serious injuries as a result of impact and fire.

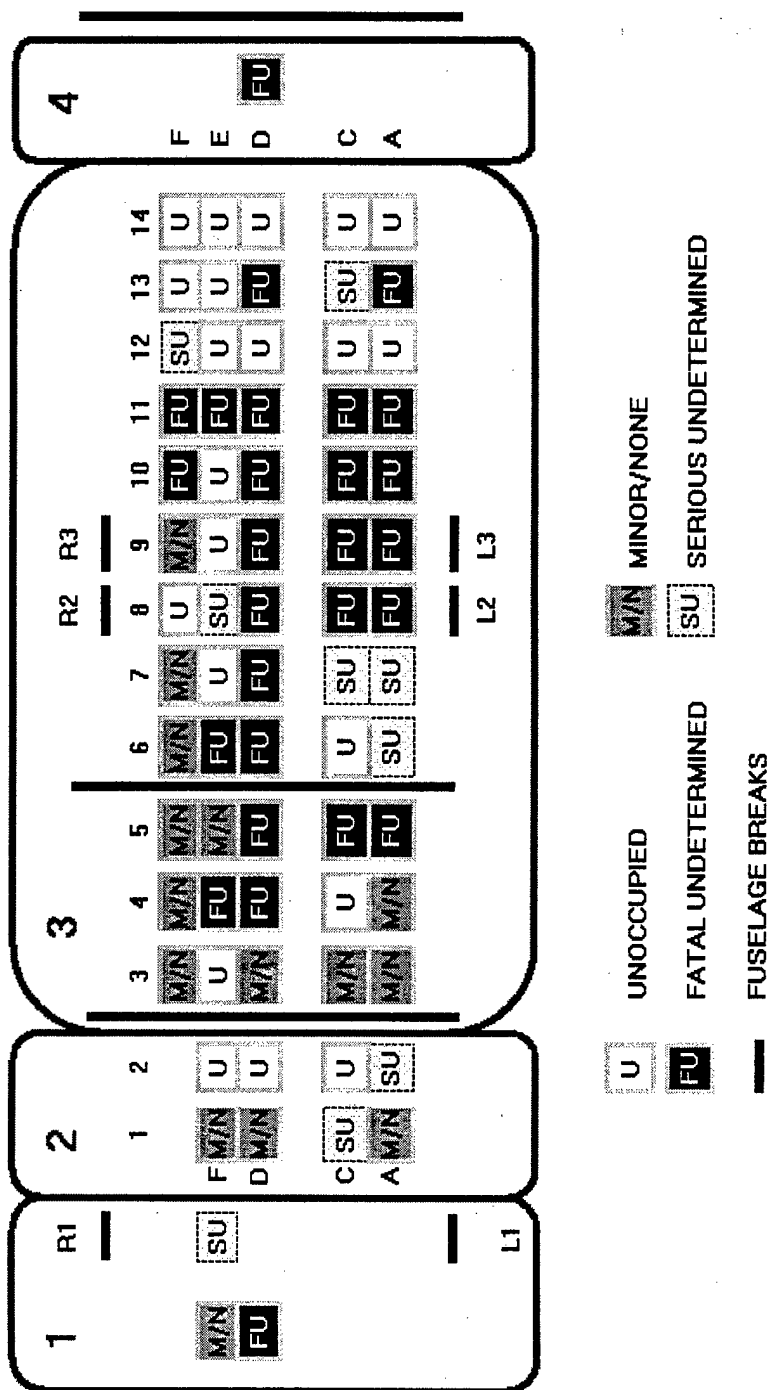
FIGURE A-11. LOCATION OF INJURIES AND SCENARIOS

This accident is divided into four separate scenarios, as shown in figure A-11. Within scenario 3, three survivability chains were used to represent the injuries.

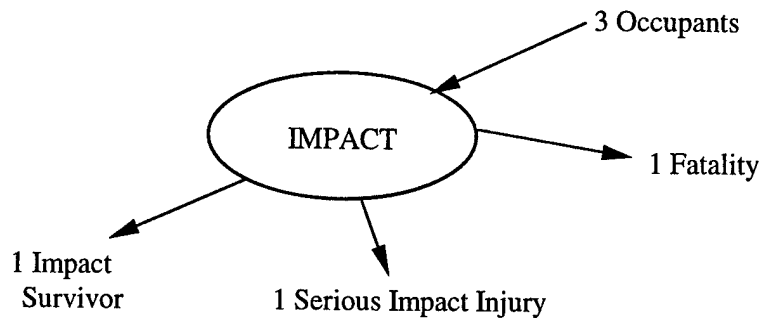
SCENARIO 1

**Scenario 1** contains the flight deck and the forward galley area which was subjected to impact damage. The scenario contains two flight crew and one flight attendant. Due to absence of detailed documentary evidence on the location of injuries, it is assumed that the captain died of blunt force trauma and the flight attendant sustained serious impact-related injuries. This is based on the fact that the left side and bottom of this section were crushed by impact forces. A hole was in the fuselage skin to the left of the captain's seat. The floor on the left side of the cockpit and the captain's seat pedestal were displaced upward. The right side of the forward fuselage near the roof exhibited compression wrinkles. There was no sign of any fire damage in this section.

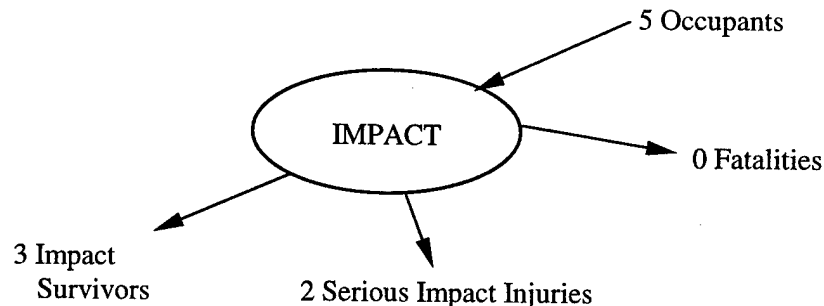
SCENARIO 2

**Scenario 2** contains passenger seat rows 1 and 2 which were subjected to impact damage. The scenario contains five passengers, three of whom suffered minor or no injuries and two suffered serious injuries.

Due to the absence of detailed documentary evidence on the location of injuries, it is assumed that the two injured passengers sustained serious impact-related injuries. This section suffered impact damage and the right side of the forward fuselage near the roof exhibited compression wrinkles. There was no sign of any fire damage in this section.

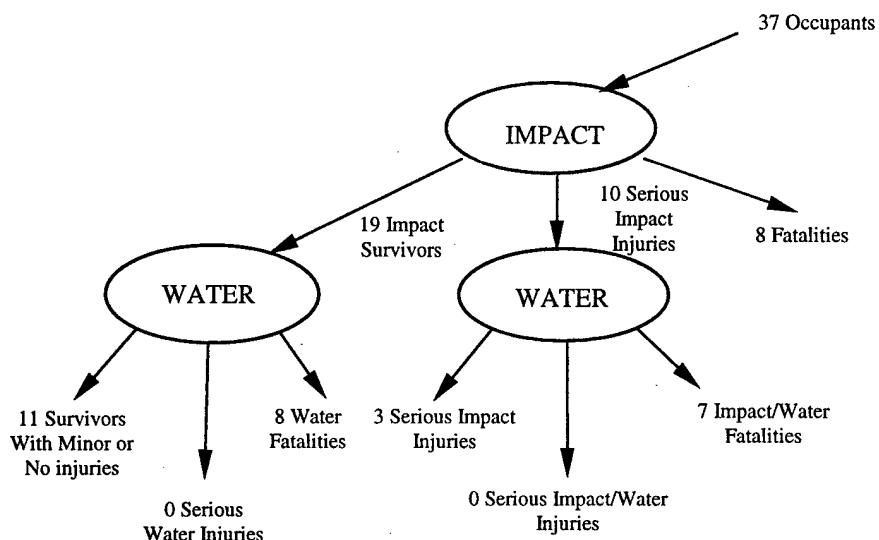
CHAIN 1

**Scenario 3 - Chain 1** represents those occupants in seat rows 3 to 14 who were subjected to the impact and then immersion in water. It contains 37 passengers. Eight passengers suffered fatal impact injuries, 7 passengers sustained serious injuries and died as a result of drowning, 8 passengers sustained minor impact injuries and died as a result of drowning, and 11 passengers received minor or no injuries. Due to the absence of detailed information on the location of injuries, it is assumed that three of the six seriously injured survivors sustained only impact injuries, but not head injuries.

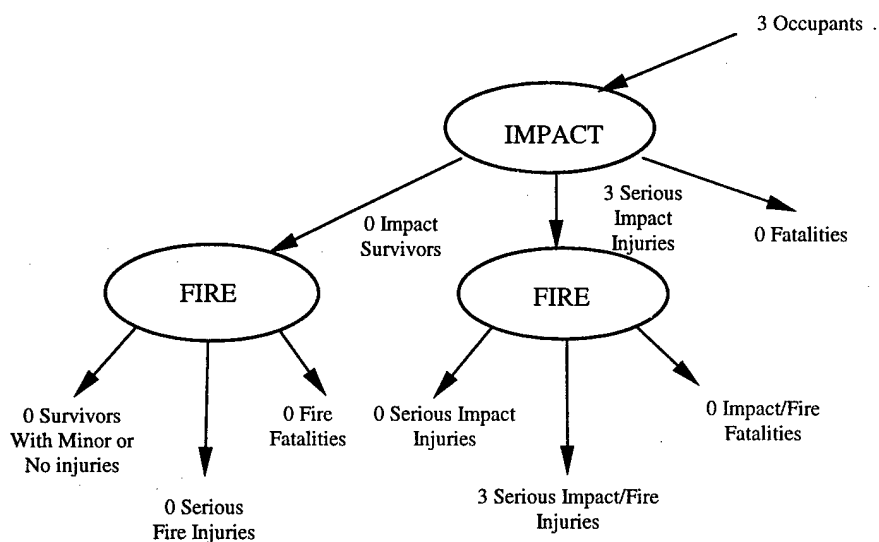
CHAIN 2

**Scenario 3 - Chain 2** represents those occupants seated between rows 6 to 13 who were seriously injured in the accident. Due to the absence of detailed information on the location of injuries, it is assumed that the three seriously impact injured survivors also suffered thermal burns but no head injuries. This is consistent with the data in the accident report.

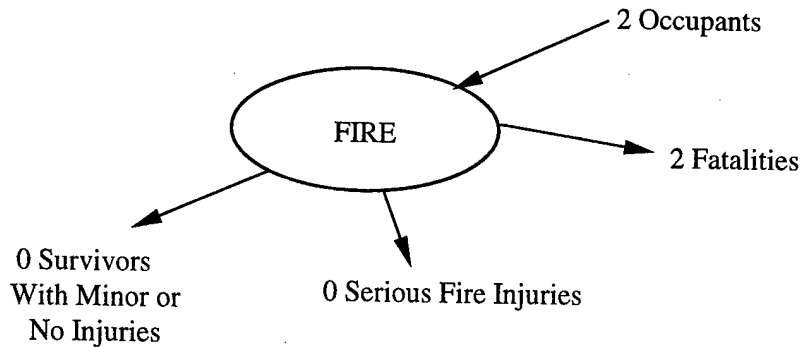
CHAIN 3

**Scenario 3 – Chain 3** represents the two occupants seated between rows 3 to 14 who were killed by the postaccident fire.

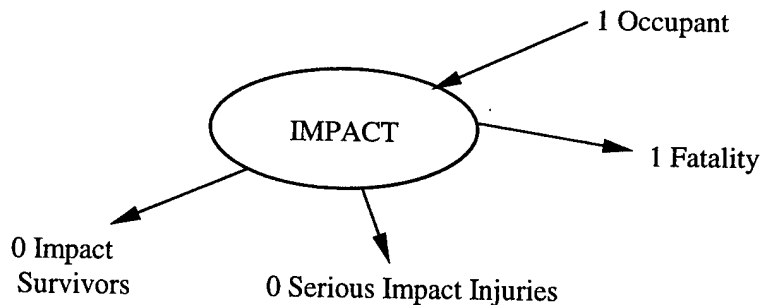
SCENARIO 4

**Scenario 4** represents the rear flight attendant's area which contains one flight attendant. Due to absence of detailed documentary evidence on the location of injuries, it is assumed that the flight attendant died of blunt force trauma.

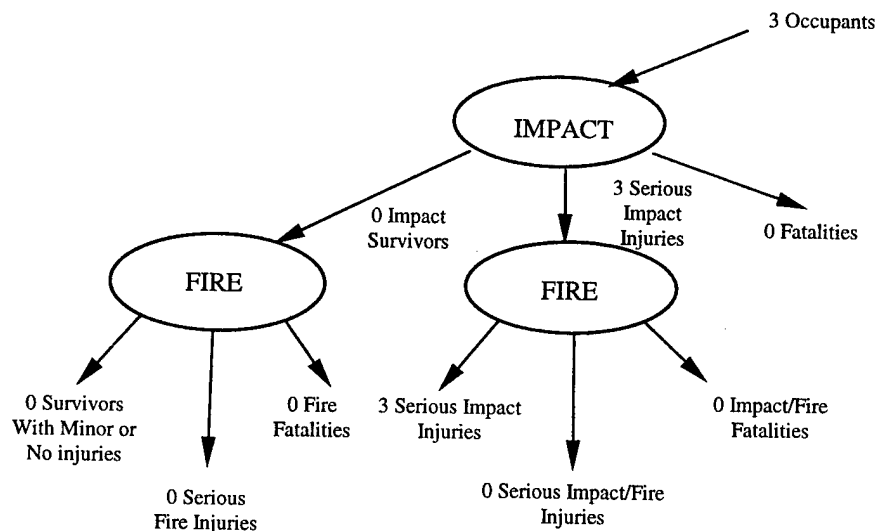
**CHAIN 2**

It is assumed that the aircraft was not configured with cabin materials compliant with the heat release requirements of the FAR 25 at amendment 61. It is further assumed that had this been the case the three impact injured passengers would not have sustained fire injuries. The survivability chain is thus modified as follows:

Since detailed information on seat related injuries is not available, the high assessment is taken as there being no change in the number of passengers seriously injured in the impact. The low assessment is based on all three passengers surviving the impact uninjured had fully compliant 16-g seats been installed. The median assessment is taken as being the average of these two extremes. This assessment is summarised as follows:

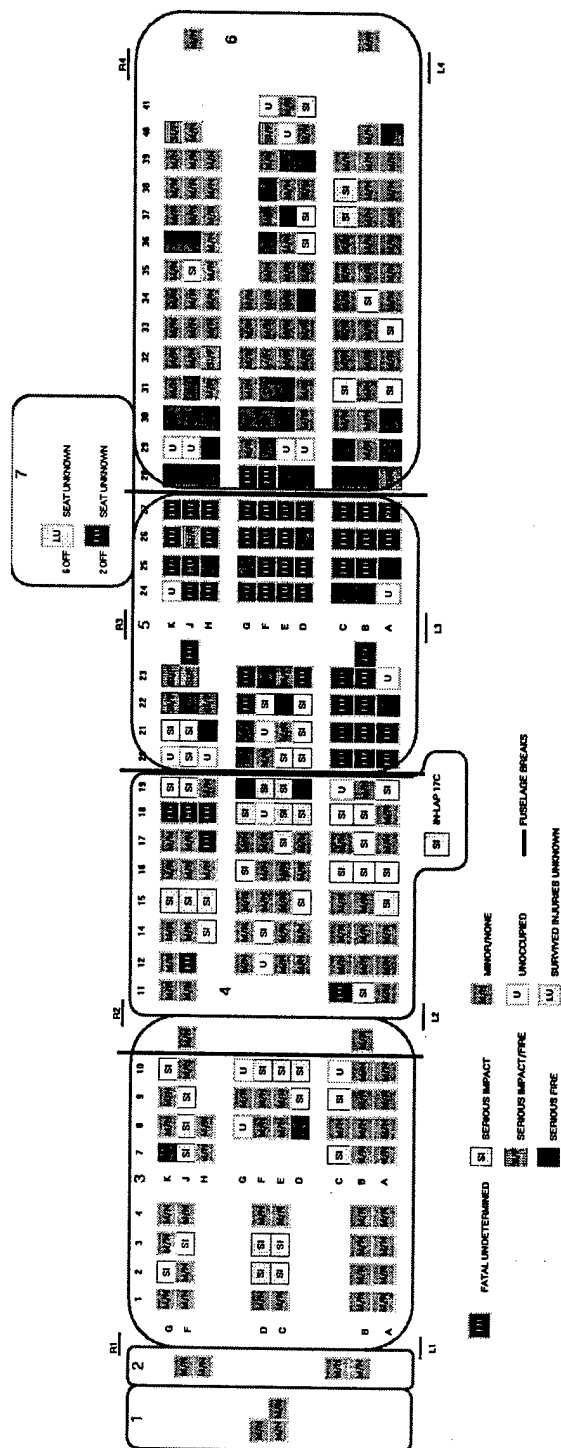
FIGURE A-12. LOCATION OF INJURIES AND SCENARIOS

This accident is divided into seven separate scenarios, as shown in figure A-12. Scenarios 3 to 6 are bounded by the fuselage ruptures.
