**DOT/FAA/AR-00/13**

# **Benefit Analysis for Aircraft 16-g Dynamic Seats**

April 2000

Final Report

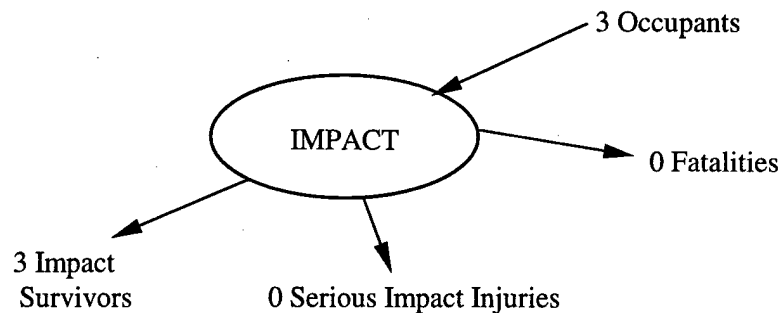
SCENARIO 1

**Scenario 1** contains the flight deck area which was subjected to the impact and was not fire damaged. The scenario contains the three flight crew.

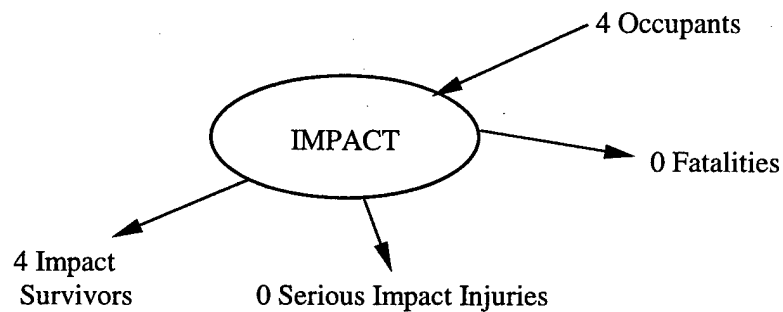
SCENARIO 2

**Scenario 2** contains the forward flight attendant area and encompasses four flight attendants, none of whom sustained serious or fatal injuries.

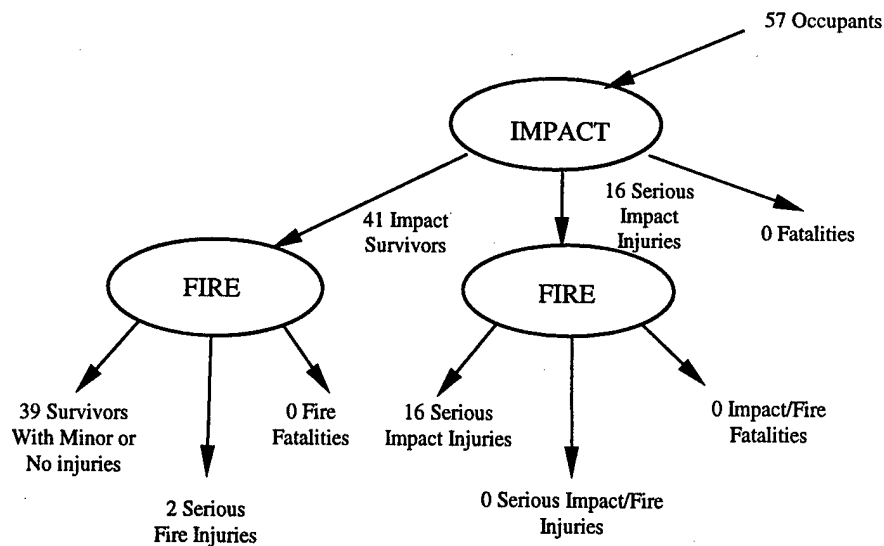
### SCENARIO 3

**Scenario 3** contains the forward fuselage, seat rows 1 to 10, which was subjected to the impact and was not fire damaged. The scenario contains 2 crew and 55 passengers. Two passengers in this scenario sustained serious fire injuries in the accident. It is assumed that the injuries were caused by fire outside the cabin during the evacuation.

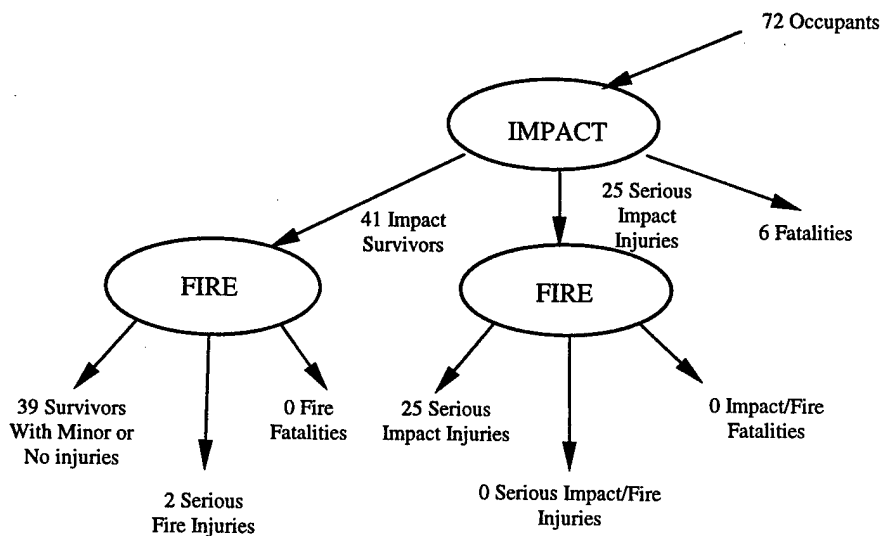
### SCENARIO 4

**Scenario 4** contains the mid-forward section, seat rows 11 to 19, which was subjected to the impact and was not fire damaged. The scenario contains 72 passengers. This section contained no fire during the accident therefore it is assumed that the six occupants who sustained undetermined injuries were killed by impact. This is supported by the fact that a large number of occupants in this section were ejected during the impact. Two passengers suffered serious injuries from fire but they were located at a fuselage break, and it is assessed that either the fire spread locally across the break or they sustained injuries during egress.

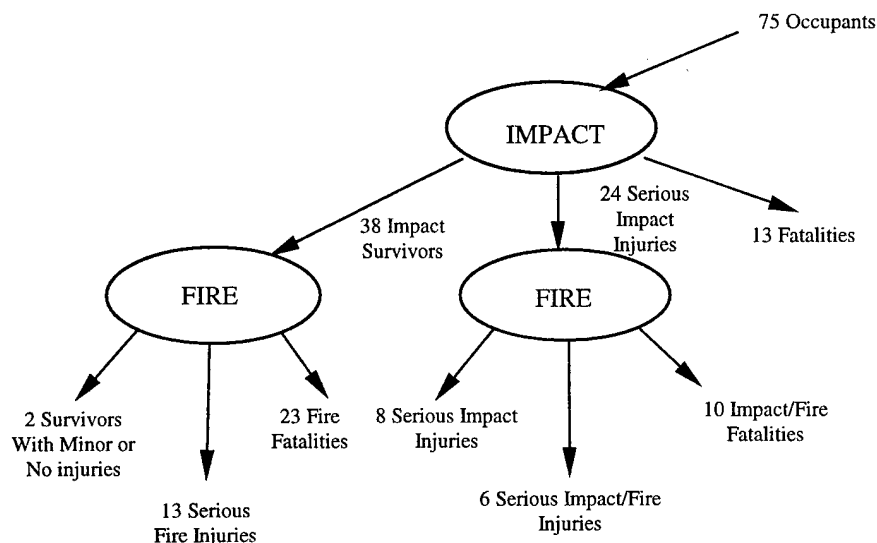
#### SCENARIO 5

**Scenario 5** contains the mid-rearward section, seat rows 20 to 27, which suffered an explosion and fire after the initial impact. The scenario contains the 2 crew and 73 passengers. It was reported that some of the passengers died as the fuselage split and it is therefore assumed that 13 of the undetermined fatally injured passengers, located along the separation, were killed by impact trauma or were thrown out. Of the remaining 33 fatalities, the 2 flight attendants were known to be killed from the fireball. Of the remaining 31 undetermined fatalities it is assumed that occupants in seat rows 21 to 23 suffered impact injuries and then died from the fire, and occupants in seat rows 24 to 26 were killed by fire only.

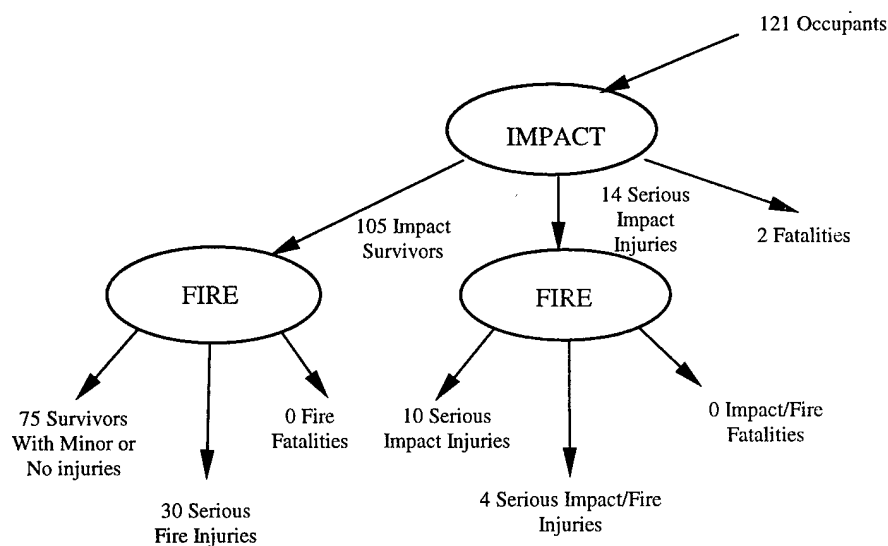
#### SCENARIO 6

**Scenario 6** contains the rear section, seat rows 28 to 41, and the rear flight attendant area, which was subjected to fire after the initial impact. The scenario contains 2 crew and 119 passengers. It is assumed that the two occupants seated in row 28F and G were killed by impact trauma as the fuselage split into sections.

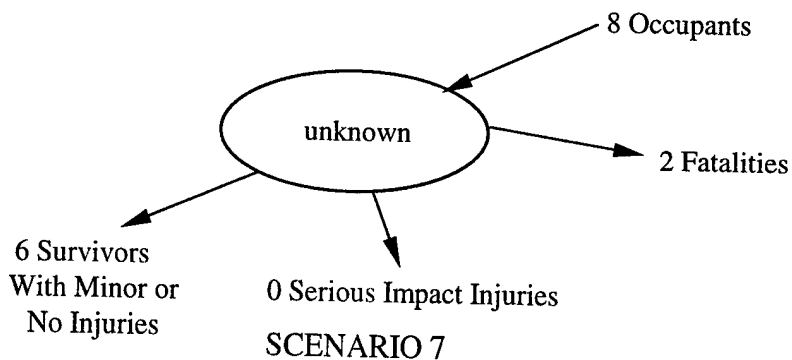
**Scenario 7** contains the eight occupants for which seat location and injuries were unknown. Absence of information results in the following simplified survivability chain. The six unknown injuries have been assumed minor or none since they were not significant enough to be reported officially. It is not possible to determine the cause of death for the two fatalities.

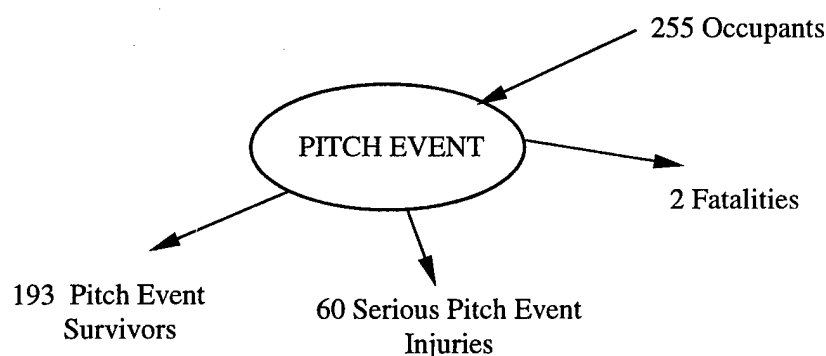
SCENARIO 1

Due to the lack of information on occupant location during the event, the aircraft has been considered as one scenario containing all occupants.

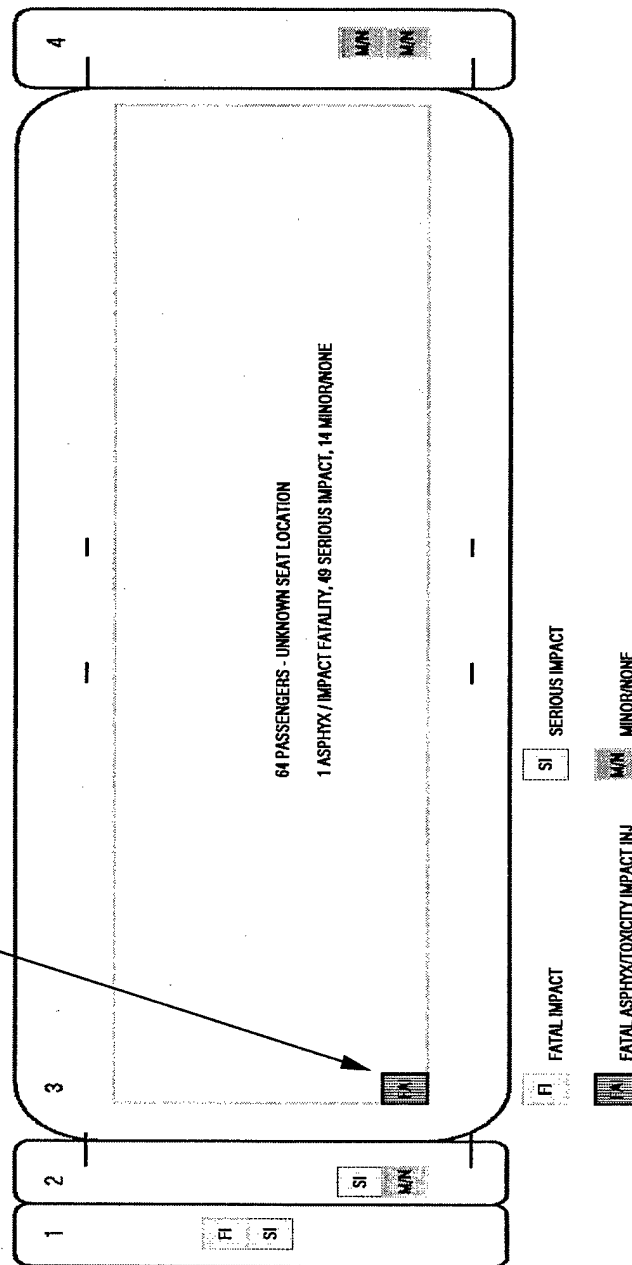
FIGURE A-13. LOCATION OF INJURIES AND SCENARIOS

This accident is divided into four separate scenarios, as shown in figure A-13.

The exact seating location of the fatally injured passenger is unknown, but was described as being in the utmost left seat in the Business Class. Although not reported as such it is assumed that this passenger also sustained serious impact injuries.

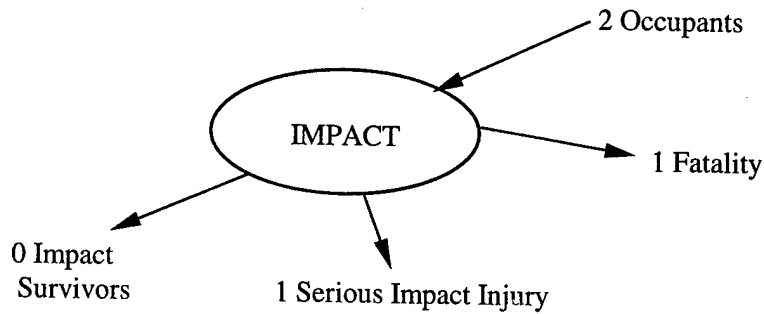
SCENARIO 1

**Scenario 1** contains the flight deck area where one flight crewmember died and the other sustained serious injuries from the impact.

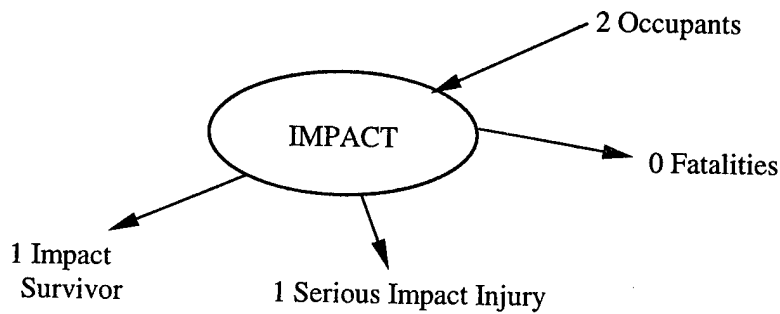
SCENARIO 2

**Scenario 2** contains the forward flight attendant area where only the chief steward sustained serious injuries from the impact. The scenario contains two flight attendants.

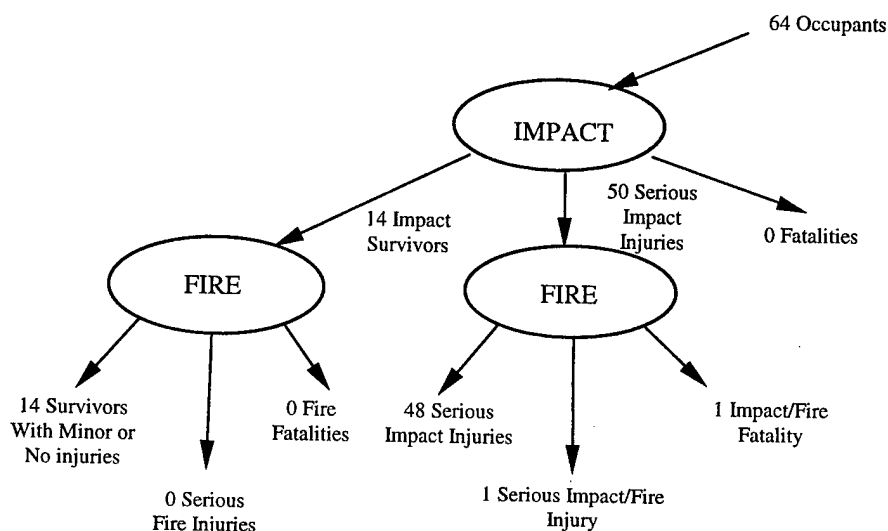
SCENARIO 3

**Scenario 3** contains the whole passenger cabin. This has been used because of limited detail on passenger locations during the accident. The scenario contains all 64 passengers. Fifty passengers received serious injuries as a result of the impact and one of these passengers died from intoxication.

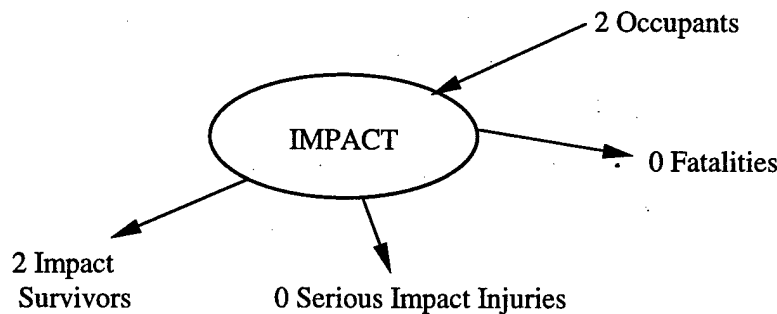
SCENARIO 4

**Scenario 4** contains the rear flight attendant area where the two flight attendants received minor or no injuries from the impact.

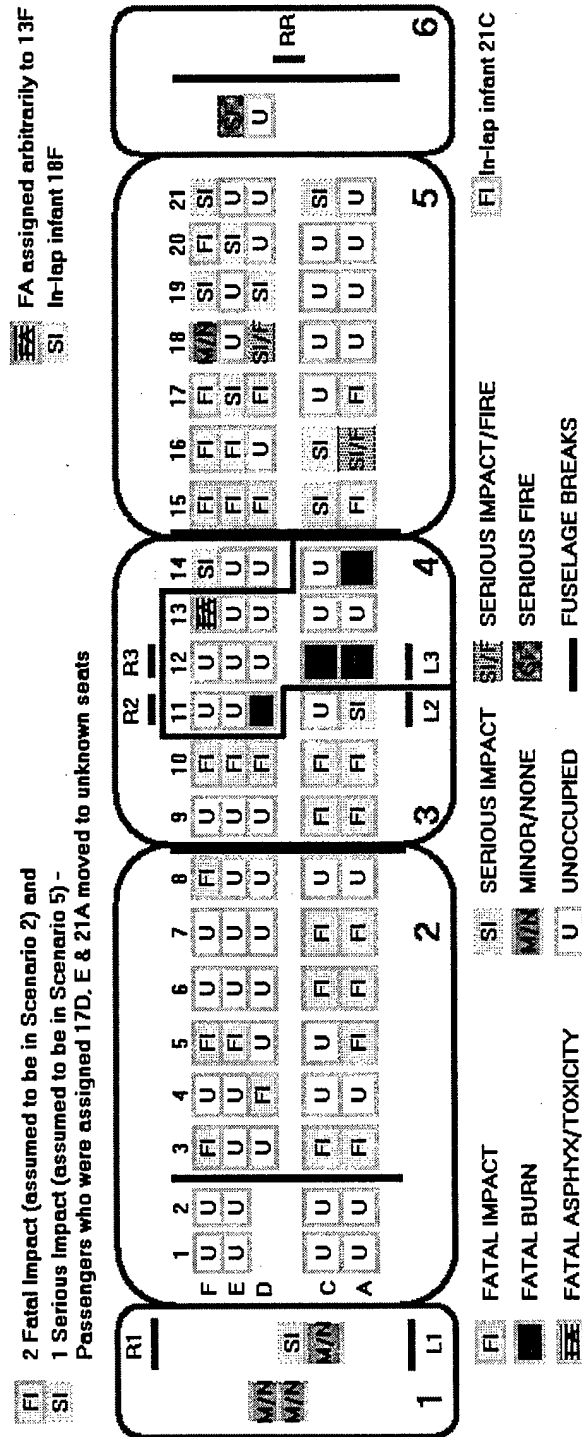
FIGURE A-15. LOCATION OF INJURIES AND SCENARIOS

This accident is divided into six separate scenarios, as shown in figure A-15.

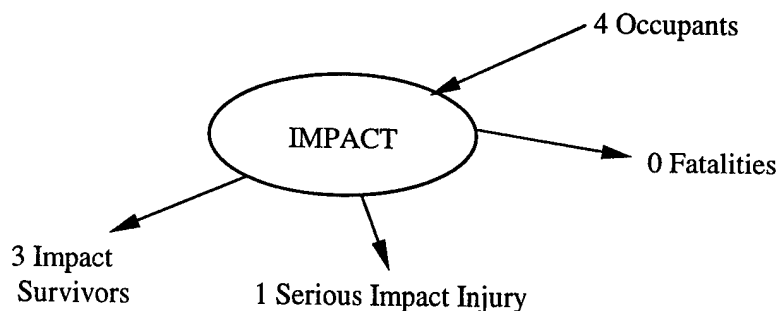
SCENARIO 1

**Scenario 1** represents the flight deck and the vestibule area containing two flight crew and two cabin crew. One cabin crewmember sustained serious injuries and the others received minor or no injuries in the impact.

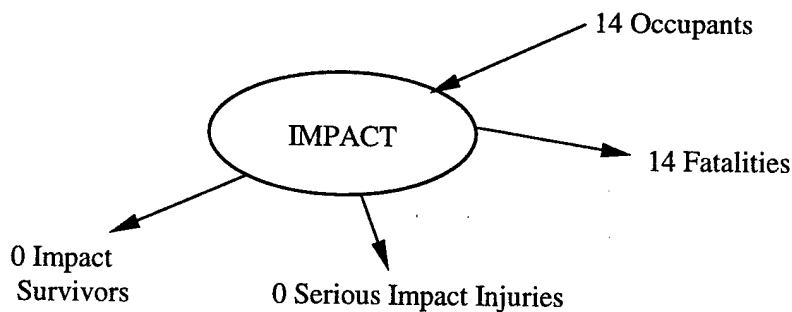
SCENARIO 2

**Scenario 2** represents the first class and part of the coach cabin area (rows 1 to 8) containing 12 fatally injured passengers. This section impacted two large hardwood trees and passenger seats were crushed against them. Due to the destruction of the fuselage in this section, it is assumed that the two impact fatalities of unknown seat location (originally assigned seats 17D and 17E) had moved to this part of the aircraft, since there were more unoccupied seats available in this section. Therefore, the total number of impact fatalities in this scenario is assessed to be 14.

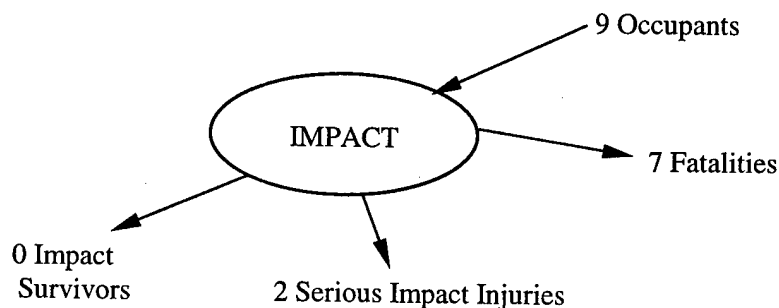
SCENARIO 3

**Scenario 3** represents passenger seat rows 9 and 10 and seats 11A and C and 14D, E, and F, which suffered impact damage and postaccident fire. Seven passengers suffered fatal impact injuries and two passengers suffered serious impact injuries. There were no fire injuries.

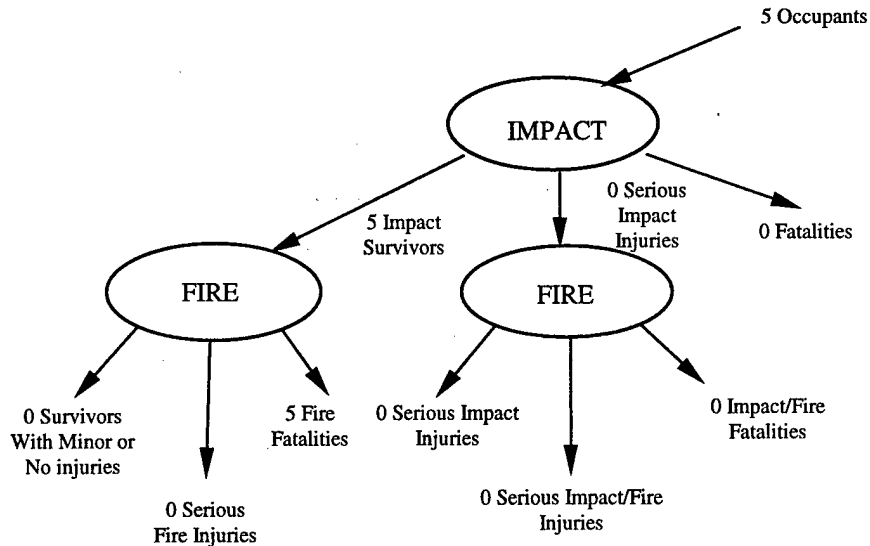
SCENARIO 4

**Scenario 4** represents passenger seat rows 12 and 13 and seats 11D, E, and F and 14A and C, which suffered impact damage and postaccident fire. Five passengers sustained fatal burn injuries. No passengers were injured as a result of the impact.

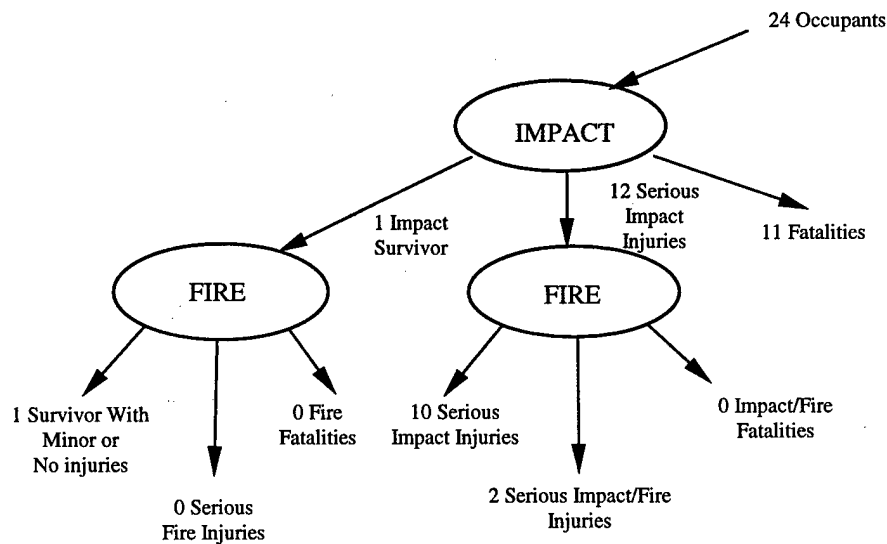
SCENARIO 5

**Scenario 5** represents passenger seat rows 15 through 21, containing 23 passengers (including 2 in-lap infants). Eleven passengers suffered fatal impact injuries, nine passengers sustained serious impact injuries, two passengers suffered serious impact and fire injuries, and one passenger received minor or no injuries. It is assumed that the passenger who suffered serious impact injuries of unknown location (originally assigned seat 21A) had moved to the unoccupied seat in 20A or 20C in front. Therefore, the total number of occupants in this scenario is assessed to be 24.

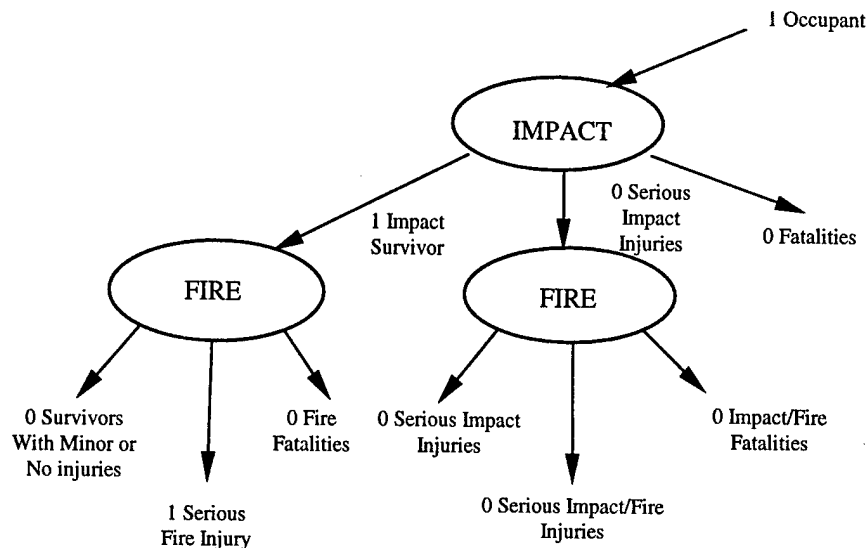
SCENARIO 6

**Scenario 6** represents the rear cabin crew area, containing one flight attendant. The flight attendant suffered serious fire burns in the accident.

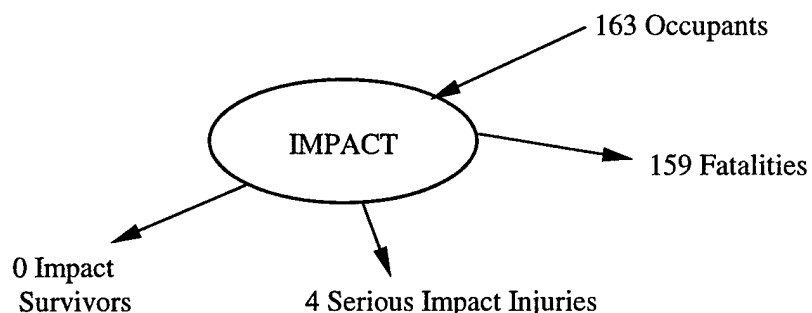
Due to the massive destruction of the aircraft, this accident was considered as a single scenario encompassing the whole cabin.

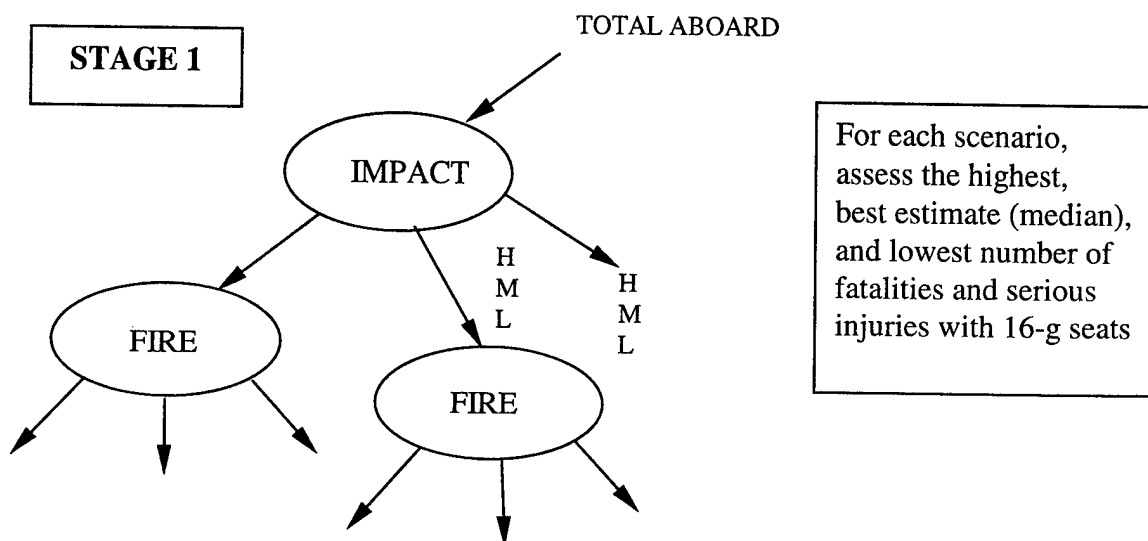
FIGURE B-1. STATISTICAL MODELLING PROCESS, STAGE 1

Stage 4 of the process is simply to determine the 2½, 50, and 97½ percentiles from the resulting distributions to ascertain a mean and likely range for the prediction.

Whilst it is recognised that the models are not perfect representations of an accident nor are the statistical assessments totally accurate, they will provide a better assessment of the likely impact of improvements to survivability factors than would otherwise be derived from a simple estimate of the resultant change in number of survivors.

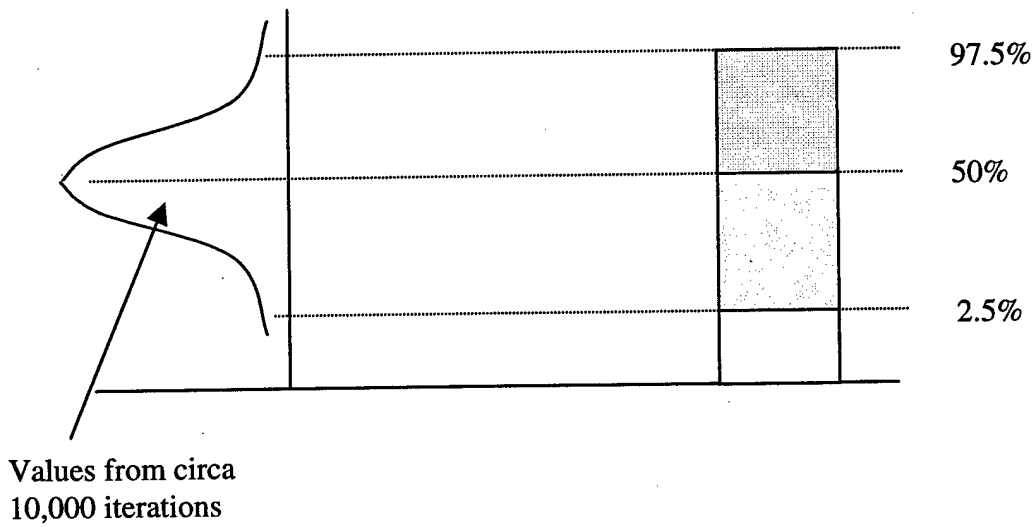
**FIGURE B-4. STATISTICAL MODELLING PROCESS, STAGE 4**

**STAGE 4**

From statistical distribution, read off 97.5, 50, and 2.5 percentiles.
