## THESIS

**AH-64 APACHE COST REDUCTION**

Daniel R. Short

March 2000

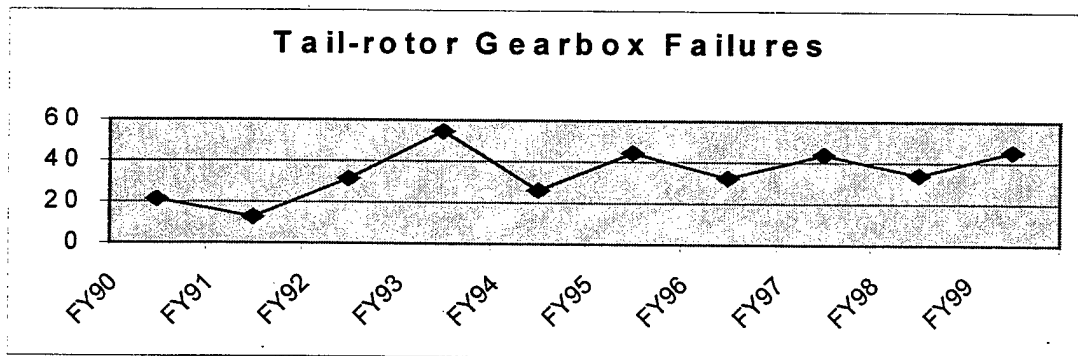
Figure 6, Plots of past nine-year's gearbox failures.  
 Source: Author, from information provided by Ref 43

The following figures are graphical depictions of the most accurate historical data on corrosion for each gearbox. The relatively consistent spike found between 1992 and 1993 is believed to reflect the extensive inspection and rebuild effort following operation Desert Storm.

The graphs show a general trend of increasing gearbox failures through time. The tail-rotor gearbox shows the clearest increases, averaging a gain in failures of approximately 1.5 gearboxes per year. The tail-rotor gearbox is heavily affected by corrosion and the increase seems to be caused by metal fatigue and removal of material for corrosion repair. The gearbox is limited by the finite number of times it can be repaired for the same failure. A "blend and finish" approach is used to repair any gearbox. Material is removed until healthy unaffected magnesium is found, and then the surface is re-finished by smoothing

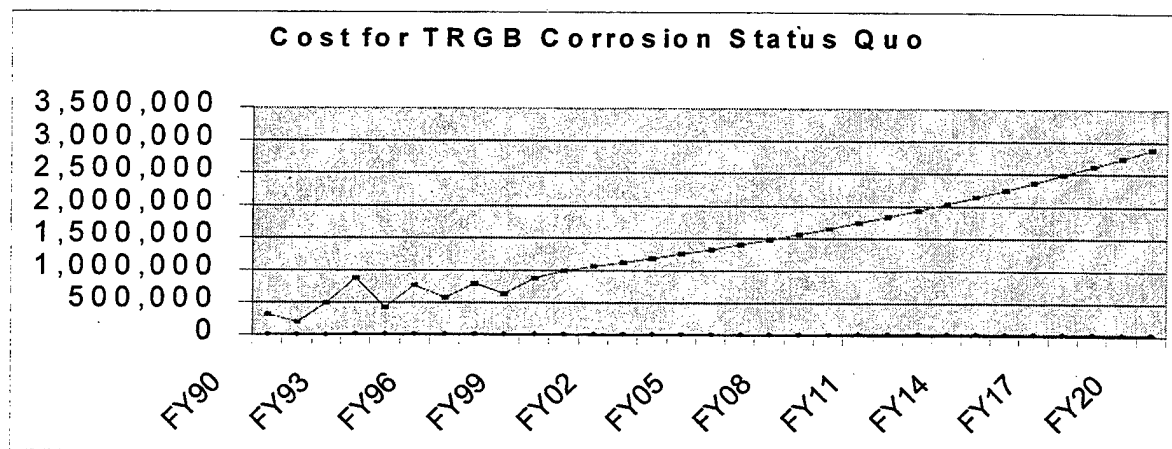
Figure 7, Gearbox rebuild costs projected through FY 2020

Figure 7 depicts the trend of Tail Rotor Gearboxes (TRG) to fail at an increasing rate due to the "aging aircraft" phenomenon. Figure 7 combines the predictions of future failure rates with increasing contractor gearbox rebuild costs.

The costs of the Status Quo: In 1997, the average cost of overhauling gearboxes was \$38,442. (See Table 3, page 52) The most recent Army Master Database File (AMDF) average cost is now \$44,712. (See Table 4, page 52)(Ref 32) Gearboxes failure rates continue to increase as contract prices escalate. (See Fig 7 below) Upgrading the gearbox corrosion protection significantly reduces life-cycle costs. Table 6 depicts the net-present-value of the upgrade to Rockhard resin coating: (See Appendix A for charts depicting the cost differentials)

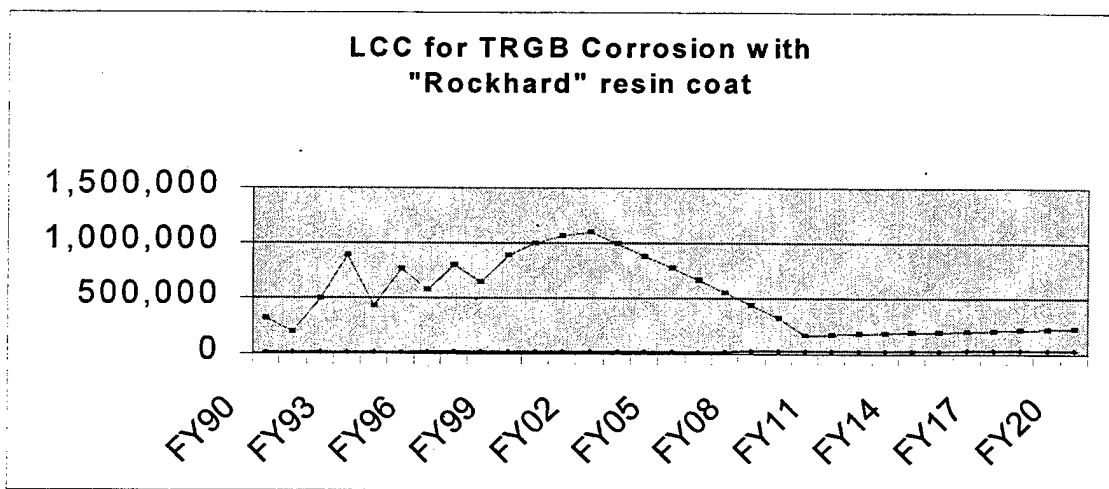
Figure 8, Projected life-cycle costs with process change to Rockhard resin

Management Command (AMMC) to pay for their administrative costs. When the cost of the resin coat is added, the overhaul cost is increased by only two percent, from \$19,346 to \$19,741. When this additional cost is added to the cost of overhaul, and is plotted against the increase in life extension, the benefits of the overhaul program are obvious.

Figure 8 depicts the increased cost plotted against the increased life of the tail-rotor gearbox.
