INSTITUTE FOR DEFENSE ANALYSES

## **Assessment of Instrumentation at Camp Lejeune**

March 2001

IDA Document D-2527

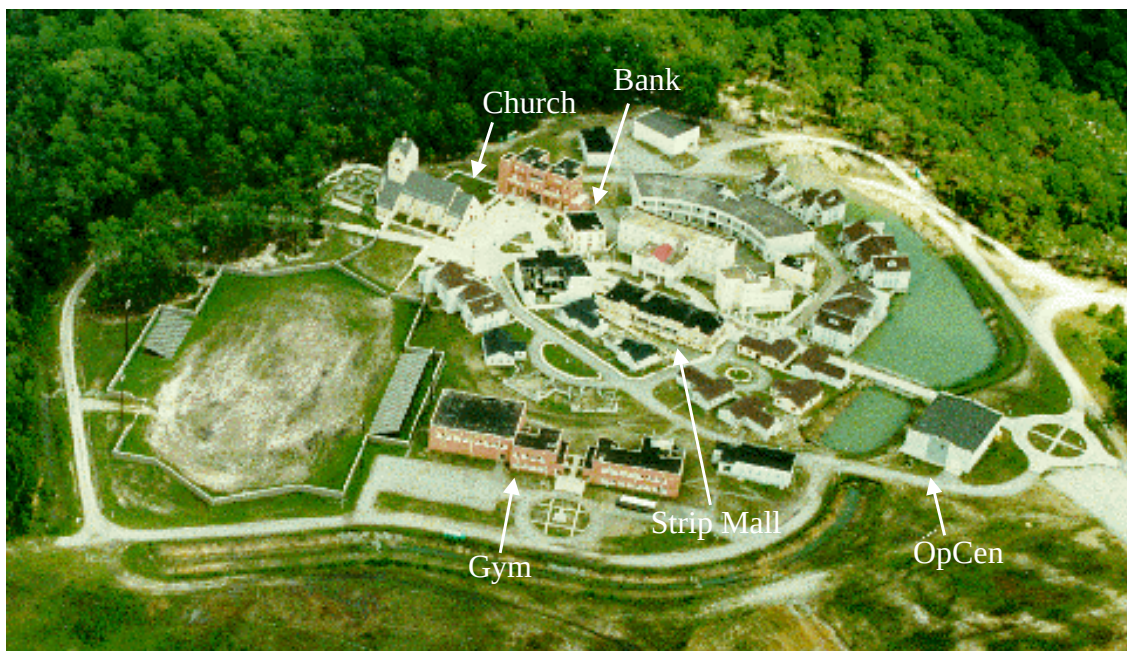
Before embarking on a detailed description of the instrumentation at Camp Lejeune, it will be helpful to describe the layout of the site itself. The MOUT site consists of over 20 buildings. Four of these – the Church, Bank, Gym, and Strip Mall – are instrumented and will be the focus of this report. Figure 1 is an aerial view of the site, showing the building sites in relationship to the other buildings. The Operations Center (OPCEN) is not one of the MOUT buildings per se; it is the coordination and after-action-review facility (described in more detail below) from which exercises are controlled and directed.

**Figure 1. The Camp Lejeune MOUT Facility (with highlighted instrumented buildings)**
