AFRL-VA-WP-TR-2000-3031

**STANDARD BONDED REPAIRS FOR
CORROSION DAMAGE**

**BRIAN J. HARKLESS
ALAN P. KERR**

**ADVANCED REPAIR TECHNOLOGY INTERNATIONAL
ONE RIDGMAR CENTRE
6500 WEST FREEWAY
FORT WORTH, TX 76116-2187**

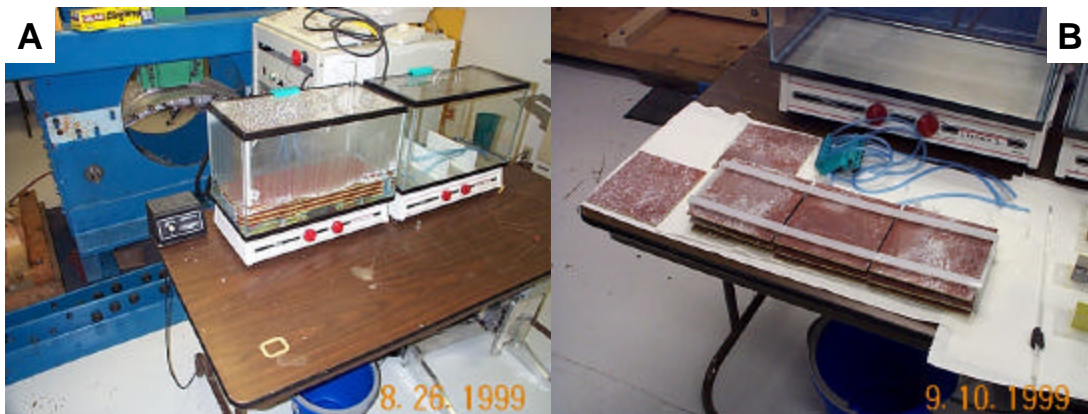
Figure 4: Static Strength Panels - A) in and B) out of tank

The test setup is shown in Figure 4.

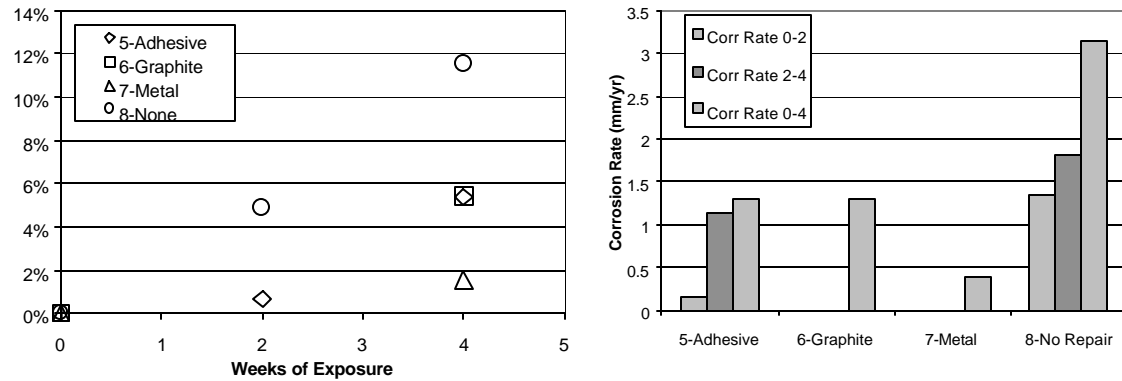
Figure 6: Repair Evaluation % Mass Loss and Corrosion Rate Graphs

The average percent mass loss and corrosion rate data is shown in Figure 6 and Table 4.

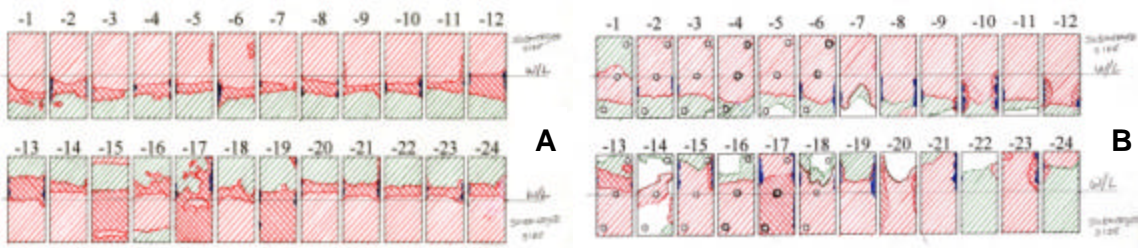
Figure 8: Damage Maps - A) no repair B) adhesive

Damage maps of all the specimens are shown in Figure 8 and Figure 9. Qualitative average damage assessments are shown for all specimens in Table 5 and Table 6.

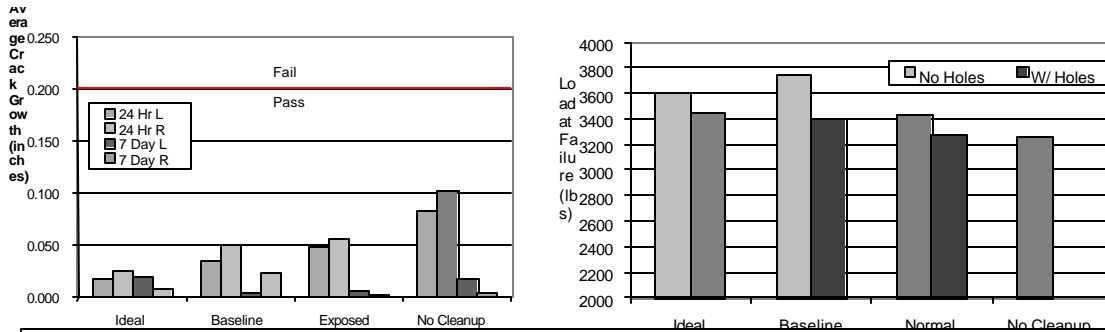
Figure 11: Boeing Wedge Test and Single Lap Shear Data

No specimens of any configuration failed the Boeing Wedge Test. The average crack growth increased from ideal to baseline. From baseline to normal exposure, the crack growth stayed relatively constant. There was an increase in crack growth between normal exposure and no cleanup coupons, but all specimens did pass the test. The data is presented in Figure 11.

There were no holes in any of the no cleanup specimens. The data is presented in Figure 11, Table 7 and Table 8.
