MANPRINT ANALYSIS OF THE DIVAD SYSTEM:

VOLUME I. HUMAN FACTORS DATA FROM SGT  
YORK FOLLOW-ON EVALUATION I

Bettina A. Babbitt  
Essex Corporation

10 March 1988

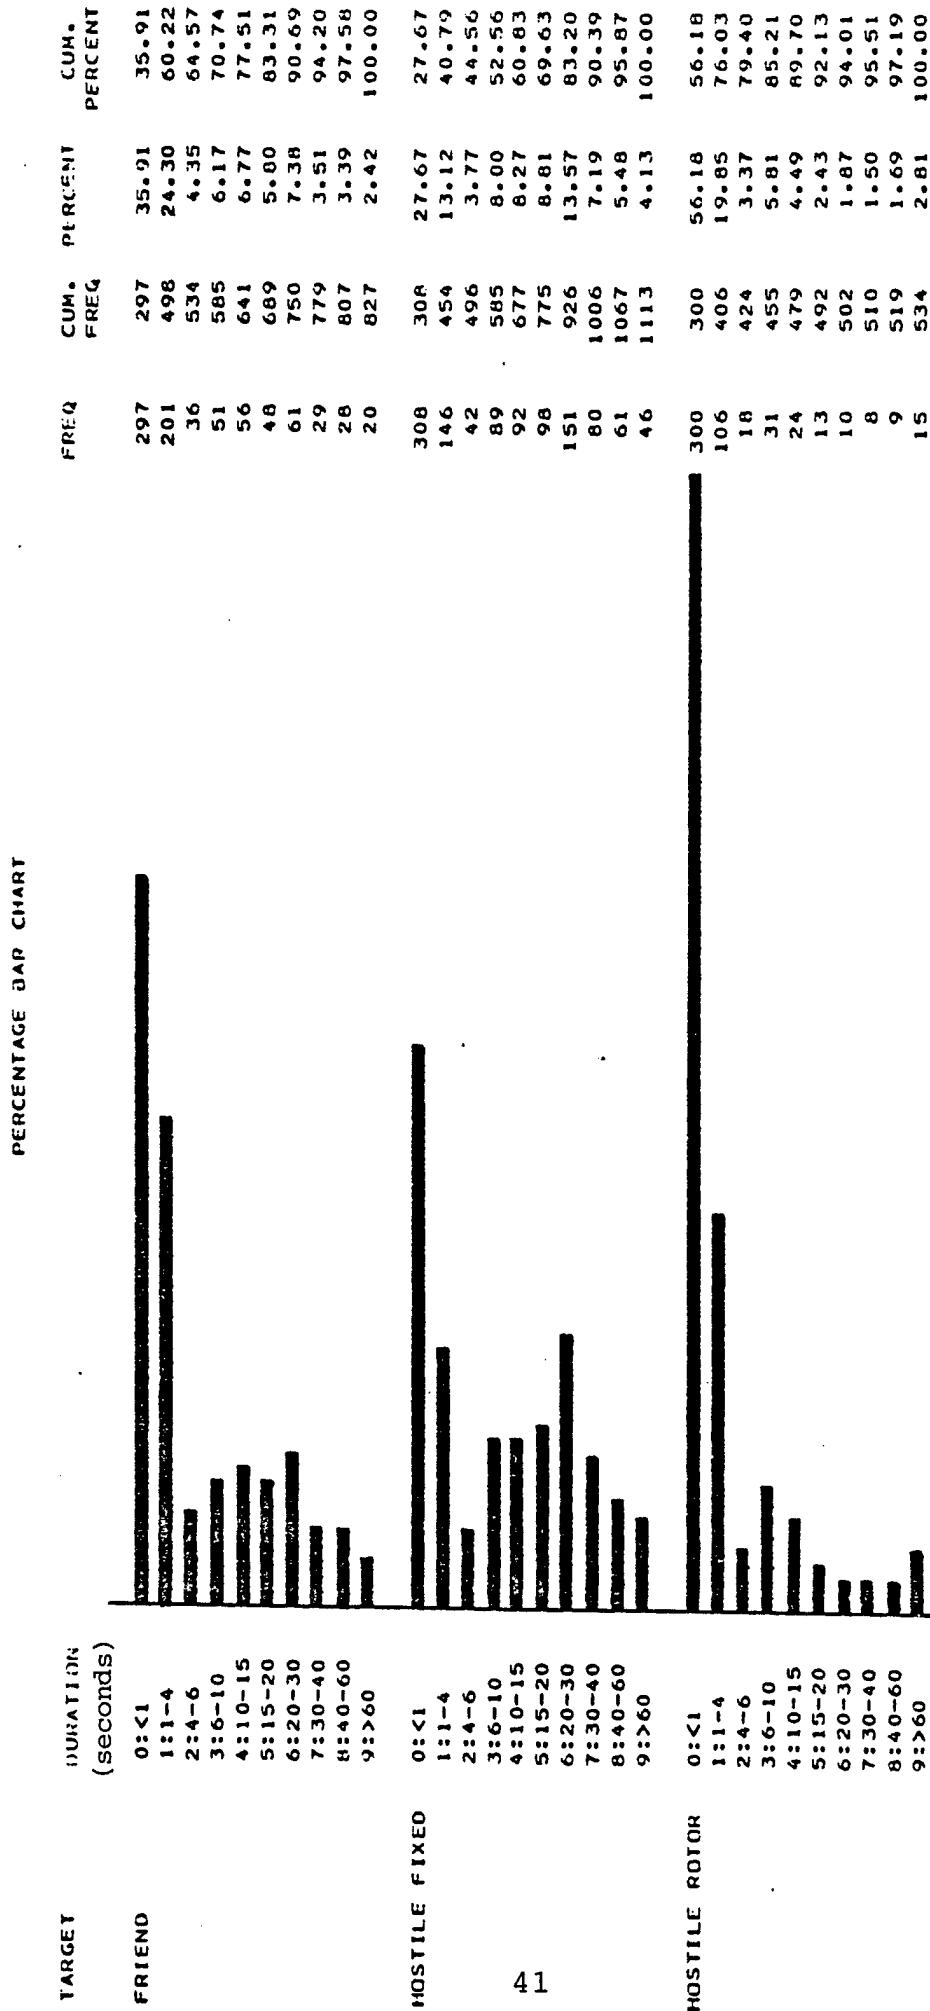
Figure 3. Distribution of Times from Start Intervisibility to First Display for All Displayed Targets. Summary Over All Trials.

As shown in Figure 3, after the start of intervisibility, 76% of the hostile rotary-wing aircraft were displayed within 4.0 seconds. Over 56% of the hostile rotary-wing aircraft were displayed in less than 1.0 second. There were a large number of short-duration hostile rotary aircraft intervisibility segments. A great proportion of intervisibility segments would have been on the verge of ending when the target was first displayed. This was substantiated by data which indicated that 48% of in-range targets were displayed for less than 5.0 seconds plus flight time.
