## **SURVIVABILITY MODELING AND VALIDATION IN COMPLEX RIB-SKIN STRUCTURES**

### **Abstract**

This paper presents a coordinated effort to model, test and validate the structural response of complex aerospace rib-skin structures in both undamaged and damaged configurations. Coordinated experimental and finite element model results are presented for cylindrical rib-skin structures each approximately nine foot long, and thirty inches in diameter. The test articles considered are of riveted aluminum construction and include internal structural components including bulkheads and complex stiffeners. Experimental reproduction of the highly idealized loading conditions used in the finite element models required the development of a custom loading rig that is described in detail. In summary, the finite element models were found to predict the structural stiffness of both the damaged and undamaged structures well for small deflections and strains. However, structural failure was not well predicted because large deflections and nonlinear material behavior were intentionally not modeled for simplicity.

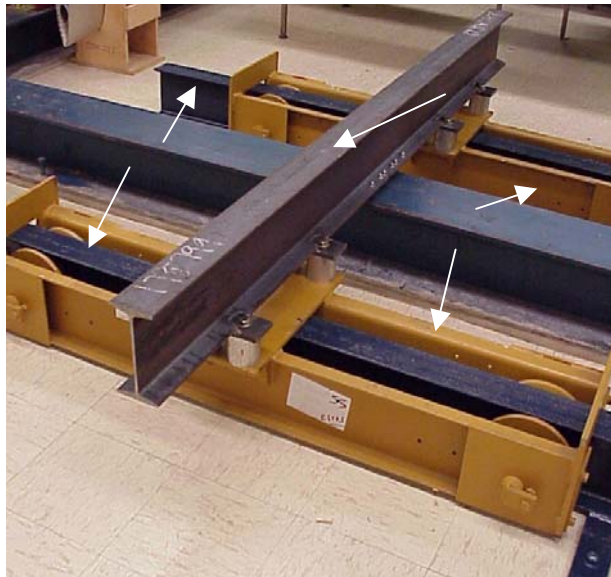
Figure 1. Runway beams, bridge beam and left and right end trucks.

specimen suddenly fails, the load is relieved but the displacement remains a constant until the operator makes a change. The complication, however, is to create a displacement controlled bending rig which also allows for tip deflections both lateral and longitudinal. The solution used in this study was to invert a bridge crane, which is normally mounted to the ceiling, and mount it to the floor. A typical bridge crane, Figure 1, is composed of two runway beams, two end trucks, a bridge beam and a trolley, Figure 2, which traverses the bridge beam.

The structure being tested is positioned equidistant between the end trucks and fixed rigidly at one end. The end trucks can then be positioned along the runway beams so that the bridge beam lies directly below the load point on the structure. Consequently, the bend rig is capable of accommodating a wide range of structures. Most importantly, however, during loading if the load point on the structure moves perpendicular to the line of action of the applied load the hydraulic cylinder is capable of tracking the motion by the traversing along the bridge beam on the trolley with little resistive force.

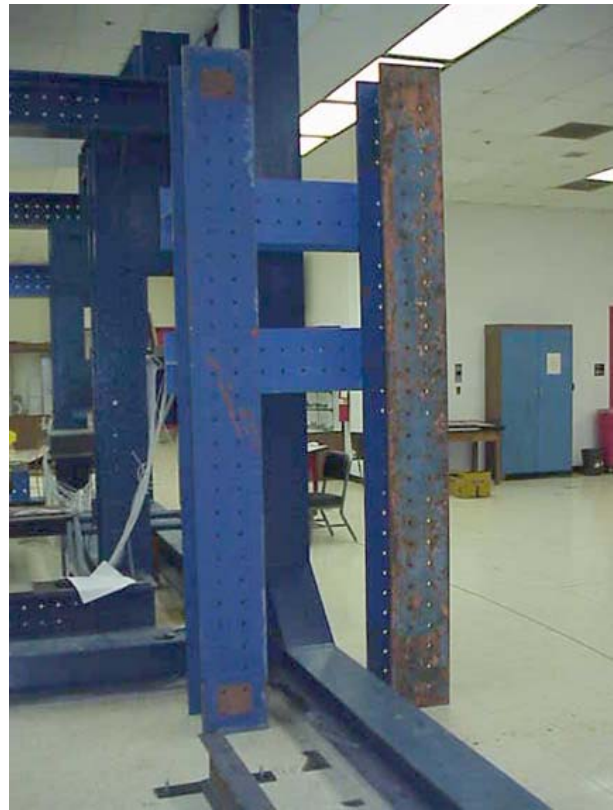
Figure 4. Load frame before mounting test article.

The test articles were mounted to the load frame, Figure 4, by a custom built test fixture. As designed the test fixture provides complete support for the fixed end of the test articles all the way around the circumference. To accomplish this an aluminum base plate was machined to attach to the load frame and then a ring of twenty four 3 in. x 3 in. x 6 in. long fixture blocks were attached to the base plate in an annular ring
