USAARL Report No. 2004-07

Issues in Design and Safety of Helmet-Mounted Displays – Results of a Rotary-Wing Pilot Survey

U.S. Army
Aeromedical Research
Laboratory

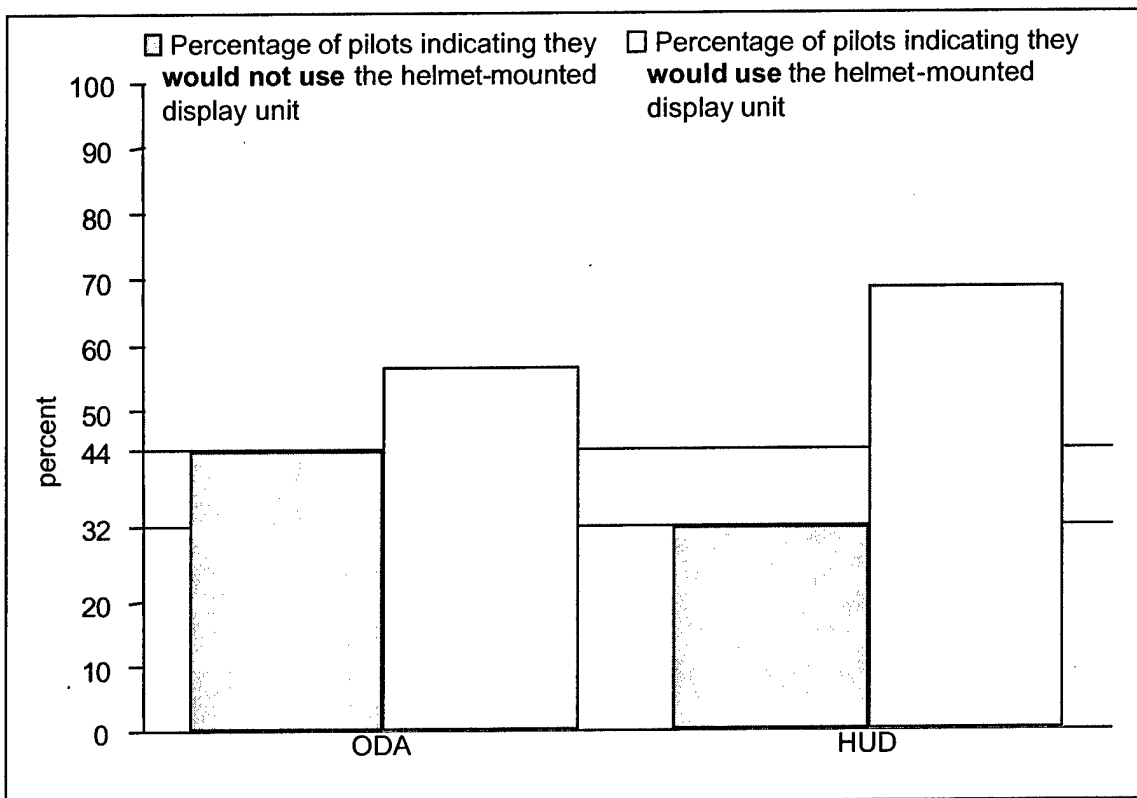
Figure 1. Percent indicating they would use the HUD/ODA.

Although the majority of respondents (257 or 63 percent) indicated that they would use their display if given the option, 76 or 32 percent of HUD users and 71 or 44 percent of ODA users indicated they would not use their display device if they were given the option (Figure 1). The following text outlines their reasons for this and their suggested modifications.

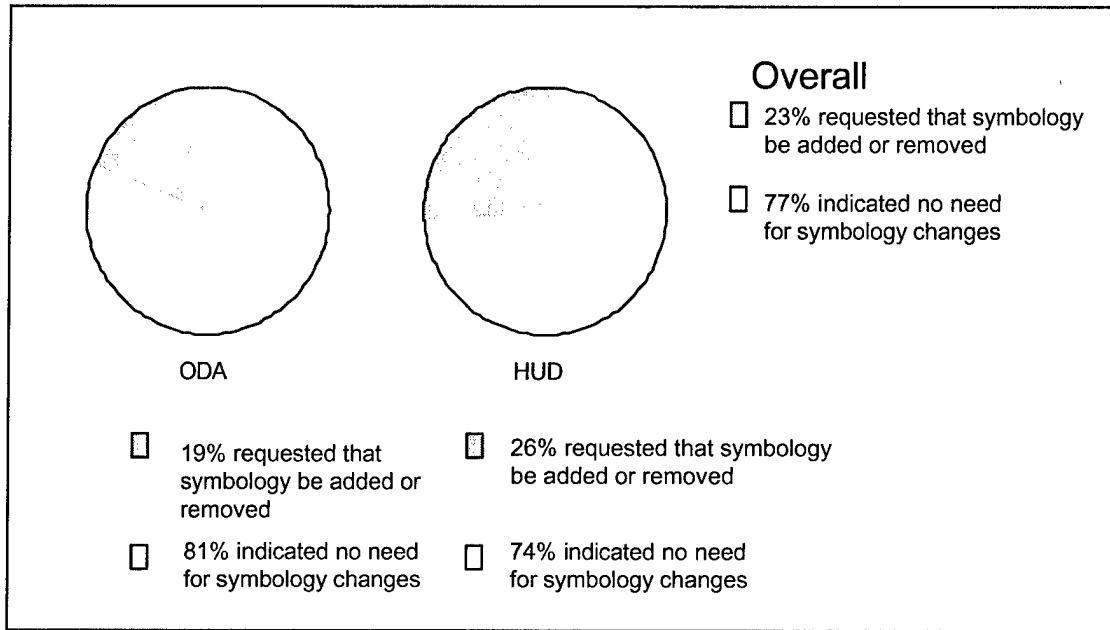
Figure 3. Percent requesting that symbology be added or removed.

Although the majority of aviators surveyed indicated no need for any symbology to be added or removed from their device, a total of 94 (23 percent) pilots surveyed indicated the need for changes in the symbology of their device (Figure 3). Of these pilots, the majority, 63 (67 percent), were HUD users.

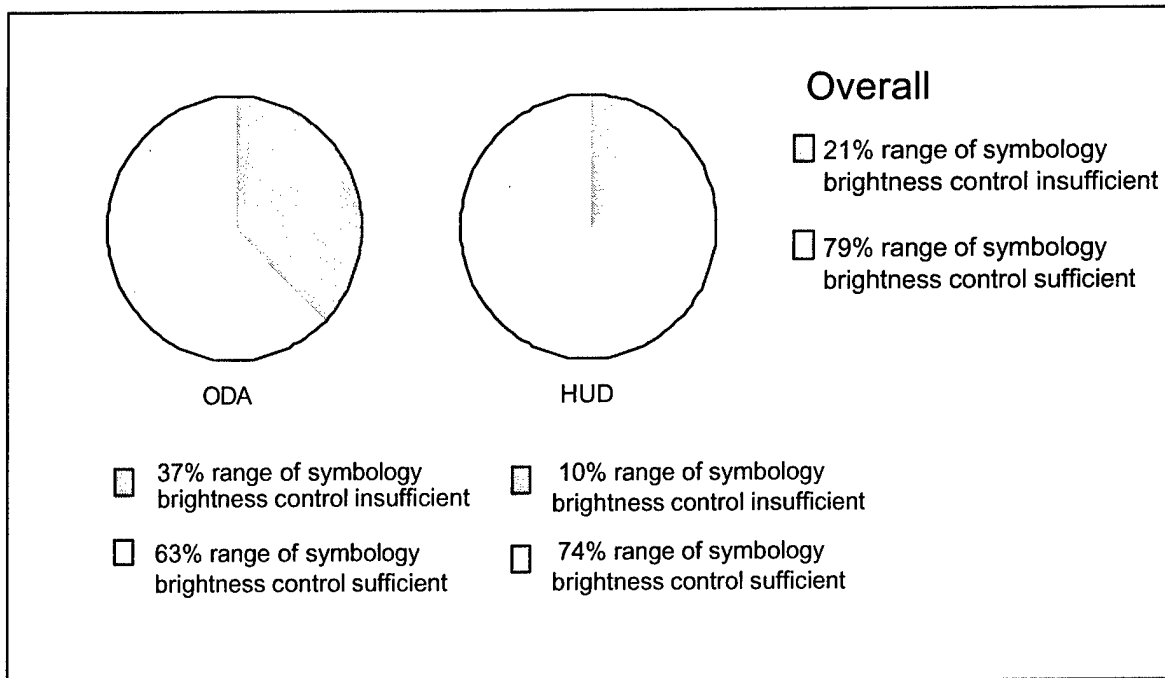
Figure 4. Percent indicating range of symbology brightness control insufficient.

A number of survey participants (86 or 21 percent) indicated that the range of symbology brightness control was not sufficient with their display device (Figure 4). A total of 25, or 10 percent of HUD users within this survey, indicated the range of brightness control was not sufficient. A total of 61 (37 percent) of ODA users also indicated their range of brightness control was not sufficient. The majority of pilots (264 or 65 percent of survey respondents) also indicated that they frequently had to adjust the brightness of their symbology. A total of 170 (64 percent) of these pilots were HUD users, while 94 (36 percent) were ODA users.

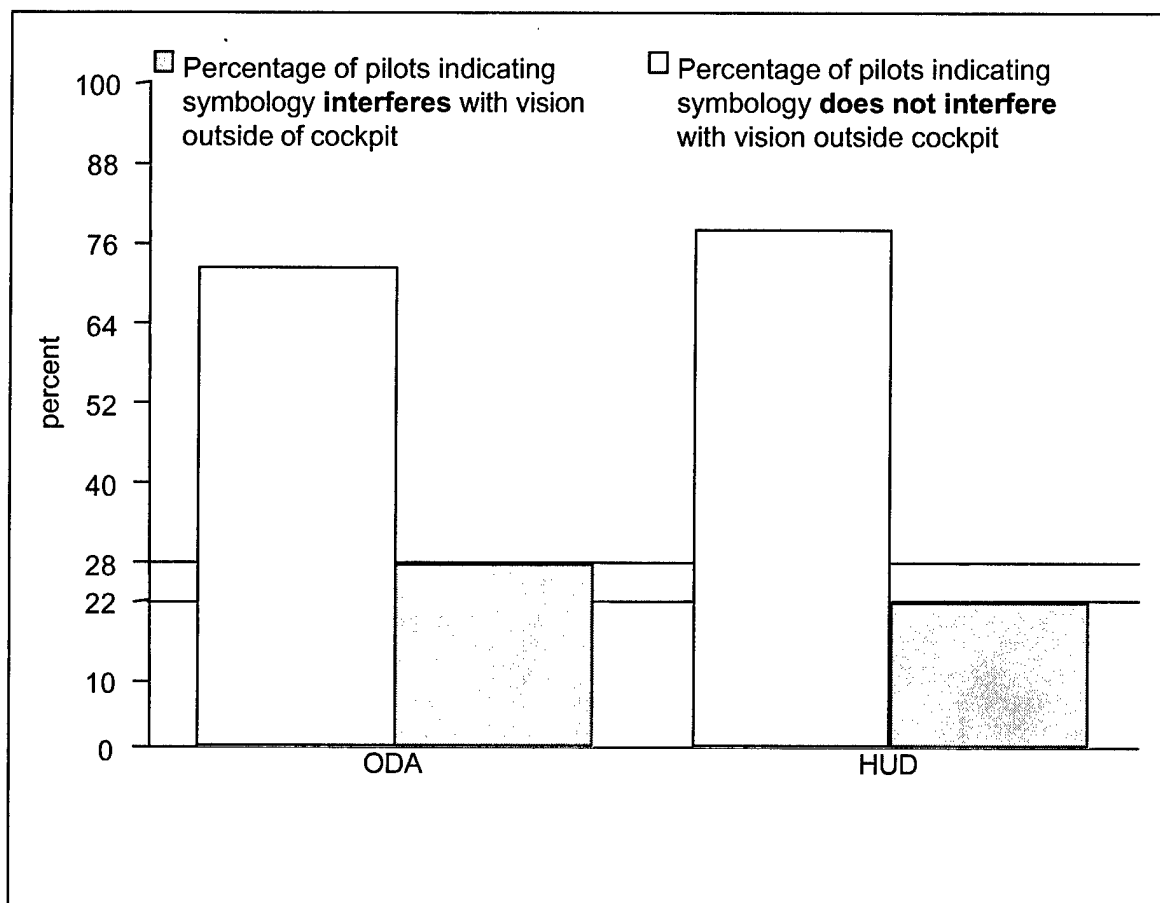
Figure 5. Percent indicating symbology interferes with vision outside the cockpit.

A total of 98 (24 percent) pilots surveyed responded that at some time the symbology of their display device interfered with their vision outside of the cockpit. A total of 53 (54 percent) of these responders were HUD users. Although the majority of both HUD and ODA users indicated that the symbology did not interfere with their vision outside the cockpit, 45 (28 percent) ODA users and 53 (22 percent) HUD users indicated that it had interfered with their vision at some time (Figure 5). Pilots also often wrote that the brightness of the display was often too bright for night operations. Written questionnaire responses suggested potential compromises in safety in the time necessary to adjust their vision from the bright display to visualize their position outside the cockpit.
