**NONDESTRUCTIVE EVALUATION
(NDE) TECHNOLOGY INITIATIVES
PROGRAM (NTIP)**

**Delivery Order 0029: Advanced Thermo-sonic
Methods (SONIC IR)**

Final Report for 01 March 2002 – 01 May 2003

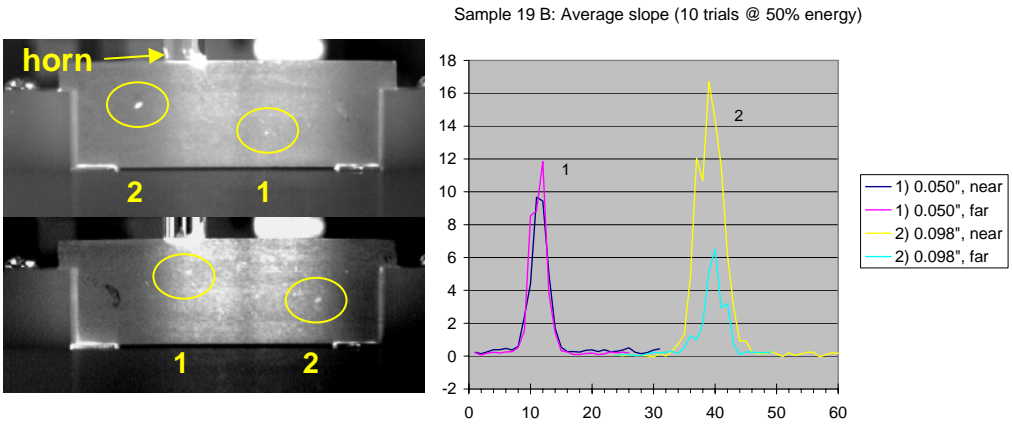
Figure C4: Left: Sample 19 B at 2 orientations with respect to the sonic horn. Right: Slope curves along the cracks. Slope results from 10 consecutive trials have been averaged to create noise reduced curves for comparison.

In the data shown in Figure C4, agreement between the near and far orientation data is quite good for the smaller (0.050”) crack. However, slope amplitude for the larger crack are extremely different at the different orientations, although the overall shape is preserved. This data is inconclusive, but suggests that there are phenomenological issues associated with sample geometry and insertion point that are beyond the scope of this investigation. However, it is worth noting that if all conditions are held constant, repeatability is preserved regardless of the location of the insertion point.

Signal repeatability as a function of the proximity of the horn to the crack location was tested by performing the 10 shot repeatability test once, and then again after rotating the sample by 180 degrees. The horn was placed approximately 1/3 of the sample length from the left edge of the sample, so that the contact point would be near and then far from each crack site in the two orientations. Although results at each orientation are quite repeatable, comparison of near and far orientation results for a given crack raise questions that are beyond the scope of this investigation (Fig.C4)
