**FRETTING FATIGUE BEHAVIOR OF SHOT-PEENED TITANIUM ALLOY
TI-6AL-4V UNDER SEAWATER CONDITIONS**

THESIS

AFIT/GAE/ENY/04-J01

AIR FORCE INSTITUTE OF TECHNOLOGY

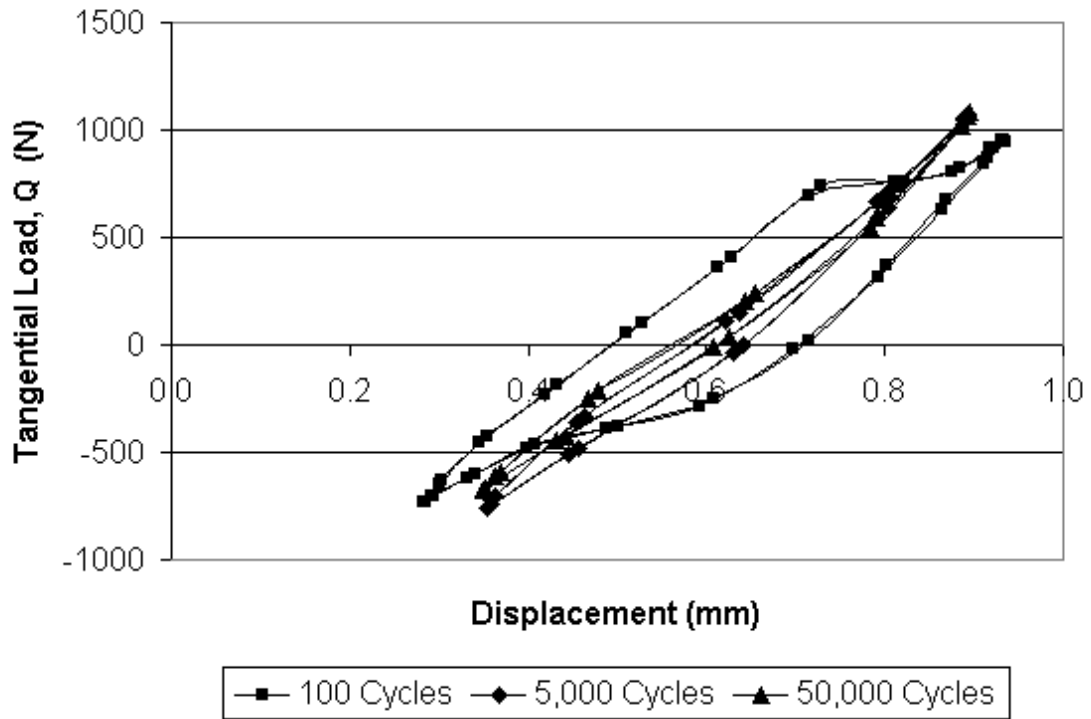
Figure 6. Hysteresis loop of Tangential Load vs. Displacement for $\sigma_{\text{eff}} = 430$ MPa.

still under a gross slip condition. A sample hysteresis loop at several different cycles is presented in Figure 6. Once the desired effective stress was achieved, seawater was added to the specimen at a flow rate of 5 mL per minute. The frequency was then increased to 10 Hz for the remainder of the experiment. The addition of seawater occurred no later than 2,000 cycles in each of the five tests. An experiment performed by Lietch [4] proved that an environmental effect would occur as long as the specimen surface was wet and water pooled at the contact surface between the specimen and the fretting pads. A frequency of 10 Hz was found to be a low enough frequency to maintain an environmental effect and a high enough frequency to expedite the experiment in a timely manner.

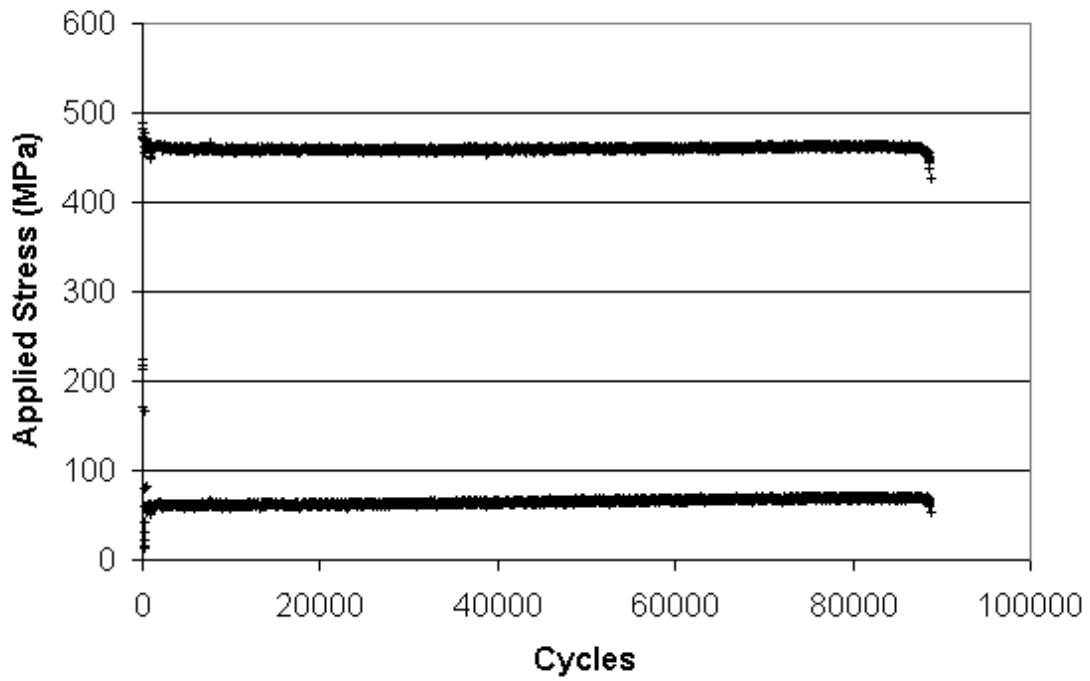
Figure 7. Applied Stress (σ) vs. Number of Cycles to Failure (N_f) for $\sigma_{\text{eff}} = 430$ MPa.

Experimental data for the five fretting fatigue experiments under seawater conditions is presented in Table 1. A typical plot of tangential load versus number of cycles is shown in Figure 7. Note that the R-value calculated using Equation 2 for this particular experiment was found to be 0.15. An attempt was made to keep a constant R-value of 0.1 for each of the five experiments. Figure 8 presents a plot of the effective stress, σ_{eff} , versus the number of cycles to failure, N_f , for the five fretting fatigue tests. Chapter 4 will compare the data from this study to previous experiments in an attempt to show the effect of saltwater on shot-peened Ti-6Al-4V under fretting fatigue conditions.

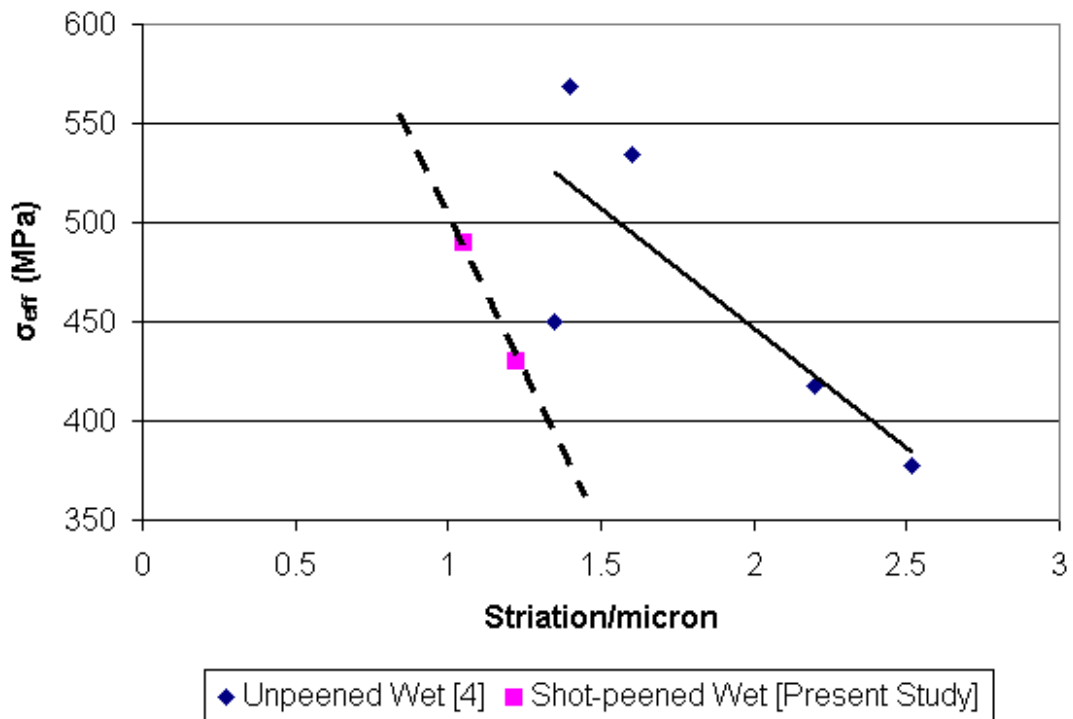
Figure 22. Effective Stress (σ_{eff}) vs. striation estimates for shot-peened samples under seawater conditions.

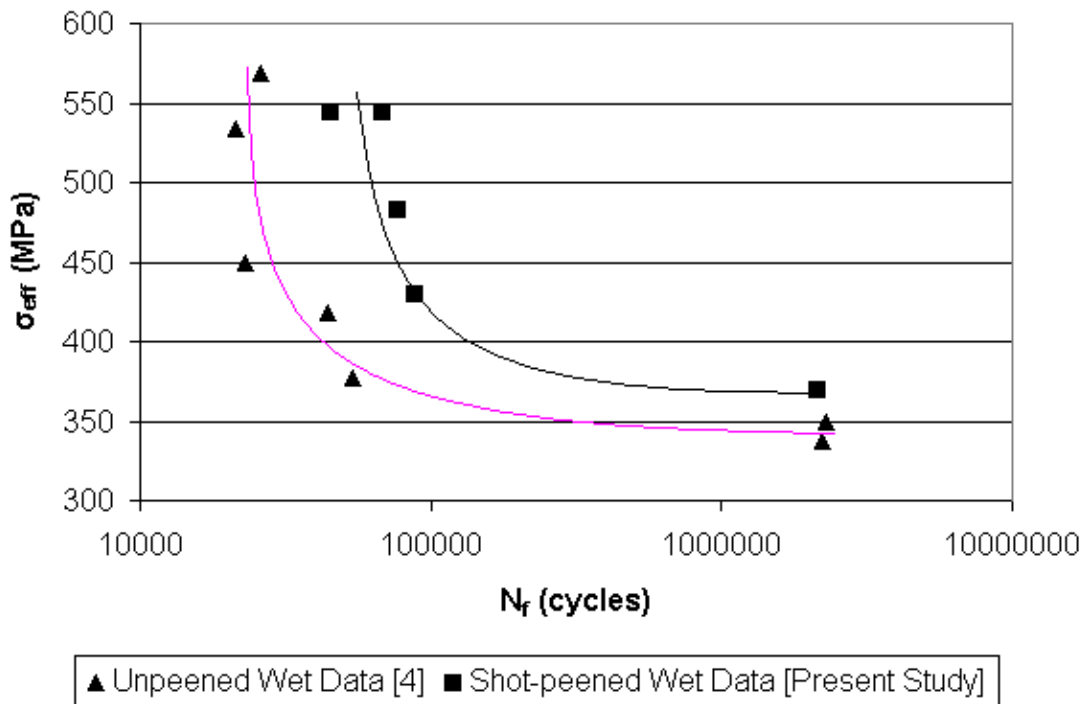
Figure 23. Comparison of Effective Stress (σ_{eff}) vs. Number of Cycles to Failure (N_f) for shot-peened and unpeened Ti-6Al-4V under seawater conditions.

crack propagation which decreased the fretting fatigue life in the high cycle regime, but provided a shielding effect in the low cycle regime thus slowing the overall crack growth rate and increasing fatigue life. Figure 23 shows both the shot-peened and unpeened fretting fatigue data expressed as the effective stress amplitude, σ_{eff} , versus the number of cycles to failure, N_f . It is clear that shot peening increased the fretting fatigue life of Ti-6Al-4V under seawater conditions in both low and high cycle fatigue. The introduction of a compressive residual stress clearly increases the fretting fatigue life of the material by preventing microcracks from forming on the contact surface of the material. This decrease in microcrack formation allows for slower crack initiation and crack propagation thus increasing the fretting fatigue life in both low and high cycle regimes.

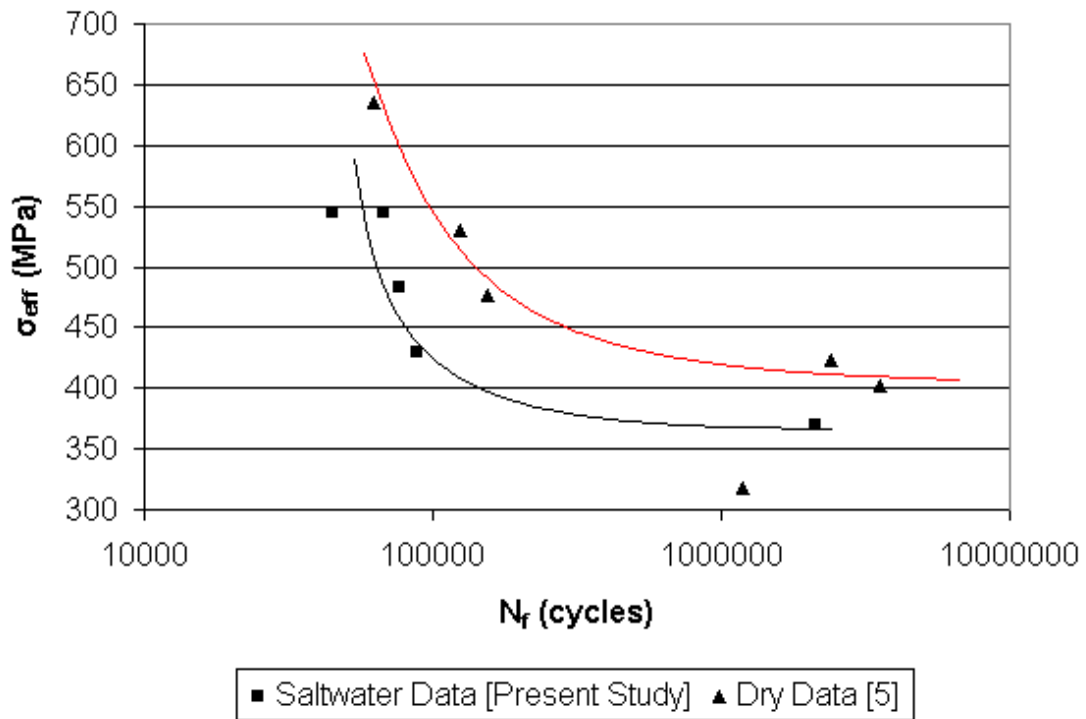
Figure 24. Comparison of Effective Stress (σ_{eff}) vs. Number of Cycles to Failure (N_f) for shot-peened Ti-6Al-4V under seawater and dry conditions.

Yuskel tested shot-peened Ti-6Al-4V under dry conditions in order to determine the effect of shot peening on fretting fatigue. Figure 24 shows both the seawater and dry fretting fatigue data expressed as the effective stress amplitude, σ_{eff} , versus the number of cycles to failure, N_f , for shot-peened Ti-6Al-4V. Seawater clearly reduces the fretting fatigue life of the shot-peened specimens in both high and low cycle fatigue regimes. The process of fretting fatigue is known to disrupt titanium alloys protective coating, allowing the corrosive material to easily penetrate the surface of the specimen. This will cause faster crack initiation and propagation resulting in a lower fretting fatigue life in both the low and high cycle regimes. Unlike the unpeened samples tested by Lietch [4], the shot-peened samples tested under seawater conditions experienced a decrease in fretting fatigue life at both the low and high cycle regimes when compared to shot-peened

samples tested in dry conditions. Lietch credited the increase in fatigue life of unpeened Ti-6Al-4V in high cycle fatigue under seawater conditions to the formation of microcracks. This phenomenon is not seen in this study due to the introduction of a compressive residual stress on the surface of the samples caused by shot peening. Therefore, the shielding effect caused by the increased number of microcracks at high cycle fatigue doesn't occur in the shot-peened samples tested under seawater conditions. This results in a decreased fretting fatigue life of shot-peened Ti-6Al-4V tested under seawater conditions when compared to its counterpart of shot-peened Ti-6Al-4V tested under dry conditions.

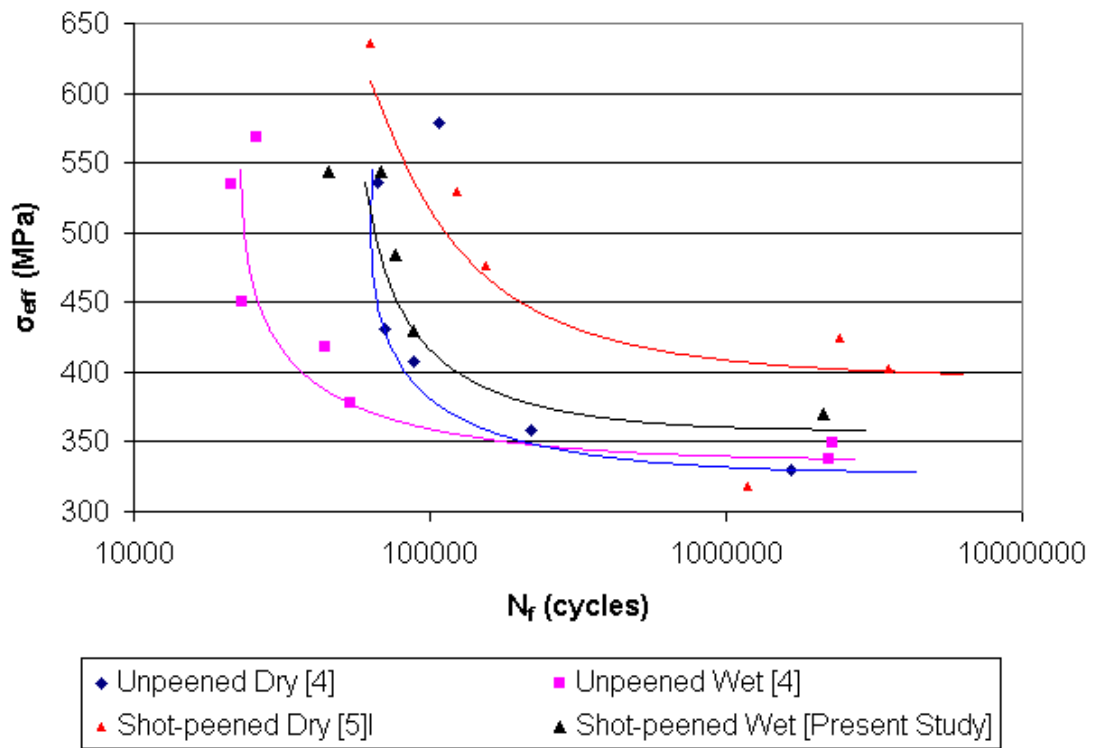
Figure 25. Comparison of Effective Stress (σ_{eff}) vs. Number of Cycles to Failure (N_f) for shot-peened and unpeened Ti-6Al-4V under seawater and dry conditions.

Figure 25 shows the effective stress, σ_{eff} , vs. the number of cycles to failure, N_f , for all four conditions; unpeened samples under seawater conditions, unpeened samples under dry conditions, shot-peened samples under dry conditions and shot-peened samples under seawater conditions. Note that the curve detailing the shot-peened Ti-6Al-4V under seawater conditions falls directly between the shot-peened specimens tested under dry conditions and directly above the unpeened specimens tested under seawater conditions. As expected, shot peening increases the fretting fatigue life of Ti-6Al-4V in both low and high cycle fatigue, whereas the addition of seawater decreases the fretting fatigue life of shot-peened Ti-6Al-4V in both low and high cycle fatigue.

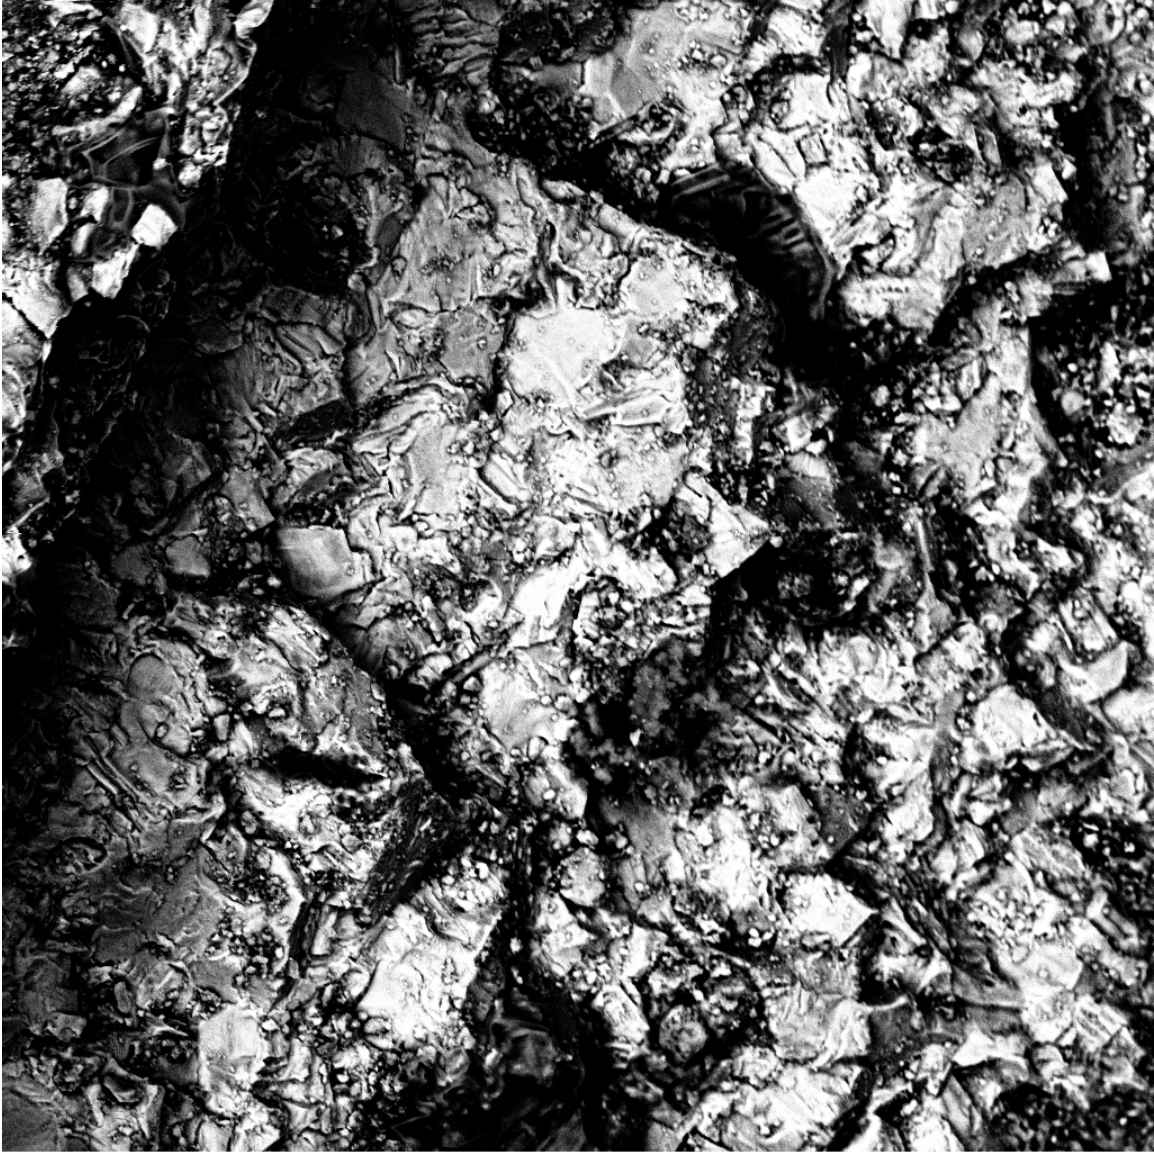
C.2. BSE SEM of fracture surface exposed to seawater conditions at $\sigma_{\text{eff}} = 544$ MPa under high magnification.
