# **Use of Multidimensional Fiber Grating Strain Sensors for Damage Detection in Composite Pressure Vessels**

Marley Kunzler<sup>a</sup>, Eric Udd  
Blue Road Research, 376 NE 219th Avenue, Gresham, OR 97030

Mont Johnson and Kurt Mildenhall  
ATK Thiokol, PO Box 707, M/S 252, Brigham City, Utah 84302

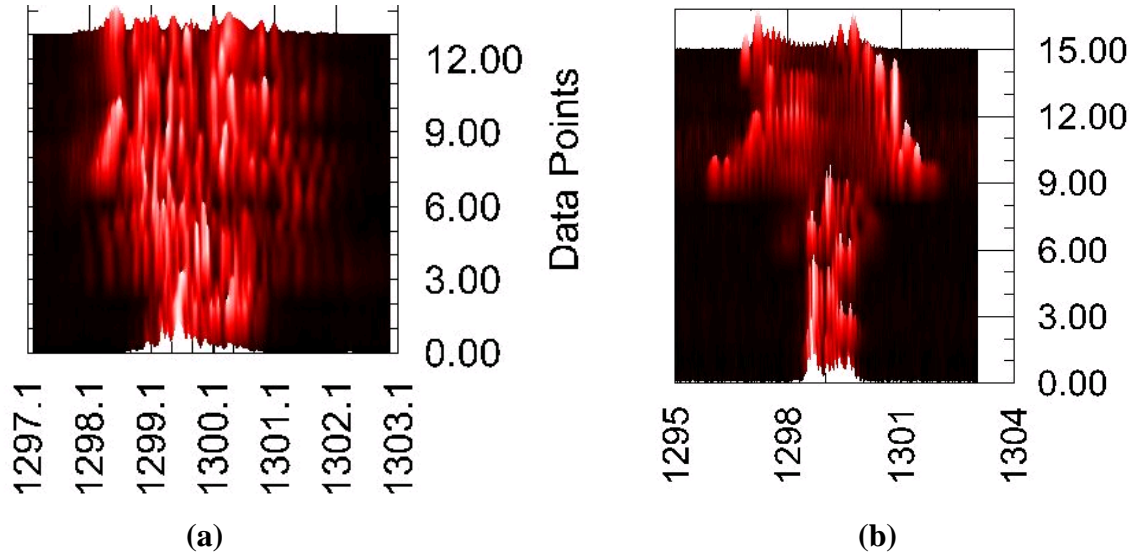
**Figure 12. A multi-axis fiber grating sensor in the vicinity of a cut tow (a), and (b) a multi-axis fiber grating sensor in the vicinity of a Teflon tape defect. The dramatic shift in (b) occurs after a second impact near the defect.**

In Figure 12, the pressure cycles have been removed to see the permanent effects of the growth of transverse strain gradients. Figure 12 shows a multi-axis fiber grating sensor near a cut tow (a) and another in the vicinity of a Teflon tape defect (b), which shows the typical peak-spread response of a grating as a delamination propagates across the sensor.

The characteristic of the growth of transverse strain gradients for the cut tow and the Teflon tape defect are very different. After cure the evidence of significant transverse strain gradients due to the cut tow is very clear in Figure 12a. At the same time the changes in the transverse strain fields after cure in the region of the Teflon tape defect are not evident in Figure 12b. Pressure cycling and impacts cause the damage site to propagate. For the case of cut tow in Figure 12a this results in a gradual broadening of the spectral profiles due to transverse and axial strain gradients. The case of the Teflon tape defect shown in Figure 12b is very different. Here the transverse strain gradients appear to be isolated from the multi-axis fiber grating sensor until a threshold damage condition is reached. At this point a very large transverse strain signal appears that appears to be gradually relieved as further damage changes the strain field conditions. The magnitude of the transverse strain gradients starts decreasing with additional damage in both the cut tow and Teflon tape defect regions likely is due to the composite starting to break up around the region of the multi-axis fiber grating sensor.

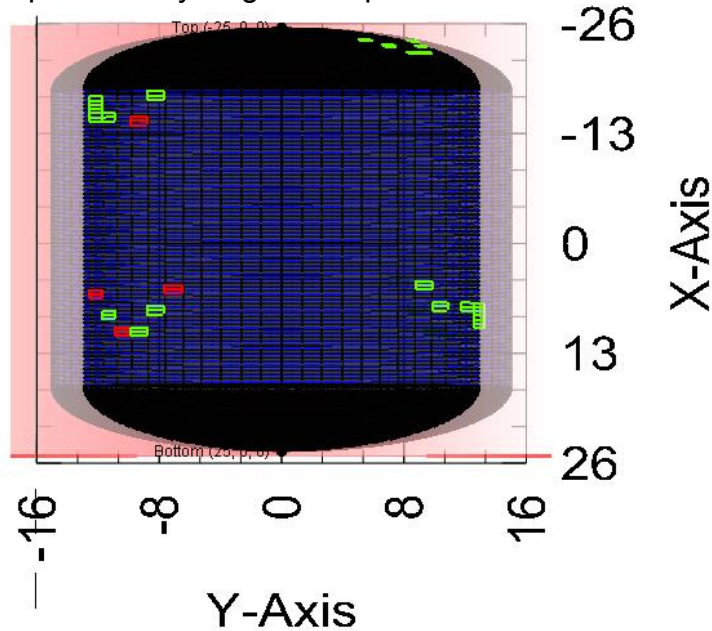
**Figure 13.** As pressure cycling and impacts change the integrity of the vessel wall, the strain fields measured by the multi-axis fiber grating strain sensors quantify and pinpoint damage to the structure.

Figure 13 illustrates an interface that has been developed to allow an end user to view changes in the damage state various cut tow and Teflon tape regions of the test article through pressure cycling and impact.
