**Amphibious Assault Ship Hangar Bay Smoke Removal Tests
Conducted Onboard the *U.S.S Saipan* (LHA-2)
and *U.S.S. Peleliu* (LHA-5)**

SEPTEMBER 2003

This report summarizes work performed onboard the U.S.S. *Saipan* (LHA-2) and the U.S.S. *Peleliu* (LHA-5) to review hangar bay smoke removal and ventilation tactics on board amphibious assault ships. The objective of this program was to describe scoping tests that were conducted for the purpose of providing guidance on changes to the ventilation procedures described in the NATOPS Firefighting Manual. The test results were used to provide recommendations for changes to the doctrine.

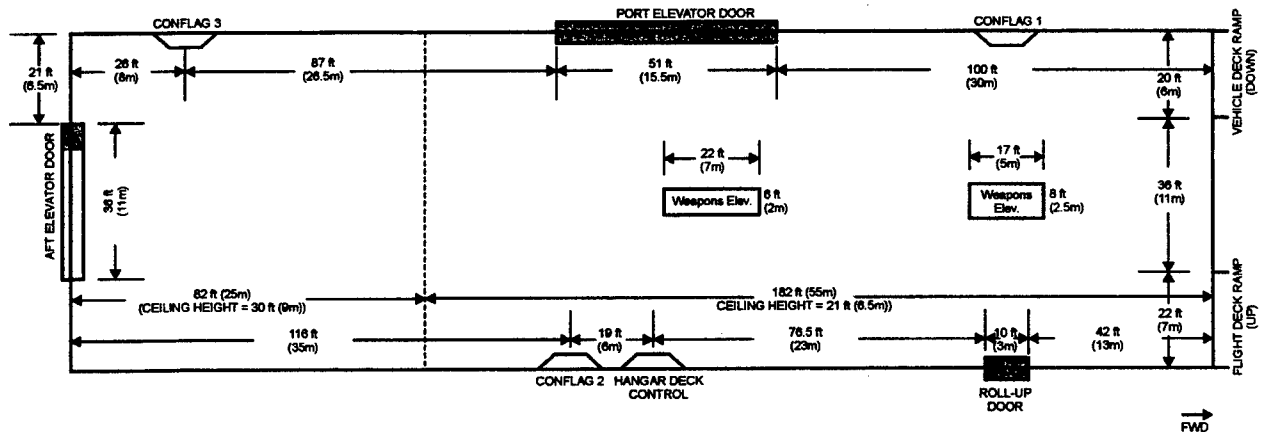
FIGURE 1. Plan View of Hangar Bay.

The Tarawa-class amphibious assault ship has one hangar bay located on the main deck, spanning from FR 83 to FR 121 and nearly the entire ship's width. Figure 1 provides a plan view of the hangar bay. The overhead height varied down the length of the hangar bay. In the aft 25 m (82 ft) the hangar bay, the overhead height was 9.1 m (30 ft). The volume in the aft portion of the hangar bay was, therefore, 5,400 m³ (192,000 ft³). The overhead height was 6.4 m (21 ft) in the forward 55 m (182 ft) of the hangar bay, resulting in a volume of 8,450 m³ (298,000 ft³). The hangar bay had two elevator doors as shown in Figure 1. One elevator door was centered in the port side hangar bay bulkhead. The other elevator door was centered in the aft hangar bay bulkhead. A roll-up door opening to weather was located in the forward portion of the hangar bay, on the starboard side, near the flight deck ramp.
