**MECHANICAL BEHAVIOR OF CRACKED PANELS  
REPAIRED WITH BONDED COMPOSITE PATCH  
THESIS**

Michael A. Hansen, Captain, USAF  
AFIT/GA/ENY/05-J01

**DEPARTMENT OF THE AIR FORCE  
AIR UNIVERSITY**

***AIR FORCE INSTITUTE OF TECHNOLOGY***

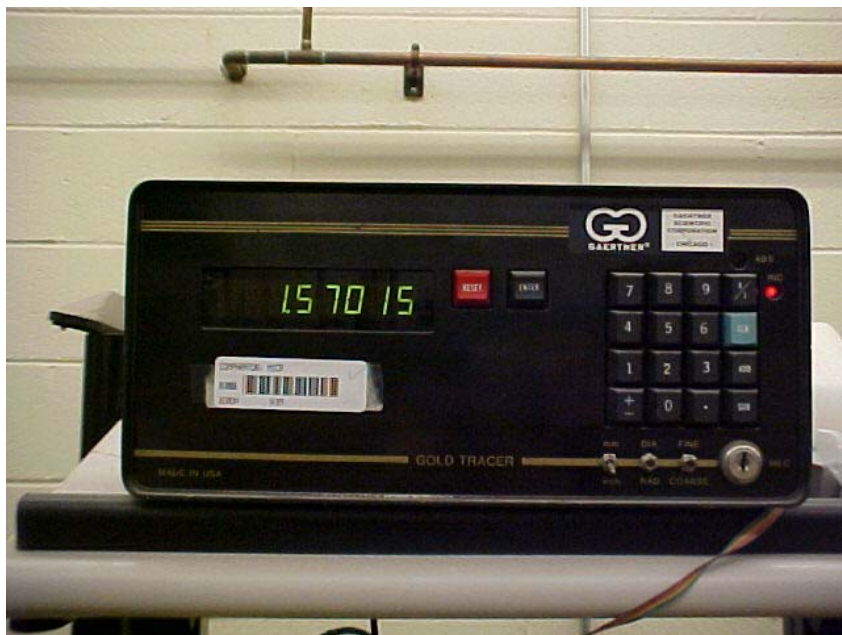
To measure the crack length a Gaertner travelling microscope with a digital readout system was used to optically measure the crack length periodically during the test (see Figures 11 and 12)

Figure 12. Gaertner Microscope Digital Readout

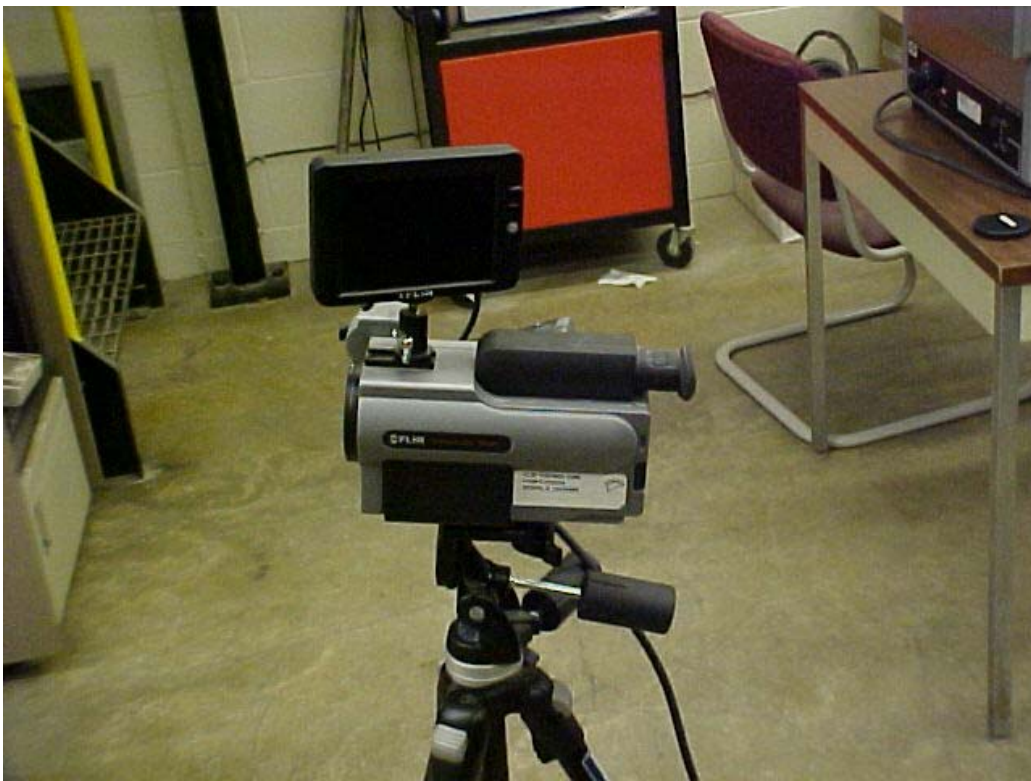
IR pictures were taken of the specimens using a FLIR IR camera, and analyzed with the associated software (see Figure13). A Master-Mite heat gun was used during the IR readings in order to quickly heat up the specimen, in order to best get the different IR readings as the areas of the disbond region would potentially heat up at a different rate than the rest of the sample (see Figure 14).

Figure 13. FLIR IR Camera

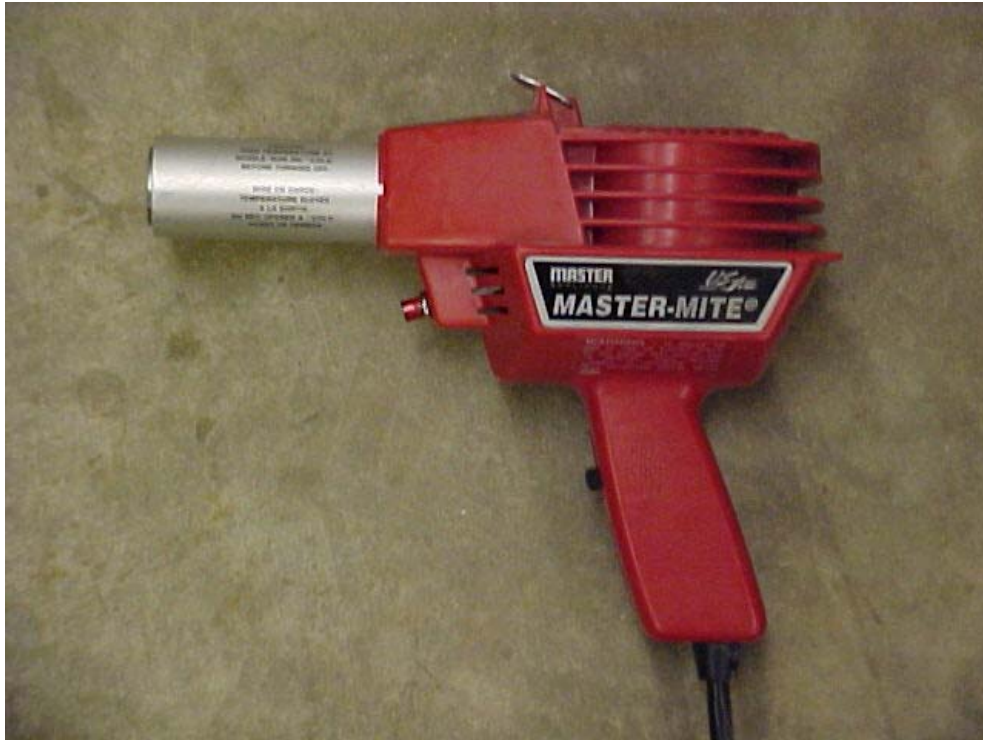
Figure 14. Master-Mite Heat Gun

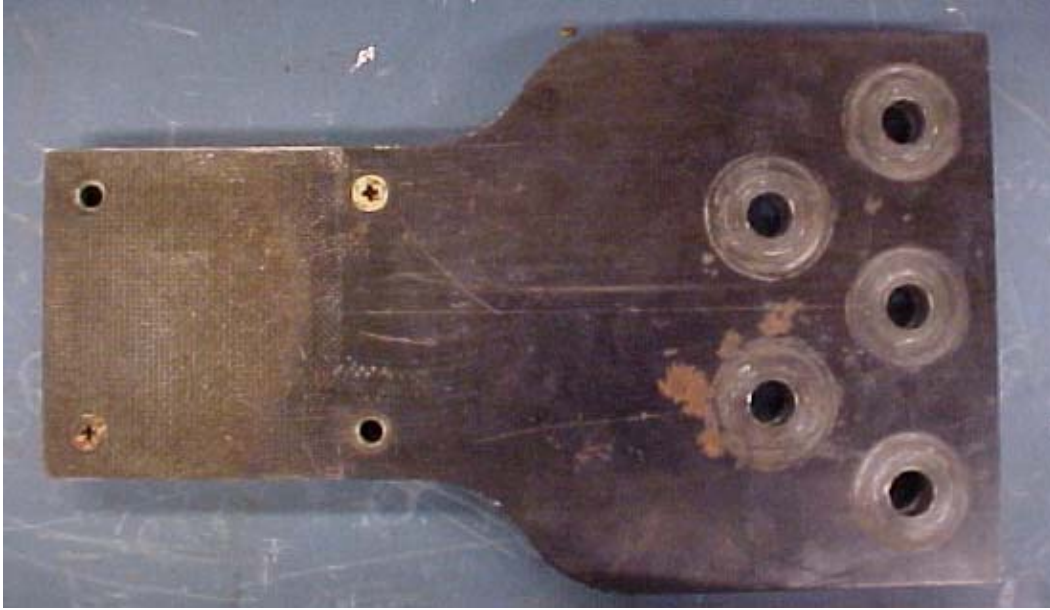
Each specimen was first laid out with 12 strain gages. The majority of the strain gages were put on the patched side of the specimen, and nearest to the center line crack (refer back to Figures 9 and 10 and table 7). Here is where the most interesting data will occur. To fit in the hydraulic machine specifically designed grips had to be attached (see Figure 15). Each specimen had to first have the five 12.7 mm diameter holes machined into the grip section, to accommodate the grips, so that it could be loaded into the machine.

Figure 15. Specimen Grips

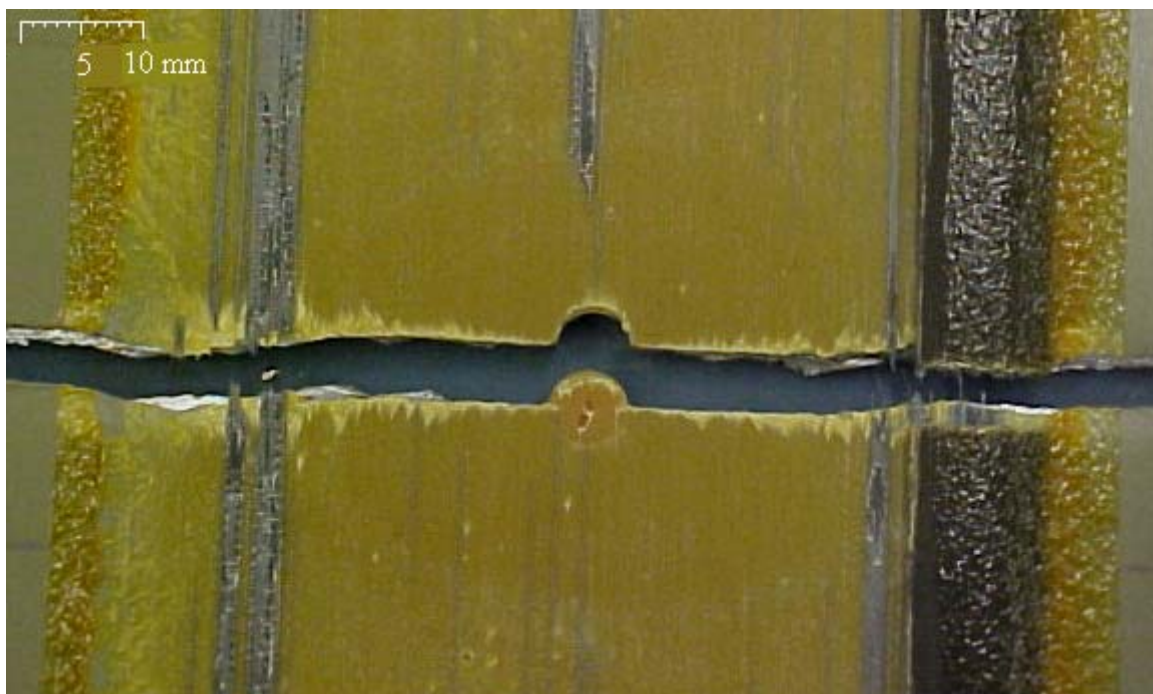
Figure 62. Close Up Photo of Test 5 Specimen

In test five, as seen in Figures 61 through 63 there was no patch left on the specimen to scan for debonds. However, the shape of the debond on the aluminum specimen and on the back of the patch can be seen fairly clearly. It is seen that in this test, most clearly in Figure 63 that this debond is unsymmetric in a different way, in that the debond is greater to the left side of the patch in this figure. This is almost certainly due to the fact that in this test the crack grew faster on that side than it did on the other. At a total crack length of 63.5 mm there was a difference in crack growth of 3.81 mm on the one side compared to the other. The unsymetric crack growth would lead to the unsymetric debond area.
